Losing the Cabin

Insights on
civil aircraft
depressurization.

BY MARK LACAGNINA

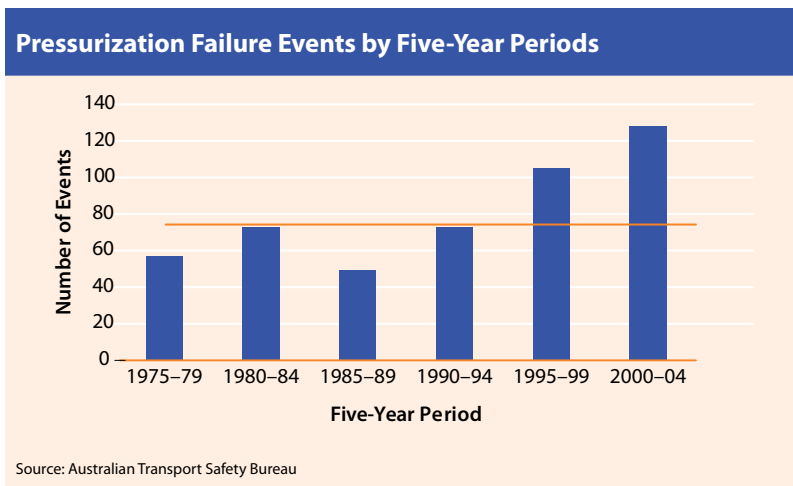
Sifting through 8,302 accidents, 95 serious incidents (near accidents) and 151,941 incidents that occurred in Australia from Jan. 1, 1975, through March 31, 2006, researchers identified 517 as “pressurization failure events.” Figure 1 shows the events grouped in five-year periods. “The apparent increase in depressurization [events] from 1985–1989 to a peak in 2000–2004 may be due to several factors, such as changes in reporting and recording of events, differences in aircraft fleet composition with each epoch, differences in hours flown per five-year period, etc.,” the report said. “In the absence of more information, it is not possible to attribute any specific significance to this apparent trend.”

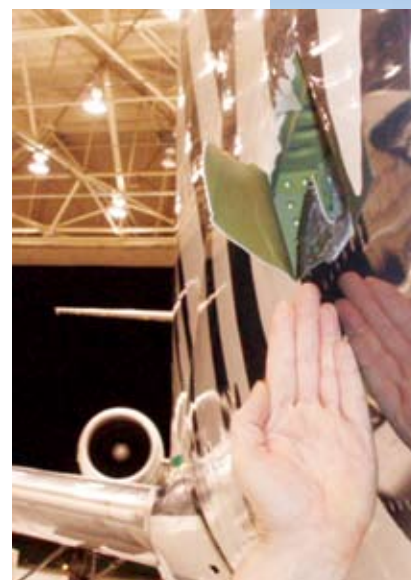
Ground damage by a tug might have led to a rupture of an MD-83's fuselage and rapid depressurization at FL 240 (see page 41).
