CASE STUDY

OISD/CS/2020-21/P&E/03

Title: Fire incident in gas terminal at one of the Indian Gas Processing Plant.

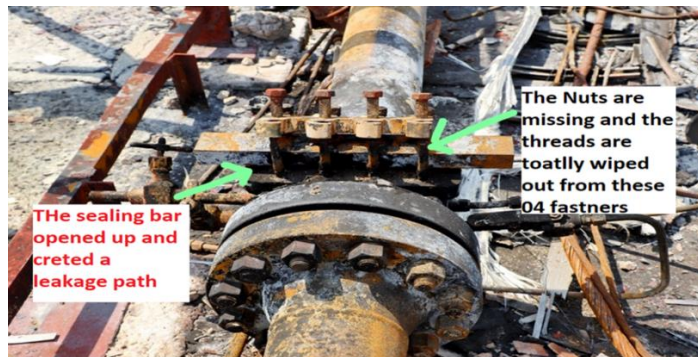
- The leakage originated from the sealing bar of the 6" single chamber orifice meter provided for measuring the condensate flow. Correlation could be established for the orifice meter as the source of leakage based on pressure and flow fluctuations observed in downstream inlet line PT and FT to CFU.

- Fasteners used in the failed orifice meter were not of standard design; It had different fasteners on the side, where the nuts got dislodged. On the other side, 02 fasteners are partially threaded and 02 fasteners are full threaded. The standby orifice meter had all the fasteners full threaded. Original design of the fasteners could not be established as drawings were not available.

Source of leak

- Loss of primary containment (LOPC) due to use of nonstandard spares during maintenance of the orifice meter.
- The immediate cause of failure of orifice meter was O-ring failure resulting in condensate leakage through the orifice sealing area under high pressure. Improper clamping of sealing surface (Bolts/ studs found loose) and / or use of non-standard O-ring might have contributed towards the cause of failure. Failure of O-rings due to gradual loss of clamping pressure was a possible scenario.

- Only genuine and standard parts from OEMs to be used for the pressure equipment.
- SOP shall include normal operation, start up and shut down procedure with responsibility for each activity. Relevant SOPs to be reviewed, signed by competent authority and same shall be made available in the Control Rooms and to concern officials.

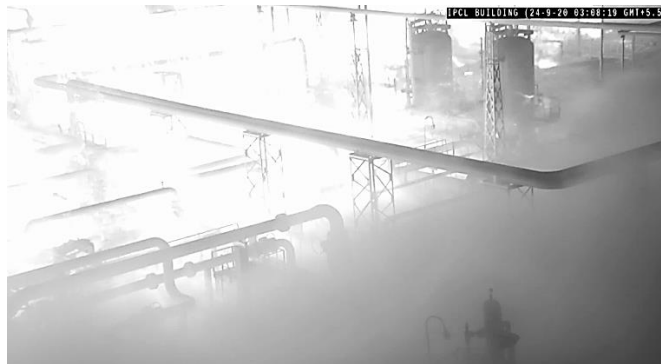
Vapour Cloud

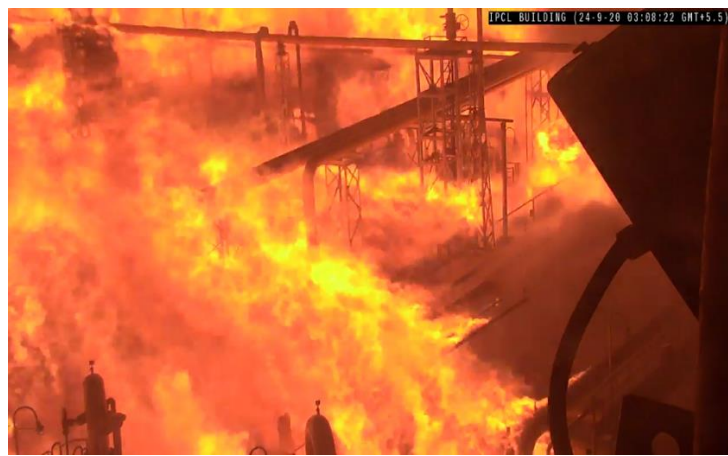
Fire incident

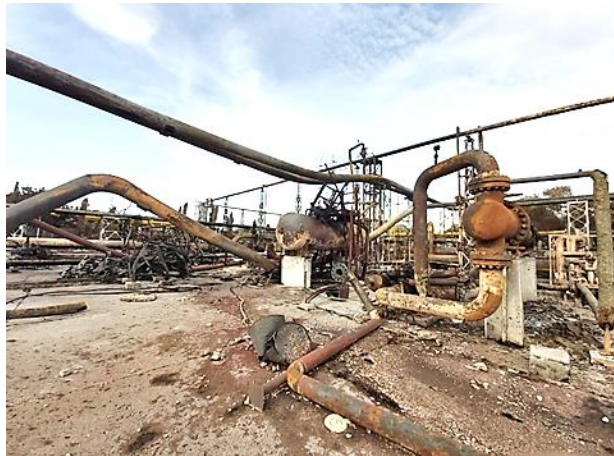
- Two pipe lines got dislocated and were in hanging position due to failure of supports. Preliminary observation showed there was no fire proofing provision for the steel truss supports.

Incident Severity

- Requirements of fire proofing of structural members to be re-evaluated in line with OISD-STD-164 and implemented for process area, as per requirement.

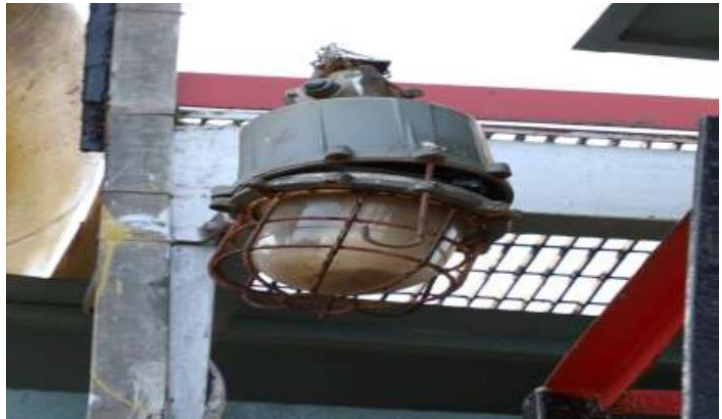
- The confirmed source of ignition could not be established; but looking at the fire propagation direction and damaged condition of one of the nearby lamps, the said lamp was suspected to have acted as the ignition source for the vapors cloud. The cage of the lamp was found broken from the joint.

- Integrity of flame proof lighting and associated fittings to be ensured.
- Electric power, which may act as ignition source to be cut off after detecting leak / HC Vapor cloud.
