# PERFORMANCE AND MAINTENANCE EXPERIENCES WITH A WIND TURBINE DURING 20 YEARS OF OPERATION

R. Nolan Clark  
Agricultural Engineer  
USDA – Agricultural Research Service  
PO Drawer 10  
Bushland, TX 79012  
[Nolan.Clark@ars.usda.gov](mailto:Nolan.Clark@ars.usda.gov)  
<http://www.cprl.ars.usda.gov>

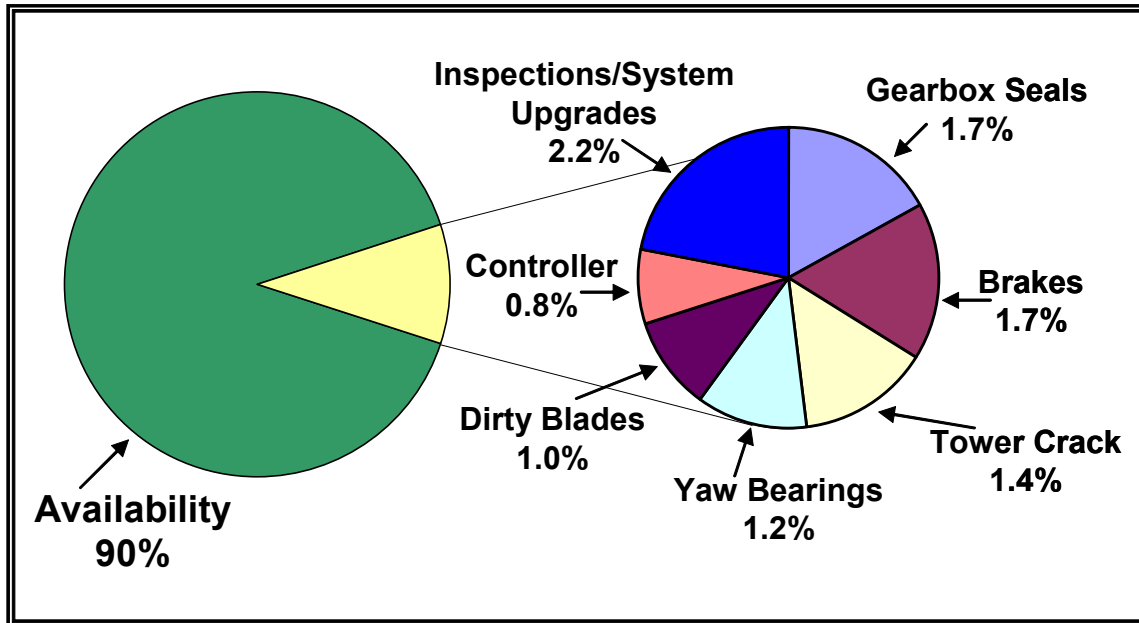
early production unit, these units performed well. Major maintenance and repairs are summarized in Figure 3. Similar items have been grouped for ease in describing events. Table 4 shows the complete list of down-times, the parts involved, the frequency of occurrence and a description what was performed. The six major causes of down time are described below.

Gearbox seals created the most lost run time because the repairs required the turbine to be removed from the tower, the hub removed and the shaft polished. The seals were replaced three times, but problems with the gearbox drain valve, vent and routine fluid checks were also included in the total of 3,271 hours or 1.7% of the 20 year period.

Close behind the gearbox repairs were repairs to the brakes. The unit had three braking systems, two of which required most of the repair. Out of the total time assigned to brakes, 2,669 hours were attributed to the parking brake and 563 hours to the tip brakes. Most of the parking brake problems were caused by the initial brake being too small and then several emergency stops during 2001-2002 when the unit was used to develop a wind/diesel hybrid control system. Repairing the parking brake required replacement of three disk pads and often times the metal spacers between the pads.

In October 1986, 4.5 years after installation, a 5-cm (2 in) long crack developed in the up-wind tower leg just below the top mounting plate. Similar cracks were found on this manufacturer's wind turbines located in the wind parks in California. After careful study by several groups, it was concluded that the crack was caused by loads translated from the free yaw movement of the rotor. Several "fixes" were suggested and we chose to replace the top tower section legs (schedule 40 pipe) with schedule 80 pipe. This was done and the turbine was returned to service resulting in 2611 hours of lost run time after locating the crack. There were 22,437 operating hours on the tower when failure occurred. This problem did not reoccur after the heavier tower leg was installed.

The yaw bearing was replaced 3 times during the 20 years resulting in lost run time of 2,534 hours. The turbine had to be completely removed from the tower for this repair. We determined that there were two contributing factors that caused excessive wear of the yaw bearing. The free yaw design allowed the turbine to waggle back and forth creating large moments on the bearing. Because of the prevailing wind direction at Bushland, significant wear occurred in a small portion of the bearing. The other contributing factor was the small diameter of the bearing, causing a large load on a small percentage of the bearing. A larger diameter bearing would have spread out the load, thus reducing the wear at the prevailing wind direction. Also included in this down time is the lubrication and inspection of the yaw bearing.

Fig. 3. Major repair and maintenance times.

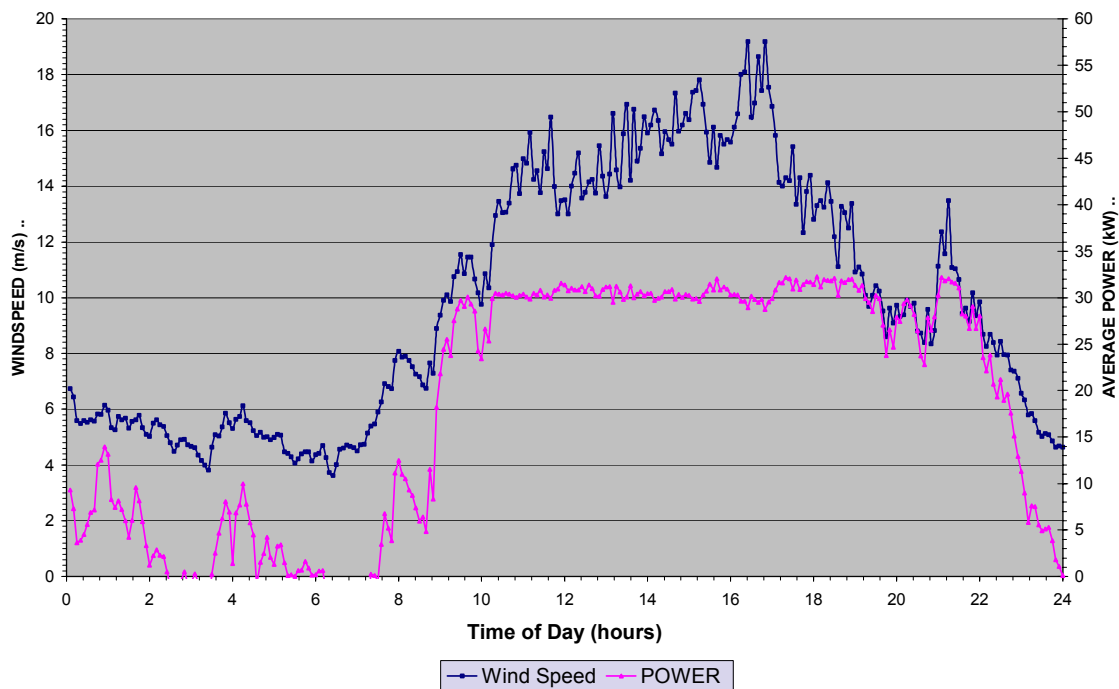
Accumulations of bugs, oil, and ice on the blades reduced power as much as 40%. Regular cleaning of the blades became a maintenance requirement. Included in the 1,705 hours of down time for cleaning the blades is several ice storms when the ice caused the airfoil shape to be changed and the turbine could not produce power. Results of the effect of dirty blades was reported by Yekuieili and Clark, 1987. Figure 4 shows the effect to

Fig. 4. Dirty blades from leaky oil, bugs, and ice reduced power by as much as 40% at rated wind speed. Regular cleaning of the blades became a maintenance requirement.

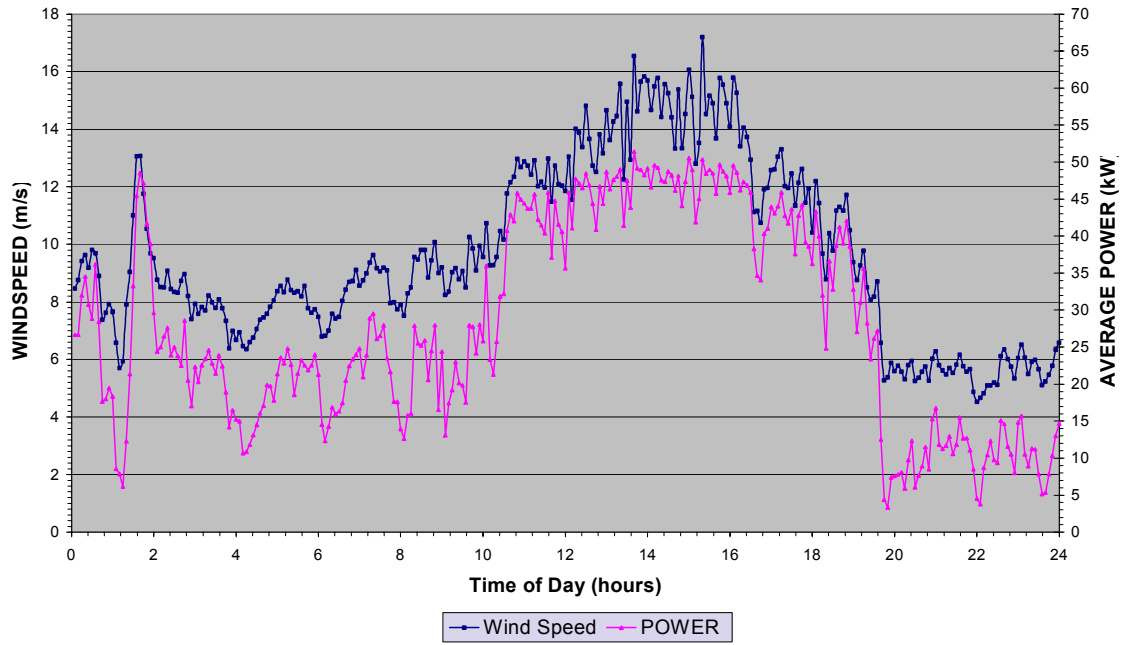
performance of dirty blades and figure 5 shows that performance is easily restored after a rain.

Fig. 5. Power was restored after blades were washed; either by rain or water spray.
