14.3.2 Loss of Laser Altimeter Altitude Data

14.3.3 Slow Deployment Of Mapping Camera

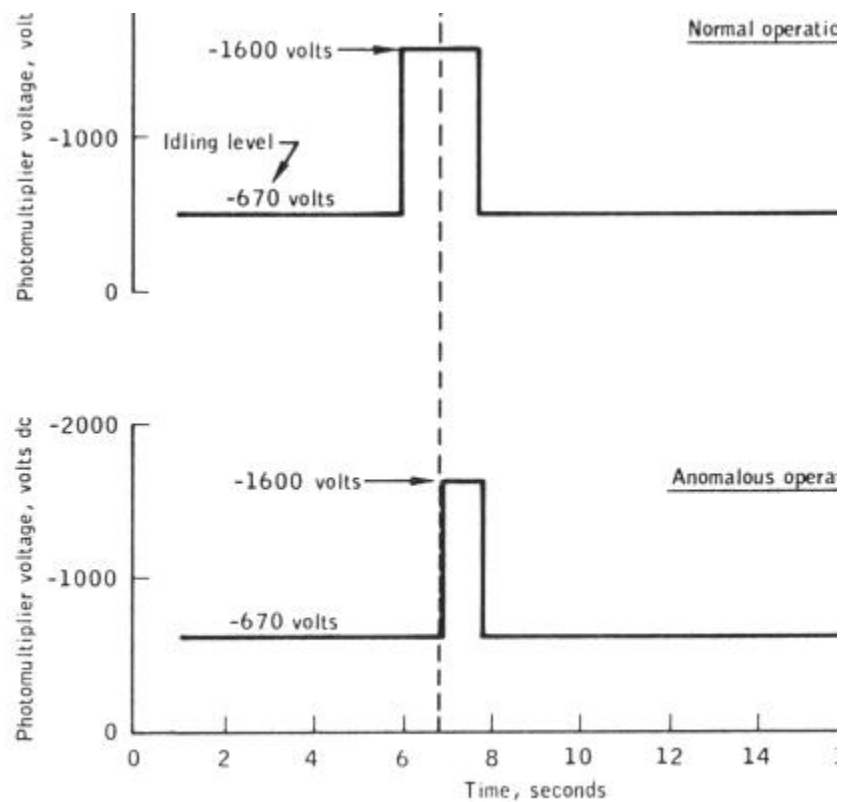
Figure 14-37.- Comparison of photomultiplier power supply volt.

- Altitude data became intermittent after revolution 24 as the result of a decrease in the laser output power.
- Beginning with revolution 38, the photomultiplier tube high-voltage power supply was held in the idling (minimum-voltage level) mode until after the laser fired, thereby causing the receiver to miss the return pulse from the lunar surface (**Fig. 14-37**). No altitude data were obtained after this anomaly occurred.

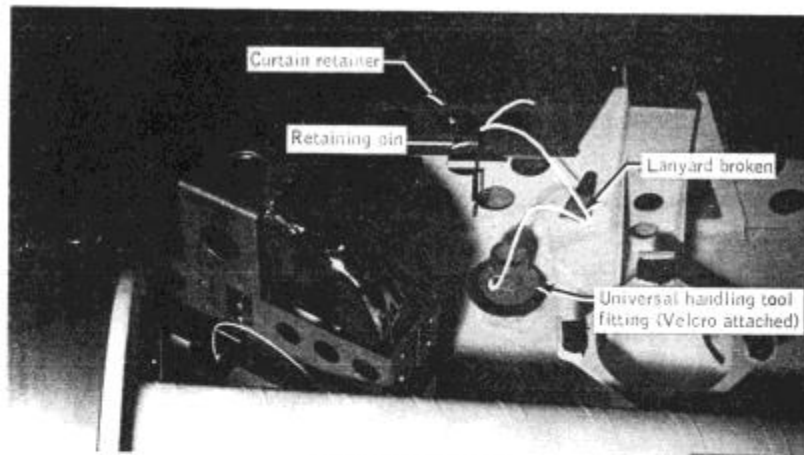
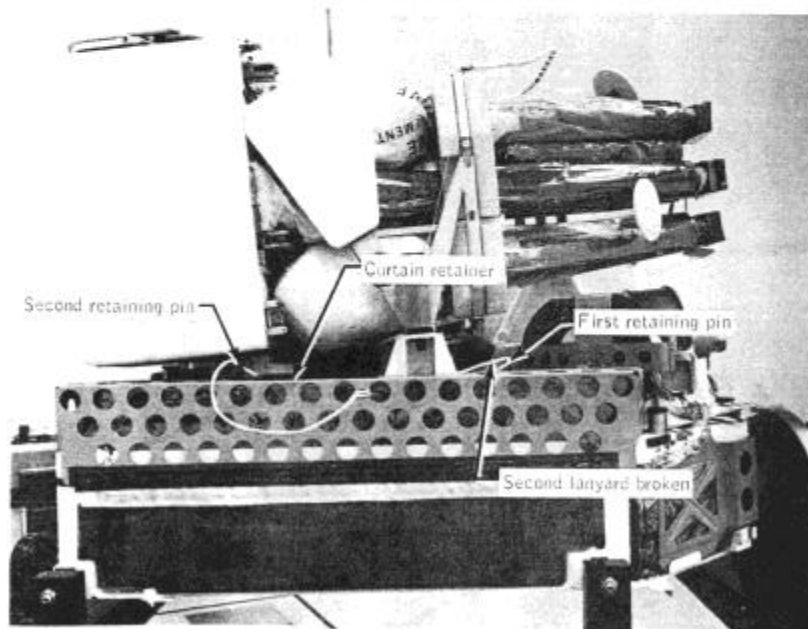
Figure 14-45.- Central station rear curtain retainer removal.

To remove the retainer for the central station rear curtain, added for Apollo 15, it was necessary to remove two retaining pins (**Fig. 14-45**). The two pins, a universal handling tool fitting, and the curtain retainer are joined by a three-section lanyard. When the universal handling tool was inserted in the fitting and raised to remove the first pin, that section of the lanyard broke. When an effort was made to remove both pins simultaneously by inserting the handle under the lanyard joining the two pins, that part of the lanyard broke. The pins and retainer were then removed by hand.

The Dacron lanyard is being changed from a 50-pound test rated material to a 180-pound test rated material with acceptance pull tests being increased to 20 pounds for

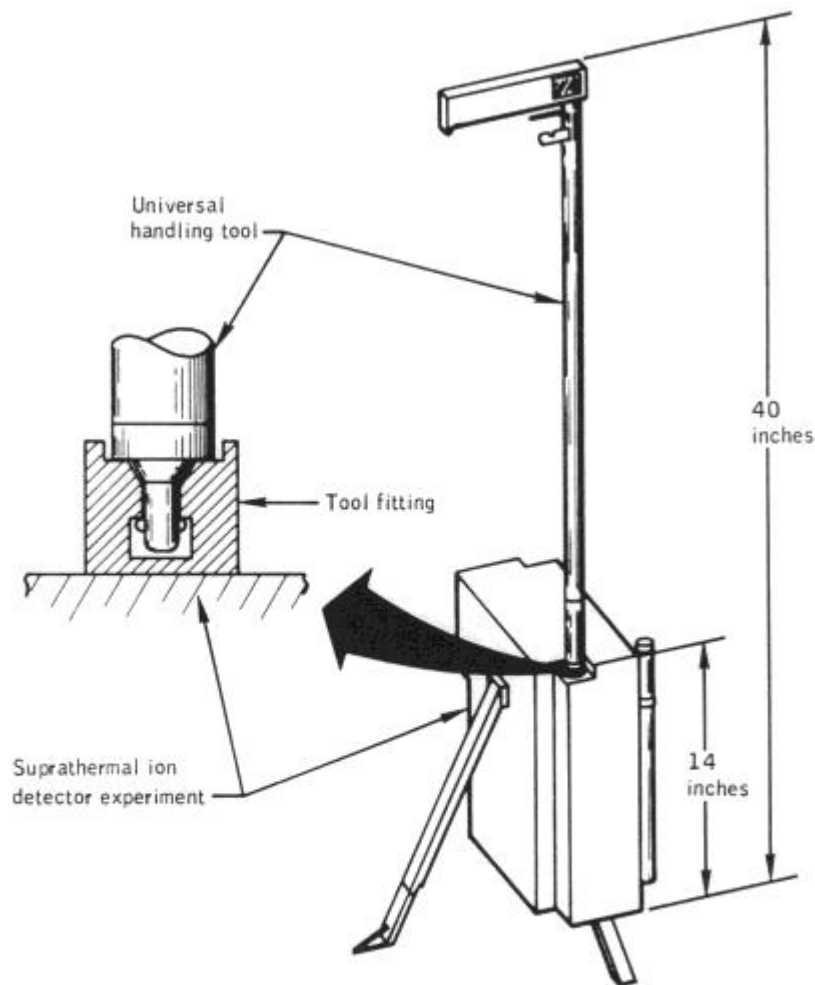
Figure 14-46.- Universal handling tool - suprathermal ion detector experiment interface.

The universal handling tool fitting on this experiment is in the highest location above the lunar surface of any of the fittings and presents an awkward position of the tool for insertion, locking, and maintaining lock in the fitting (**Fig. 14-46**).

Corrective action includes training procedures to avoid inadvertent tool-release triggering because of the position of the tool. There are no present plans for the suprathreshold ion detector experiment to be carried on future missions, and no other scheduled experiments have a similarly located fitting.

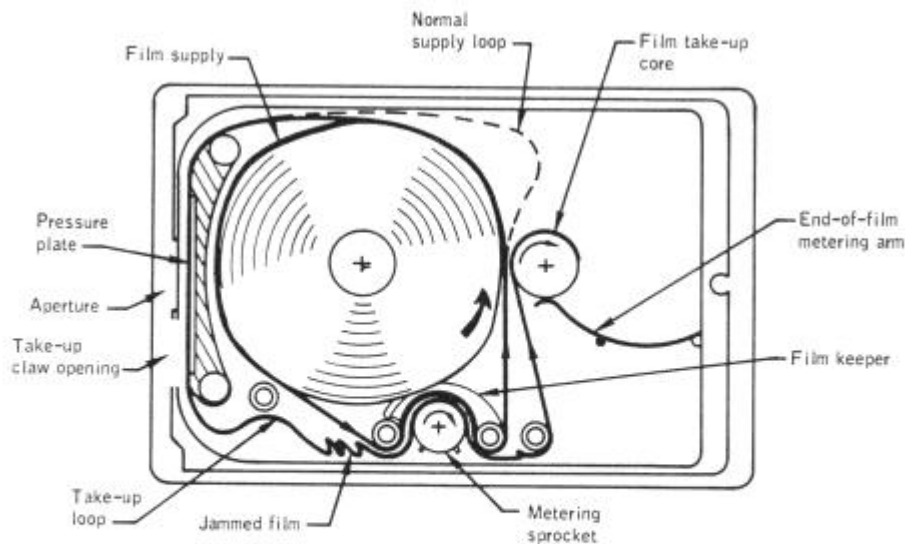
Figure 14-50.- Lunar surface 16mm camera magazine.

advancement varied from five to twenty-one frames in the jammed magazines. The film supply loop (**Fig. 14-50**) normally contains three to five excess frames. The normal procedure is to inspect the magazine for proper frame alignment in the aperture area, and manually advance the film not more than one frame, if required to obtain proper alignment. The excessive manual advancement depleted the film supply loops in all magazines.

Hardware analysis, air-to-ground voice tapes, and crew debriefing indicate that the lunar surface camera functioned properly, and the jammed magazines resulted from procedural errors. Corrective actions are to insure adequate crew training through scheduled prelaunch briefings, stress malfunction procedures and corrective actions, and put a removal flag on the tape.

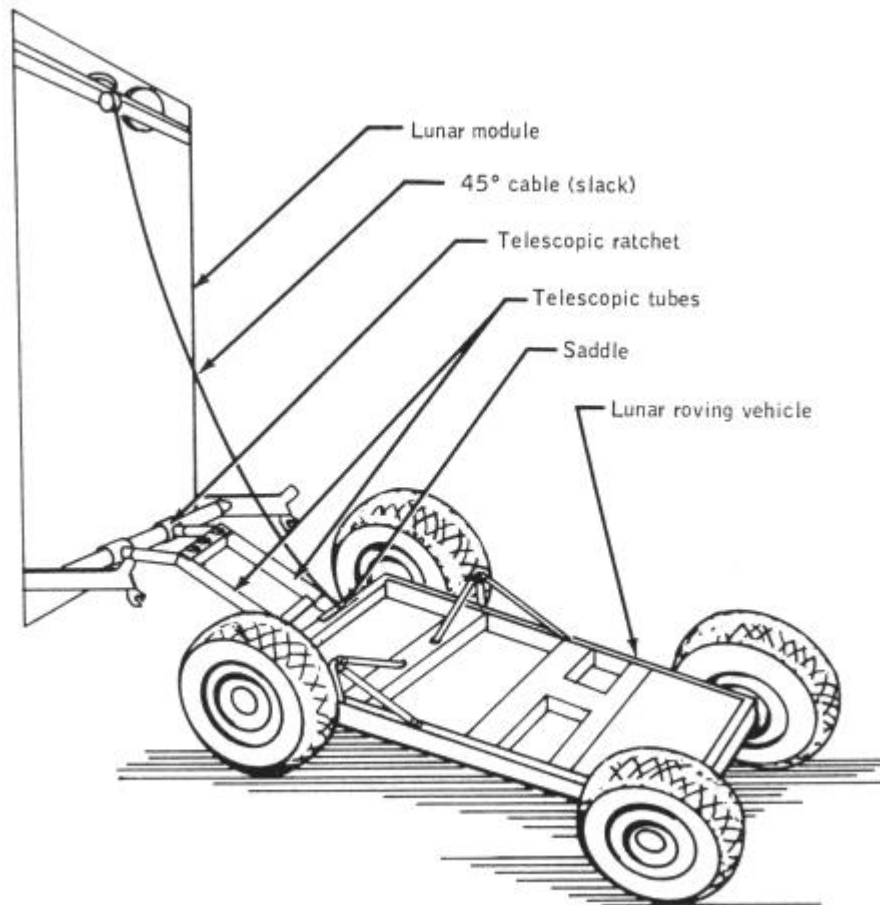
Figure 14-55.- Lunar roving vehicle deployment.

Ground tests have shown that if the partially deployed lunar roving vehicle resting on the surface but not yet detached from the saddle and lunar module, is rolled either to the left or right, the saddle/rover chassis interface will bind. The interface can be released, and the saddle dropped to the ground by one crewman adjusting the roll back to zero while the other taps the saddle with a hand tool. The corrective action is to insure adequate crew training.
