# Zinc Whiskers

Could Zinc Whiskers  
Be Impacting  
Your Electronics?

Jay Brusse

QSS Group, Inc. @ NASA Goddard Space Flight Center

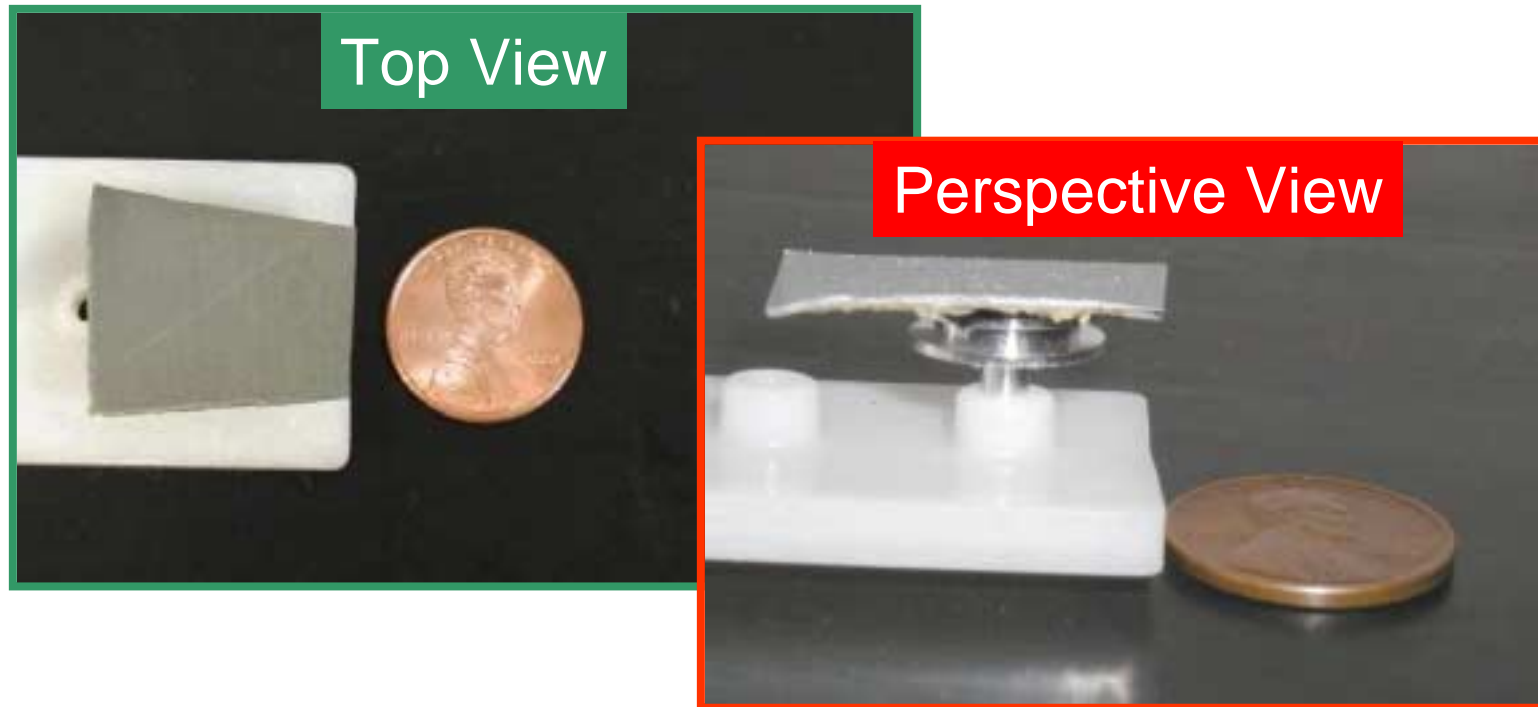
# Zinc-Plated Steel Removed from Access Floor Tile

Sample Has Been Mounted to an Aluminum Stage Using Double-Sided Conductive Tape to Facilitate Optical and Scanning Electron Microscope Inspection

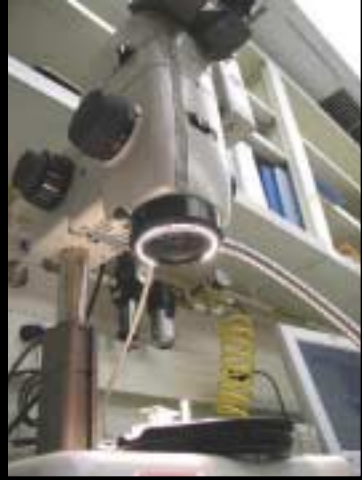
Microscope w/  
“Ring” Light for  
Top Illumination

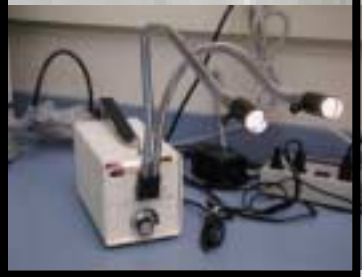
Side Illumination  
Via “Flex” Light

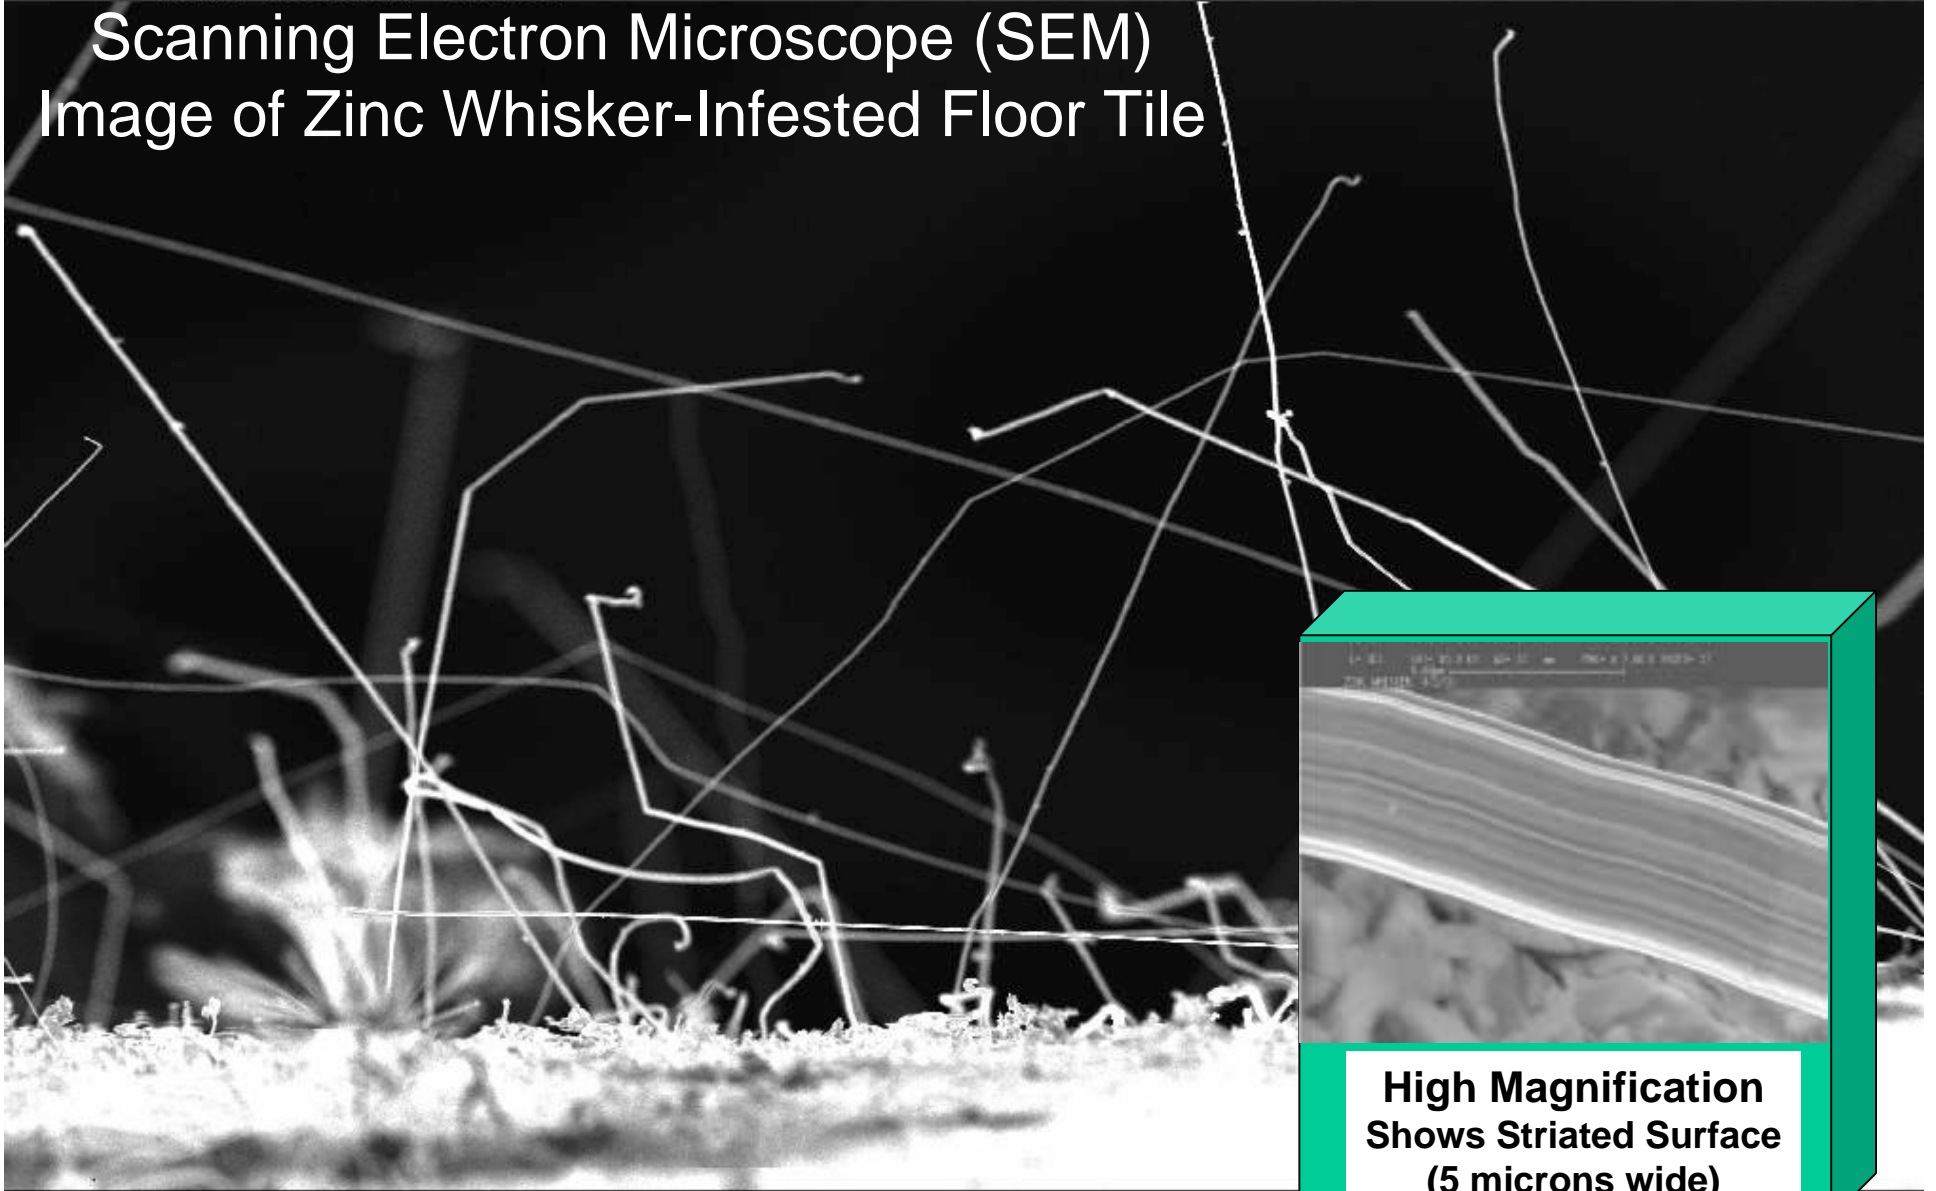
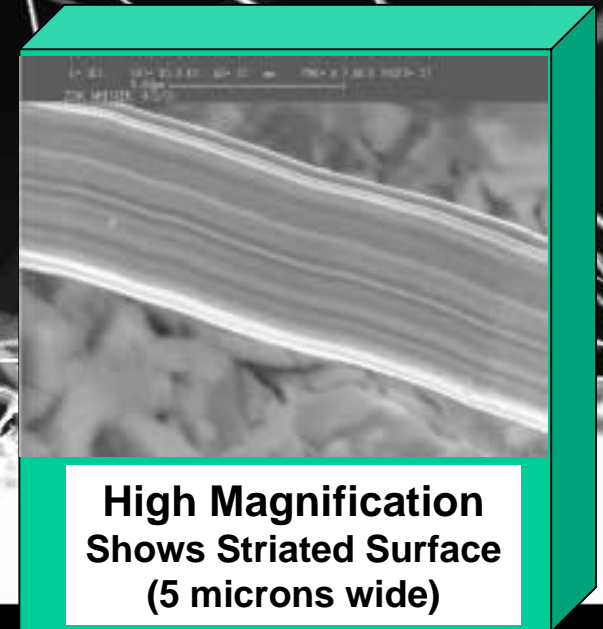
# Scanning Electron Microscope (SEM) Image of Zinc Whisker-Infested Floor Tile

**High Magnification  
Shows Striated Surface  
(5 microns wide)**
