SECOND FIVE-YEAR REVIEW REPORT

Bally Ground Water Contamination Superfund Site

Borough of Bally

Berks County, Pennsylvania

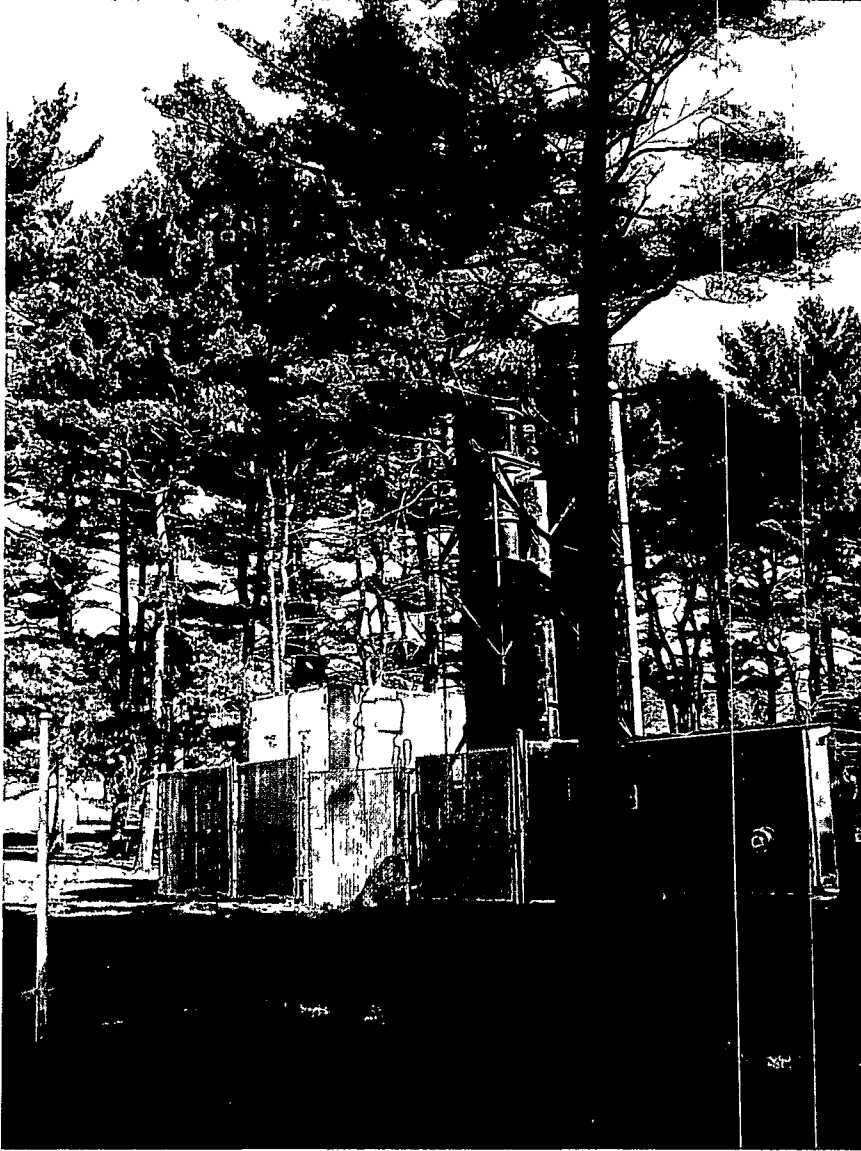
Photograph of the air-stripper treatment system present at Bally Municipal Well Number Three.

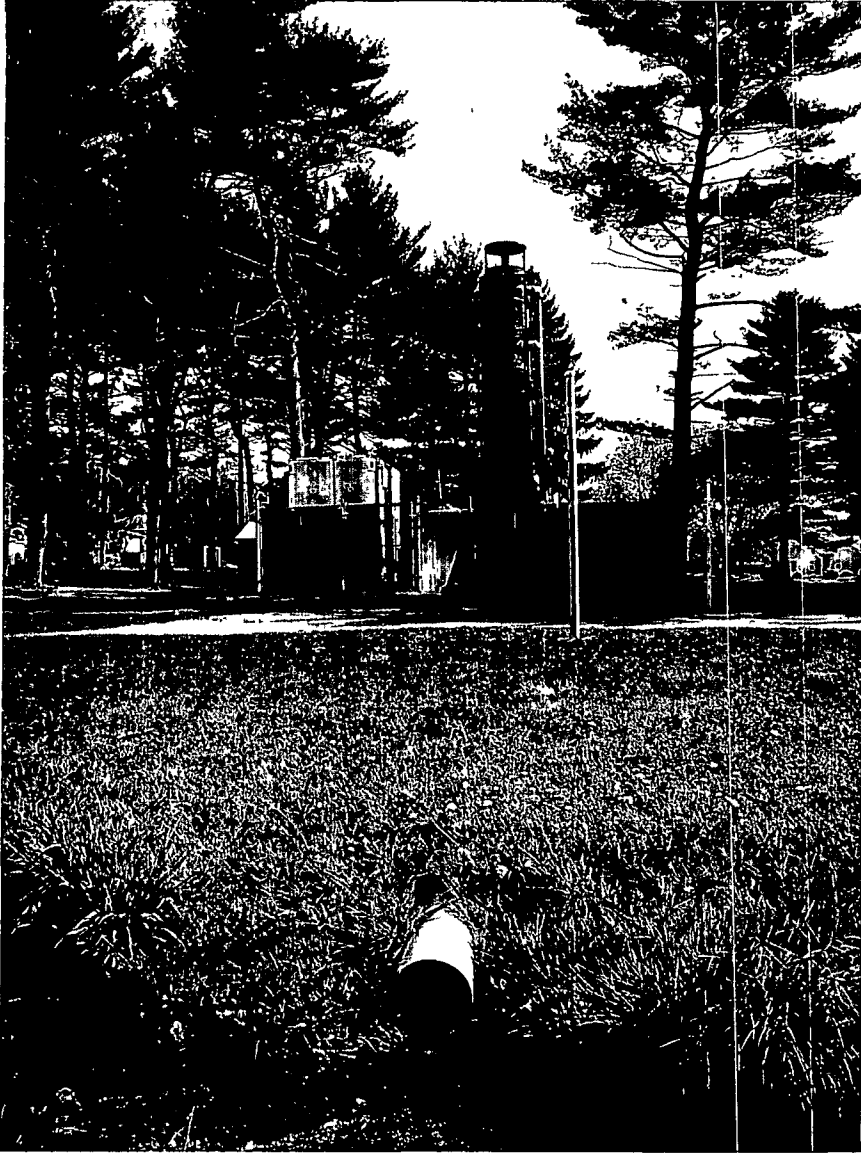
Photograph of the air-stripper treatment system outfall into an unnamed tributary of the West Branch of the Perkiomen Creek.
