Effect of Molding and Machining on Polychlorotrifluoroethylene

Jess Waller, White Sands Test Facility,
Johnson Space Center

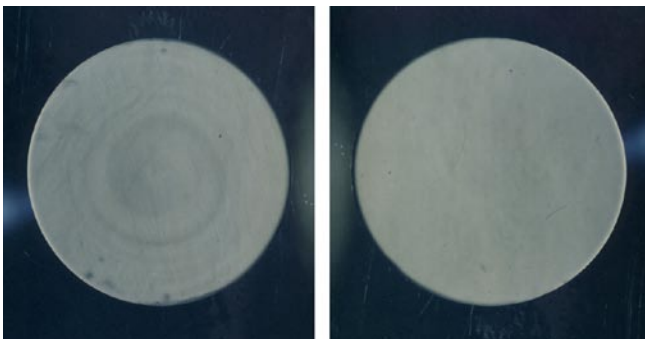
Estimation of the maximum allowable extrusion due the stress relief of the as-fabricated interference fit revealed that observed levels of extrusion often exceeded the theoretically predicted maximum, suggesting that factors other than thermally-induced extrusion or stress relief were contributing to extrusion (Figure 1). Intermittently welded pilot seat assemblies frequently reached higher levels of extrusion than their circumferentially welded counterparts despite having fewer years in service. Type I extrusion cases, exhibiting both pilot seal id and od extrusion, were determined to be a more advanced form of Type II extrusion (only exhibiting pilot seal od extrusion). Extrusion-related in-flight thruster anomalies were also determined to be of the more severe Type I extrusion category.

Observed (symbols) vs. predicted extrusion (dashed lines) for circumferentially welded (left) and intermittently welded (right) extrusion cases.
