NMP EO-1

DELTA PRE-SHIP REVIEW

Hyperion

Grating Imaging Spectrometer

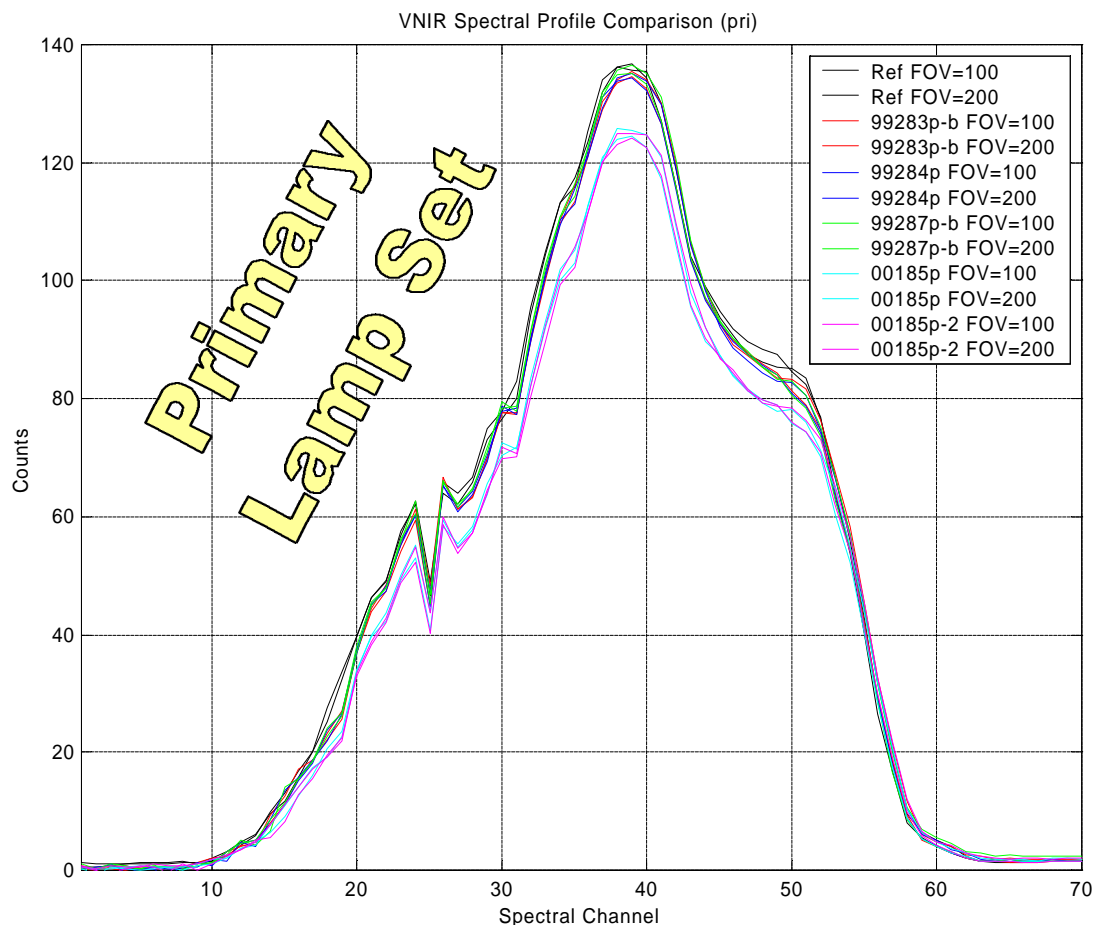
Internal Calibration Lamp VNIR Response

- ◆ ***May 28, 2000: Analysis of VNIR response to the primary internal cal lamp image from CPT 8, 10 testing under ambient conditions on May 26 found that the response was about 7% lower than a reference image taken during the first EO-1 T/V test.***
 - *Review of data acquired earlier found gradual decreases in response had taken place*
- ◆ ***A quick check of the secondary lamp, which is operated less frequently, initially found it had been stable over the same period of time, with a small increase.***
 - *VNIR focal plane not suspected to be a problem because the two lamps produced different responses*
 - *Later comparison with TRW data found Redundant lamp response had increased.*
- ◆ ***Modified plans for T/V II testing to use both cal lamps more frequently***

- ◆ **Response to primary internal cal lamps is lower than at TRW**
 - EO-1 TV#1 same as TRW
 - EO-1 TV#2 data lower than TV#1
- ◆ **Trend of gradual degradation:**
 - YR 99 Day 238 [8/25/99] = 0% using as a reference
 - YR 99 Day 268 [9/25/99] = 2% decrease at band 40
 - YR 99 Day 342 [12/8/99] = 4.3% decrease at band 40
 - YR 99 Day 343 [12/9/99] = 5.5% decrease at band 40
 - YR 00 Day 147 [5/26/00] = 9% decrease band at 40
 - YR 00 Day 157 [6/5/00] = 9% similar to above

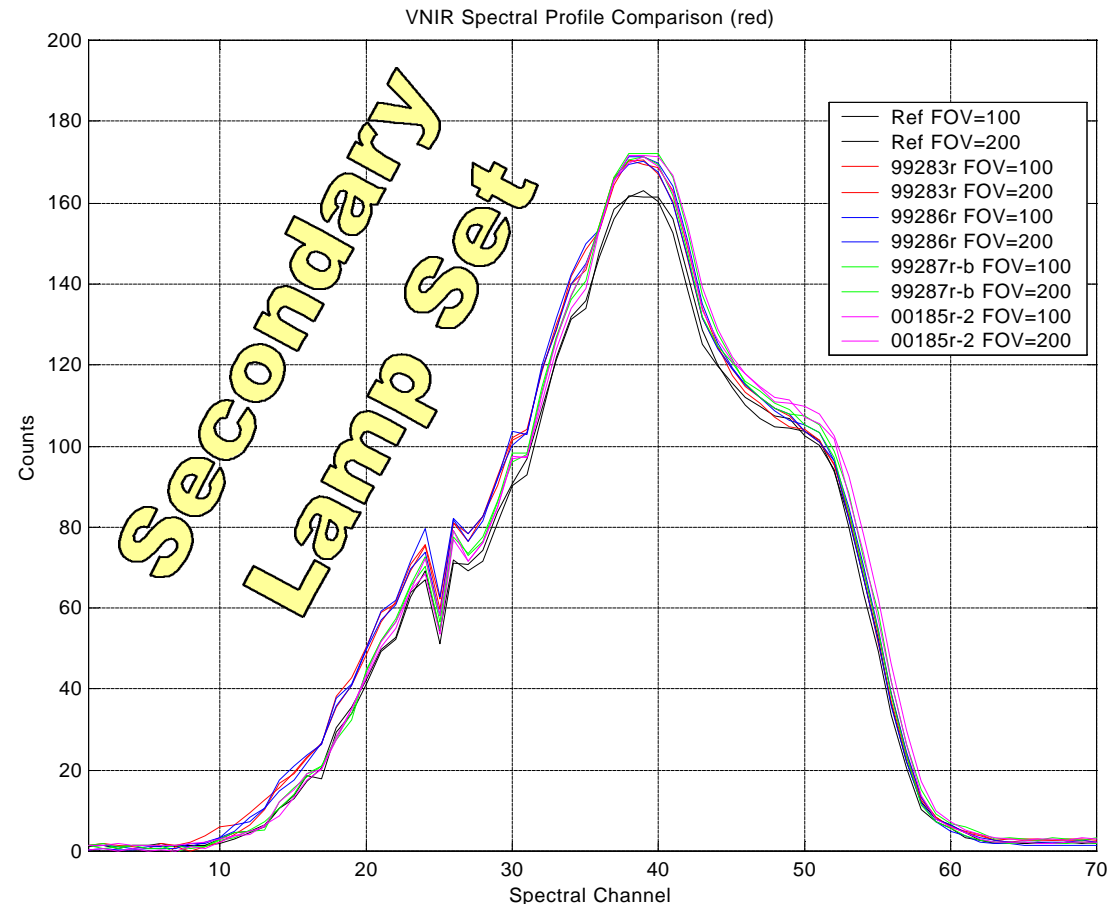
Internal Calibration Lamp VNIR Response

- ◆ **Recent data from redundant internal cal lamps is higher than at TRW by 5%**
 - *Data acquired at GSFC is stable*
- ◆ **Lamps were not burned-in to stabilize properties before using them**
 - *Burn-in modifies tungsten filament grain structure, increasing output*

- ◆ ***Perform additional burn-in time on both lamps until response is repeatable***
 - *Accumulate on-time necessary to stabilize, at least 6.5 hours.*
 - *Primary lamp set has accumulated approximately 4 hours.*
 - *Secondary cal lamp has accumulated approximately 1 hour.*
- ◆ ***Increase lamp on time to 3 minutes after each DCE***
 - *Ensure glass envelope achieves sufficiently high temperature to activate the halogen cycle*
- ◆ ***Consider revised calibration sequence to utilize both lamps***
 - *Image (dark file)*
 - *Lamp 1 on 3 minutes, image lamp 1*
 - *Lamp 2 on 3 minutes, image (both lamps)*
 - *Lamp 1 off 3 minutes, image lamp 2*
 - *Lamp 2 off 3 minutes, image (dark file)*

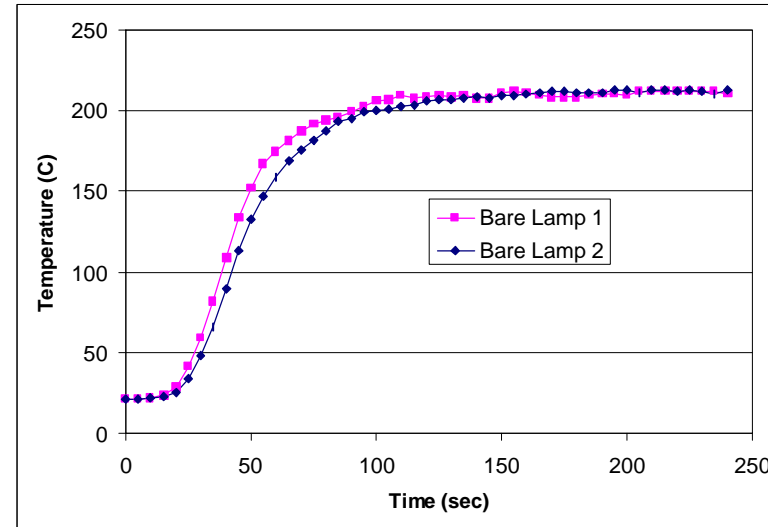
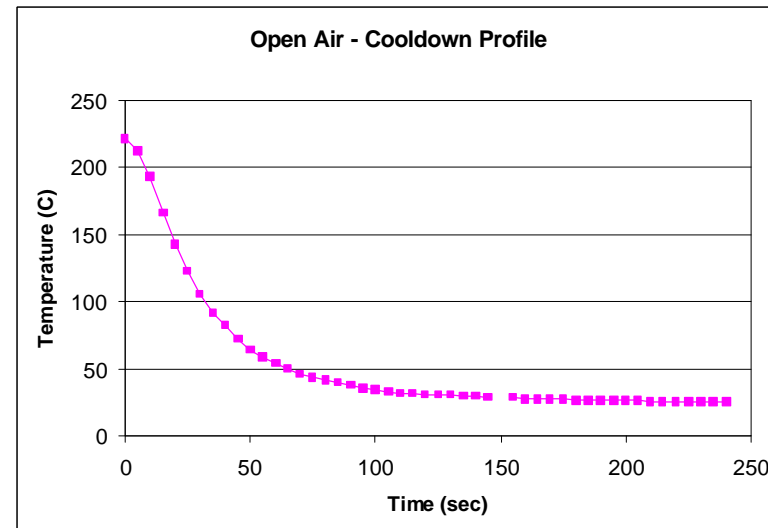
Cal Lamp Investigation Findings (1)

- ◆ **Measured lamp envelope temperature rise vs. time:**
- ◆ **Bare Bulb:**
 - *Lamp envelope temperature at 40 seconds is up to 100C less than stabilization temperature*
 - *2 to 3 minutes required to reach 200 to 210C*
- ◆ **Flight Assembly:**
 - *Peak temperature achieved is 20 to 30C below bare bulb, in same time.*
 - *Other lamp components get warm (72C)*
- ◆ **Bare bulb cooldown time comparable to warm up**

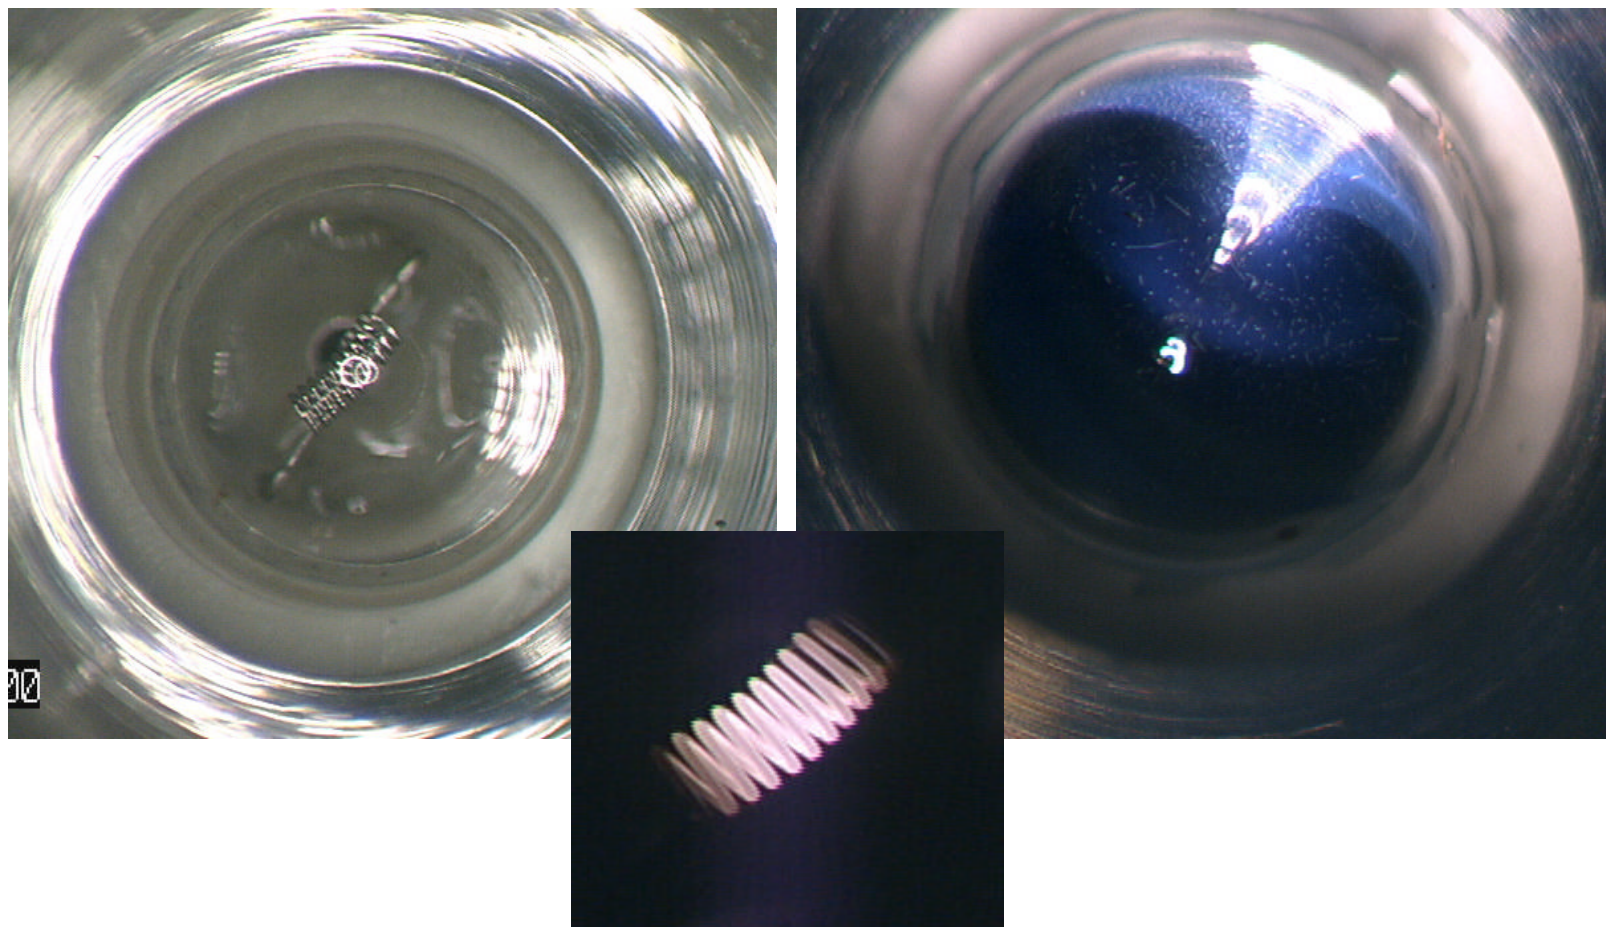
Sample Cal Lamp Photos

- ◆ ***Tested HEA lamp circuits using Hyperion Instrument Test Set & ISU***
 - *No abnormal operation; circuits stable and linear, as tested at TRW*
- ◆ ***Measured resistance of lamps from HEA connector.***
 - *Measured 4 circuits: 1.1, 1.4, 1.3, 1.3 ohms (normal)*
- ◆ ***Inspected & photographed lamps with filament on and off***
 - *First impression: could not tell any difference between primary and secondary lamps by eye; generally lamps & reflectors looked like new*
 - *Filaments looked normal unpowered and powered*
 - *Under some lighting, some speckles evident on envelope*
 - *Swabs taken of primary lamps and reflector - no evidence of anything visible on swab*
 - *Cal sequence run before & after cleaning; very slight difference*
 - *Swabs to be analyzed*
 - ***Note: Maximum lamp on time was 7 minutes during photographic sequence***

- ◆ *Lamp filament off an on (inset), and envelope images*

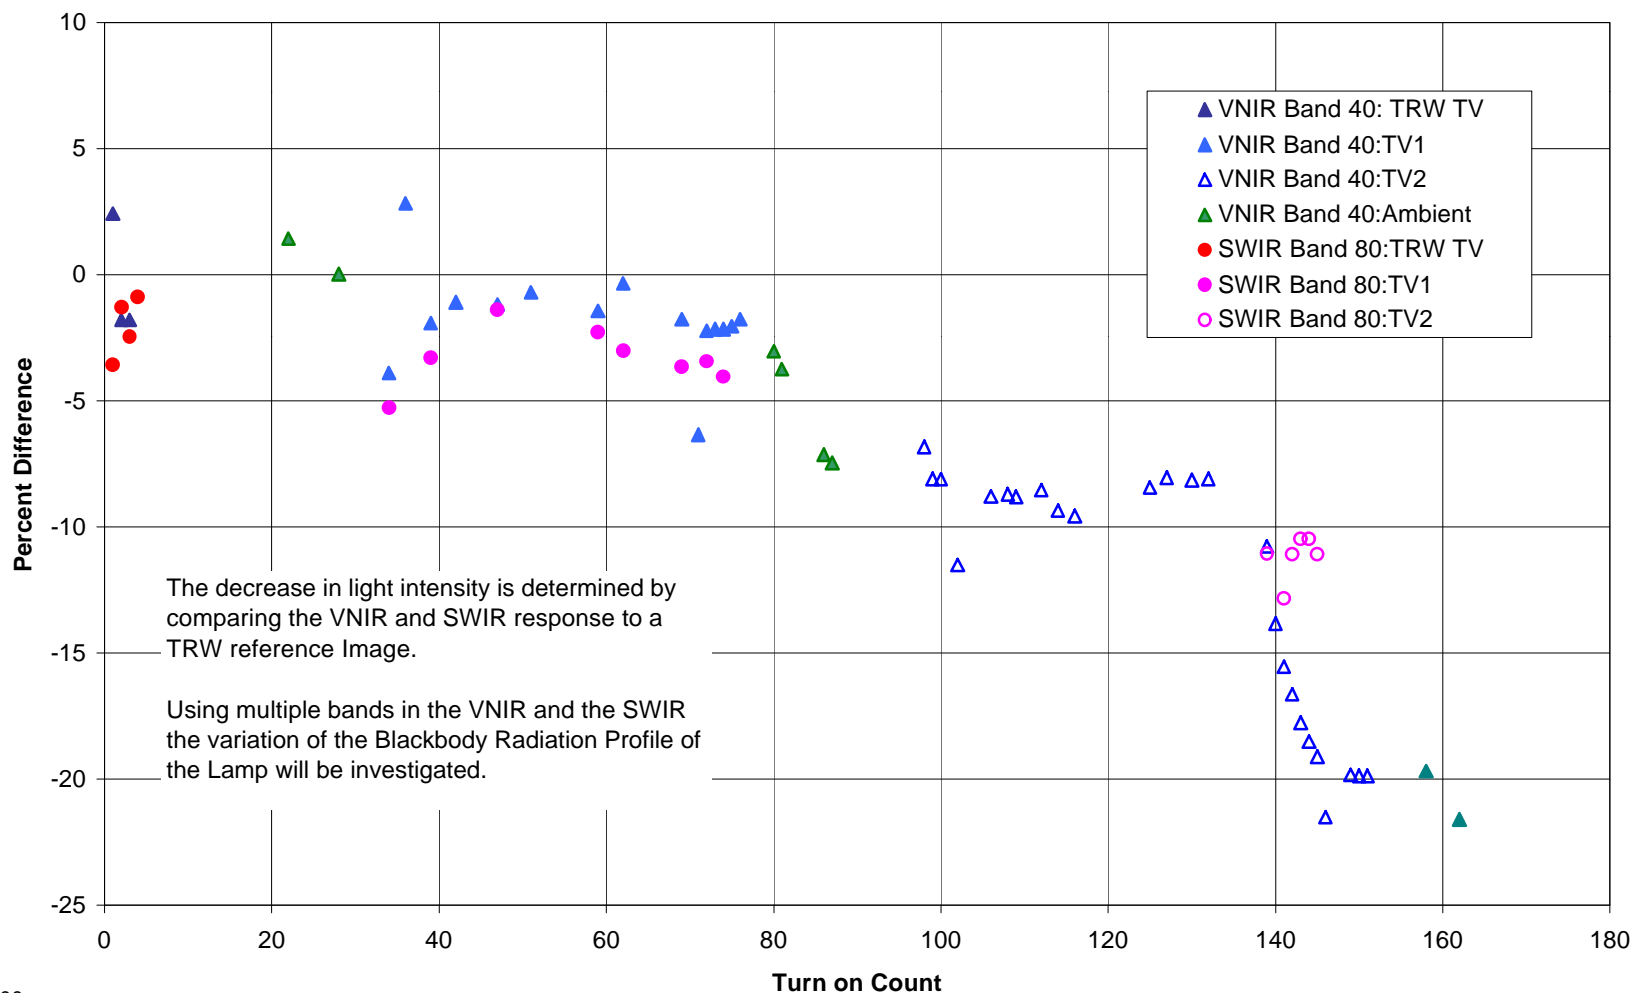
Primary Cal Lamp Response History

- ◆ Plot of % change of spectral channels 40 & 80 from TRW reference image since time of delivery. Both VNIR and SWIR response shown.

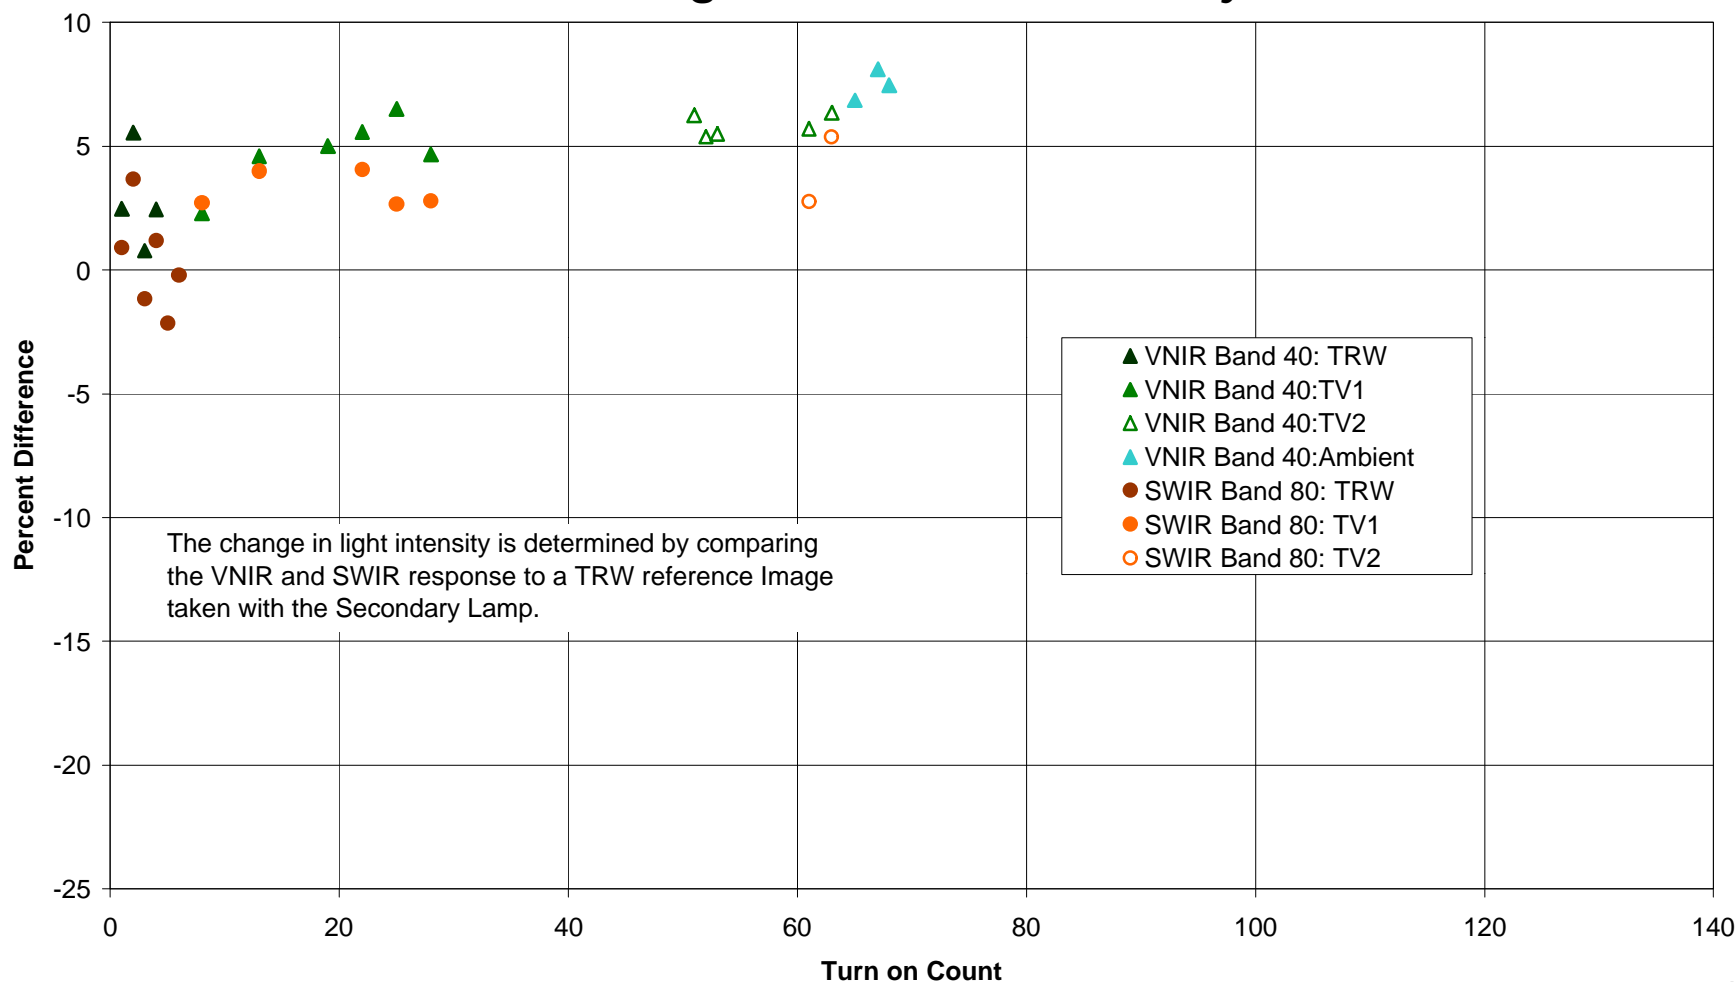
Secondary Cal Lamp Response History

- ◆ Plot of % change of VNIR spectral channel 40 & SWIR channel 80 from TRW reference image since time of delivery.

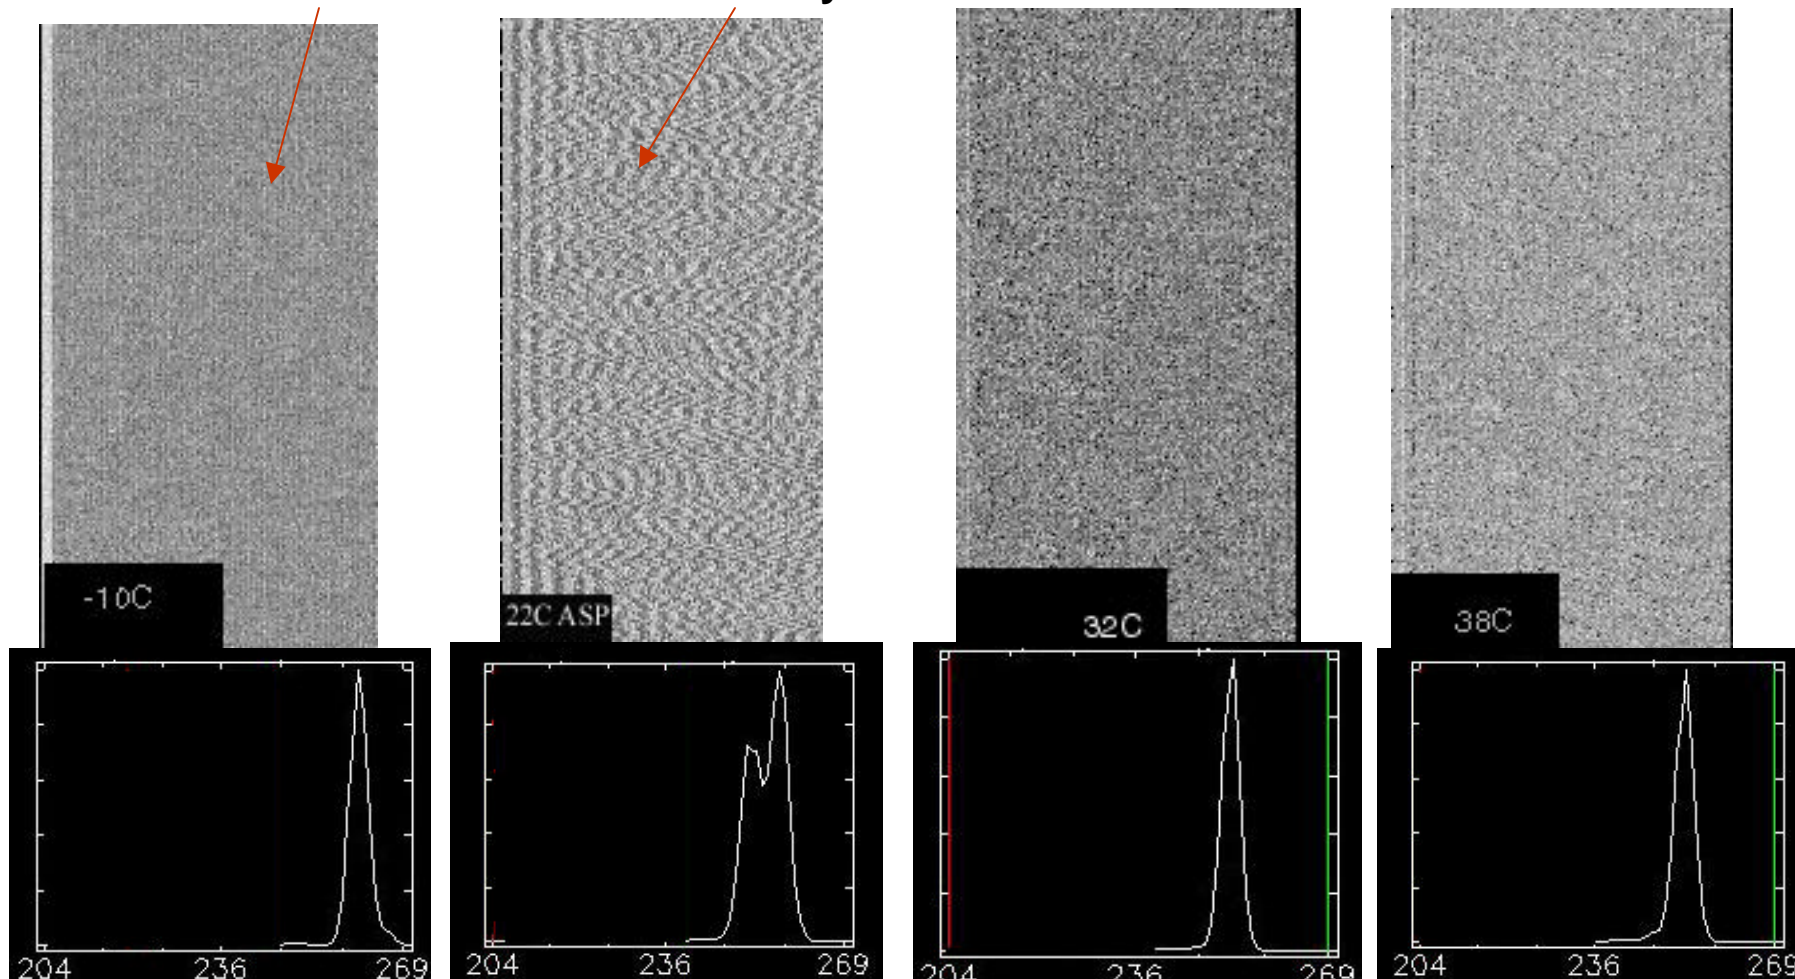
Impact of ASP Temperature on VNIR Image

- ◆ *Increased noise in the VNIR data is observed for ASP operating temperatures between 5C and 32C.*
- ◆ *The noise level increased only for the two quadrants associated with shorter wavelengths of the VNIR. The noise levels in the other two quadrants are independent of ASP temperature.*
- ◆ *The noise characteristics indicate both a broader dual Gaussian distribution and a small coherent overlay. This increase is due to the temperature sensitivity of the signal processing electronics.*
- ◆ *The noise has been characterized and can be avoided by operating the ASP at temperatures above 32C, but below the red limit of 50C. This was demonstrated during T/V II.*

- ◆ *The VNIR noise increase was characterized and increased noise can be avoided by operating the ASP at temperatures above 32C. This was tested during T/V II.*
- ◆ *Thermal models predict ASP temperature ranges of 32C to 41C when the ASP heater setpoints are 32C on and 34C off; 41C is acceptably below the upper ASP operating limit of 50C.*
- ◆ *Noise Performance during T/V II was measured with ASP temperatures from 32C to 45C and noise decreased with increasing temperature as predicted in the earlier analysis.*
- ◆ *The issue has been resolved through a change in heater set point and operating conditions.*
