Pompano - Hurricane Ivan

VK989A (Pompano)

Hurricane Ivan Damage (Sept 2004) – Pompano

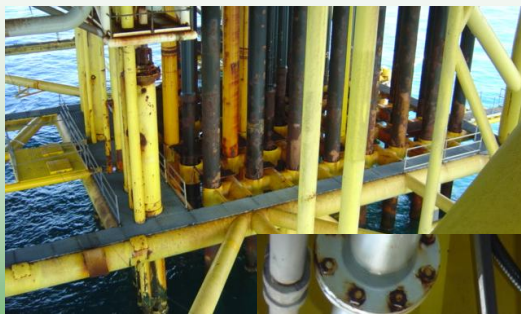
Top of Jacket
Handrails missing

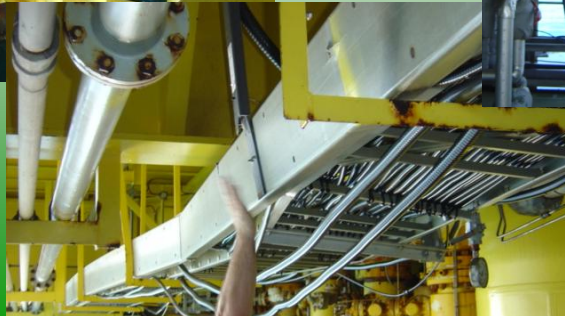
Damaged Cable
Trays
EL (+) 63 ft

- Observed damage to cable trays at EL (+) 63 ft.
- 3rd order stream function , 55% of wave above MSL
- Estimated wave height = 105 ft assuming 6ft tide & surge.
- Ultimate strength analyses correlate to Pompano surviving event.

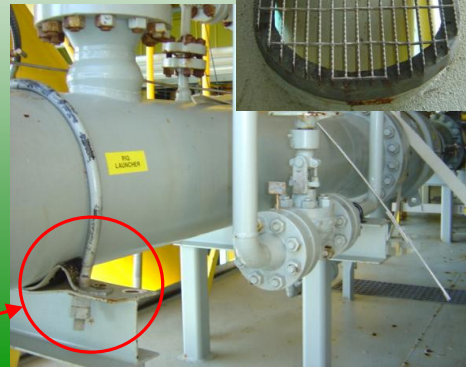
Damage

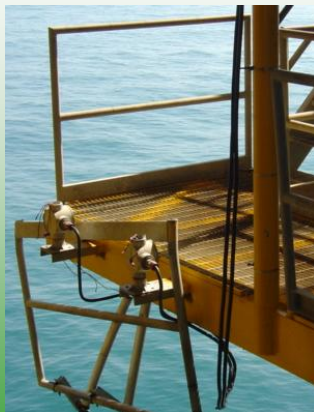
Sub-Cellar handrail damage

Sub-cellar East extension building damage

Sub-cellar deck light damage

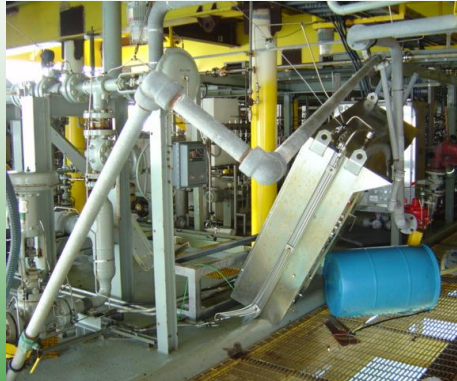
Sub-Cellar typical panel and ancillary piping damage

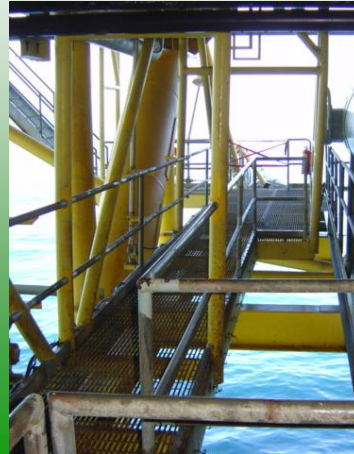
Sub-Cellar deck NW walkway minor lateral displacement

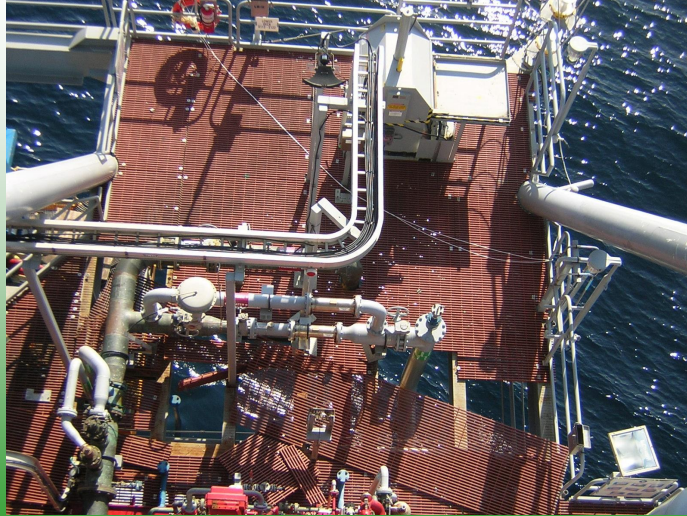
Grating Damage – SE Cellar Deck NE Mooring h Porch – H.R. & Grtg.

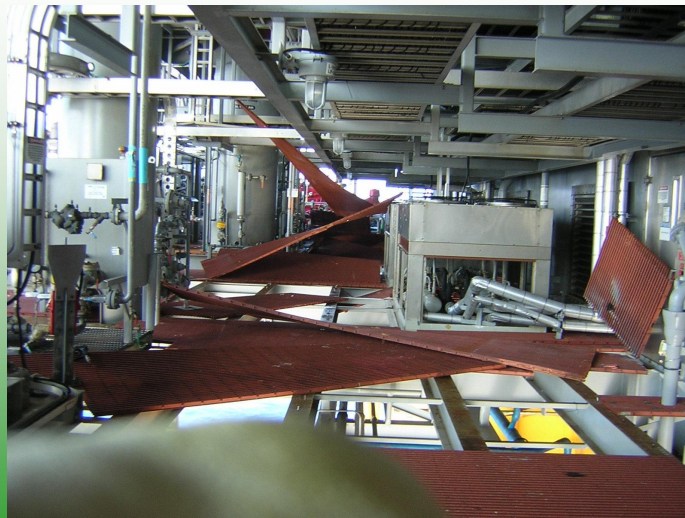
Damage NE Mooring Porch – Debris

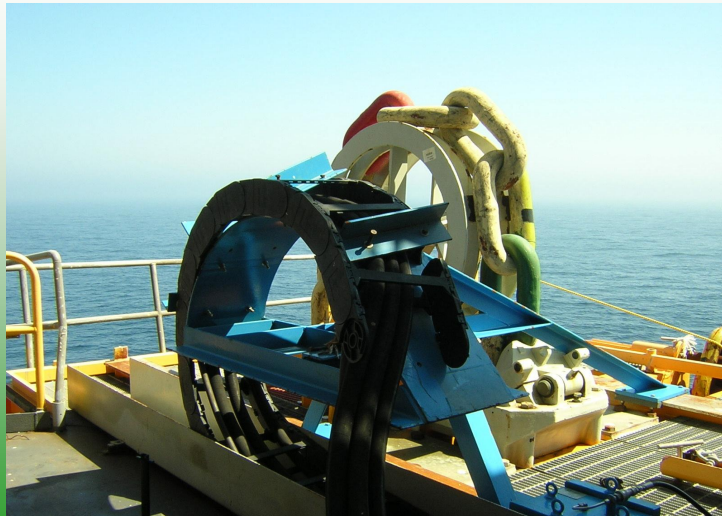
NE Mooring Porch – Damage to Drag Chain Storm Brace SE Mooring Porch
