REFERENCE: Docket No. PRM-40-28

SUBJECT: Comments on Proposed Rulemaking

**Department of the Air force
Robins Airforce Base**

**Report: Repair and Refurbishment of Aircraft
Counterweights**

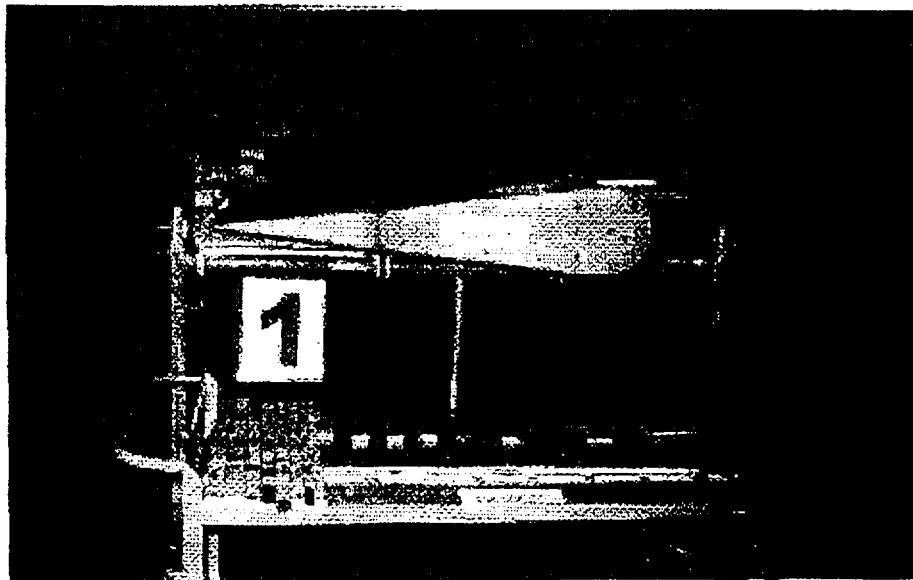
Figure 3, Counterweights Removed From Elevator 1

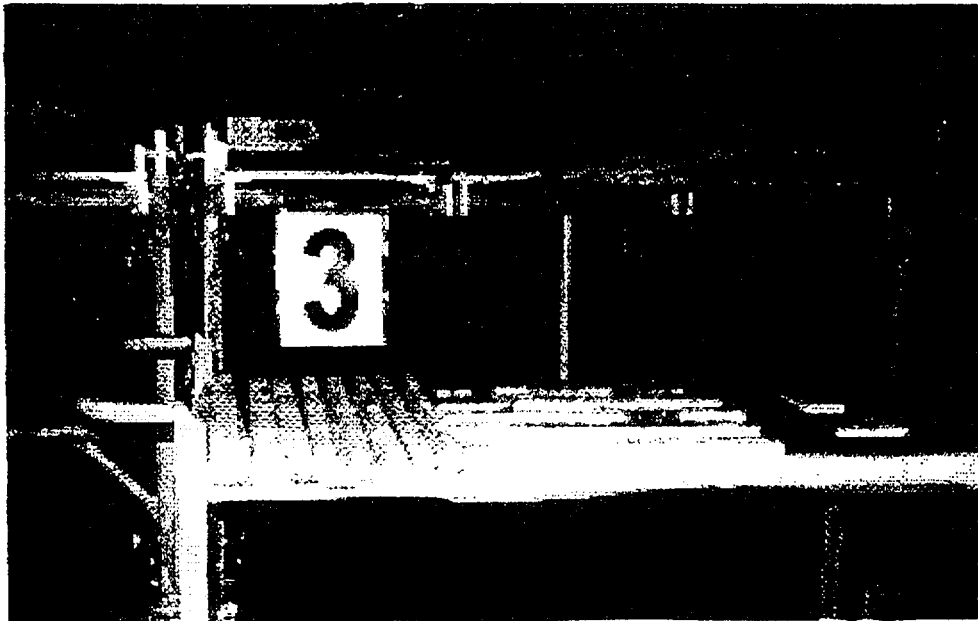
Figure 5, Counterweights Removed From Elevator 3

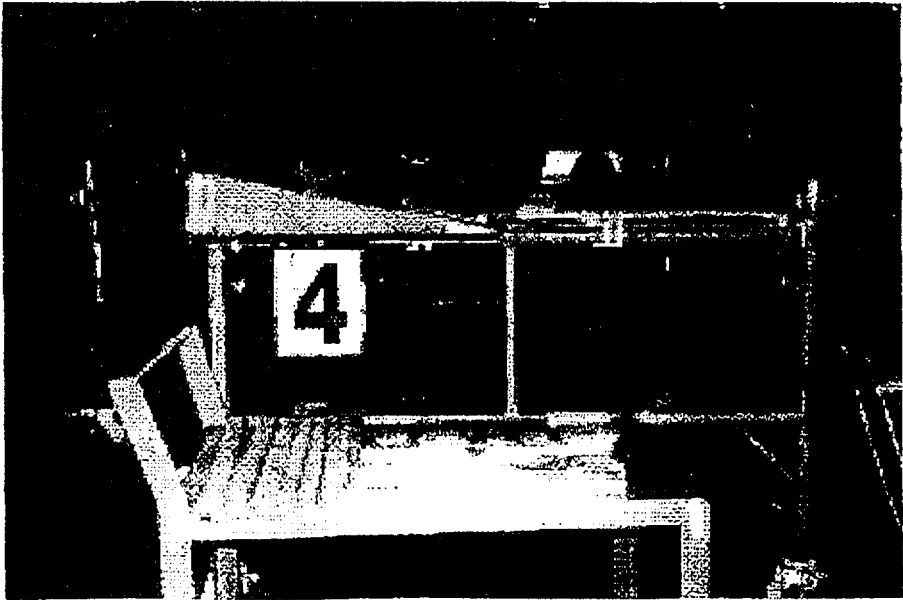
Figure 6, Counterweights Removed From Elevator 4
