Yakima River Basin Phase II Fish Screen Evaluations, 2002

J. A. Carter
G. A. McMichael
M. A. Chamness

January 2003

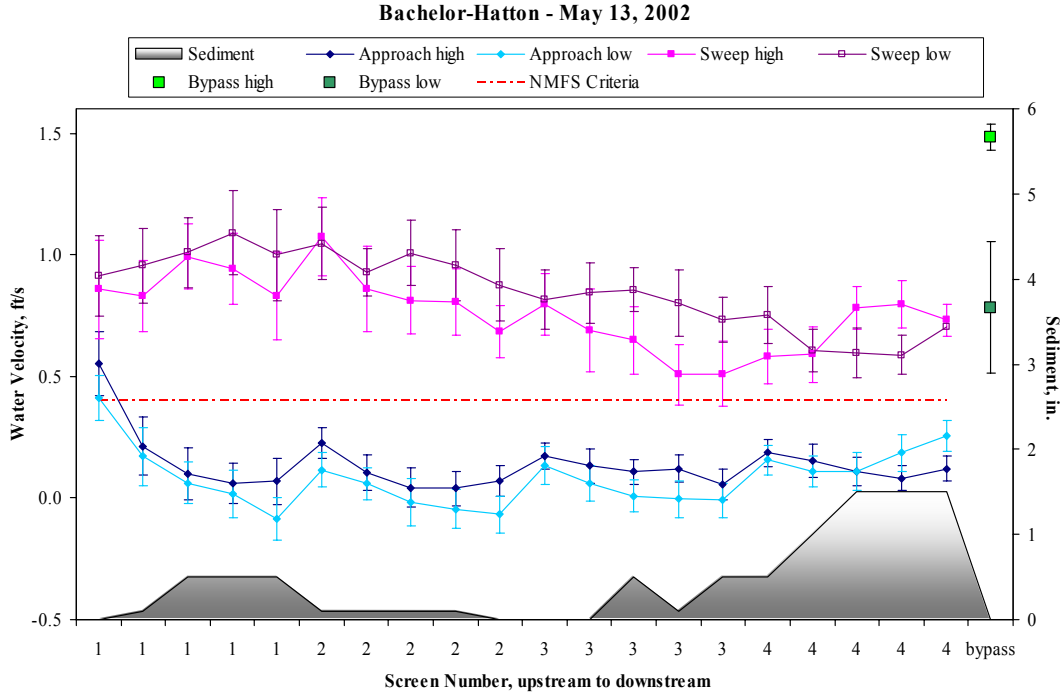
Approximately 4 in. of sediment had accumulated in front of screens 3 and 4 in May, which increased to 5 in. in June and was still present in September. A fair amount of twigs and other debris were present in front of screen 4 and in the bypass during all surveys. Bypass conditions were good in May, but in June the bypass appeared to be backed up and did not drop into the downwell. Bypass outfall conditions met standards for safe fish passage in May and June. A juvenile salmonid was observed in front of screen 2 in June, and several small, unidentified fish were seen in the forebay in September.

Figure 4. Water Velocities and Sediment Accumulation at Bachelor-Hatton in May 2002. Error bars (\pm the root-mean-squared [RMS]) represent turbulence at each point.

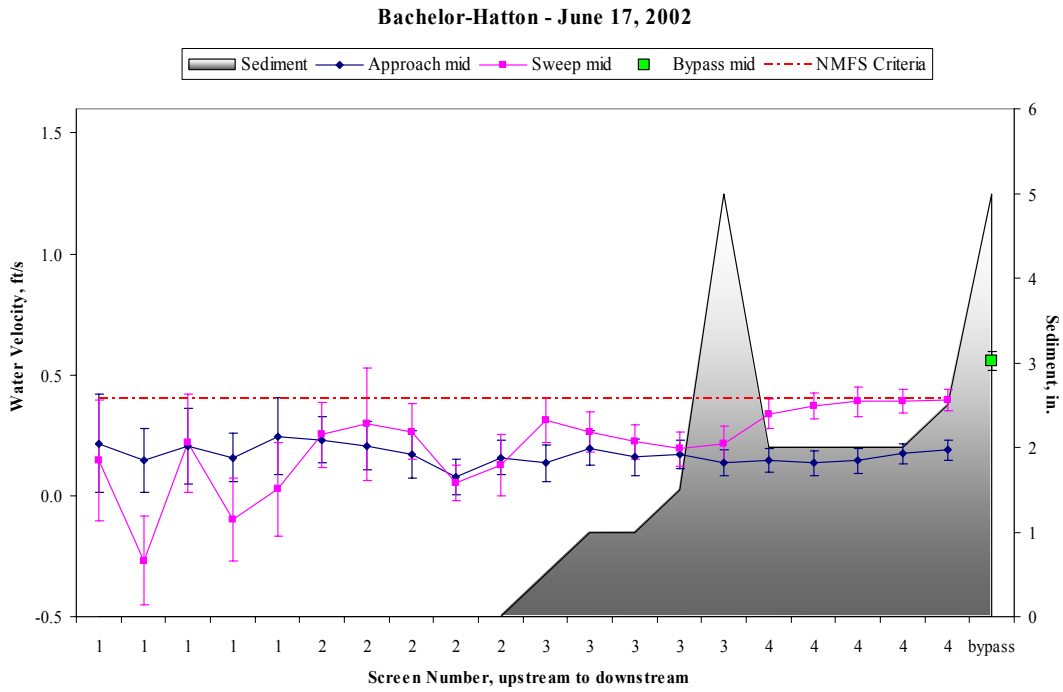
Figure 5. Water Velocities and Sediment Accumulations at Bachelor-Hatton in June 2002. Error bars show turbulence (\pm the root-mean-squared [RMS]) at each point.

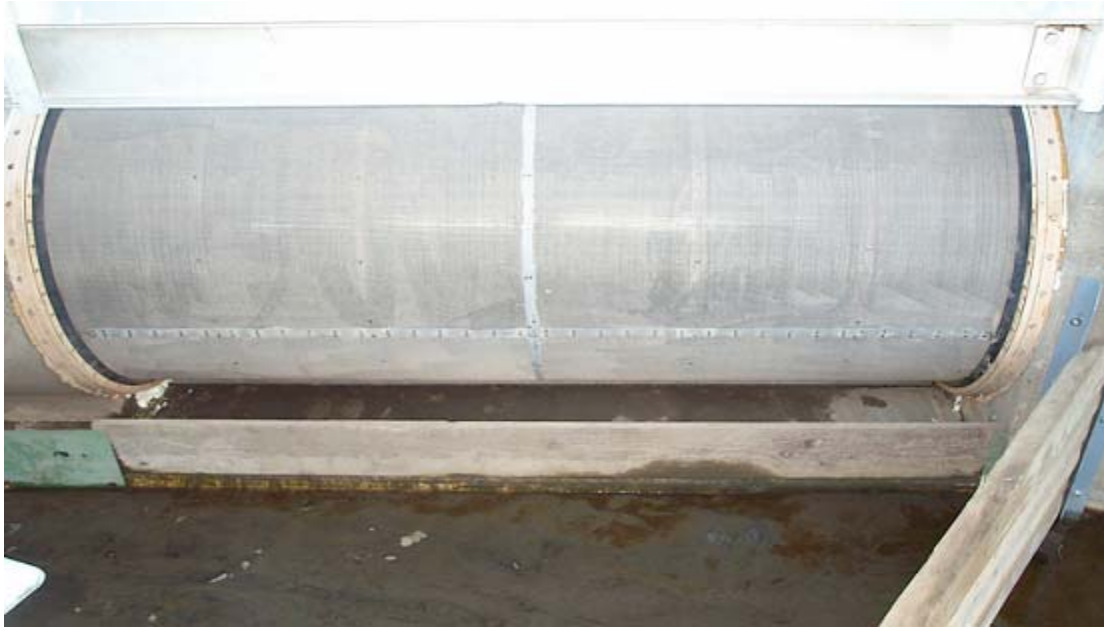
Figure 26. Screen 1 at Naches-Cowiche with Stoplogs in Front of the Screen (parallel) and Upstream of the Screen Bays (perpendicular to the direction of water flow). The upstream stoplogs were blown out by high flows early in the irrigation season.

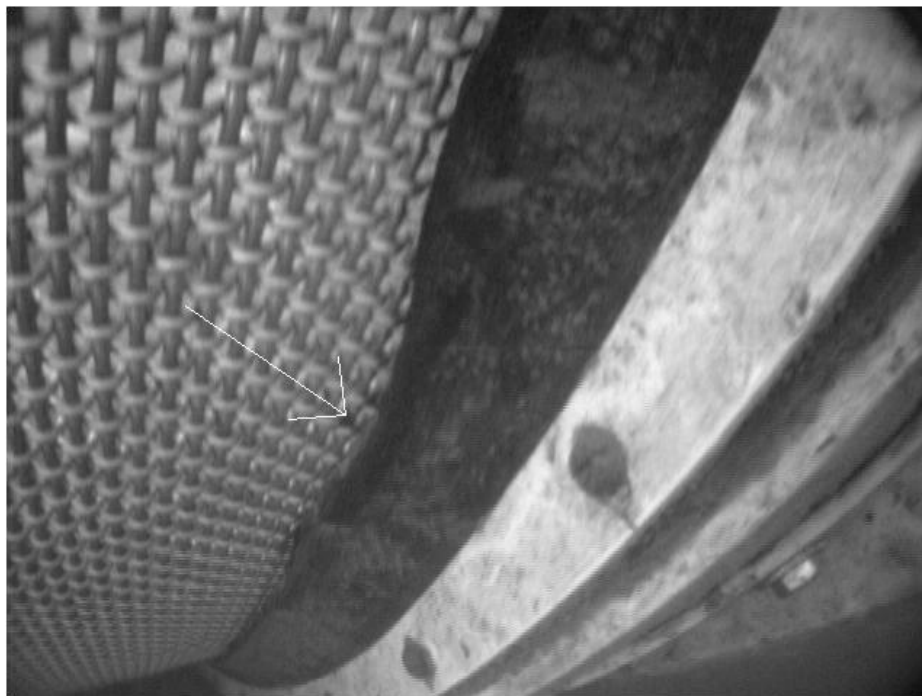
Figure 30. Damaged Seal at New Cascade, Downstream on Screen 8

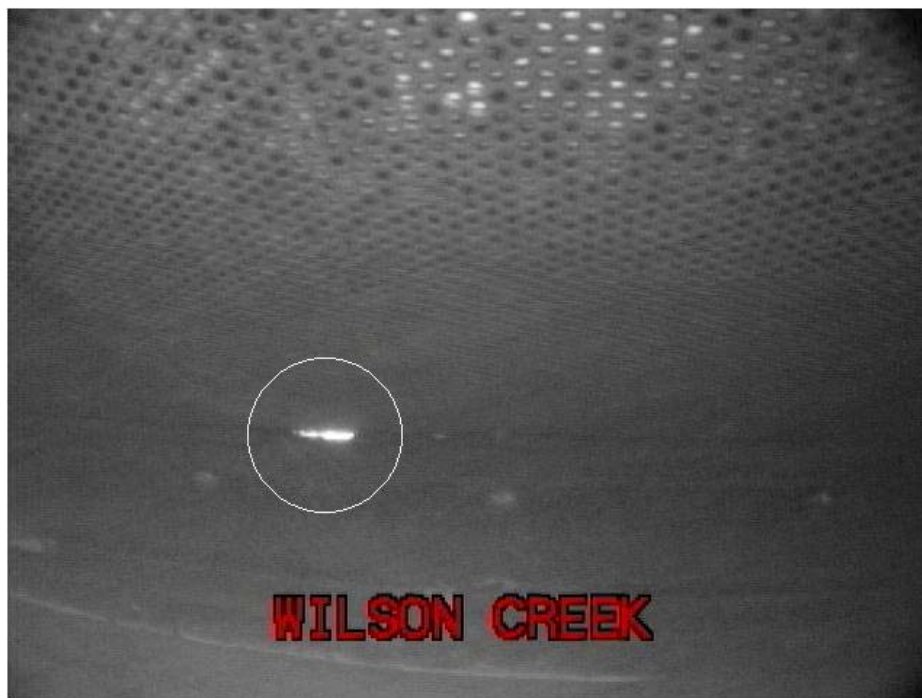
Figure 49. Gap Between the Bottom Seal and the Screen Observed at Wilson Creek in June 2002
