Yakima River Basin Phase II Fish Screen Evaluations, 2003

J. A. Vucelick
G. A. McMichael
M. A. Chamness

May 2004

Prepared for the U.S. Department of Energy
Bonneville Power Administration
under Project 1982-06200

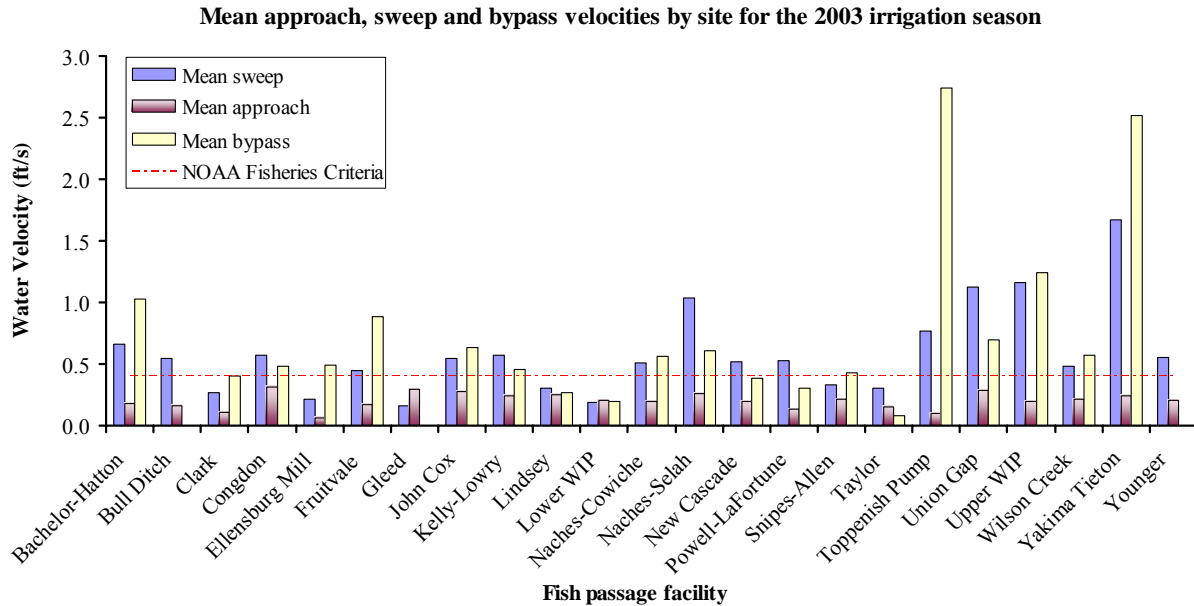
Overall, 94% of all approach velocity measurements met the NOAA Fisheries approach criteria of less than or equal to 0.4 ft/s (4% more than in 2002). This was slightly lower than the 97% reported in 2001; however, 2001 was an exceptionally low-water year, and many sites did not have enough water to meet other criteria, such as submergence and bypass flow. Similar conditions existed in 2003, with many sites unable to meet bypass flow requirements. Areas of the screen (i.e., top, bottom, upstream, downstream) that exceeded approach criteria were dependent on factors at the individual sites.

Figure 4. Mean Approach, Sweep, and Bypass Velocities at Phase II Fish Screen Facilities in the Yakima River Basin in 2003 Shown Against a Reference Line for the NOAA Fisheries Approach Criteria (less than or equal to 0.4 ft/s)

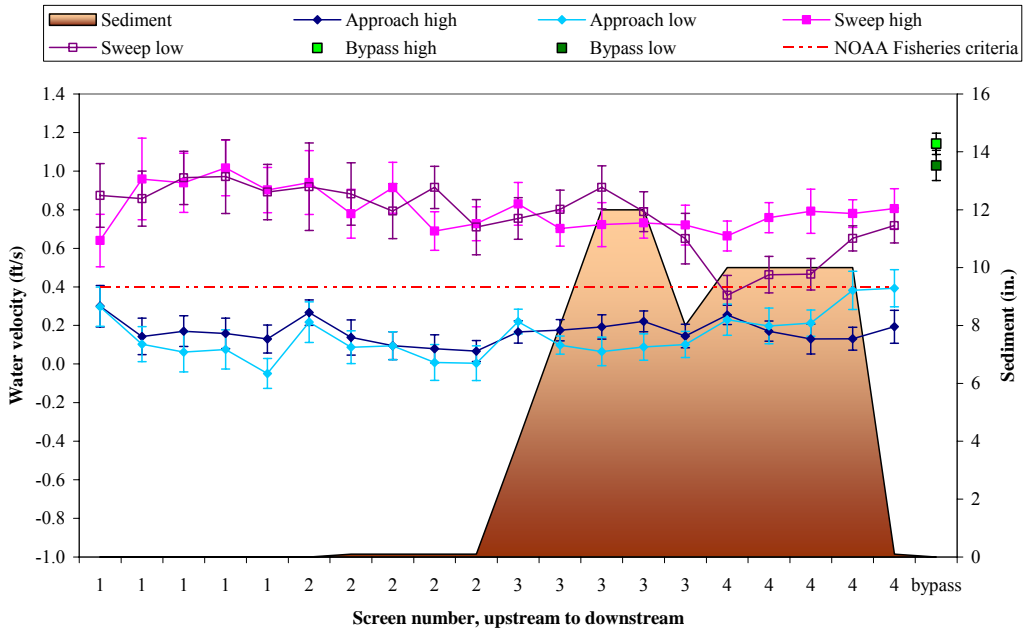
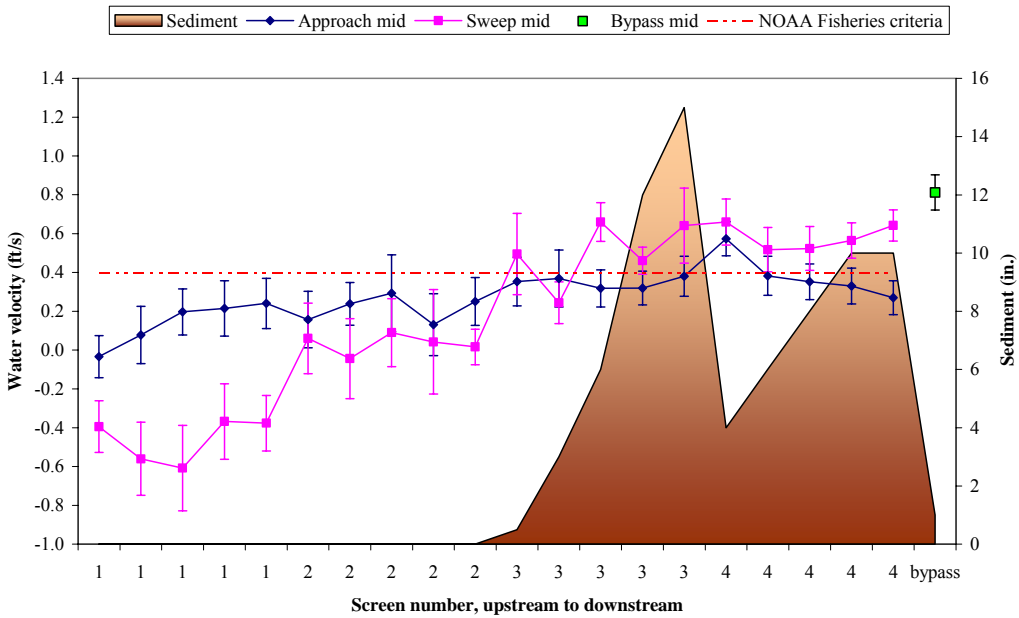
Figure 5. Water Velocities and Sediment Accumulation at Bachelor-Hatton in May 2003. Error bars (\pm the root-mean-squared [RMS]) represent turbulence at each point.

Figure 6. Water Velocities and Sediment Accumulations at Bachelor-Hatton in June 2003. Error bars show turbulence (\pm the root-mean-squared [RMS]) at each point.

Video surveys in all three months showed that the visible portions of the screen seals were in good condition. Approximately 12 in. of sediment had accumulated in front of screens 3 and 4 in May, which increased to a maximum of 15 in. in June. A fair amount of twigs and other debris were present in front of screen 4 and in the bypass during all surveys. Bypass conditions were good in May and June, and bypass outfall conditions met standards for safe fish passage in May and June. Flooding in early spring rerouted the stream away from the outfall. A small channel was dug to provide some flow of water to and from the outfall pipe, but water levels in this small channel may not stay consistently deep enough, and predation by birds or mammals could occur.

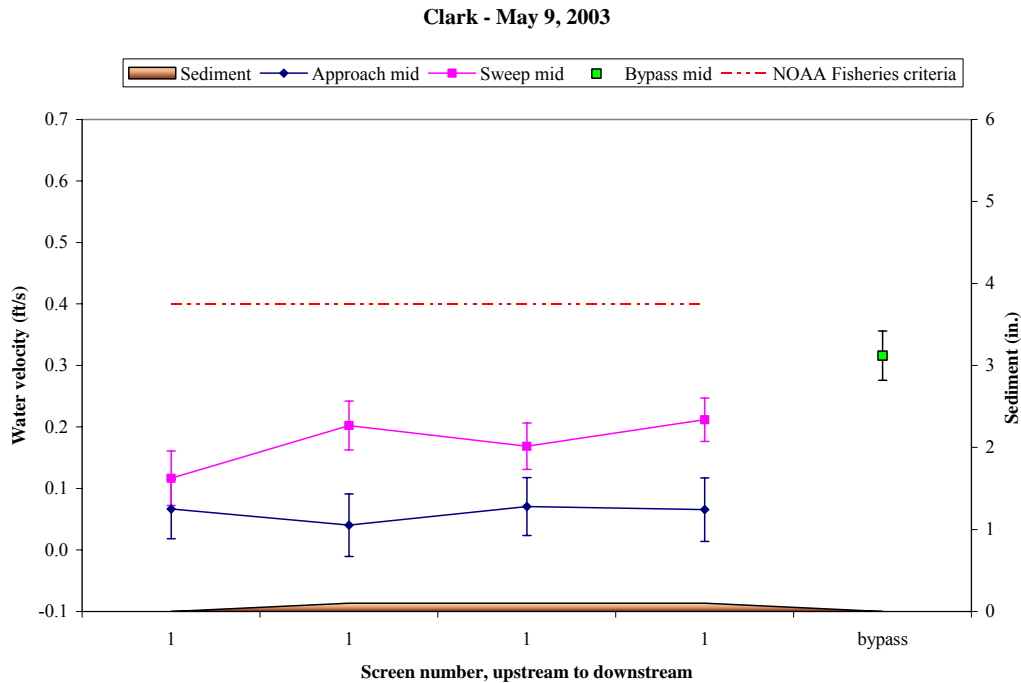
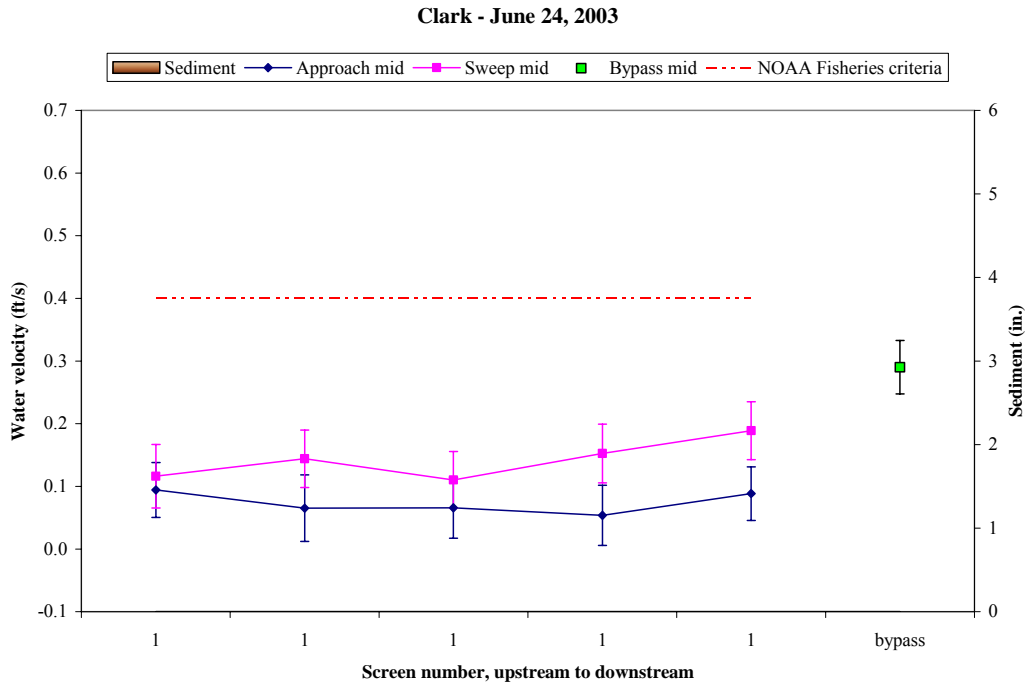
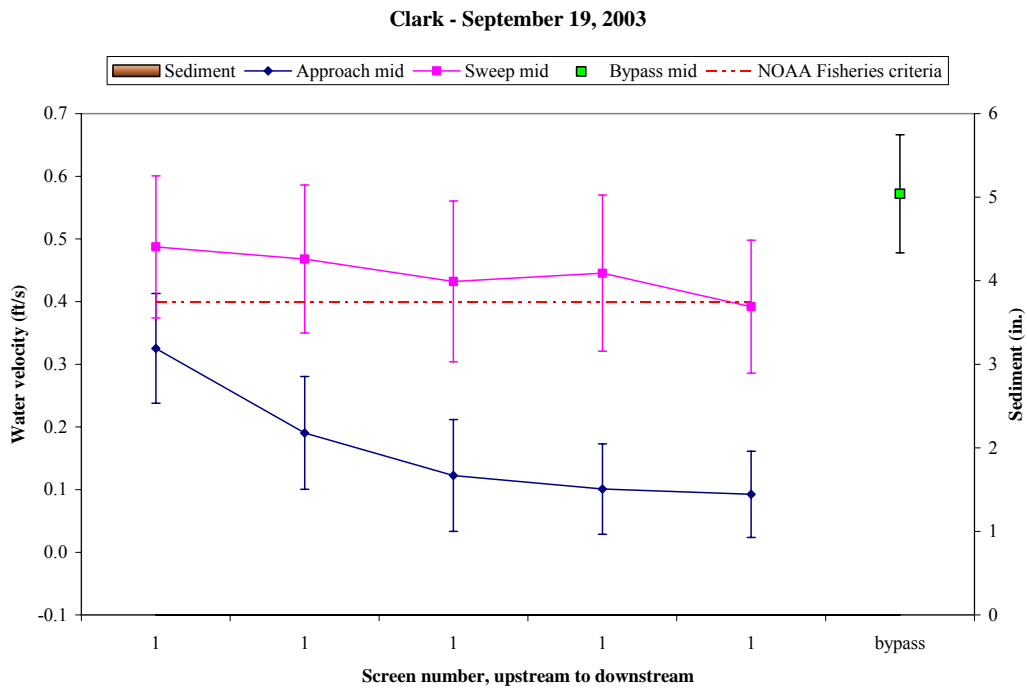
The Clark screening facility was visited on May 9, 2003; June 24, 2003; and September 19, 2003. Water velocities at this site complied with NOAA Fisheries criteria during all surveys. All approach values were less than 0.4 ft/s, and sweep velocities were always higher than approach velocities (Figures 7, 8, and 9). The water velocity in the bypass was always greater than the average sweep velocity, and except for September, there was a clear increase in sweep velocity from upstream to downstream within the site. These conditions created a clear trajectory towards the bypass and would be expected to expedite fish passage through the site.

The condition of the screen and seals was good throughout all surveys. Little sediment was present in front of the screens in May, and none was present in June or September. Screen submergence met

Figure 7. Water Velocities and Sediment Depths at Clark in May 2003. Error bars show turbulence (\pm the root-mean-squared [RMS]) at each point.

Figure 8. Water Velocities and Sediment Depths at Clark in June 2003. Error bars show turbulence (\pm the root-mean-squared [RMS]) at each point.

Figure 9. Water Velocities and Sediment Depths at Clark in September 2003. Error bars show turbulence (\pm the root-mean-squared [RMS]) at each point.

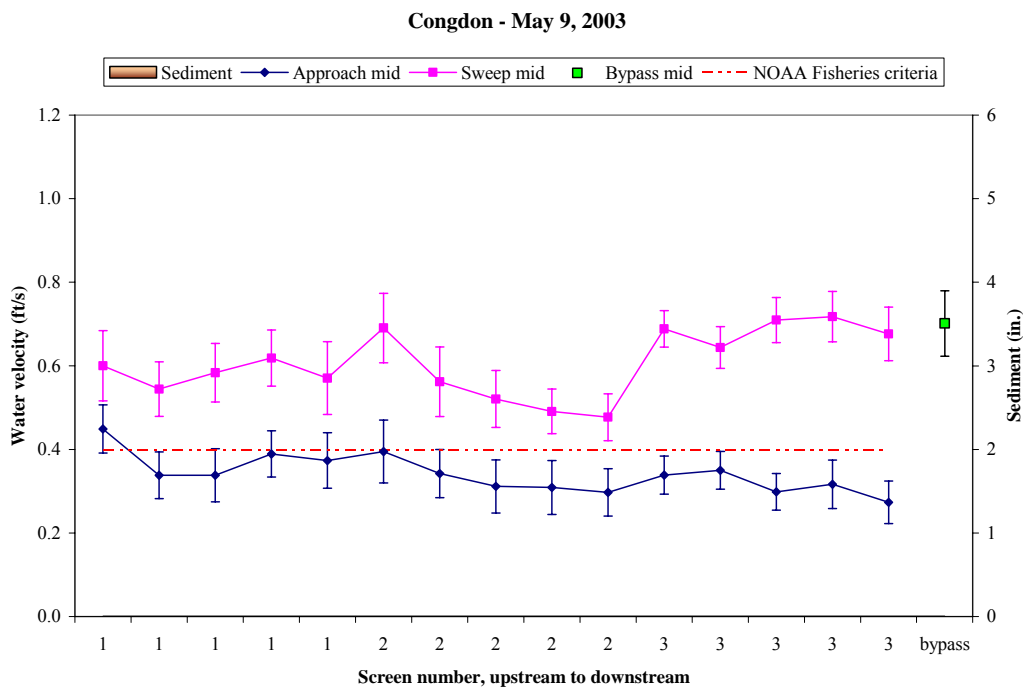
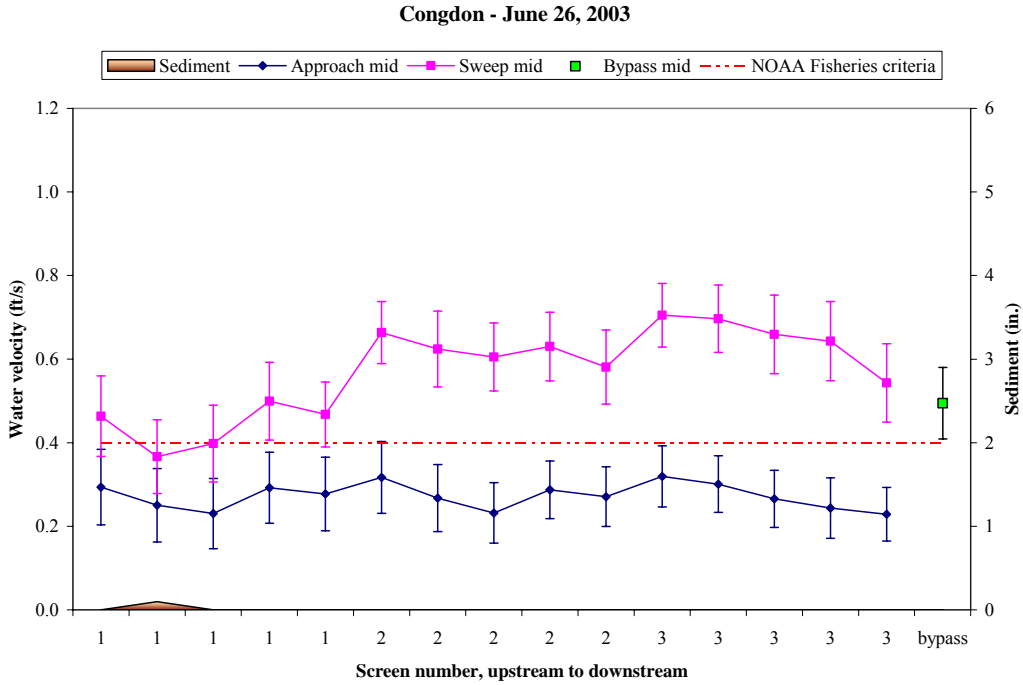
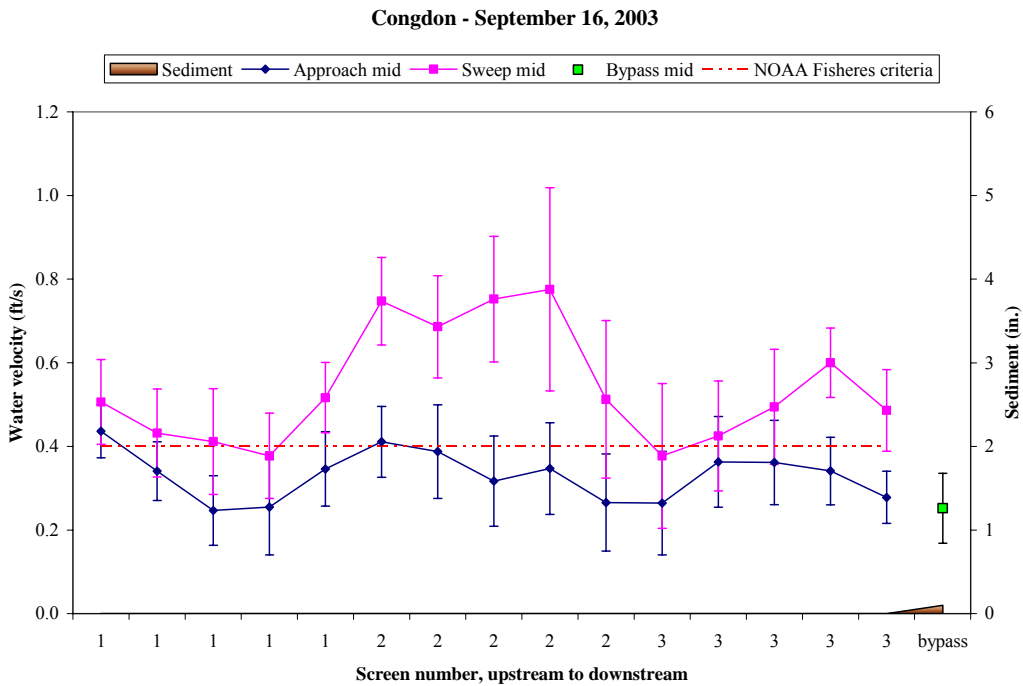
The screen seals were in good condition. There was very little sediment in front of the screens during all of the surveys. Submergence was at the high end of the criteria range throughout the survey period: 85% during May, 87% in June, and 83% in September. The depth of water flowing over the weir and through the outfall met NOAA Fisheries criteria. Water ran freely through the bypass, and the surging at the bypass outfall mentioned in previous years was not observed in 2003.

Figure 10. Water Velocities and Sediment Levels at Congdon in May 2003. Error bars show turbulence (\pm the root-mean-squared [RMS]) at each point.

Figure 11. Water Velocities and Sediment Depths at Congdon in June 2003. Error bars show turbulence (\pm the root-mean-squared [RMS]) at each point.

Figure 12. Water Velocities and Sediment Depths at Congdon in September 2003. Error bars show turbulence (\pm the root-mean-squared [RMS]) at each point.

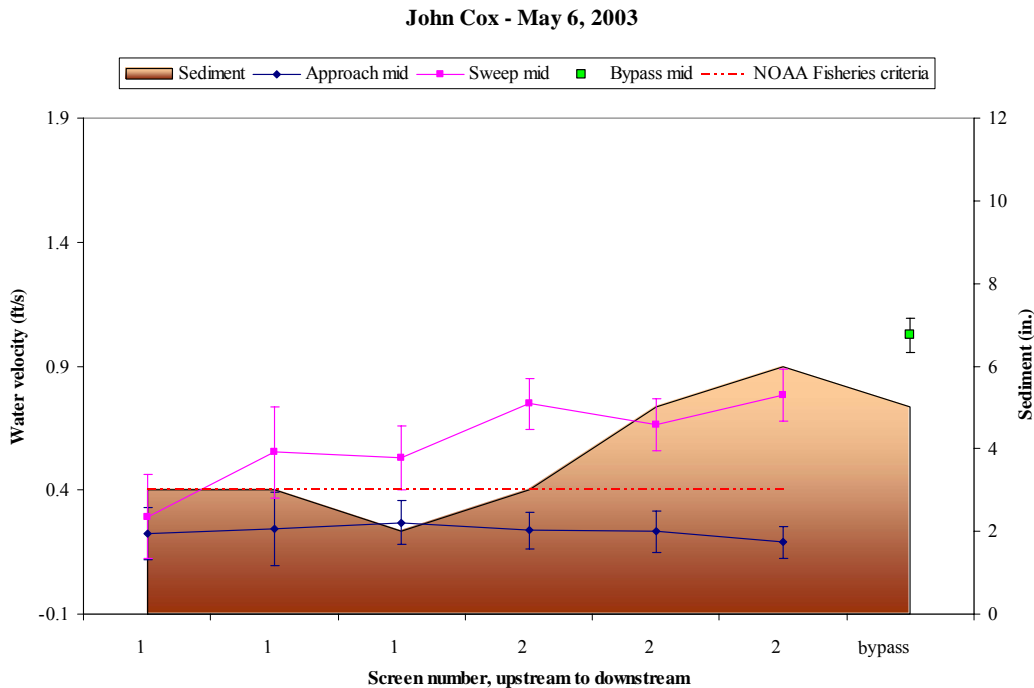
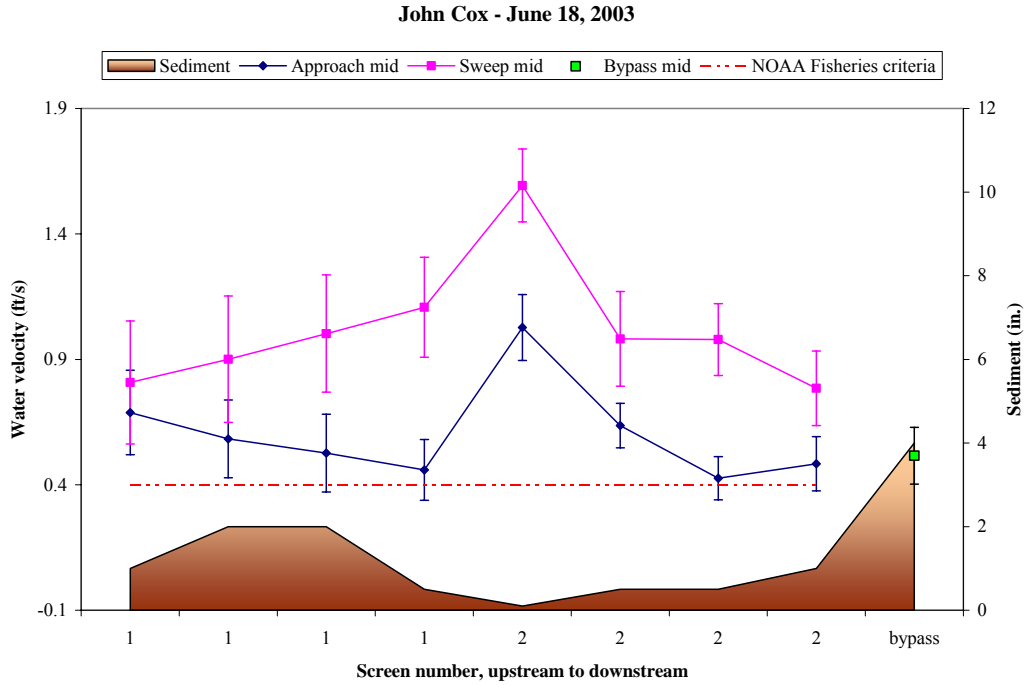
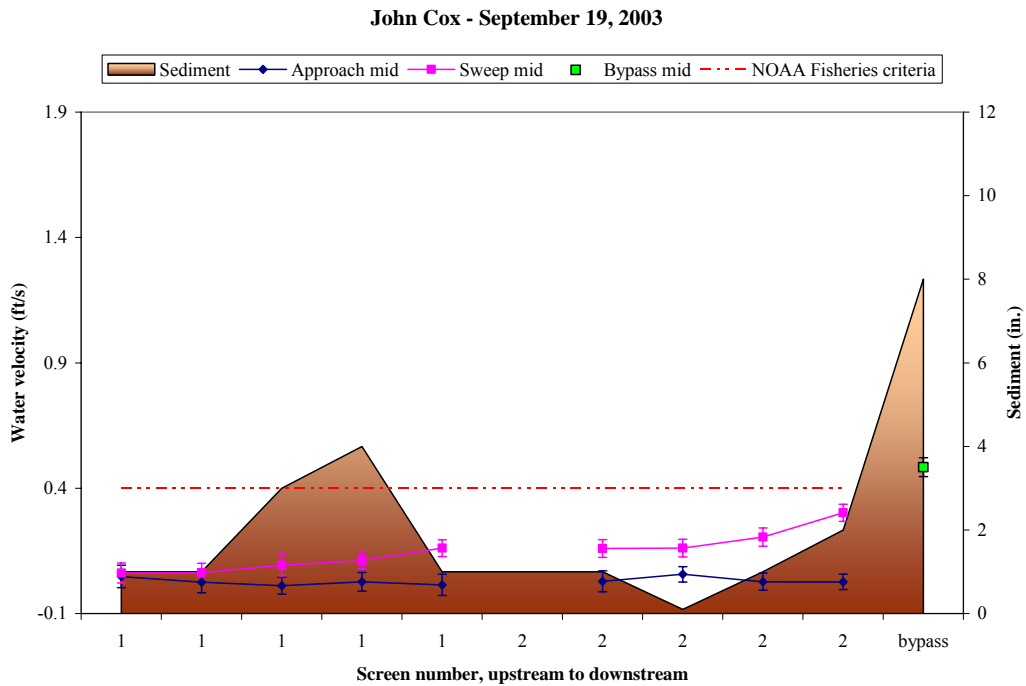
The screen seals appeared to be in good condition throughout the survey period, and the gap between the bottom seal and screen 2 noted in 2001 was not present in 2002. Submergence met NOAA Fisheries criteria in May and June, at 85% and 80%, respectively, though submergence had dropped to 61% in September. In June, there was a lot of woody debris in front of the screens and in September, there was enough sediment accumulation to cover the bottom seal and woody debris prevented flow measurements at the upstream end of screen 2.

Figure 13. Water Velocities and Sediment Depths at John Cox in May 2003. Error bars show turbulence (\pm the root-mean-squared [RMS]) at each point.

Figure 14. Water Velocities and Sediment Depths at John Cox in June 2003. Error bars show turbulence (\pm the root-mean-squared [RMS]) at each point.

Figure 15. Water Velocities and Sediment Depths at John Cox in September 2003. Error bars show turbulence (\pm the root-mean-squared [RMS]) at each point.

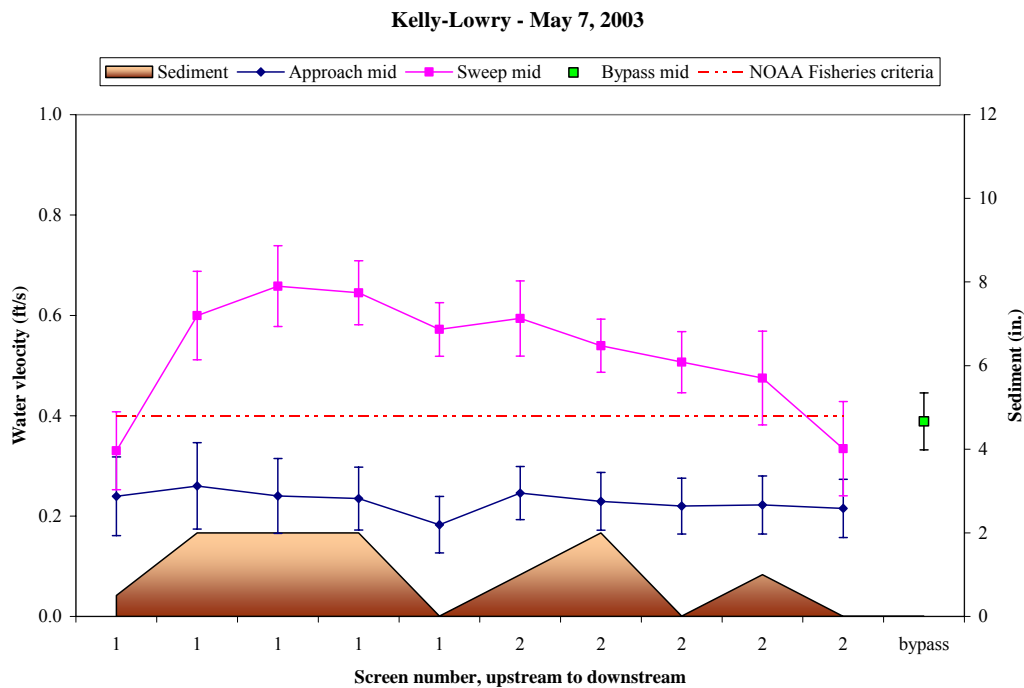
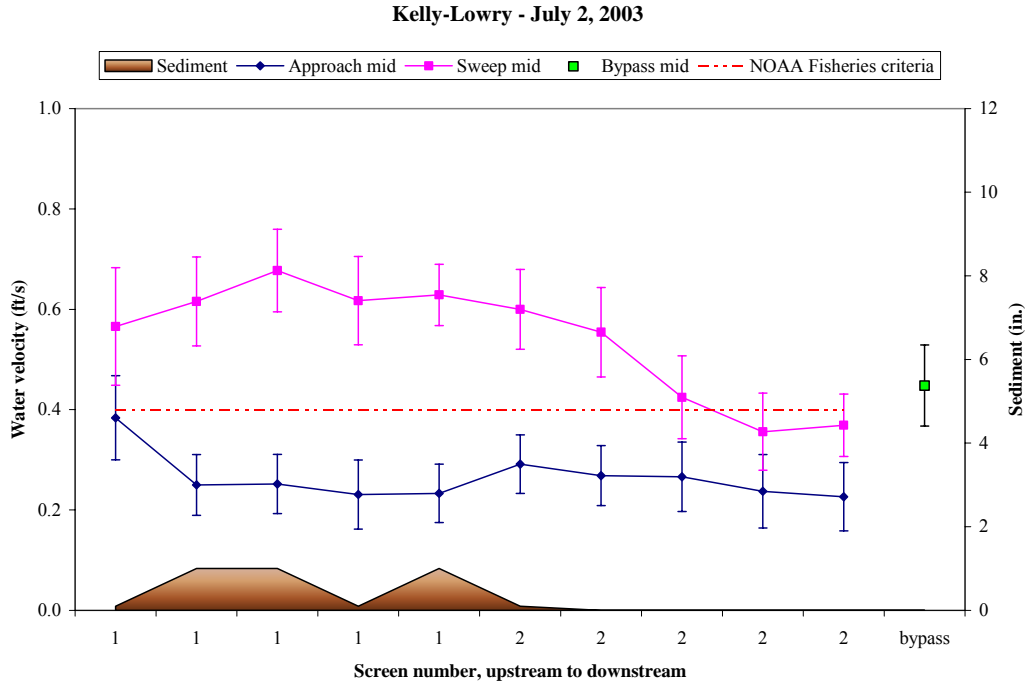
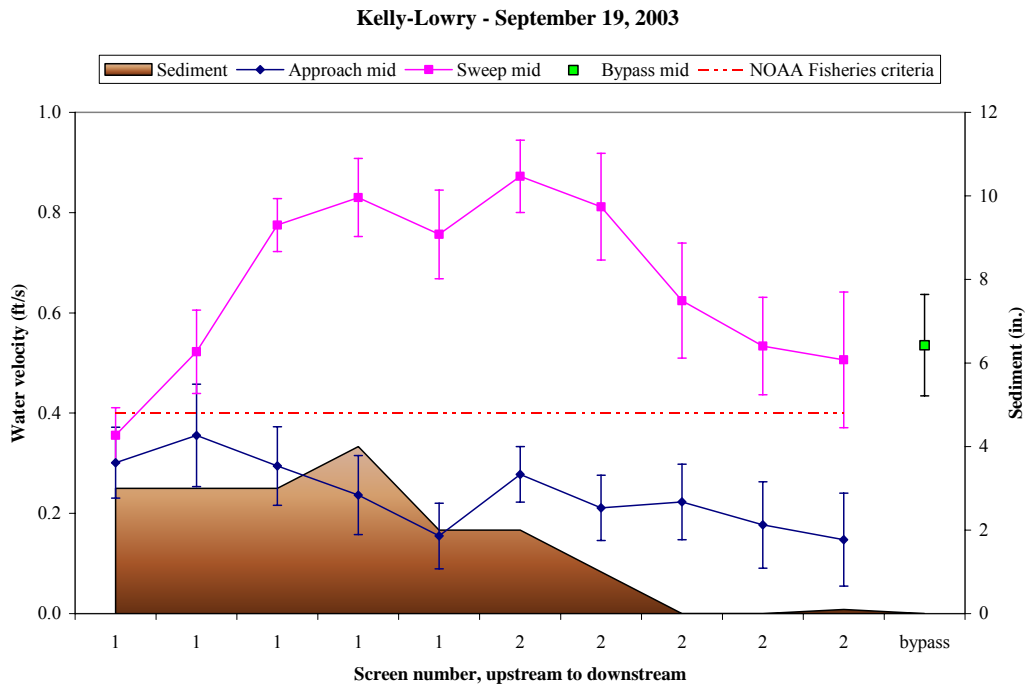
The screen seals all looked to be in good condition. A significant amount of debris had built up on the trash rack before the May survey and was present throughout the survey period. There was also a large pile of debris approximately 2 ft tall in the forebay in May. The gaps between the metal screen frames and the concrete wall noted in 2001 and 2002 were filled with spray-in insulation sometime before the May 2003 survey.

Bypass conditions were conducive to safe fish passage in May and appeared to be passable in July and September, though the path to the outfall was too overgrown in June and September to measure it. Water ran freely over the weir, and the PNNL researchers did not observe any accumulation of debris at the outfall pipe. The depth of water at the outfall was greater than 1 ft in May, and appeared to be greater than 1 ft in July and September. Water discharge at the outfall surged slightly in May, and was smooth in July and September.

Figure 16. Water Velocities and Sediment Depths at Kelly-Lowry in May 2003. Error bars show turbulence (\pm the root-mean-squared [RMS]) at each point.

Figure 17. Water Velocities and Sediment Depths at Kelly-Lowry in July 2003. Error bars show turbulence (\pm the root-mean-squared [RMS]) at each point.

Figure 18. Water Velocities and Sediment Depths at Kelly-Lowry in September 2003. Error bars show turbulence (\pm the root-mean-squared [RMS]) at each point.

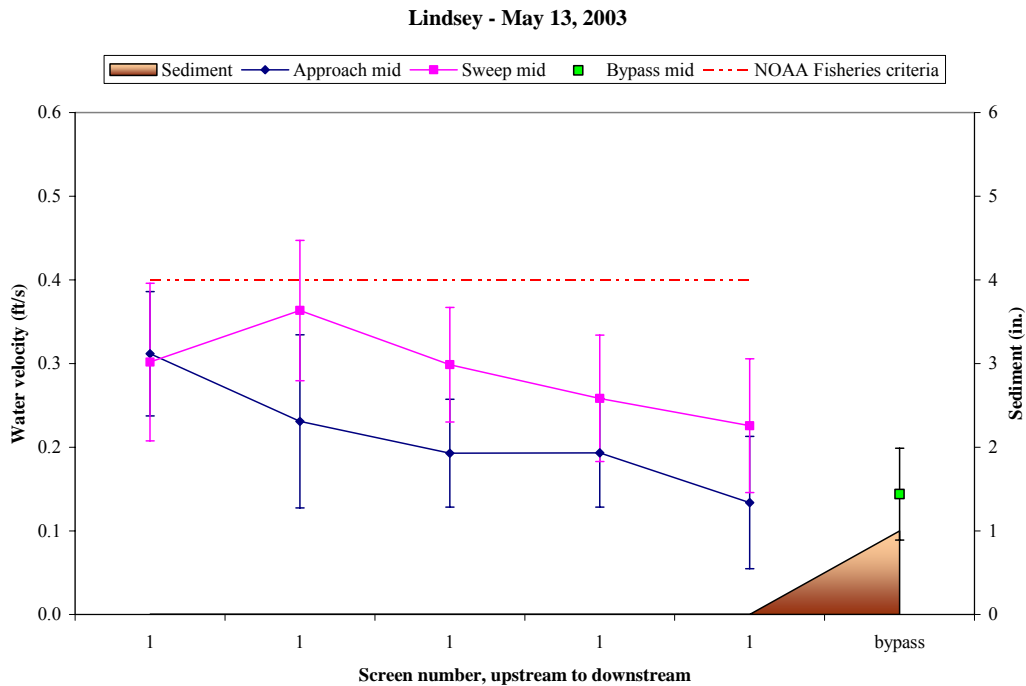
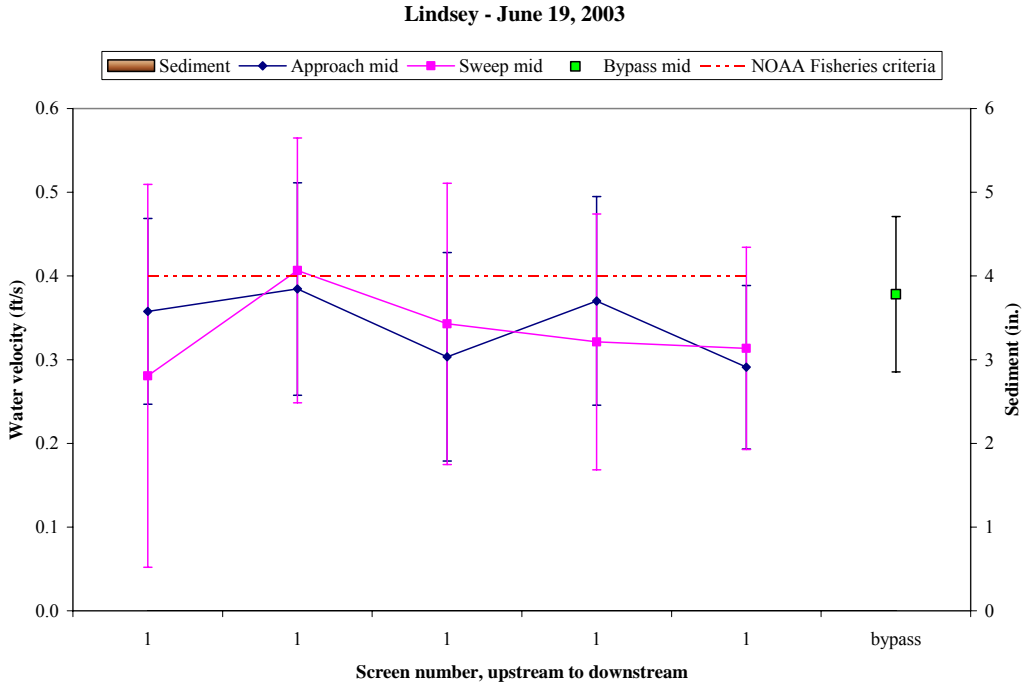
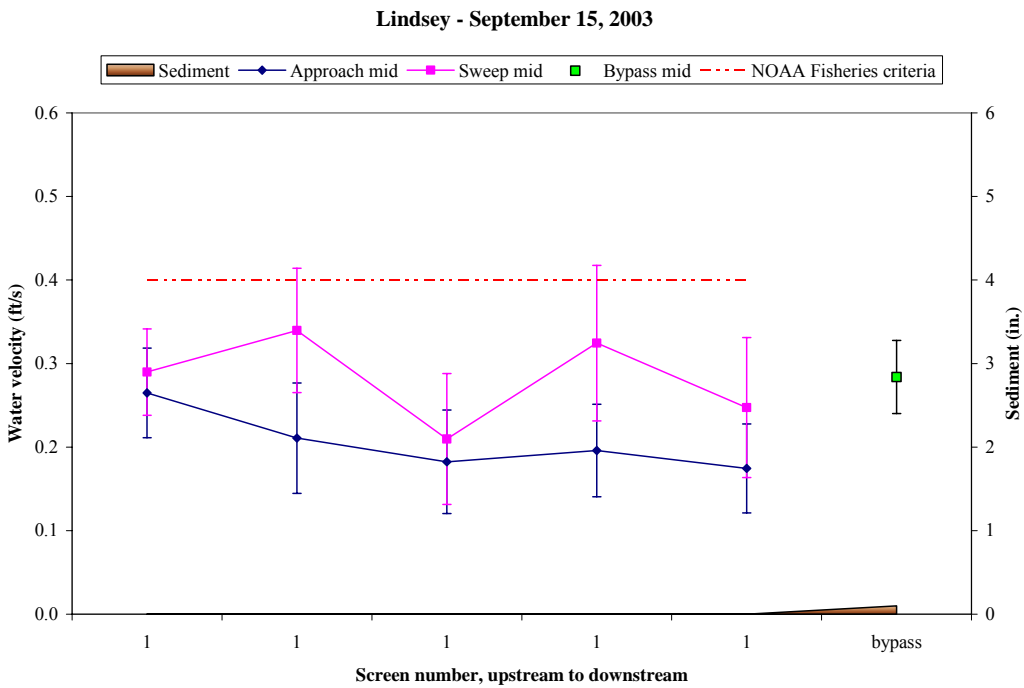
The screen seals were in good condition, and the drum moved leaf matter and other floating debris into the canal effectively. In May submergence was slightly below NOAA Fisheries criteria at 62% (criteria = 65% to 85%). Ray Gilmore was contacted on May 13 concerning the low submergence, although no operational changes were made to correct the condition. Notes in the logbook subsequent to our May site visit indicate submergence dropped to approximately 40% before the river level rose and changes in the operating conditions were made to increase the submergence level. Submergence met criteria in June and September at 85% and 66%, respectively. The gaps between the metal frame of the screen and the cement wall were filled with expanding foam insulation that will prevent entrainment of small fish in these gaps.

Bypass conditions were conducive to safe fish passage. Water flowed freely over the weir and through the outfall, where the depth was always greater than 1 ft.

Figure 19. Water Velocities and Sediment Depths at Lindsey in May 2003. Error bars show turbulence (\pm the root-mean-squared [RMS]) at each point.

Figure 20. Water Velocities and Sediment Depths at Lindsey in June 2003. Error bars show turbulence (\pm the root-mean-squared [RMS]) at each point.

Figure 21. Water Velocities and Sediment Depths at Lindsey in September 2003. Error bars show turbulence (\pm the root-mean-squared [RMS]) at each point.

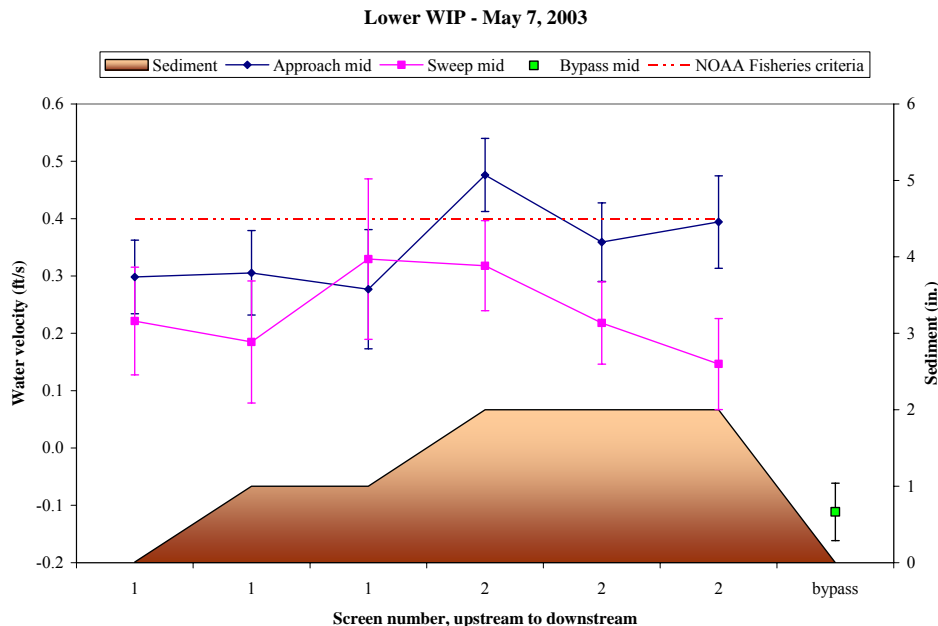
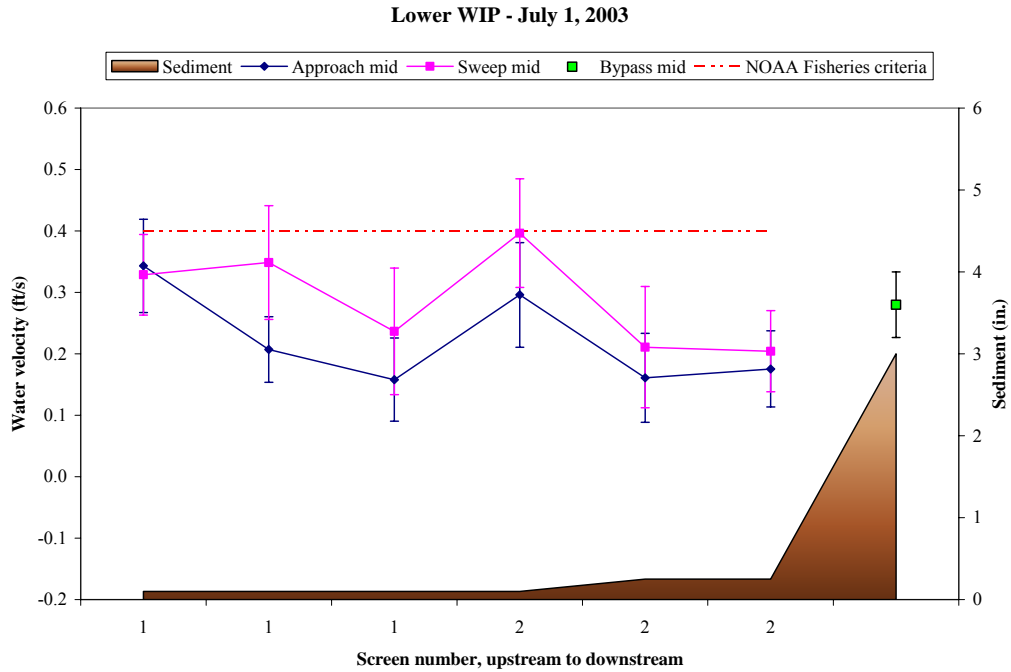
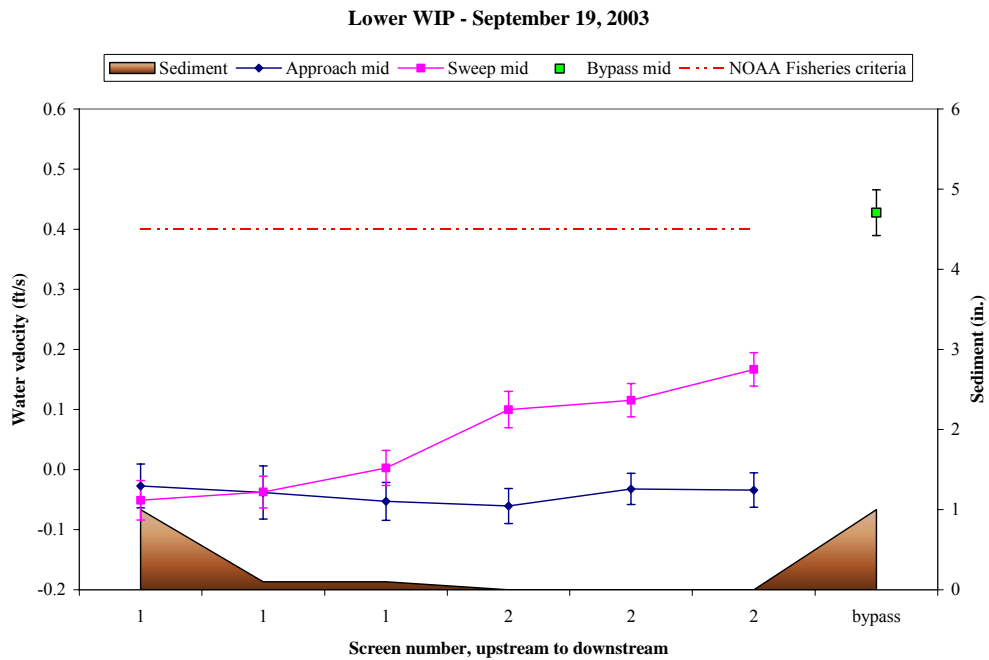
During May and July, an excessive amount of sand was present in the forebay, in front of the screens, and in the bypass. At the shallowest point in July there was only 4 in. of water over the sand. Submergence met criteria in May at 80%. In July and September, submergence was slightly outside criteria limits at 64% and 88%, respectively. Sediment deposits at the site were removed in August and September. In September, the bypass appeared to be backed up; there was no drop into the downwell, probably due to high stream flows. Bypass outfall conditions met NOAA Fisheries criteria during all surveys, although it was noted in June that if the water level in the stream was to drop fish could become trapped because the fish channel in the diversion dam was blocked.

The screen seals that were visible (i.e., not obstructed by sediment or debris) appeared to be in good condition, although there were some gaps higher up on the side seals that would not be expected to cause any problems because they should not ever be under water.

Figure 22. Water Velocities and Sediment Depths at Lower Wapato Irrigation Project (WIP) in May 2003. Error bars show turbulence (\pm the root-mean-squared [RMS]) at each point.

Figure 23. Water Velocities and Sediment Depths at Lower Wapato Irrigation Project (WIP) in July 2003. Error bars show turbulence (\pm the root-mean-squared [RMS]) at each point.

Figure 24. Water Velocities and Sediment Depths at Lower Wapato Irrigation Project (WIP) in September 2003. Error bars show turbulence (\pm the root-mean-squared [RMS]) at each point.

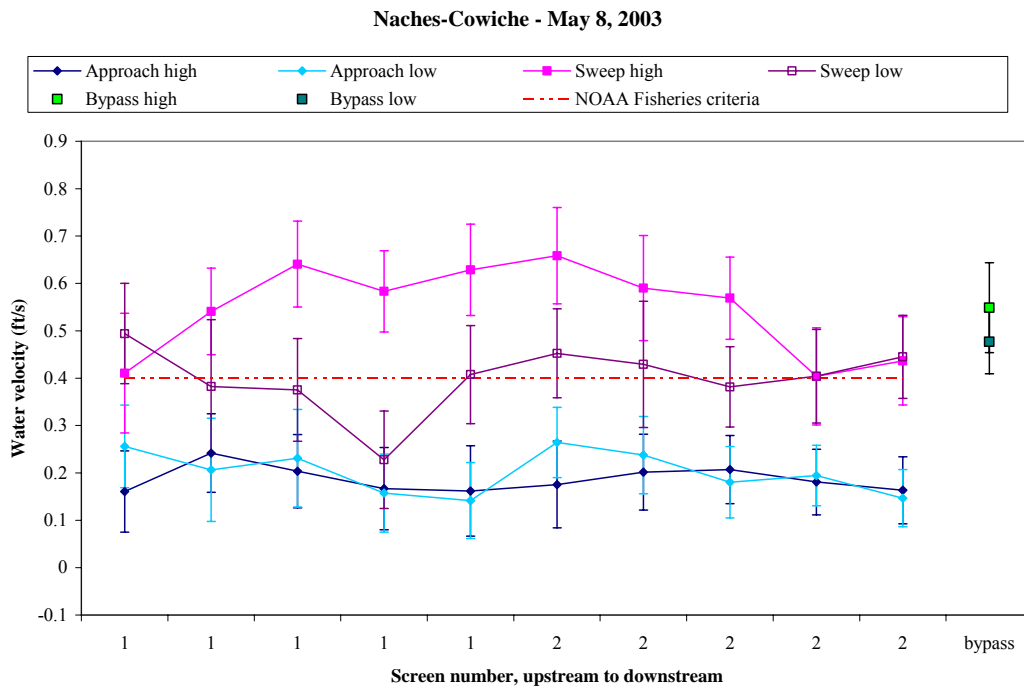
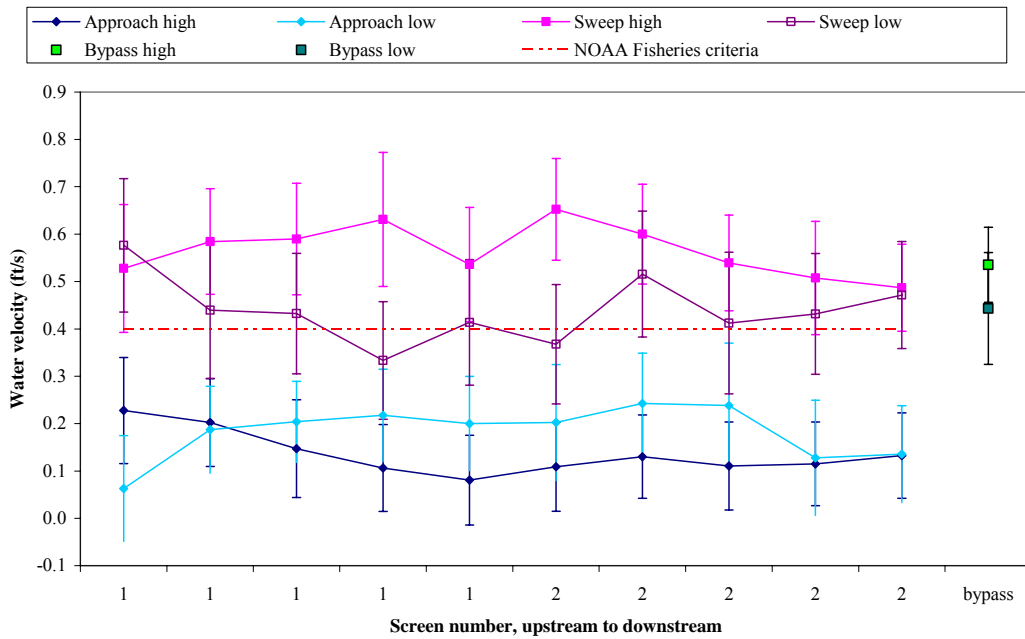
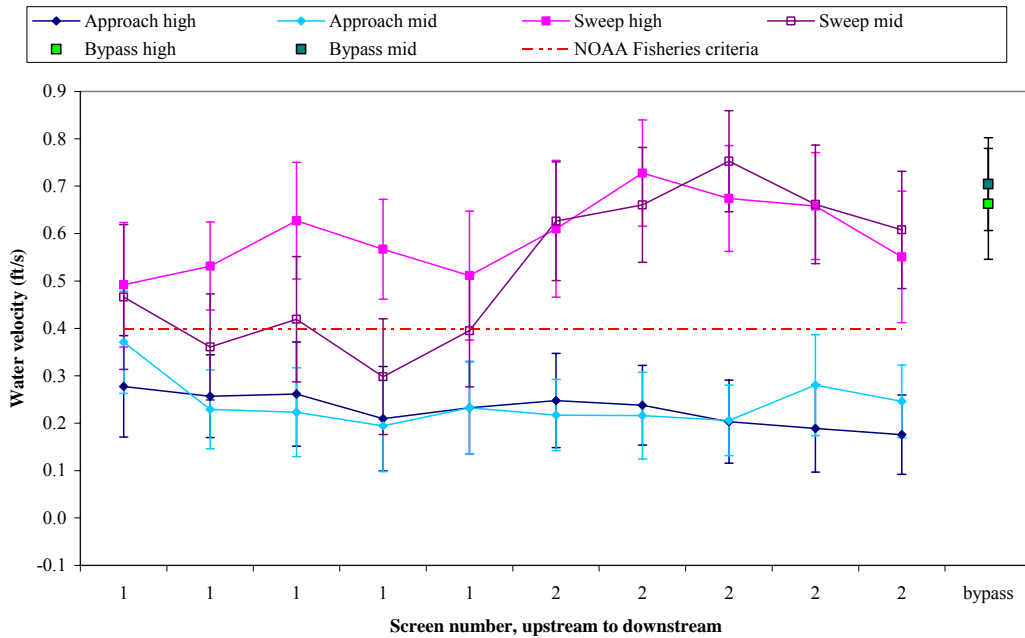
The stoplogs in front of the screens prevented an evaluation of the bottom seals with the video camera. All other visible seals were in good condition. During the June and September evaluations it was evident that debris had built up between the stoplogs and the screens. Submergence was within criteria during all visits and bypass conditions were generally good for safe fish passage. In June, the bypass outfall became plugged. It was cleaned out on the morning of June 26, and two dead fish were found. Fish in the screen facility have no way out if the outfall is blocked, although WDFW raises the weir to prevent movement through the bypass if blockage is suspected. In 2002, there was some concern that the design of the bypass outfall did not compensate enough for the shifting riverbed because it became filled with rock when flows were high. The outfall channel has been dug out several times in the past, only to get filled in again when the river level rose. Sometime before our September evaluation, ecology blocks were placed on three sides of the outfall channel in an attempt to stop rocks from being shifted into the outfall channel.

Figure 25. Water Velocities and Sediment Depths at Naches-Cowiche in May 2003. Error bars show turbulence (\pm the root-mean-squared [RMS]) at each point.

Figure 26. Water Velocities and Sediment Depths at Naches-Cowiche in June 2003. Error bars show turbulence (\pm the root-mean-squared [RMS]) at each point.

Figure 27. Water Velocities and Sediment Depths at Naches-Cowiche in September 2003. Error bars show turbulence (\pm the root-mean-squared [RMS]) at each point.

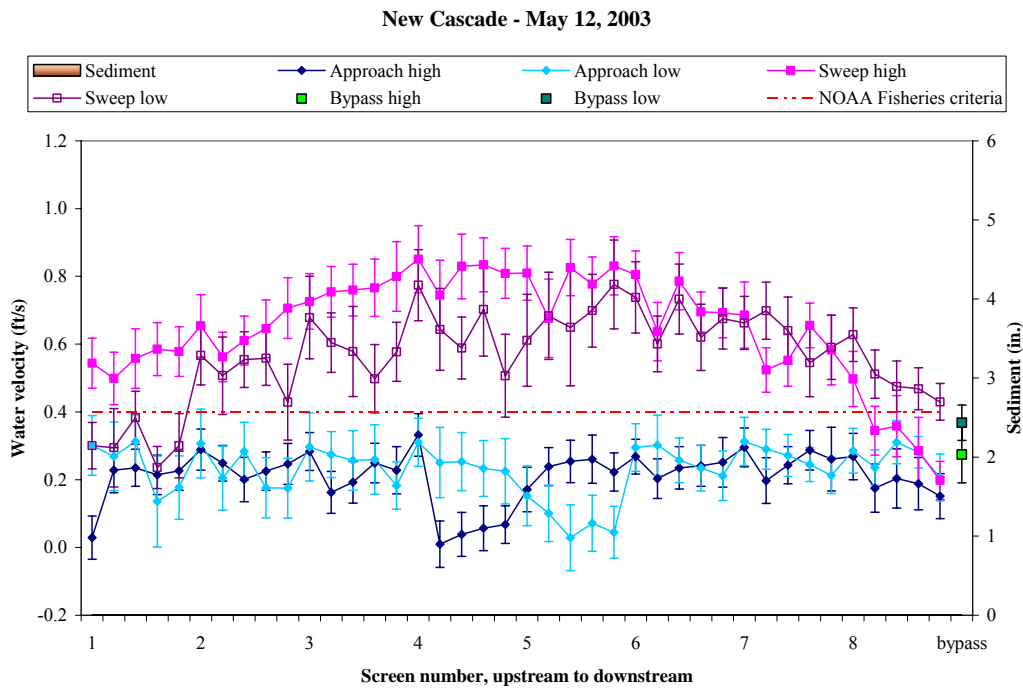
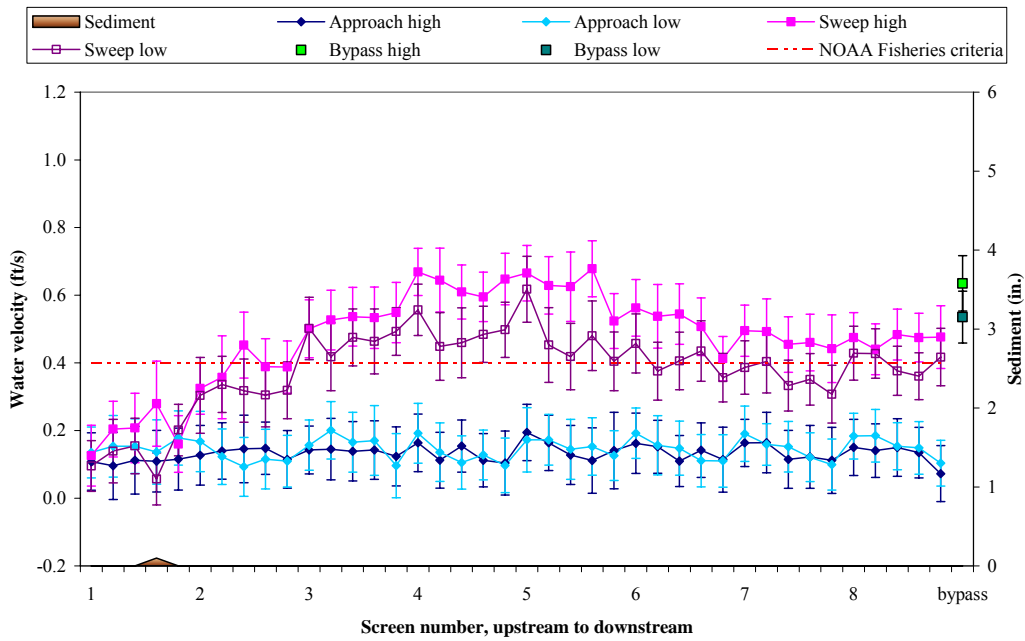
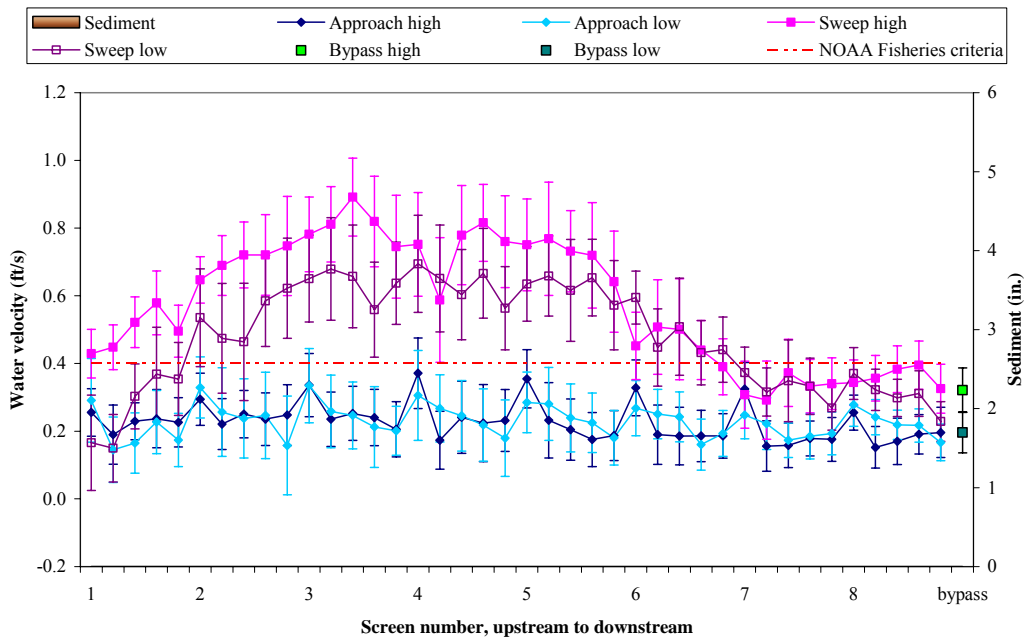
Submergence slightly exceeded criteria in May, June, and September, at 90%, 89%, and 88%, respectively. Ray Gilmore was notified on May 12 of the high submergence level. No changes were made in operating conditions. In the past this site has had problems with sediment buildup, especially in the downstream corners of the screen bays. However, very little sediment accumulation occurred during the 2003 season. All bottom seals were replaced in the fall of 2002, as were the left side seal on screen 1 and the right side seal on screen 8, which had been warped for several years. All seals appeared to be in good condition, and all cheeks were sealed with expanding foam insulation.

Bypass conditions were conducive to safe fish passage during all surveys. Water flowed freely over the weir and through the outfall, where the depth was greater than 1 ft except in June when the depth in the outfall apron was only 9 in. However, the depth in the stream just beyond the fish outfall apron was greater than 12 in.

Figure 28. Water Velocities and Sediment Depths at New Cascade in May 2003. Error bars show turbulence (\pm the root-mean-squared [RMS]) at each point.

Figure 29. Water Velocities and Sediment Depths at New Cascade in June 2003. Error bars show turbulence (\pm the root-mean-squared [RMS]) at each point.

Figure 30. Water Velocities and Sediment Depths at New Cascade in September 2003. Error bars show turbulence (\pm the root-mean-squared [RMS]) at each point.
