Yakima River Basin Phase II Fish Screen Evaluations, 2003

J. A. Vucelick
G. A. McMichael
M. A. Chamness

May 2004

Prepared for the U.S. Department of Energy
Bonneville Power Administration
under Project 1982-06200

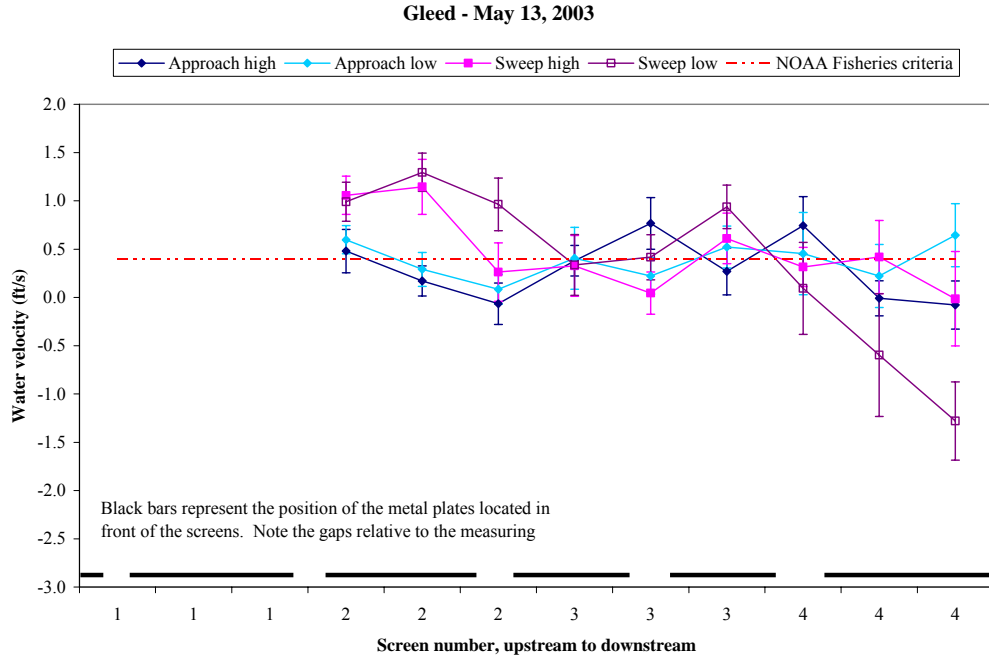
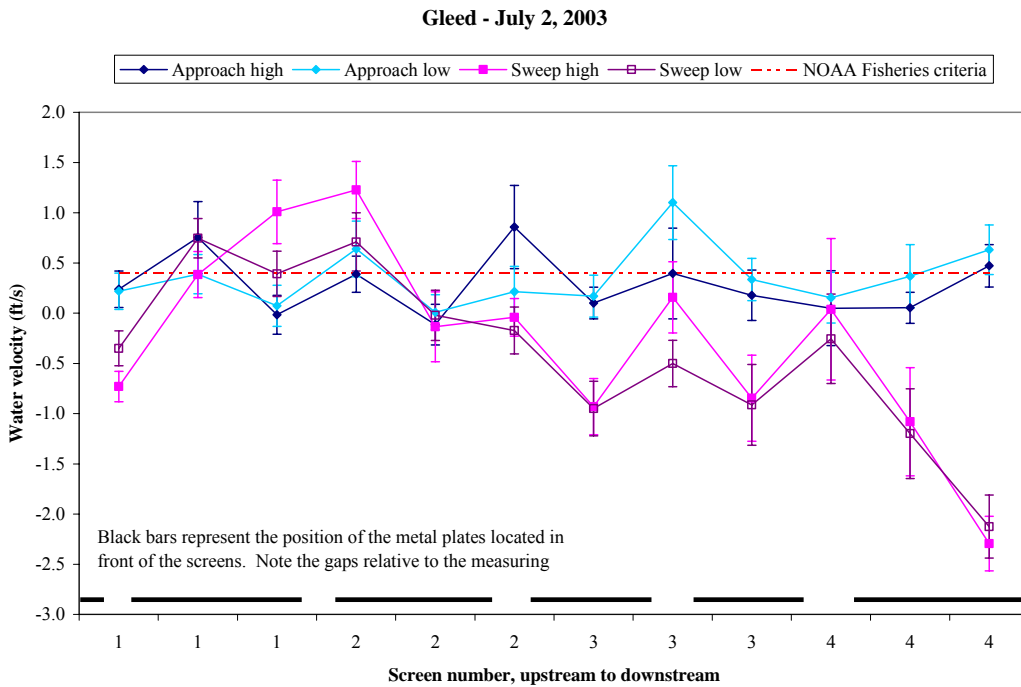
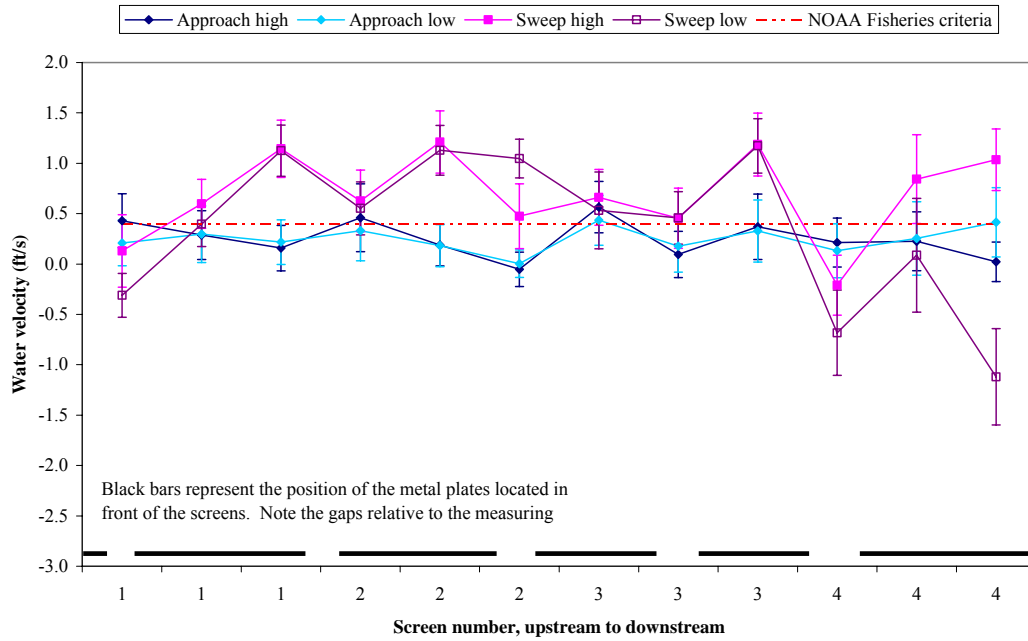
Figure 68. Water Velocities and Sediment Depths at Gleed in May 2003. Measurements were not taken in front of screen one because a sheet of plywood had been placed directly in front of the screen. Error bars show turbulence (\pm the root-mean-squared [RMS]) at each point.

Figure 69. Water Velocities and Sediment Depths at Gleed in July 2003. Error bars show turbulence (\pm the root-mean-squared [RMS]) at each point.

Figure 70. Water Velocities and Sediment Depths at Gleed in September 2003. Error bars show turbulence (\pm the root-mean-squared [RMS]) at each point.
