<i>Title:</i> <b>ET Tiger Team Report – Part I : Interim</b>	<i>Revision:</i> Rev C	<i>Date:</i> 07 Oct 05	<i>Page:</i> 1 of 80
---	---------------------------	---------------------------	-------------------------

As a result of foam loss on STS-114, an ET Tiger Team was chartered by the Headquarters Mission Director for Space Operations (MDSO) and NASA's Chief Officer for Safety and Mission Assurance (COSMA), to review unexpected External Tank (ET) Thermal Protection System (TPS) foam loss. Foam losses of significance occurred in five areas of ET foam, including the Protuberance Air Load (PAL) ramp, the left bi-pod fitting closeout, several locations on the ice/frost ramps covering the re-pressurization line attachment brackets, two locations on the liquid hydrogen (LH<sub>2</sub>) tank-to-intertank flange, and two locations in the LH<sub>2</sub> tank acreage. The largest piece, approximately one pound, was from the PAL ramp. The ET Tiger Team reviewed foam performance to determine most likely root causes, to determine whether these were unique to STS-114/ET-121, and to make both near- and long-term recommendations to minimize likelihood of recurrence.

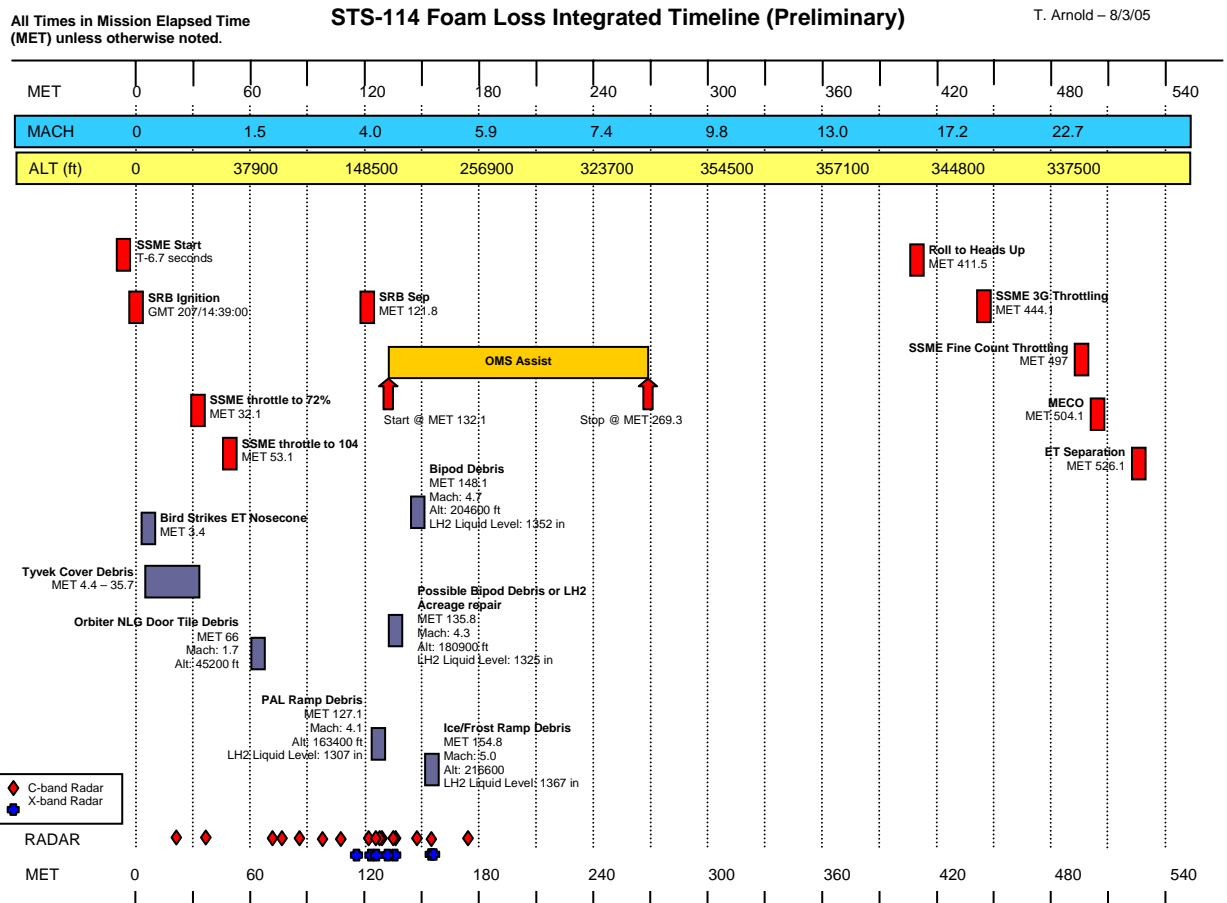
**Figure 4.0-1. STS-114 ET Foam Loss Timeline**

STS-114 post-launch photo and video analysis highlighted the loss of a significant piece of foam from the PAL ramp and fifteen other instances of significant ET foam loss (refer to Table 4.0-1 and Figure 4.0-1). Nine of the 16 were referred for immediate assessment to one of five of the SSP's independent IFA Resolution Teams. Four of the remaining seven foam losses appeared to have been caused by debris strikes from sources external to the tank. One of the seven represented foam lost from an area of the LH<sub>2</sub> intertank flange outside the critical debris zone and not subjected to RTF modifications. The remaining two, one from a LO<sub>2</sub> feedline bracket and one from the aft thrust structure, are still under assessment by the SSP video analysis teams.

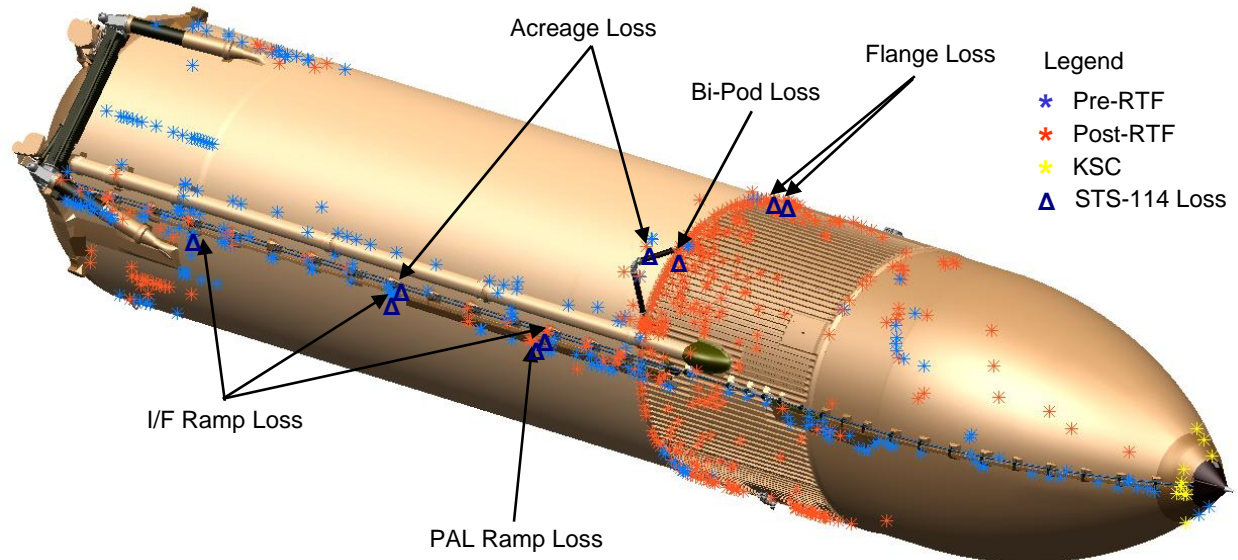
While ground-handling loads were judged inconsequential, the occurrence of collateral damage during ground processing appears significant with numerous cuts, scratches, crushed foam and other damage documented during ET-121 processing. The rework of ET-121 and subsequent tanks, and the performance of that work after installation of the LH<sub>2</sub> PAL ramp, represents a significant departure from the normal processing flow. A high correlation was noted between areas of the tank with the highest levels of processing traffic (those adjacent to work platforms, mats, etc.), the locations of documented repairs known as nonconformance documents, or NCDs, and the locations from which foam was lost on STS-114 (Figure 5.2-1). Comparison to the -Z side of the tank, which sees relatively little processing activity, illustrates the point (Figures 5.2-2 and 5.2-3). Data collected for ET-119 and ET-115 shows a similar pattern: foam loss typically occurs in locations that have seen the highest levels of processing traffic (Appendix A). This suggests the possibility that undetected collateral damage may be a direct or contributing cause of some foam loss.

**Figure 5.2-1. ET-121 Nonconformance Document (NCD) Map with STS-114 Foam Loss Overlay**  
*NCD locations shown here and in Figure 5.2-2 are approximate. Since all NCDs do not carry detailed x-y-z coordinate data, not all discrepancy locations are plotted.*

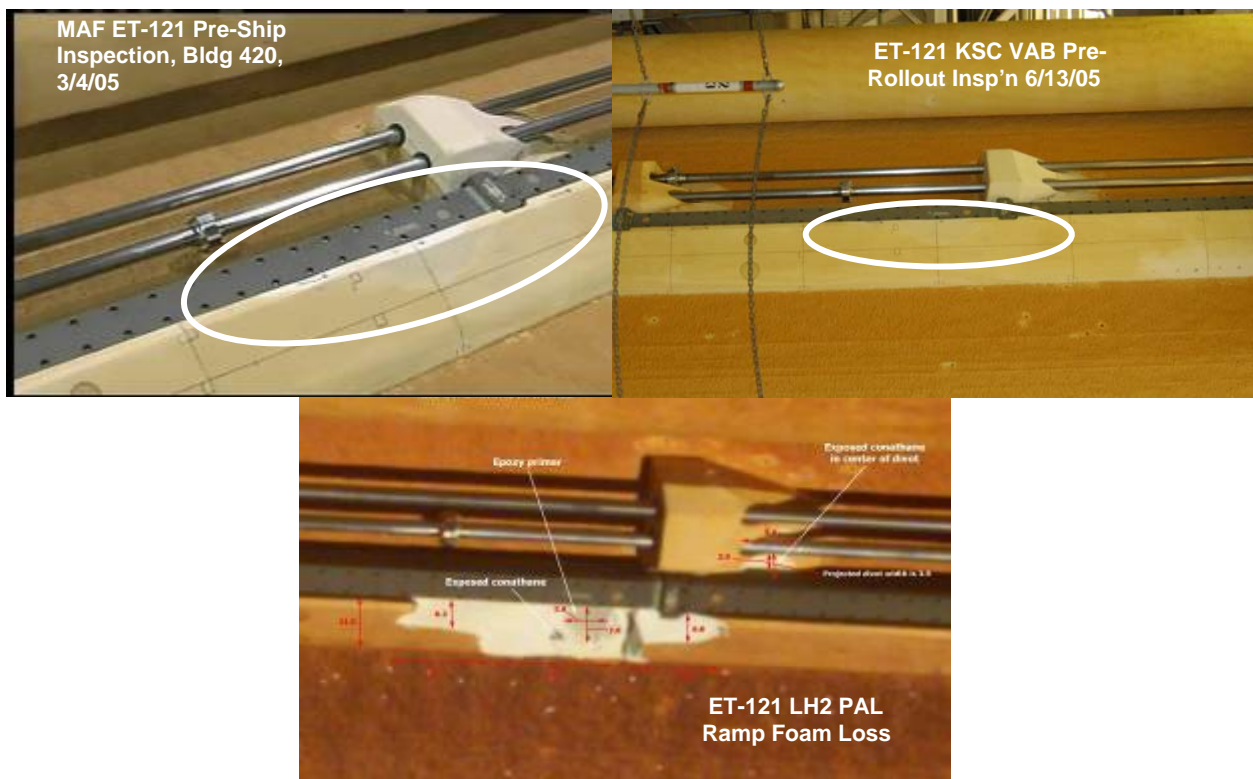
**Figure 6.0-1. STS-114 PAL Ramp Foam Loss**

A section of foam approximately 36 x 11 inches (1 lbm) was lost from the LH<sub>2</sub> PAL ramp at 127.1 seconds mission elapsed time (MET) (Figure 6.0-1).

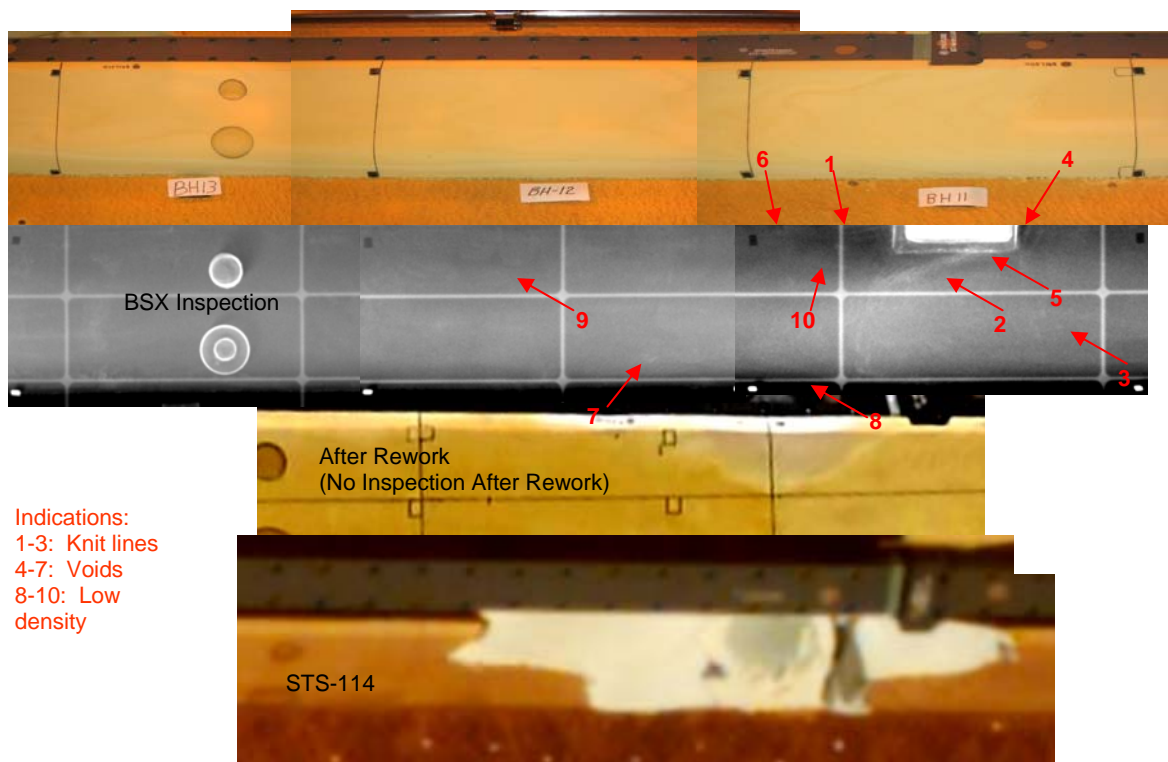
**Figure 6.0-3. Backscatter Image of ET-121 PAL Ramp Foam Loss Area**

NDE of the PAL ramp was performed before flight to gather data useful for long-term development of NDE tools. Post-flight evaluations of terahertz and backscatter data techniques highlighted a low density region along the leading edge of the PAL ramp most prominent in the area of foam loss, a concentration of knitlines in the region, and a low density indication (Figures 6.0-3 and 6.0-4). These NDE observations were generally consistent with other parts of the ET-121 LH<sub>2</sub> and LO<sub>2</sub> PAL ramps and were thought insignificant at the time the data was collected (ref. 16). The NDE results in the ET-119 LO<sub>2</sub> PAL ramp are very similar to those in the ET-121 LH<sub>2</sub> PAL ramp divot region. Eight of the 10 indication types identified in the divot region were observed in the LO<sub>2</sub> PAL ramp. The sharp low density indication (Type 9 in Figure 6.0-3) and the broad low density indication (Type 10 in Figure 6.0-3) were not observed in the ET-119 LO<sub>2</sub> PAL ramp.

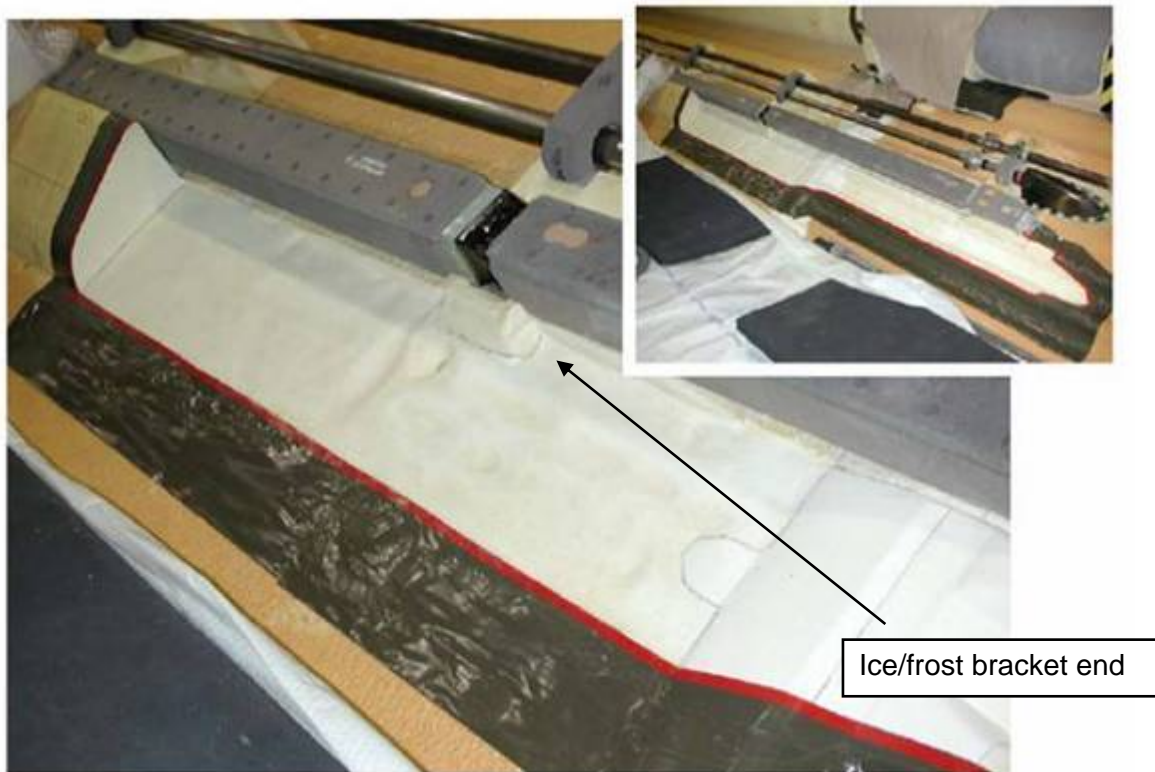
**Figure 6.0-6. ET-120 PAL Ramp prior to Re-spray Showing Location of the Ice/Frost Bracket**  
*Complex geometry in this area may contribute to void formation during PAL ramp spray.*

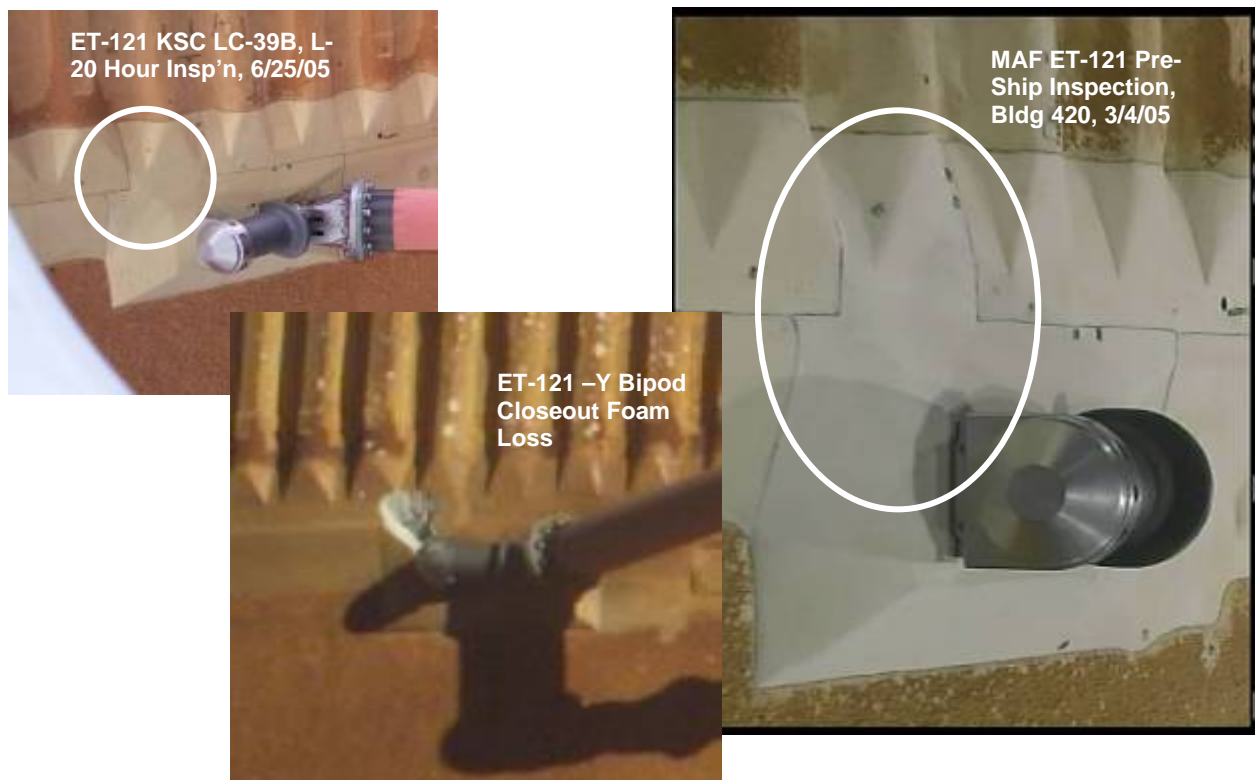
**Figure 7.0-1. STS-114 Bi-pod Foam Loss**

A 7 x 8 inch divot (0.023 lbm) was observed on the forward outboard portion of the –Y bi-pod closeout at approximately 148 seconds MET (Figure 7.0-1). Exposed substrate is visible in the post-ET separation photographs. Loss occurred in proximity to the bi-pod fitting heater wires, as indicated by Computer Aided Three-Dimensional Interactive Application (CATIA) modeling (Figure 7.0-2).

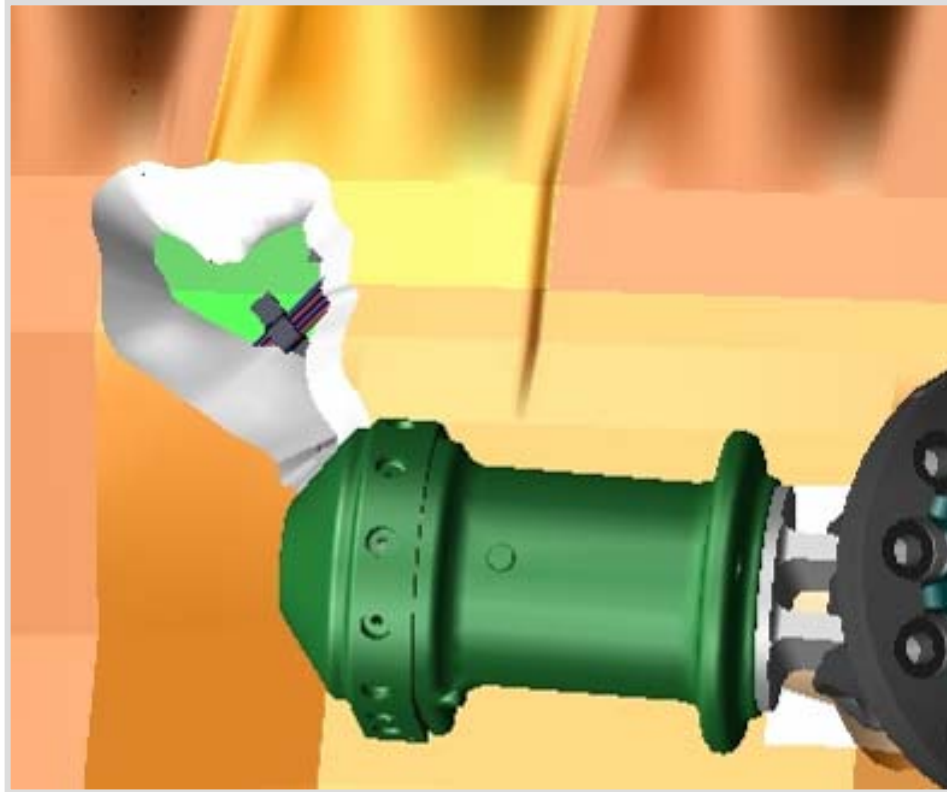
**Figure 7.0-2. CATIA Model of the STS-114 Bi-Pod Foam Loss Area**  
*Wiring location is approximate.*

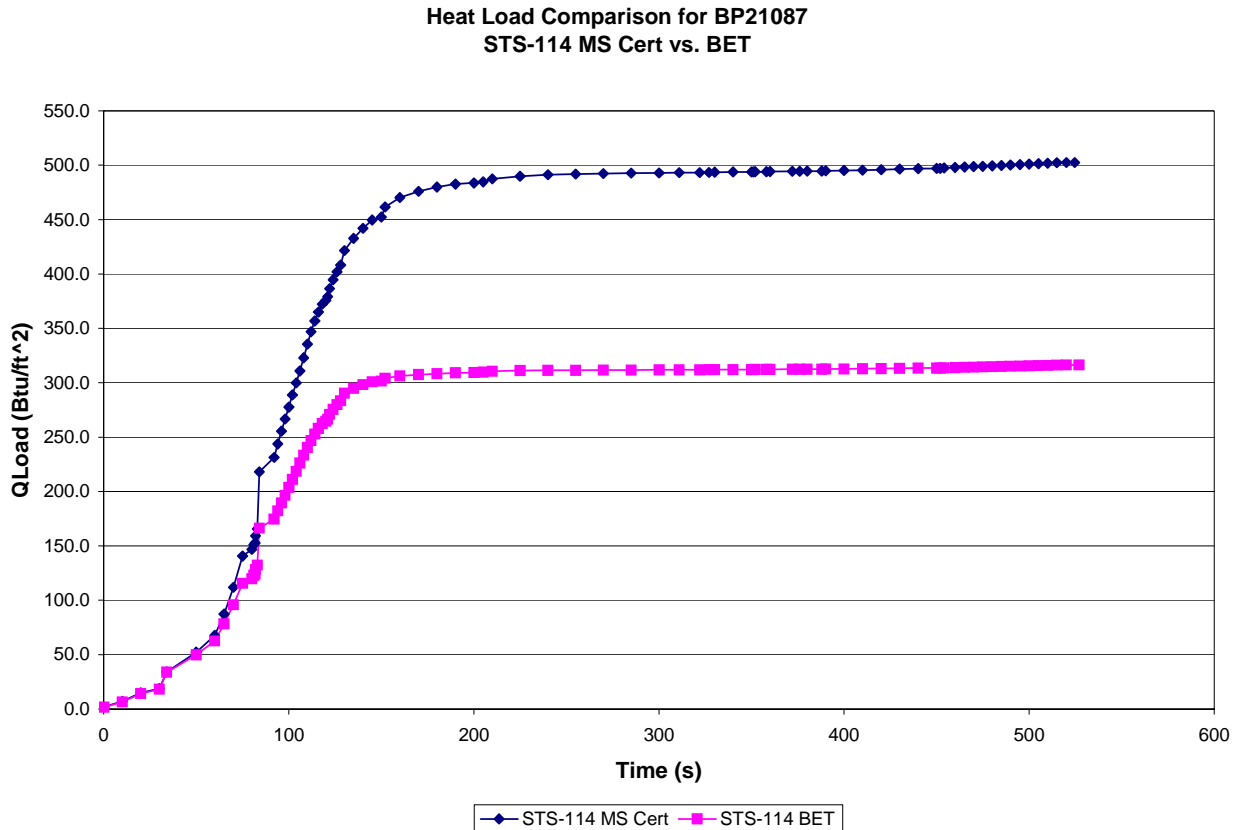
**Figure 7.0-3. STS-114 Bi-Pod Heat Load Comparison to Certification Limits**

Reconstruction of the ET-121 ascent environment surfaced no unusual conditions that would have contributed to loss of the bi-pod foam. Accelerometers installed in the intertank area for STS-114 recorded no values outside certified limits (ref. 5). STS-114 reconstructed BET aeroheating was found to be within STS-114 mission specific (MS) certification at 44 locations. The heat load at body point BP 21087 slightly inboard of the –Y bi-pod fitting is depicted in Figure 7.0-3 (ref. 30).

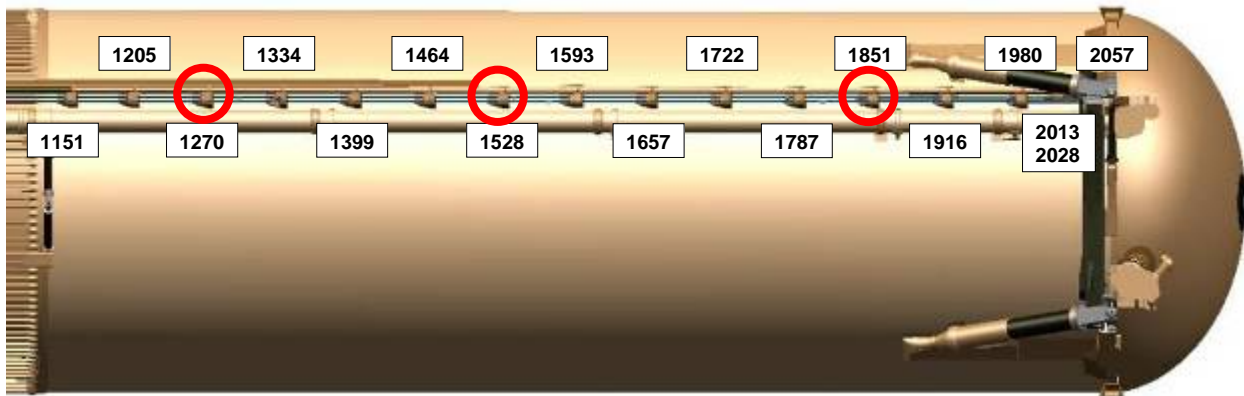
**Figure 8.0-1. LH<sub>2</sub> Ice/Frost Ramp Location Map Showing Location of the Three Ramps that Shed Foam**

Foam was lost from ET-121 ice/frost ramps at three locations: station 1262 (5.6 x 3.5 inches/0.024 lbm) at 154.8 seconds MET, station 1525 (7.3 x 1.9 inches/0.022 lbm along the outer edge of the ramp coincident with the re-pressurization line) and 1841 (4 x 2.6 inches/0.002 lbm extending beneath the re-pressurization lines). Refer to Figures 8.0-1 through 8.0-4. Note the station locations refer to the Xt coordinates of the damage and differ slightly from the Xt locations of the ramps themselves, which are depicted in Figure 8.0-1.

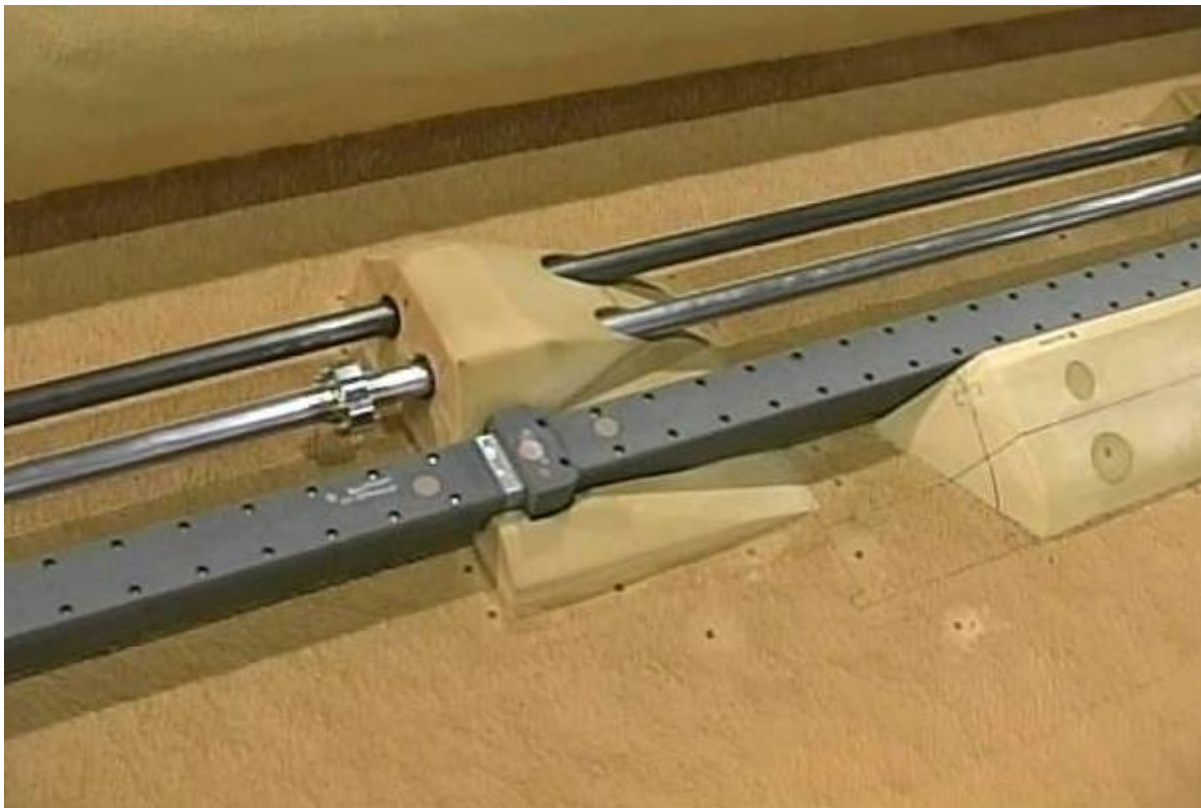
**Figure 8.0-5. Repairs in the Vicinity of the ET-121 Station 1528 Ice/Frost Ramp**

Three NCDs were documented during processing, one pertaining to an initial material viscosity test failure attributed to shipment-related settling of the PDL material, one to voids noted during removal dissection of the original 1270 upper ramp, and one to increase the PDL charge size required for fabrication of the 1270 replacement ramp (ref. 28, 29, and 30). None of the NCDs reviewed was considered a probable contributor to the loss, although the presence of a void noted during 1270 upper ramp dissection clearly demonstrates the potential for void entrapment during the fabrication process. Two IPRAS were reviewed, one for a void in the 1270 ramp and one for a knife cut in the 1851 ramp (ref. 30 and 31). The void repair was in an area of the ramp where foam was lost, but the knife cut repair is not a likely contributor to foam lost from the 1851 ramp.

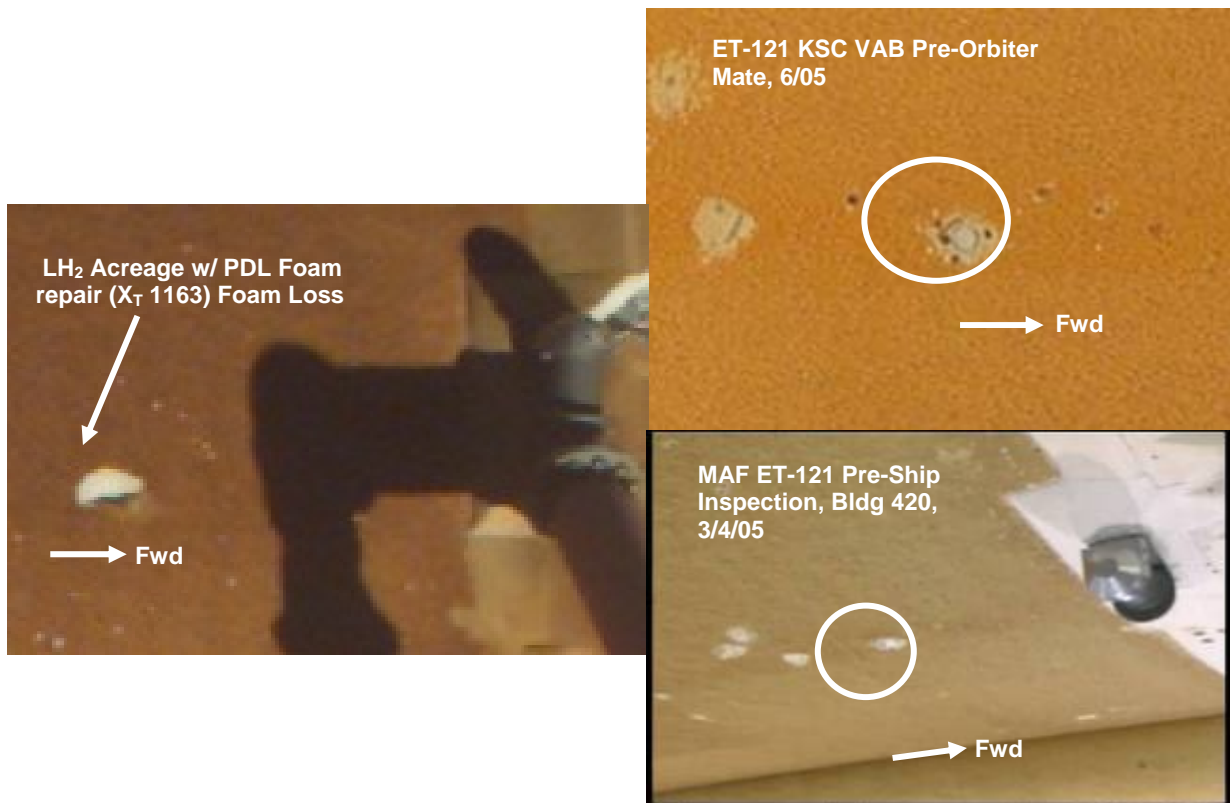
**Figure 9.0-1. Station 1163 Acreage Foam Loss**

Divots were noted in acreage foam aft of the -Y bi-pod attachment point at station 1163 (4.8 x 3.3 inches/0.003 lbm) and adjacent to the ice/frost ramp at station 1839 (10.3 x 7.8 inches/0.03 lbm). Refer to Figures 9.0-1 and 9.0-2.

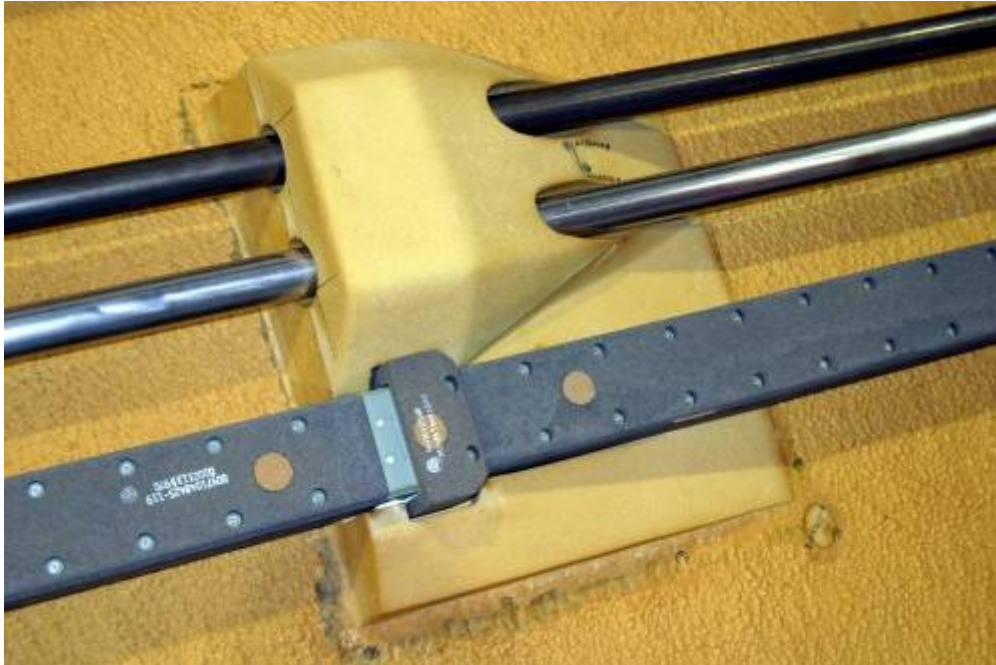
**Figure 9.0-4. ET-118 Ice/Frost Ramp**

*Discolored area of acreage adjacent to the ramp is caused by the lower compression mold bladder seal.*

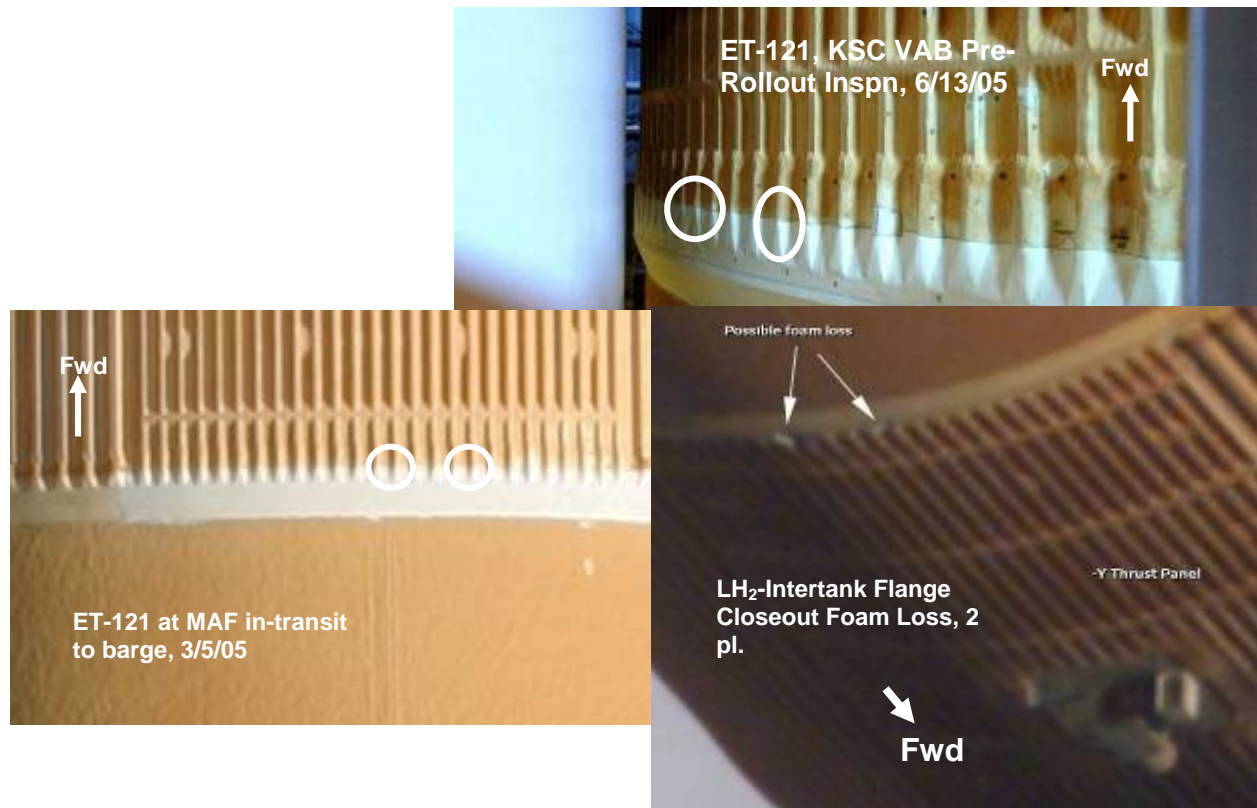
Figure 10.0-1. STS-114 PAL Ramp Foam Loss

Two areas of foam (7.5 x 7.5 inches/0.066 lbm and 4.5 x 4.5 inches/0.011 lbm) were lost from the upper LH<sub>2</sub> intertank flange closeout on the -Y axis in the SRB thrust panel structure (Figure 10.0-1). Time of loss is unknown, but is believed to have occurred after SRB separation. The damage was difficult to discern in flight photography and did not appear to have significant depth. The flange closeout is a 3-step process where the first step is a point fill of the stringers with BX-265 followed by upper and then the lower section manual sprays of BX-265. These last two closeouts are divided into ten 22° “windows” labeled A through J. The smaller of the two foam loss regions was at the spray window G and H juncture, two individually hand-sprayed circumferential sections separated by a Conathane bond. The larger was at the flange and intertank acreage spray juncture, also separated by a Conathane layer.
