## **Patient Safety Alert**

AL09-06 November 20, 2008

**Item**: Maxi Move patient lifts with "Lock and Load" system (Combi Hanger):

### MAXI MOVE with Lock & Load system (Combi Hanger) ID [080811AHE]

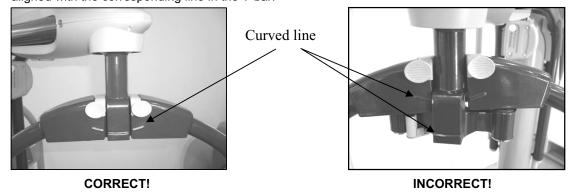
- Re-train caregivers not to lower the hanger bar onto rigid surfaces, thereby avoiding the possibility that the hanger will be dislodged.
- Re-train caregivers on how to ensure the hanger is properly attached to the T-bar before and during the
  initial phase of all lifting operations. This is easily done by confirming that the hanger's curved line is
  aligned with the corresponding line in the T-bar.

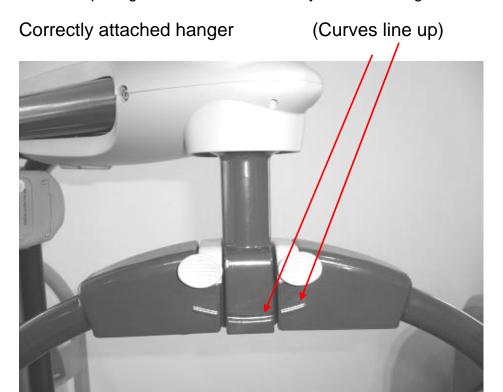
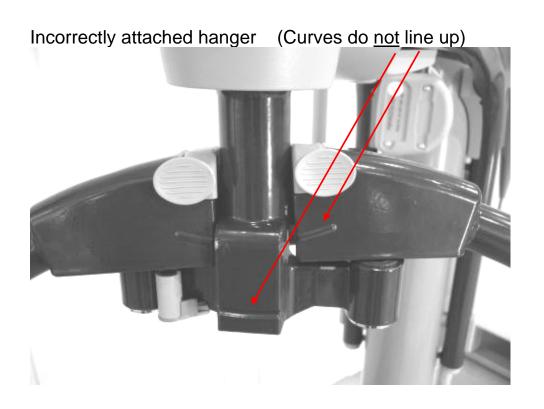
**Attachment 2**Photos depicting corrected and incorrectly attached hangers

However, there is a remote possibility that, when pushed upwards, the hanger will be only <u>partly</u> detached, in which case a complete detachment may occur later, e.g. when a patient is being transferred. Such a detachment could result in a patient fall and there is a possibility the patient could sustain bumps, bruises, cuts, or more serious injuries, should a fall occur.
