Federal Building and Fire Safety Investigation of the World Trade Center Disaster

Aircraft Impact Damage Analysis: Comparisons and Findings

September 14, 2005

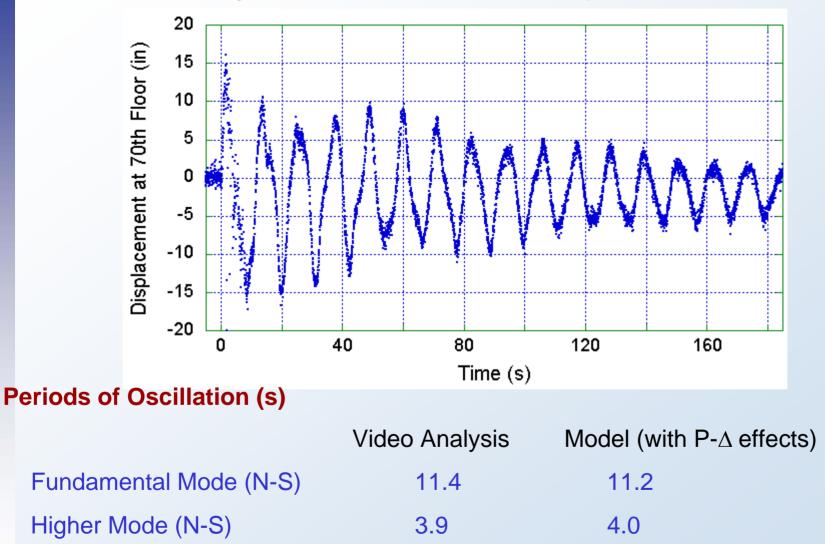
Motion Analysis of WTC 2 after Impact

- The estimated period of oscillation was nearly equal to the calculated first mode period of the undamaged structure, indicating that the overall lateral stiffness of the tower was not affected appreciably by the impact damage.
- The maximum deflection at the top of the tower was estimated to be more than 1/3 of the drift resulting from the original design wind loads (about 65 in. in the N–S direction). Since the lateral stiffness of the building before and after impact was essentially the same, it can be concluded that the additional stresses in the columns due to this oscillation were roughly 1/3 of the column stresses resulting from the original design wind loads. The building demonstrated an ability to carry this additional load and therefore, still had reserve capacity.

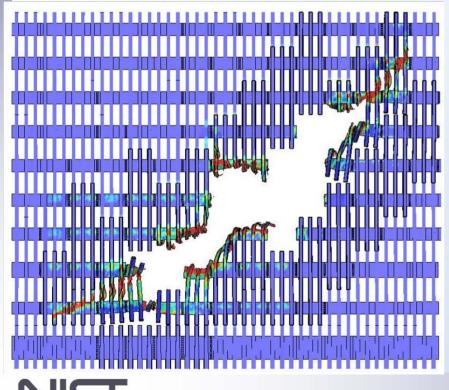
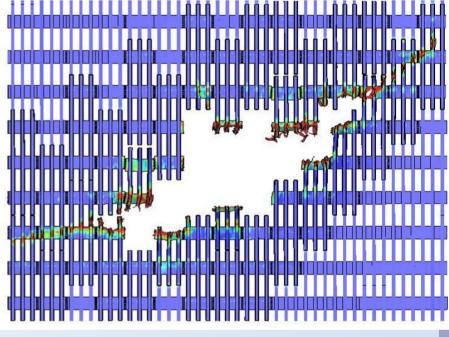
WTC 2

Comparison between WTC 1 and WTC 2: Exterior Damage

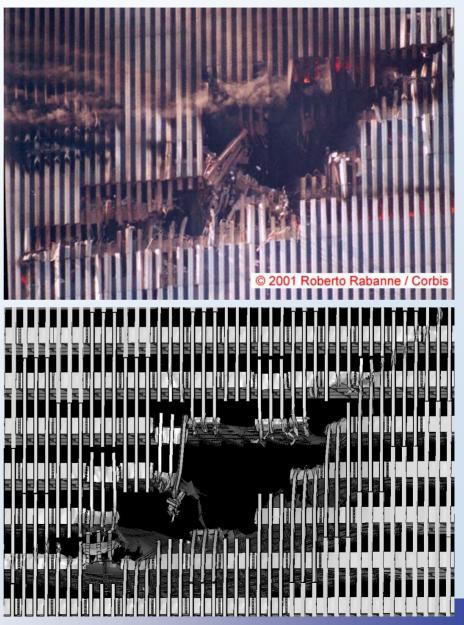
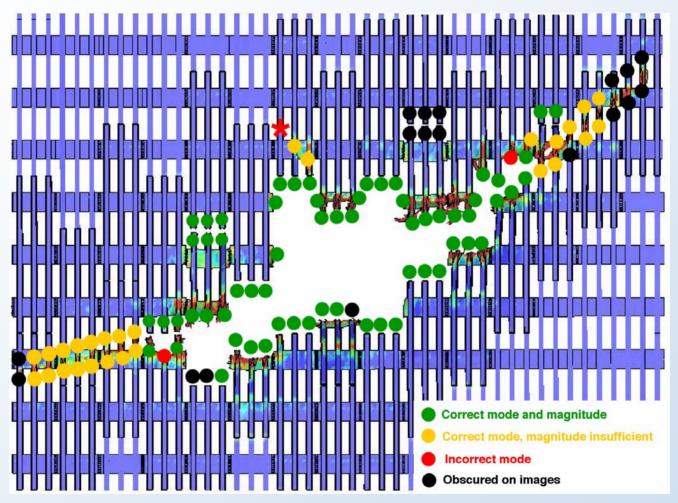
Comparison of observed and calculated base case impact damage to the north wall of WTC 1

- The aircraft had a speed of 443±30 mph with a roll angle of 25±2 degrees (port wing downward). The vertical approach downward angle was 10.6±3 degrees, and the lateral approach angle was close to being normal to the north wall of the tower.
- The aircraft impact resulted in extensive damage to the north wall of the tower, which failed in the regions of the fuselage, engine, and fuel-filled wing section impacts. Damage to the exterior wall extended to the wing tips, but the exterior columns were not completely severed in the outer wing and vertical stabilizer impact regions. 34 columns were completely severed, 4 columns were heavily damaged, and 2 columns were moderately damaged. The results of the impact analyses matched well with this damage pattern to the north wall. An exterior panel on the south wall between floors 94 to 96 was dislodged.

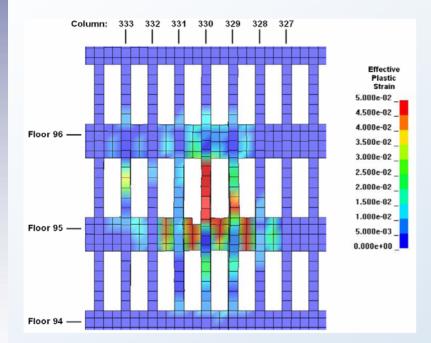
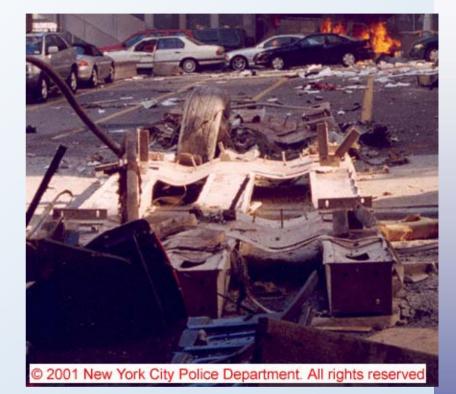
Calculated damage to the south wall of WTC 1

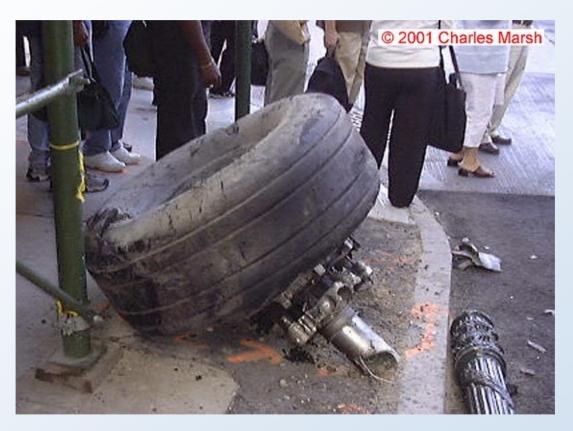
Landing gears were stopped in the core in the WTC 1 simulations

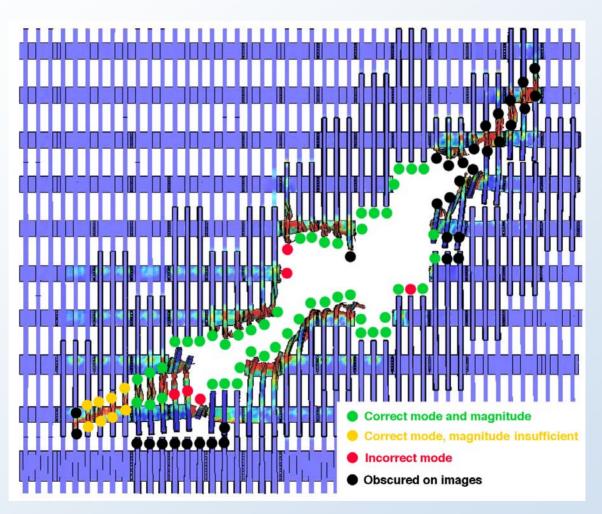
Comparison of observed and calculated base case impact damage to the south wall of WTC 2

- The impacting aircraft had a speed of 542±24 mph, with a roll angle of 38±2 degrees (port wing downward). The vertical approach downward angle was 6±2 degrees, and the lateral approach angle was 13±2 degrees clockwise from the south wall of the tower.
- The aircraft impact resulted in extensive damage to the south wall of the tower, which failed in the regions of the fuselage, engine, and fuel-filled wing section impacts. Damage to the exterior wall extended to the wing tips, but the exterior columns were not completely failed in the outer wing and vertical stabilizer impact regions. 29 columns were completely severed, and 1 column was heavily damaged. The 2 columns were obscured by smoke, but the analysis results showed that these columns were moderately damaged. results of the impact analyses matched the damage pattern to the south wall well. 4 columns on the north wall were failed.

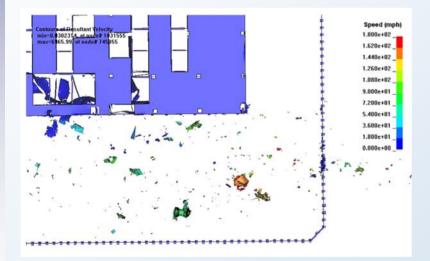
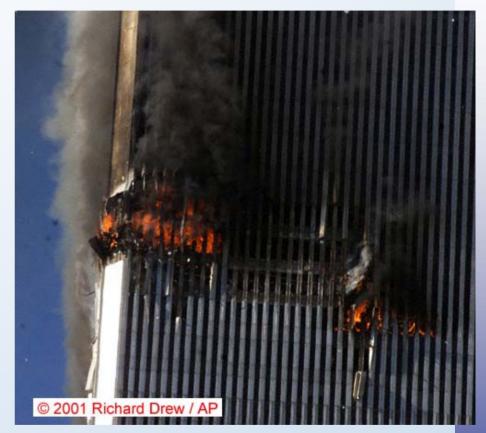
Calculated response to the north wall of WTC 2

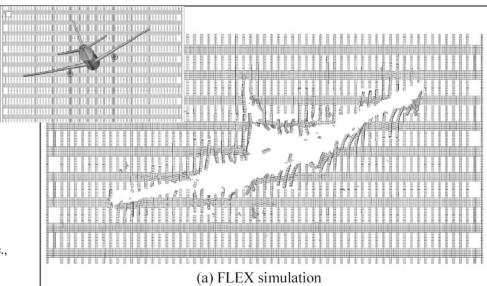
Used a finite element analysis to estimate damage to both towers
