*Federal Railroad Administration  
Office of Safety  
Headquarters Assigned  
Accident Investigation Report  
HQ-2005-19*

*Union Pacific  
Meachum, Oregon  
March 5, 2005*

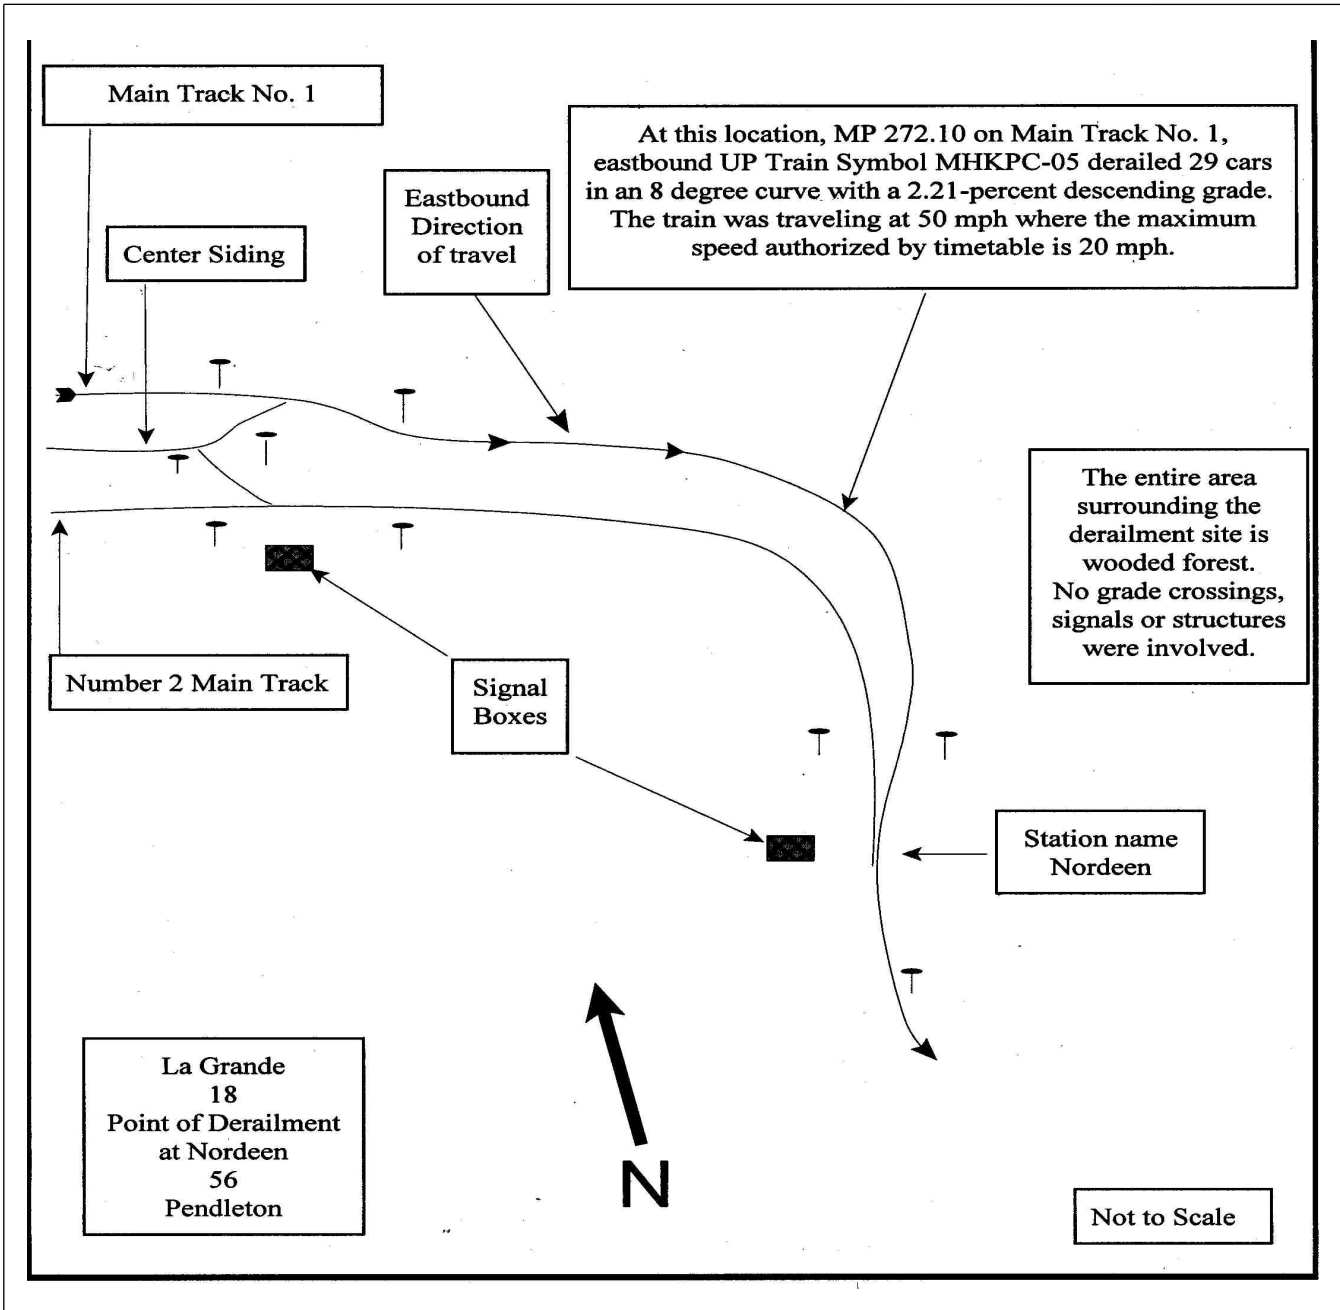
HQ-19-  
2005  
Sketch.jpg

108. DRAW A SKETCH OF ACCIDENT AREA INCLUDING ALL TRACKS, SIGNALS, SWITCHES, STRUCTURES, OBJECTS, ETC., INVOLVED.
