Chandra Flight Note

FLIGHT NOTE NO.	439
SUBJECT	2003:319 Attitude Disturbance
DATE	29 June 2004
AUTHOR	S. Bucher / E. Martin

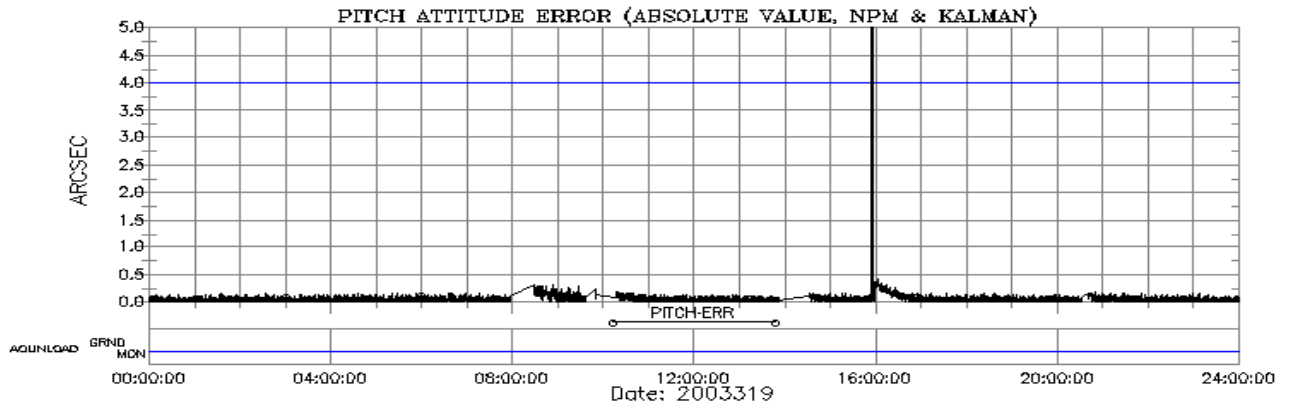
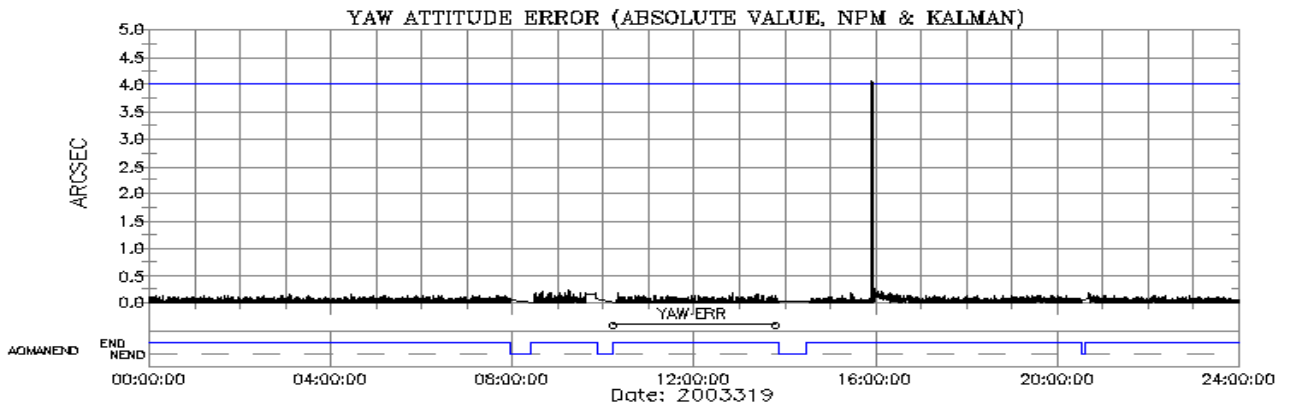
Figure 1: Pointing Stability

Routine checks of the Spacecraft Engineering Daily Plots showed a disturbance in the pointing stability just before 16:00 UT on 2003:319 (**Figure 1**). The daily limit exception file and remaining daily plots were checked for any other indications of unusual behavior. The other PCAD daily plots are: One-shot Attitude Update (**Figure 2**), Sun Sensors (**Figure 3**), Gyro Bias (**Figure 4**), Gyro Current (**Figure 5**), Gyro Temperatures, Maneuvers (**Figure 6**), Reaction Wheel Temperatures and Speeds (large scale), Reaction Wheel Torque Currents (**Figure 7**) and Stars (**Figure 8**). The one-shot plot showed an event not associated with the end of a maneuver at the same time as the pointing stability disturbance, but all of the remaining plots were nominal. The Propulsion System Momentum plot was also checked, and appeared nominal (see **Figures 13** and **14** for momentum plots).

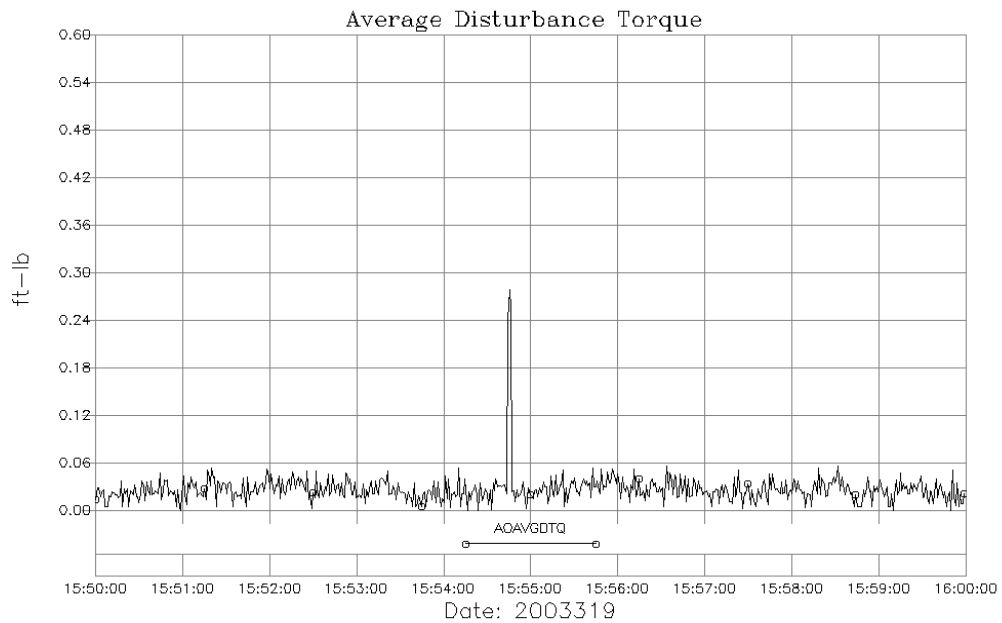
Figure 10: Disturbance torque

Once the daily plots were checked and the usual explanations (in terms of anticipated or unanticipated spacecraft commanding) were ruled out, a more thorough investigation of the telemetry was required. First, the top level PCAD health and status GRETA display (EHS_A_1NOC.dec) was played back for the time period and checked for any unusual behavior. None was found. A plot of the spacecraft rates and attitude errors was used to establish a time and size for the observed disturbance (**Figure 9**). The disturbance occurred at 2003:319:15:54:43 and had a magnitude of approximately 13 arcsec. Along with the rate, the disturbance torque, which is the input to the spacecraft momentum monitor that compares the expected change in momentum from thruster firings to the observed change in the momentum, was checked (**Figure 10**). The disturbance was noticeable, but far too small to trip the spacecraft momentum monitor.

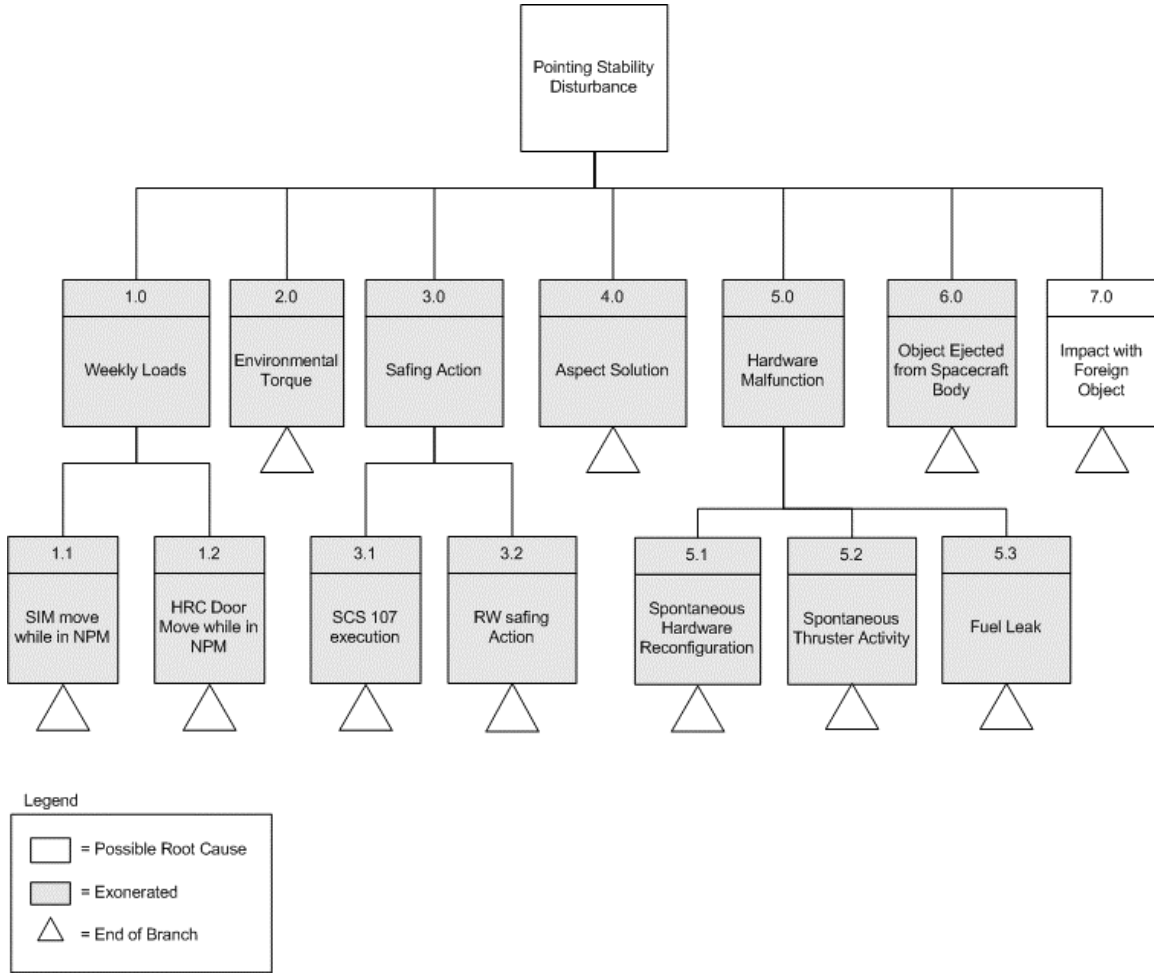
Figure 11: 2003:319 Attitude Disturbance Fault Tree

Once the weekly loads and safing actions were exonerated and the disturbance was characterized a systematic fault investigation was started. The items investigated are shown in **Figure 11**.

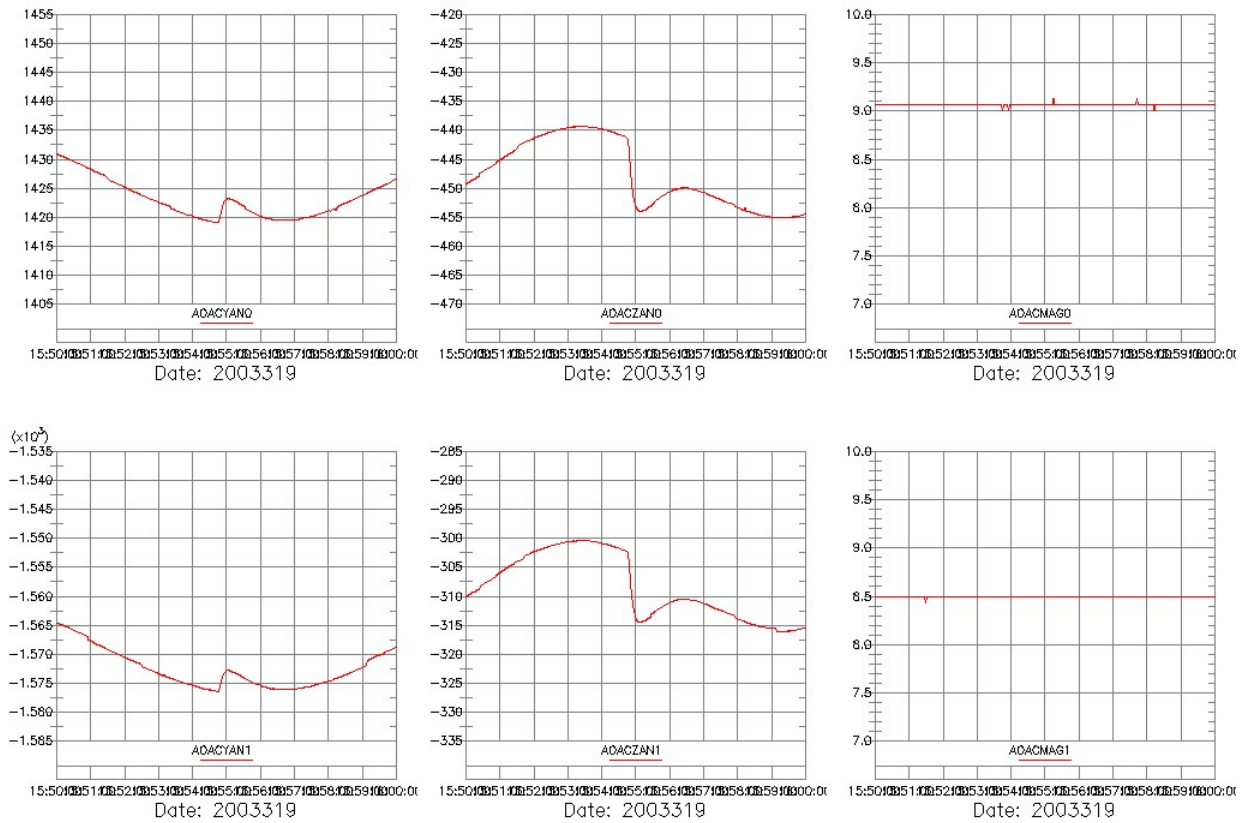
Figure 12: Star Positions (one of four)

Stray light in the Aspect Camera can cause an error in the aspect solution, which in turn can cause a spike in the on-board attitude error calculation. This would produce a disturbance in the pointing stability plot. Plots of star positions were used to determine the source of any possible error (**Figure 12**). Due to the nature of the disturbance, if it were caused by stray light in the camera, the source would have to be instantaneous, such as a cosmic ray. A cosmic ray would shift the centroid of only one star. If the attitude were perturbed (exonerating the camera), all of the stars would instantaneously shift in the same direction. The data supported the latter characterization of the event.

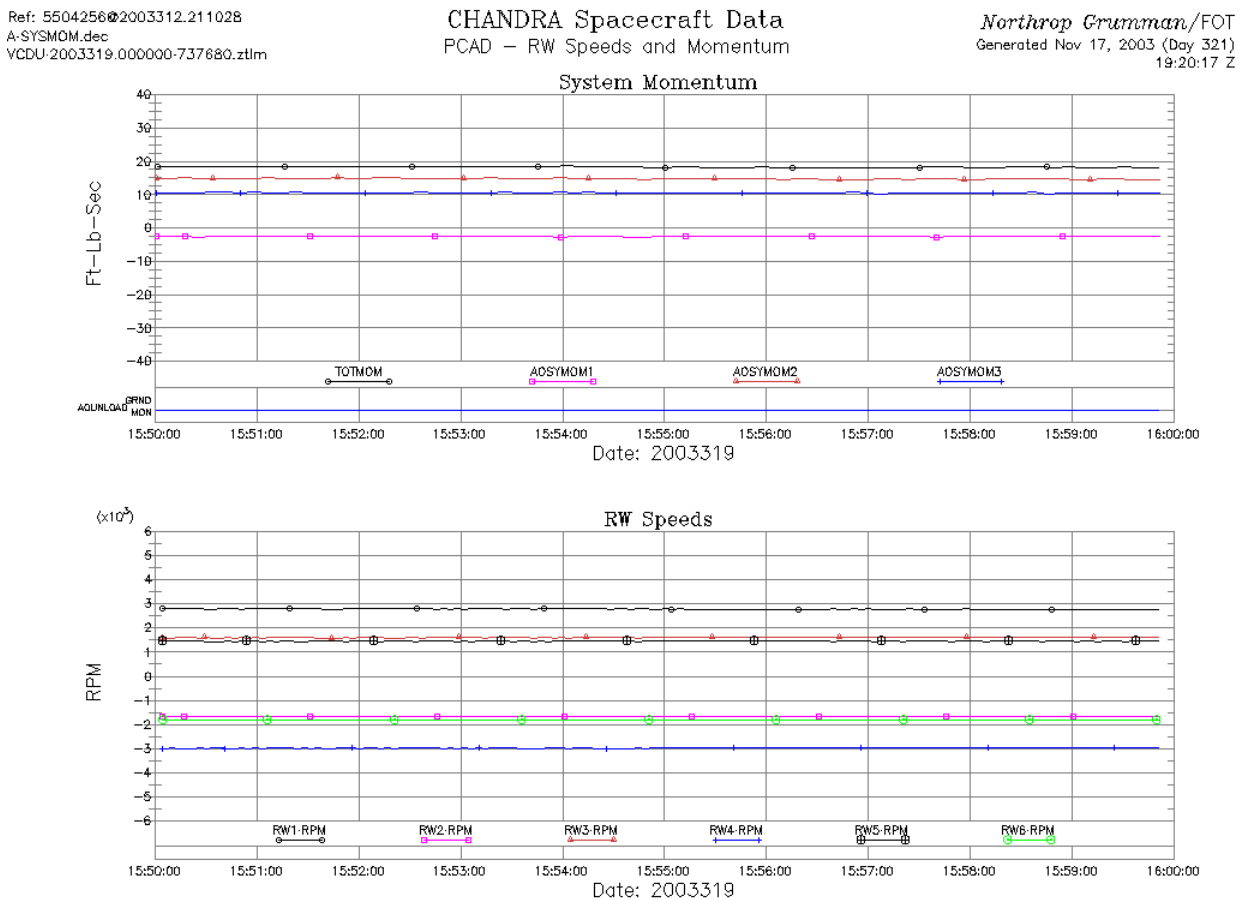
Figure 13: System Momentum GRETA display

The GRETA plot for system momentum showed no change at the time of the disturbance (**Figure 13**). However, the OBC only reports the telemetry for system momentum once every eight seconds. It was felt that an attitude error of thirteen arcsec would certainly cause some redistribution of momentum. Due to the MUPS anomaly, a tool that calculates the system momentum from the reaction wheel speeds and gyro counts had been developed. This tool provides system momentum on a quarter second time step. The tool was used to calculate the system momentum for the disturbance (**Figure 14**).

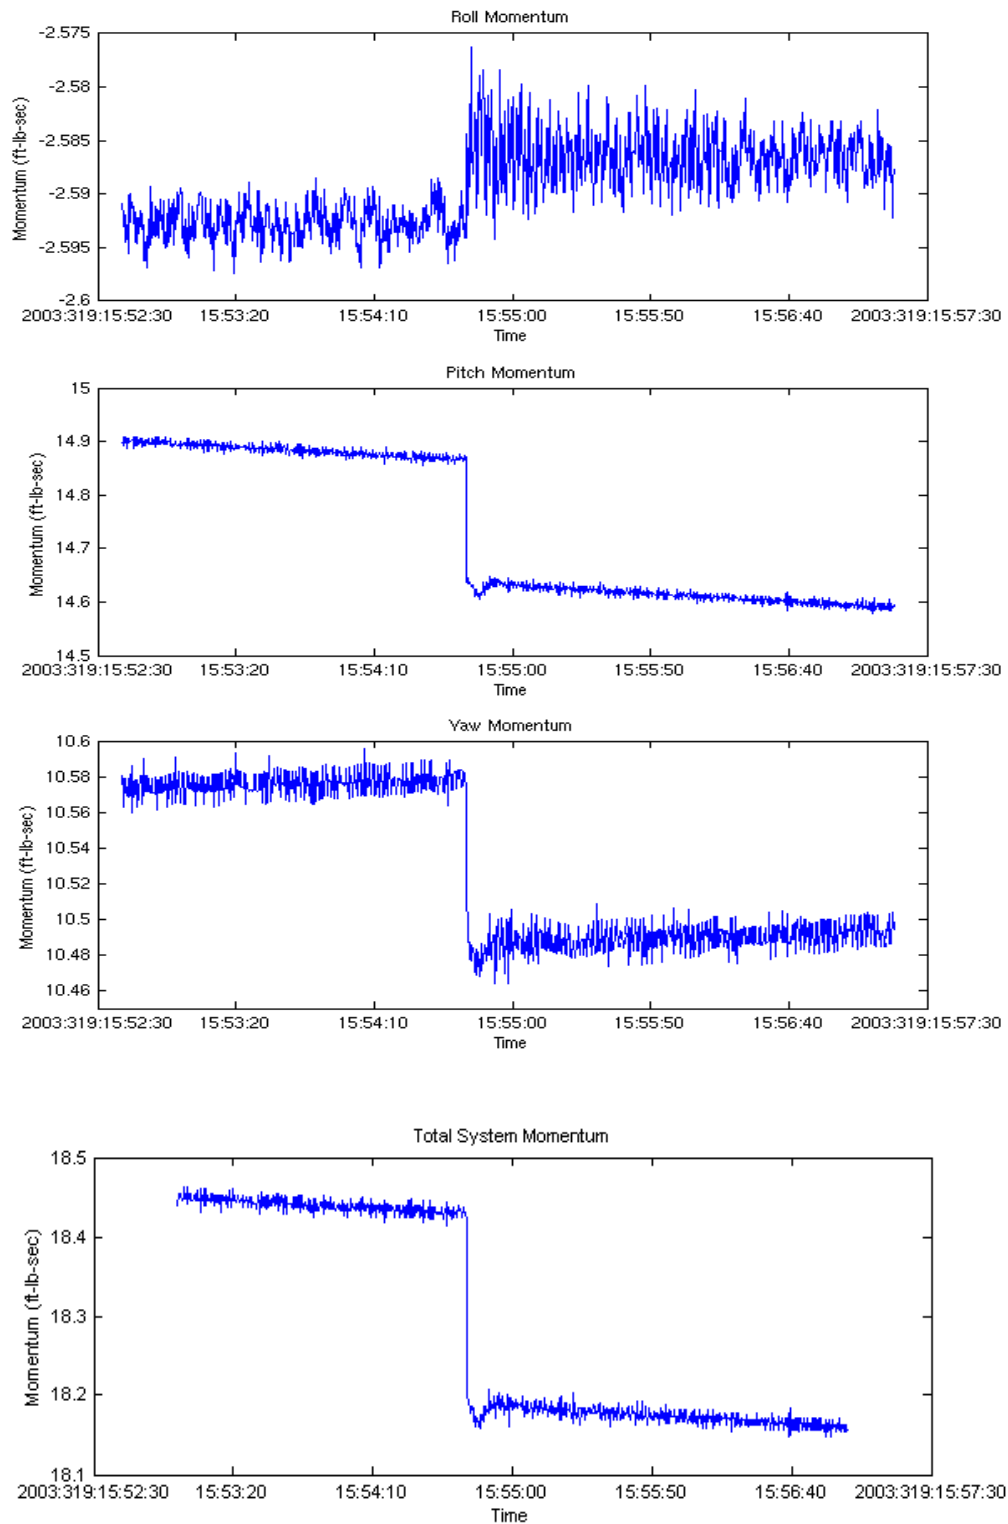
Figure 14: System Momentum Computed from RW and Gyro Data

A hardware reconfiguration can cause the spacecraft momentum to redistribute itself among the spacecraft axes. Due to the conservation of momentum, a reconfiguration cannot create or dissipate momentum (the total system momentum remains unchanged). Figure 14 shows that the disturbance changed the total system momentum, so it cannot be due to a spontaneous hardware reconfiguration.

of momentum accumulation, not an instantaneous change. If the attitude disturbance were due to a fuel leak, Figure 14 would show a change in slope, which it does not.

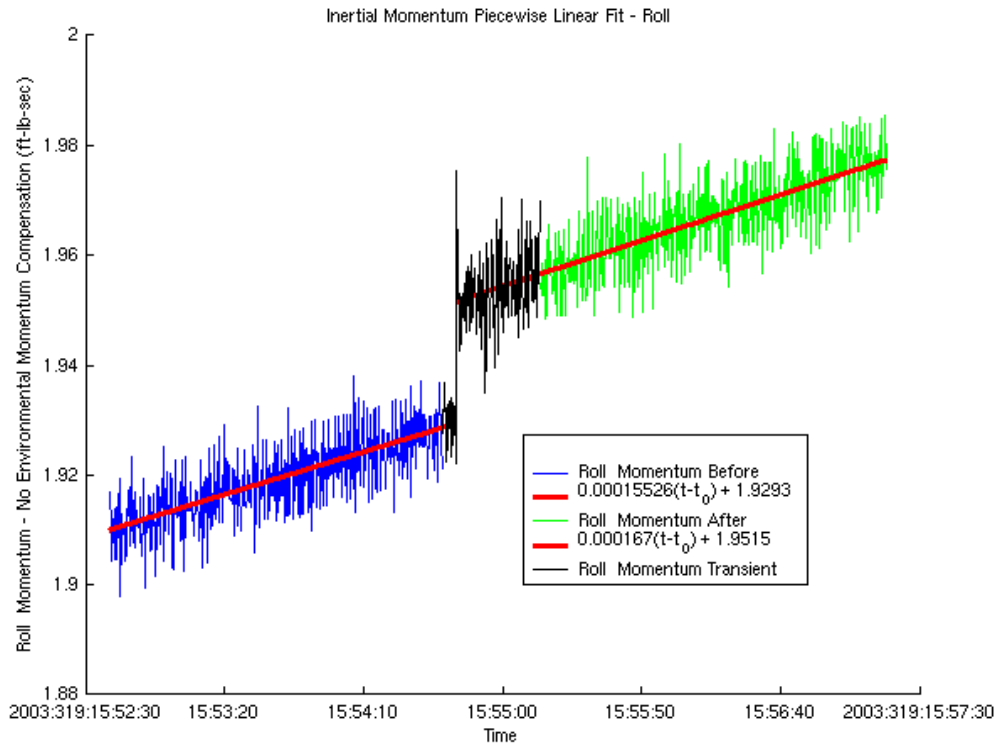
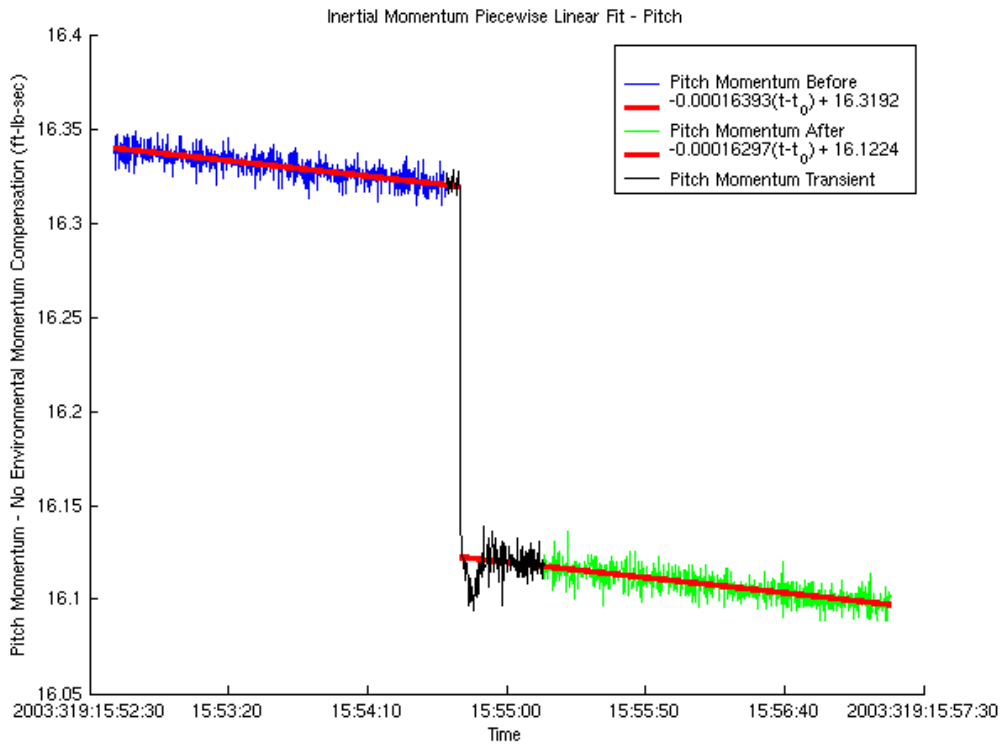
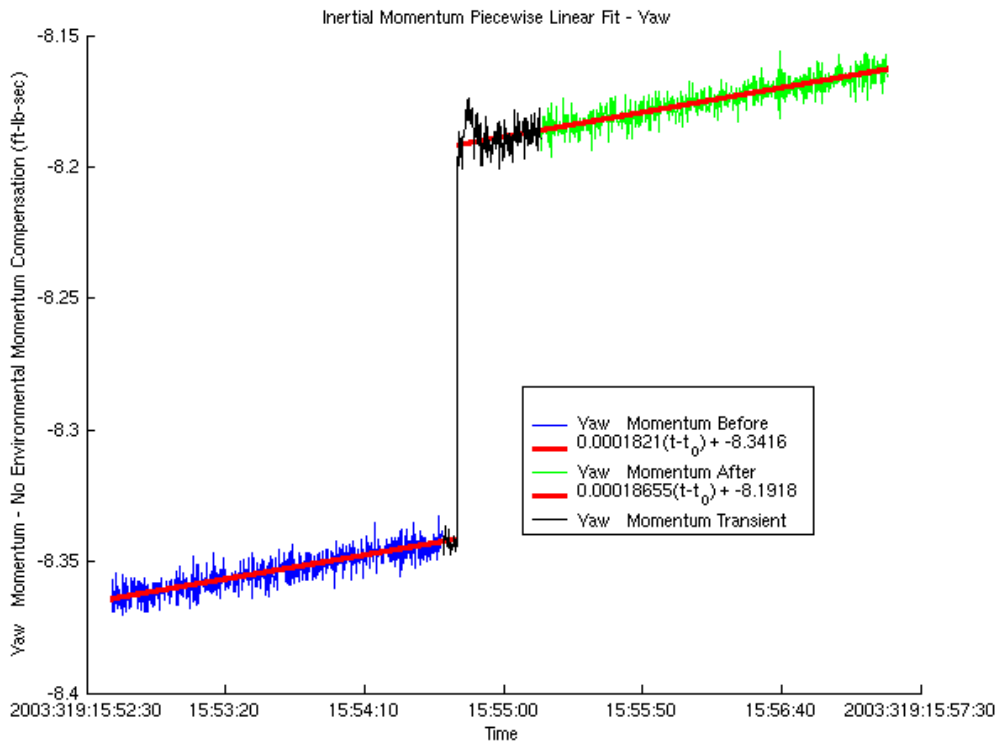
The results are plotted in Figures 15-17.

The computed delta momentum is: [0.0222, -0.197, 0.150] ft-lb-s

The computed one sigma error is: [0.0074, 0.0076, 0.0057] ft-lb-s

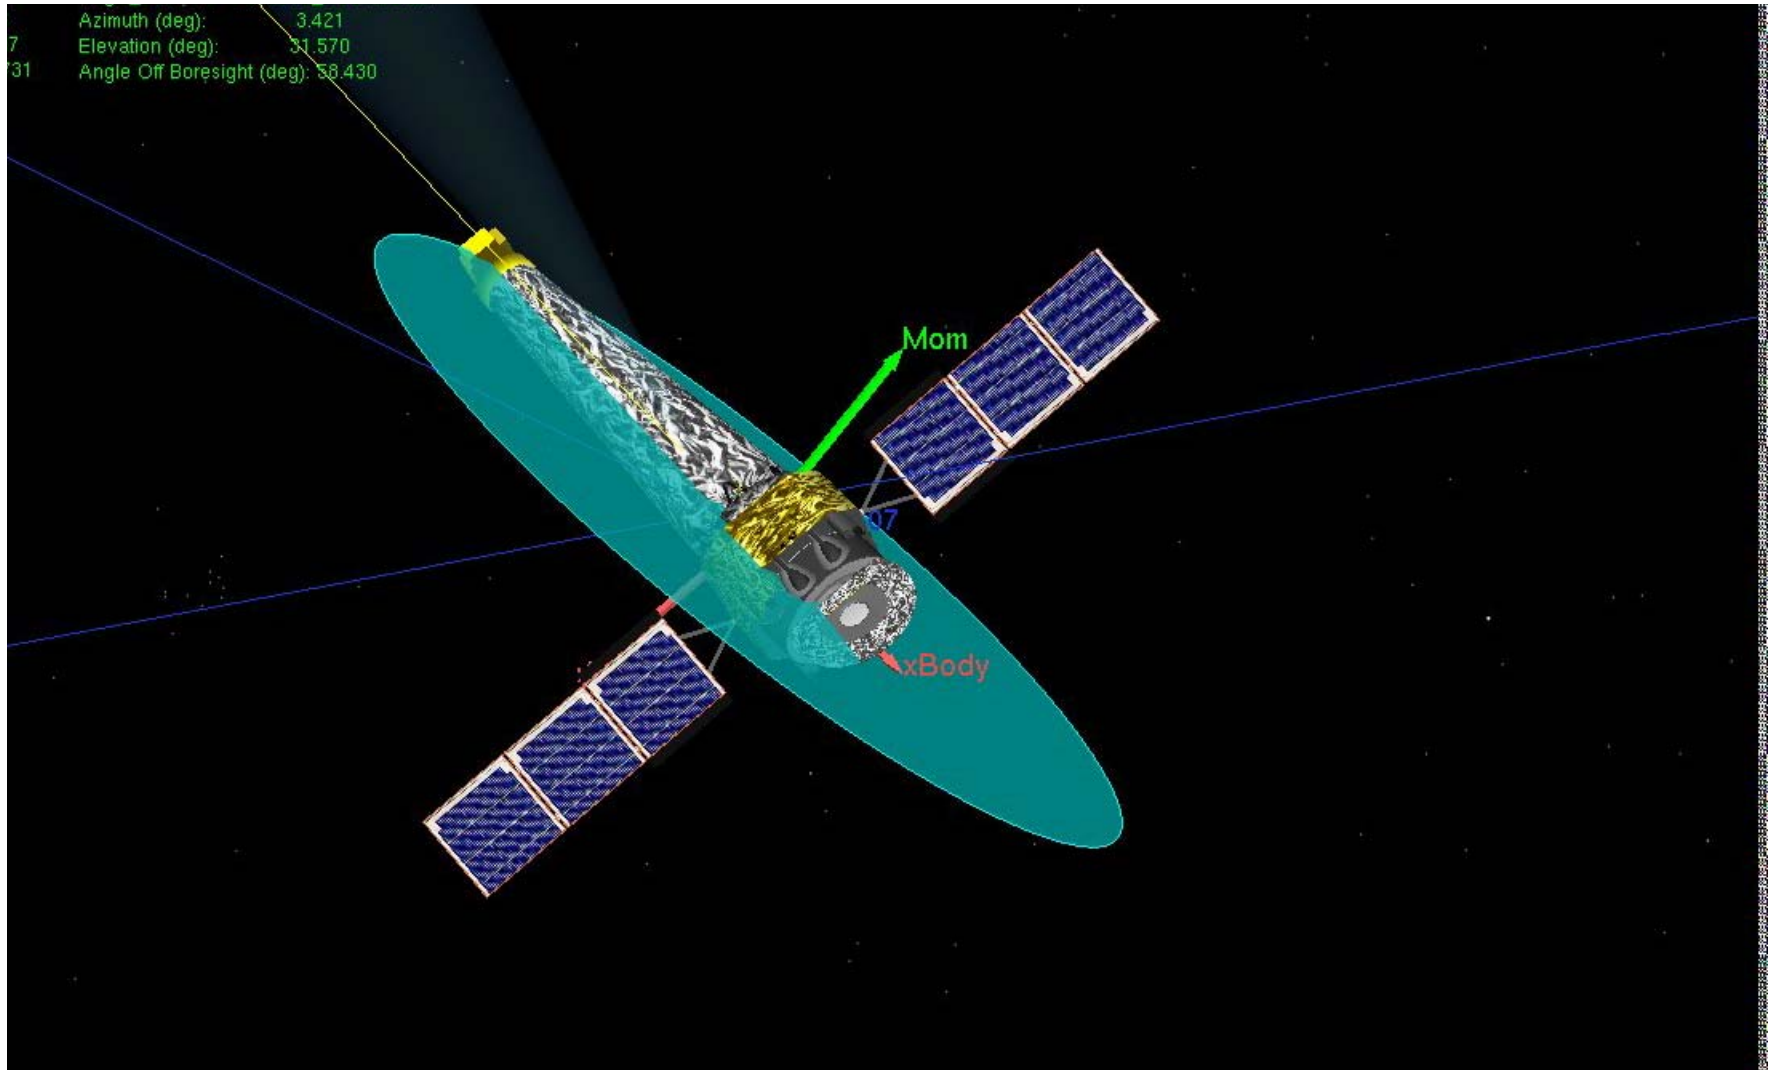
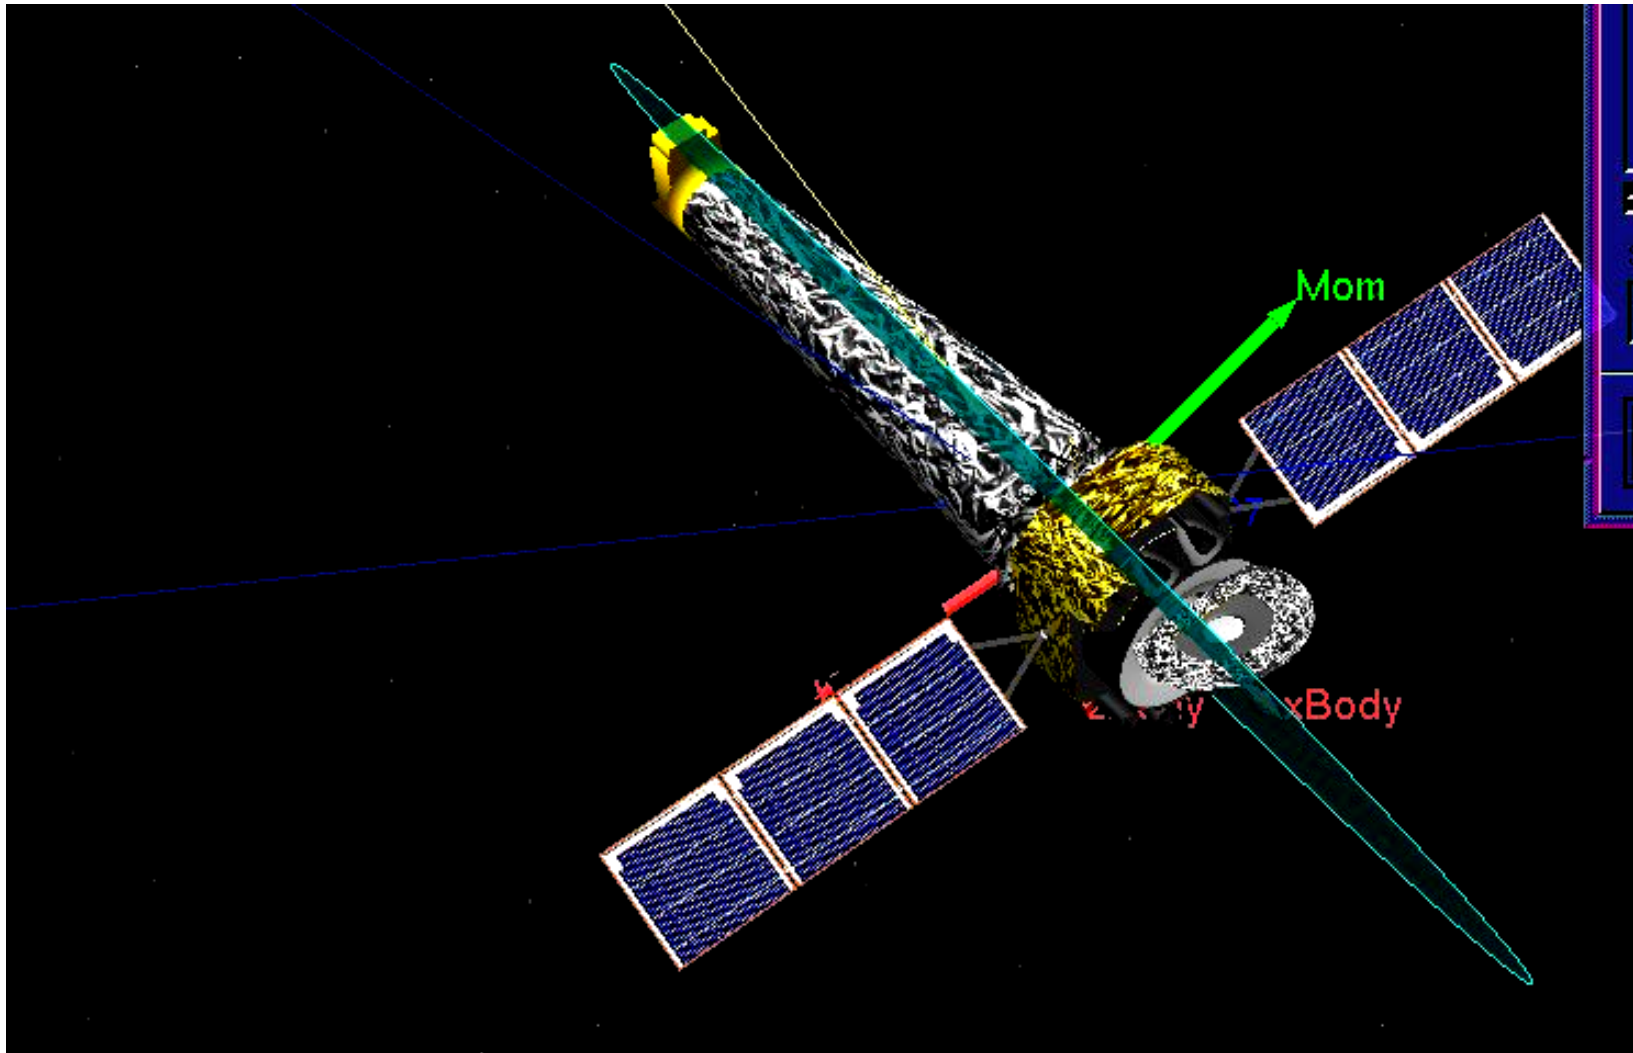
Snapshots of the model with the possible impact plane are shown in **Figures 18 and 19**.

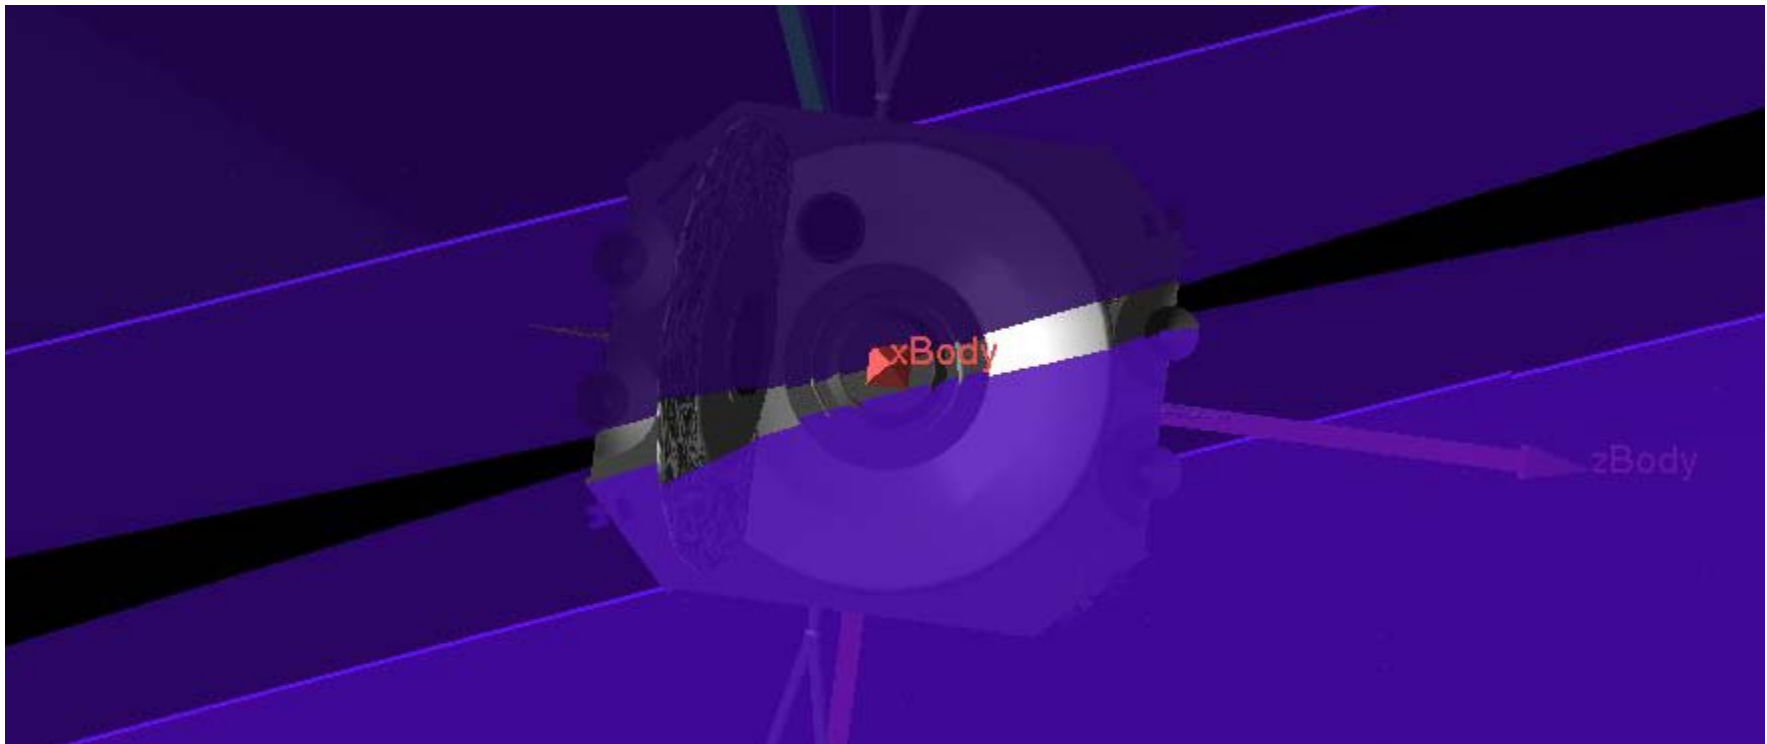
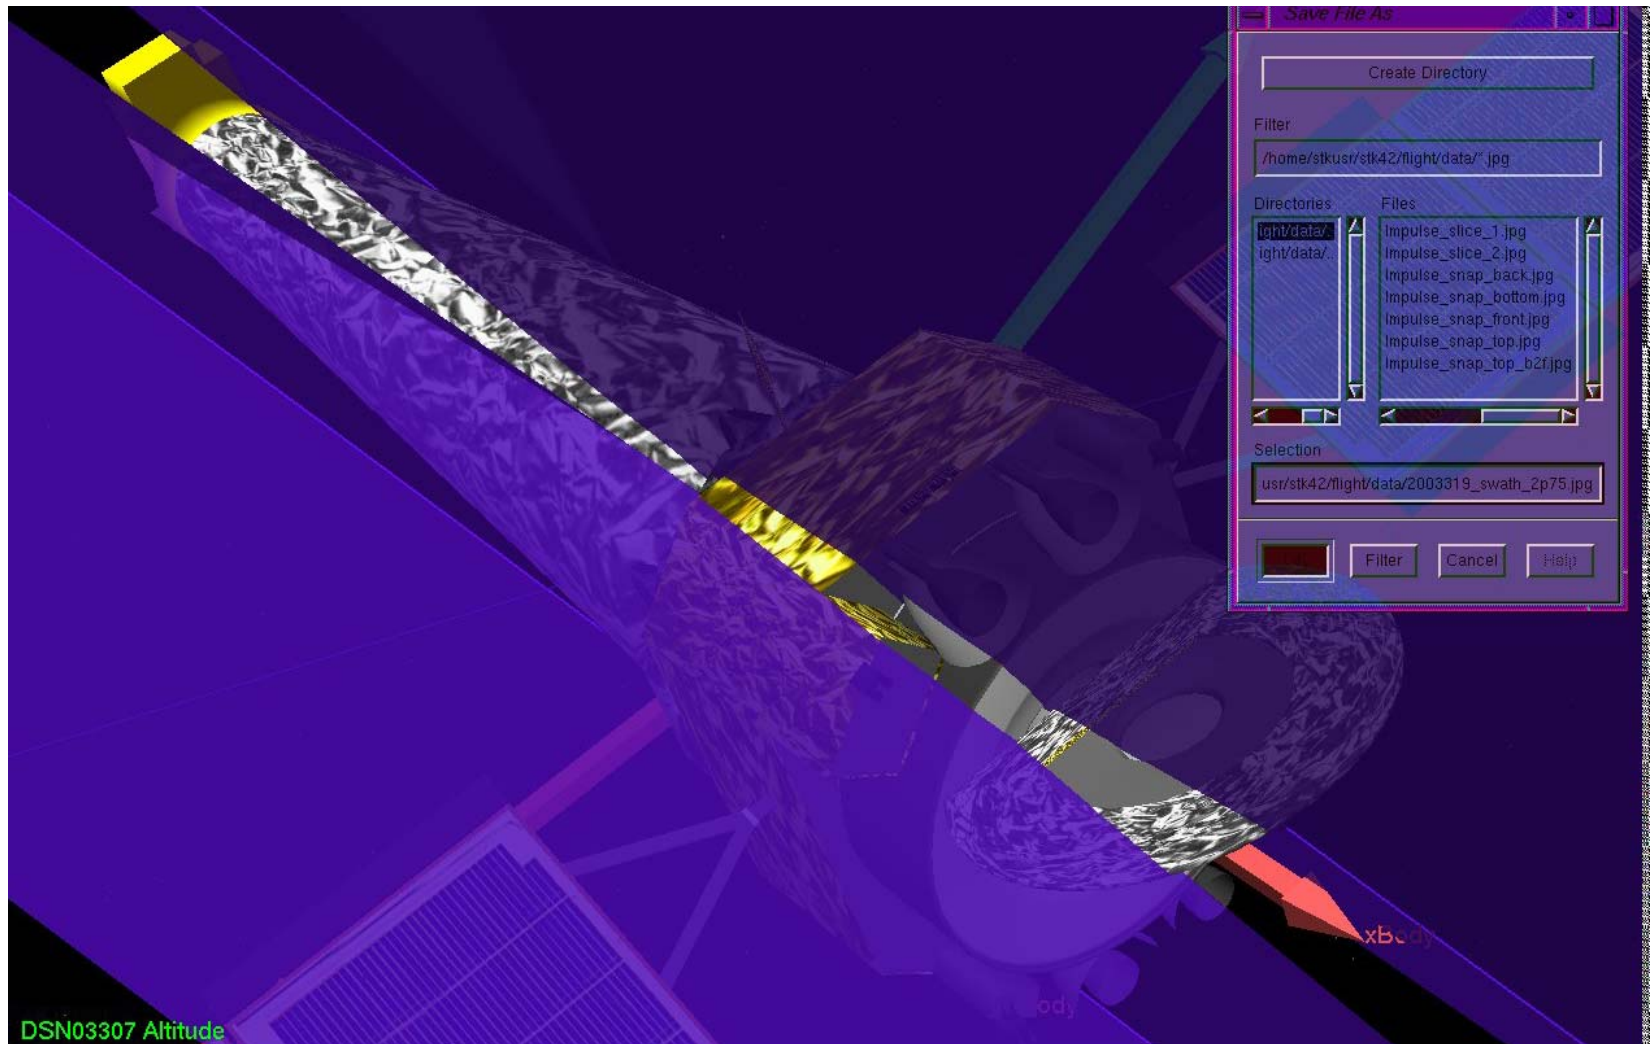
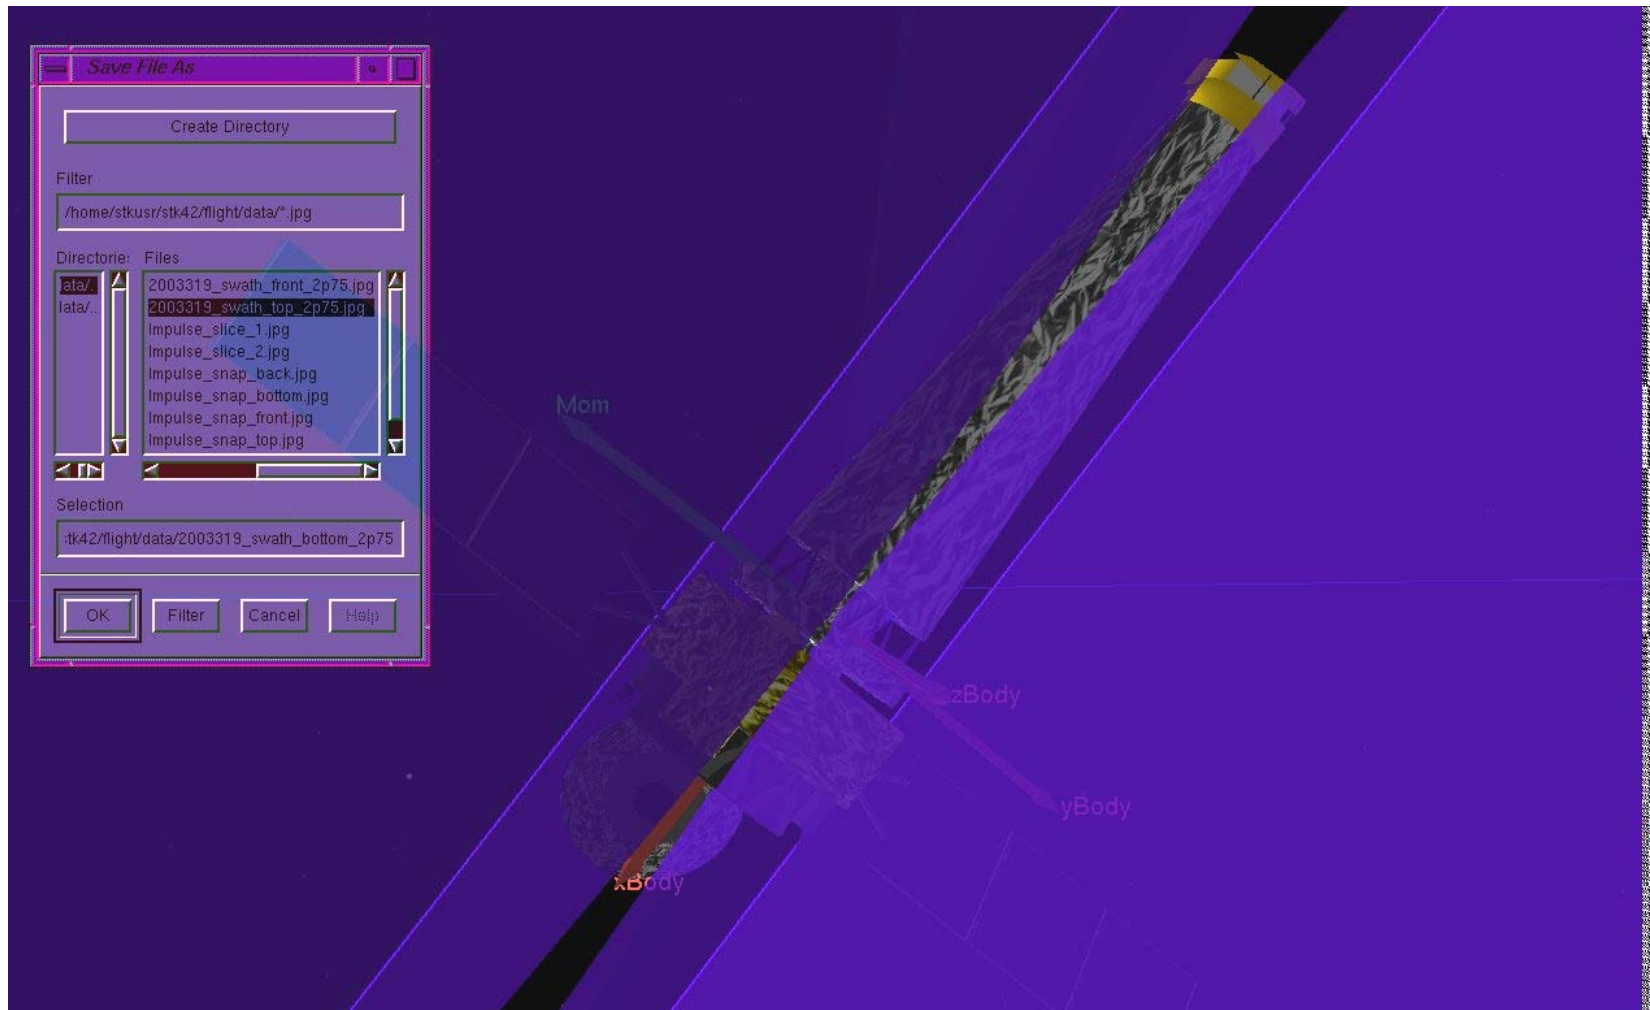
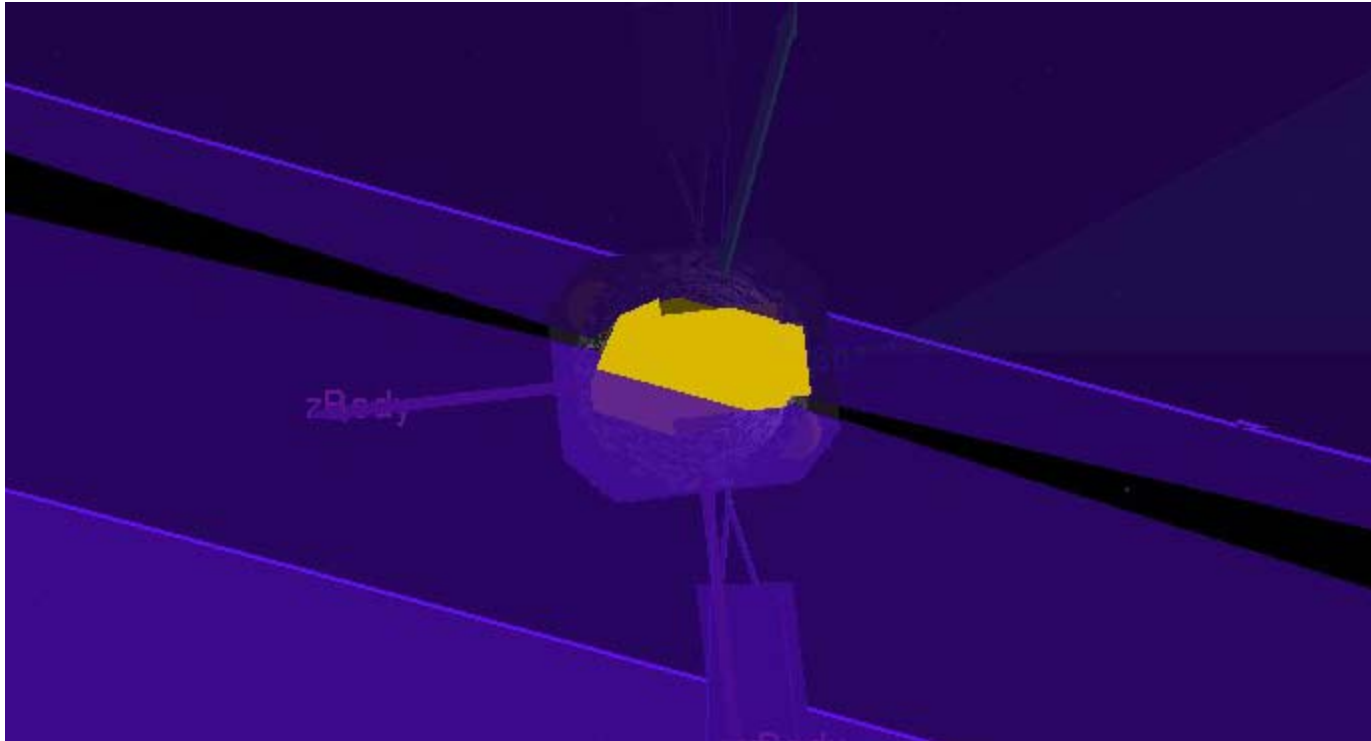
To better depict the possible impact region, the error in the momentum vector and its impact on the plane must be taken into account. The one sigma error computed in the delta momentum calculation was multiplied to give a three sigma error. The three sigma error was then used to form a box around the delta momentum vector. The angle between the delta momentum vector and each corner of the box was checked. The largest of these angles was taken as the error in the momentum vector and thus the plane. The largest angle was 2.75 degrees. The conic sensor depicting the plane was edited to have half angles of 87.25 and 92.75 degrees. This formed a swath through the spacecraft body. Any area inside of this swath is inside the potential impact region. Figures 20 to 23 show the swath.

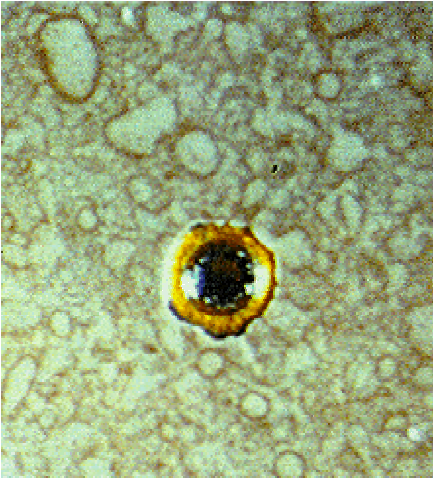
Surface	Impact	Image
<p>MLI over GFRP facesheets</p>	<p>A study of micrometeoroid damage in the Eureka program post-flight analysis showed that the multi-layer insulation (MLI) structure retains particles up to a certain size very efficiently. Of 71 detected impacts only two penetrated the MLI. Any loss in thermal-control function due to the particle impacts was negligible. Study of the HST MLI blankets, similar to those used on Chandra, shows that each layer of insulation slows down and fractures the particle. There were no impacts that penetrated the MLI on HST.</p> <p>Were a particle to penetrate the MLI it would have been significantly slowed down and would likely have been fractured by its impact with each of the MLI layers. This (these) lower velocity, smaller mass particle(s) would not likely penetrate underlying GFRP facesheet.</p>

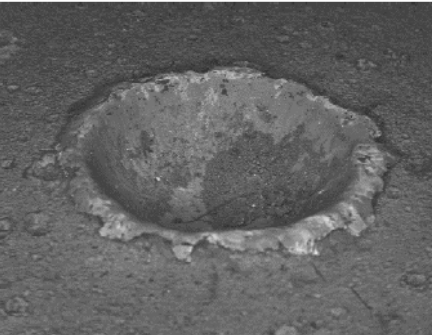
<p>GFRP</p>	<p>In the studies consulted no information could be found on the damage to GFRP caused by an incumbent particle. Further attempts to find information were unsuccessful. The only GFRP surface in the possible impact region not protected by MLI is the translation table. Due to the strength of the material it is thought to be highly unlikely that the particle would cause any significant damage.</p>	
<p>Titanium</p>	<p>The impact studies consulted only studied the impact on titanium fuel tanks. The image provided is that of a crater in a titanium fuel tank. There is no report of a fuel tank being compromised by an incumbent particle.</p>

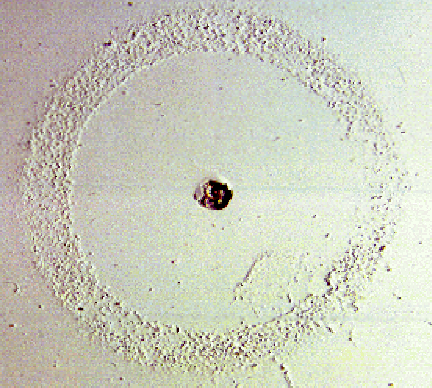
Surface	Impact	Image
Painted surfaces	The studies consulted showed that, when a painted surface is impacted by a micrometeoroid, a spall zone, shown right, is created. Any marring of the painted surfaces will decrease their reflective/absorptive properties, decreasing their thermal performance. The damage caused by such a spall zone is thought to be negligible when compared to the degradation from several years on orbit.

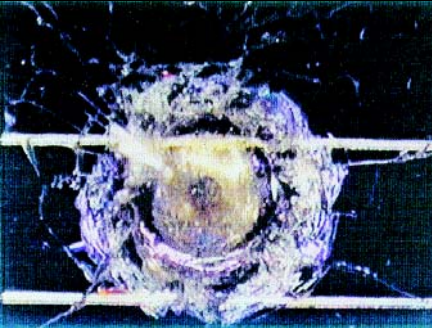
OSRs (Optical Solar Reflectors, quartz)	There were no data provided on OSRs, but extensive information on damage to solar array cells is available. It is expected that the shattering of the cover glass seen in solar array cells would also be present if an OSR was impacted. This would decrease the impacted OSRs ability to reflect solar radiation, decreasing its functionality. It is not anticipated that damage to a single OSR will significantly impact the thermal protection provided by the set of OSRs.

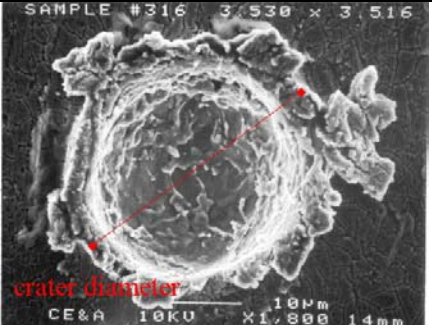
Aluminum Plate	The image at right shows a crater in an aluminum plate created by a small, high velocity particle. The size of the crater is dependant on the incumbent particle's mass and velocity. Were the incumbent particle to have enough mass and velocity the particle can, and has been seen to, penetrate the plate.
