Death in the line of duty...

A Summary of a NIOSH fire fighter fatality investigation

May 1, 2001

Volunteer Assistant Chief Dies During a Controlled-Burn Training Evolution–Delaware

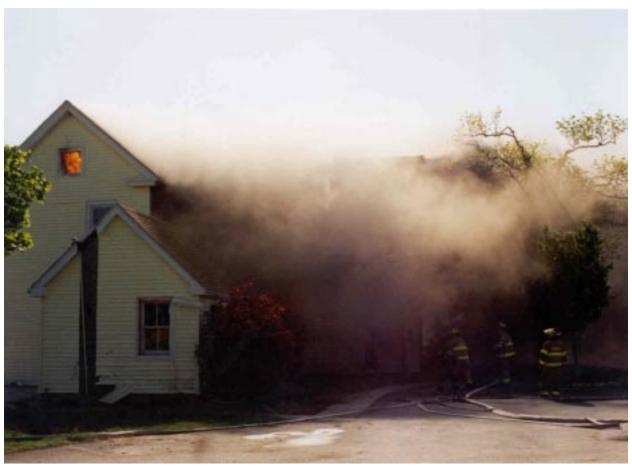
Photo. Structure Involved in This Incident

The structure involved in the incident was a $2\frac{1}{2}$ story farm house with an attic. The structure was built in the late 1800s. The foundation was constructed of masonry block and the structure was ballooned framed using 2- by 4-inch lumber. The roof system was raftered using 2- by 4-inch lumber and covered with ½-inch plywood. The exterior roof was comprised of cedar shake shingles overlapped with two layers of asphalt shingles. Vinyl siding covered the exterior walls and the insulation was fiberglass. The structure was approximately 3,000 square feet including the area of the attic.

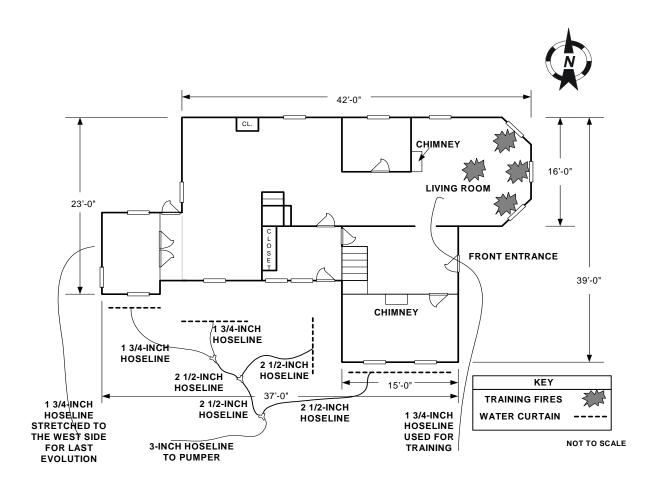
Diagram 1. First Floor Layout

In preparation to start the training evolutions, the fire fighters made the cuts as a part of their Fire Chief, victim, and the Second Rescue testing. The attic space was approximately 1,000 Lieutenant entered the first floor front door and placed hay in the living room, next to the walls (see Diagram 1). The Chief exited the house and briefed the fire fighters who would be performing the training. He told the fire fighters to enter through the front door, search for the fire, and knock it down. The Chief then ordered the victim to exit the structure and wait to reenter with the fire fighters performing the training, to evaluate their performance. The victim was equipped with full turnouts and a new self-contained breathing apparatus (SCBA), which the sales representative provided for him to use. Note: The sales representative had briefed the victim on the SCBA and the victim was familiar with its operation. The victim had also used this SCBA prior to this day. The Second Rescue Lieutenant was ordered by the Chief to start the first fire. Using a 1-gallon sprayer, filled with diesel fuel, the Second Rescue Lieutenant sprayed the hay and used a flare to start the fire. The Second Rescue Lieutenant then exited the structure. The fire fighters and the victim entered the structure in full turnouts and SCBAs. They stretched a 1³/₄-inch hoseline inside the structure, found the fire, and immediately knocked it down, completing the first evolution. Three additional evolutions were completed in the same manner. The evolutions lasted approximately 1 hour and the fire fighters then took a break. After the break, the sales representative provided the department with a new gasoline-powered chain saw to use for training. The fire fighters, including the victim, performed a series of cuts on the exterior of the house. Fire fighters then took the chain saw they were testing, along with one of their own chain saws, inside the house and proceeded to the attic to cut holes in the attic floor. They cut two holes, 2 feet by 2 feet, directly under a window on the west wall and a window under the south wall (see Diagram 3). Note: The

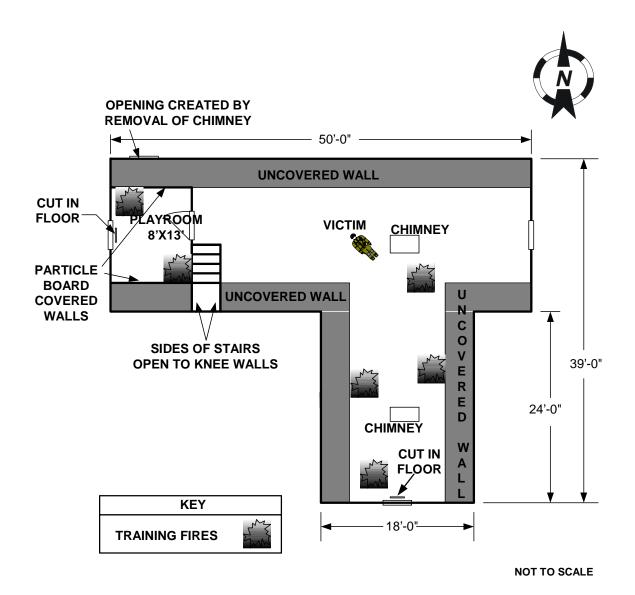
Diagram 3. Attic Layout

square feet with 4-foot knee walls around the perimeter. The ceiling was approximately 8 feet in height and sloped with the roof pitch. Completing the cuts in the attic, the fire fighters went back to the first floor to cut additional holes in the floor. The fire fighters met up with the Chief who was knocking free the base of the two chimneys with a sledge hammer (see Diagram 1). He was freeing the chimney bases because he wanted the chimneys to collapse as the house burned. As the fire fighters cut holes in the floor, the victim, along with the Second Rescue Lieutenant, the Third Assistant Chief Engineer, and a fire fighter, entered the first floor and met up with the Chief. The victim was wearing complete turnouts with a SCBA and the others were just wearing turnouts. The Chief told them to go the attic and prepare it for the last burn. He told the victim to start spraying diesel fuel on the south wall and work his way back to the stairs, spraying it last. He then checked the victim's SCBA air gauge and told the victim that it was half full. The victim, who was equipped with the diesel fuel sprayer, the Second Rescue Lieutenant, Third Assistant Chief Engineer, and a fire fighter proceeded to the attic at approximately 0920 hours. The victim walked across the attic and surveyed the layout before returning to the steps and met back up with the others. The victim noticed that cardboard boxes, papers, a Christmas tree, and clothing were spread throughout. Due to the inexperience of the fire fighter, the victim told him to return to the first floor and exit. The victim and Second Rescue Lieutenant walked over to the south wall of the attic as the Third Assistant Chief Engineer entered a 12-foot by 8-foot playroom on the west side (see Diagram 3). Starting on the south wall, the victim sprayed the diesel fuel on the walls and debris, making his way back around by the chimney in the middle of

the floor (see Diagram 3). The Second Rescue Lieutenant struck a flare and started lighting the areas the victim had sprayed. The victim met with the Third Assistant Chief Engineer in the playroom (near the exit) and told him to strike a flare and ignite the room. Soon after, the Rescue Captain reached the attic floor. He stated that there was a breeze coming through the playroom, which he thought was coming through the playroom window. The Second Rescue Lieutenant confirmed that both windows on the south and west walls in the playroom were open before they started the final burn. The victim returned to the middle of the attic as the Third Assistant Chief Engineer lit various objects (e.g., a small, dried out shrub, a poster hanging on the ½-inch particle board wall, a piece of flex duct, and debris on the floor). The Engineer stated that the room quickly became engulfed in flames and the heat forced him to exit and shut the room's door. The Third Assistant Chief Engineer met back up with the victim and stated that he could see a small fire in the south section of the attic. The Third Assistant Chief Engineer told the victim that the playroom was lit and the fire was intensifying. The two of them remained in the middle of the attic before the Third Assistant Chief Engineer noticed that the smoke was starting to get heavy and the heat was intensifying. The Rescue Captain noticed the same conditions and exited down the stairs to the second floor. At approximately 0930 hours, the Third Assistant Chief Engineer exited the attic and met up with the Chief on the first floor, relating to him that the attic was lit. The Second Rescue Lieutenant finished igniting the south section of the attic and noticed the victim was spraying additional fuel on the small fires in the same section. The Second Rescue Captain stated that the smoke was banking down and there was moderate heat in that area. He told the victim that they should exit and he started toward the stairway. The victim told him that he was going throw a ladder to the second floor roof, which
