REPORT OF INVESTIGATION

Fatal Electrical Accident
July 19, 2003

Upper Big Branch Mine-South
Performance Coal Company
Naoma, Raleigh County, West Virginia
I.D. No. 46-08436

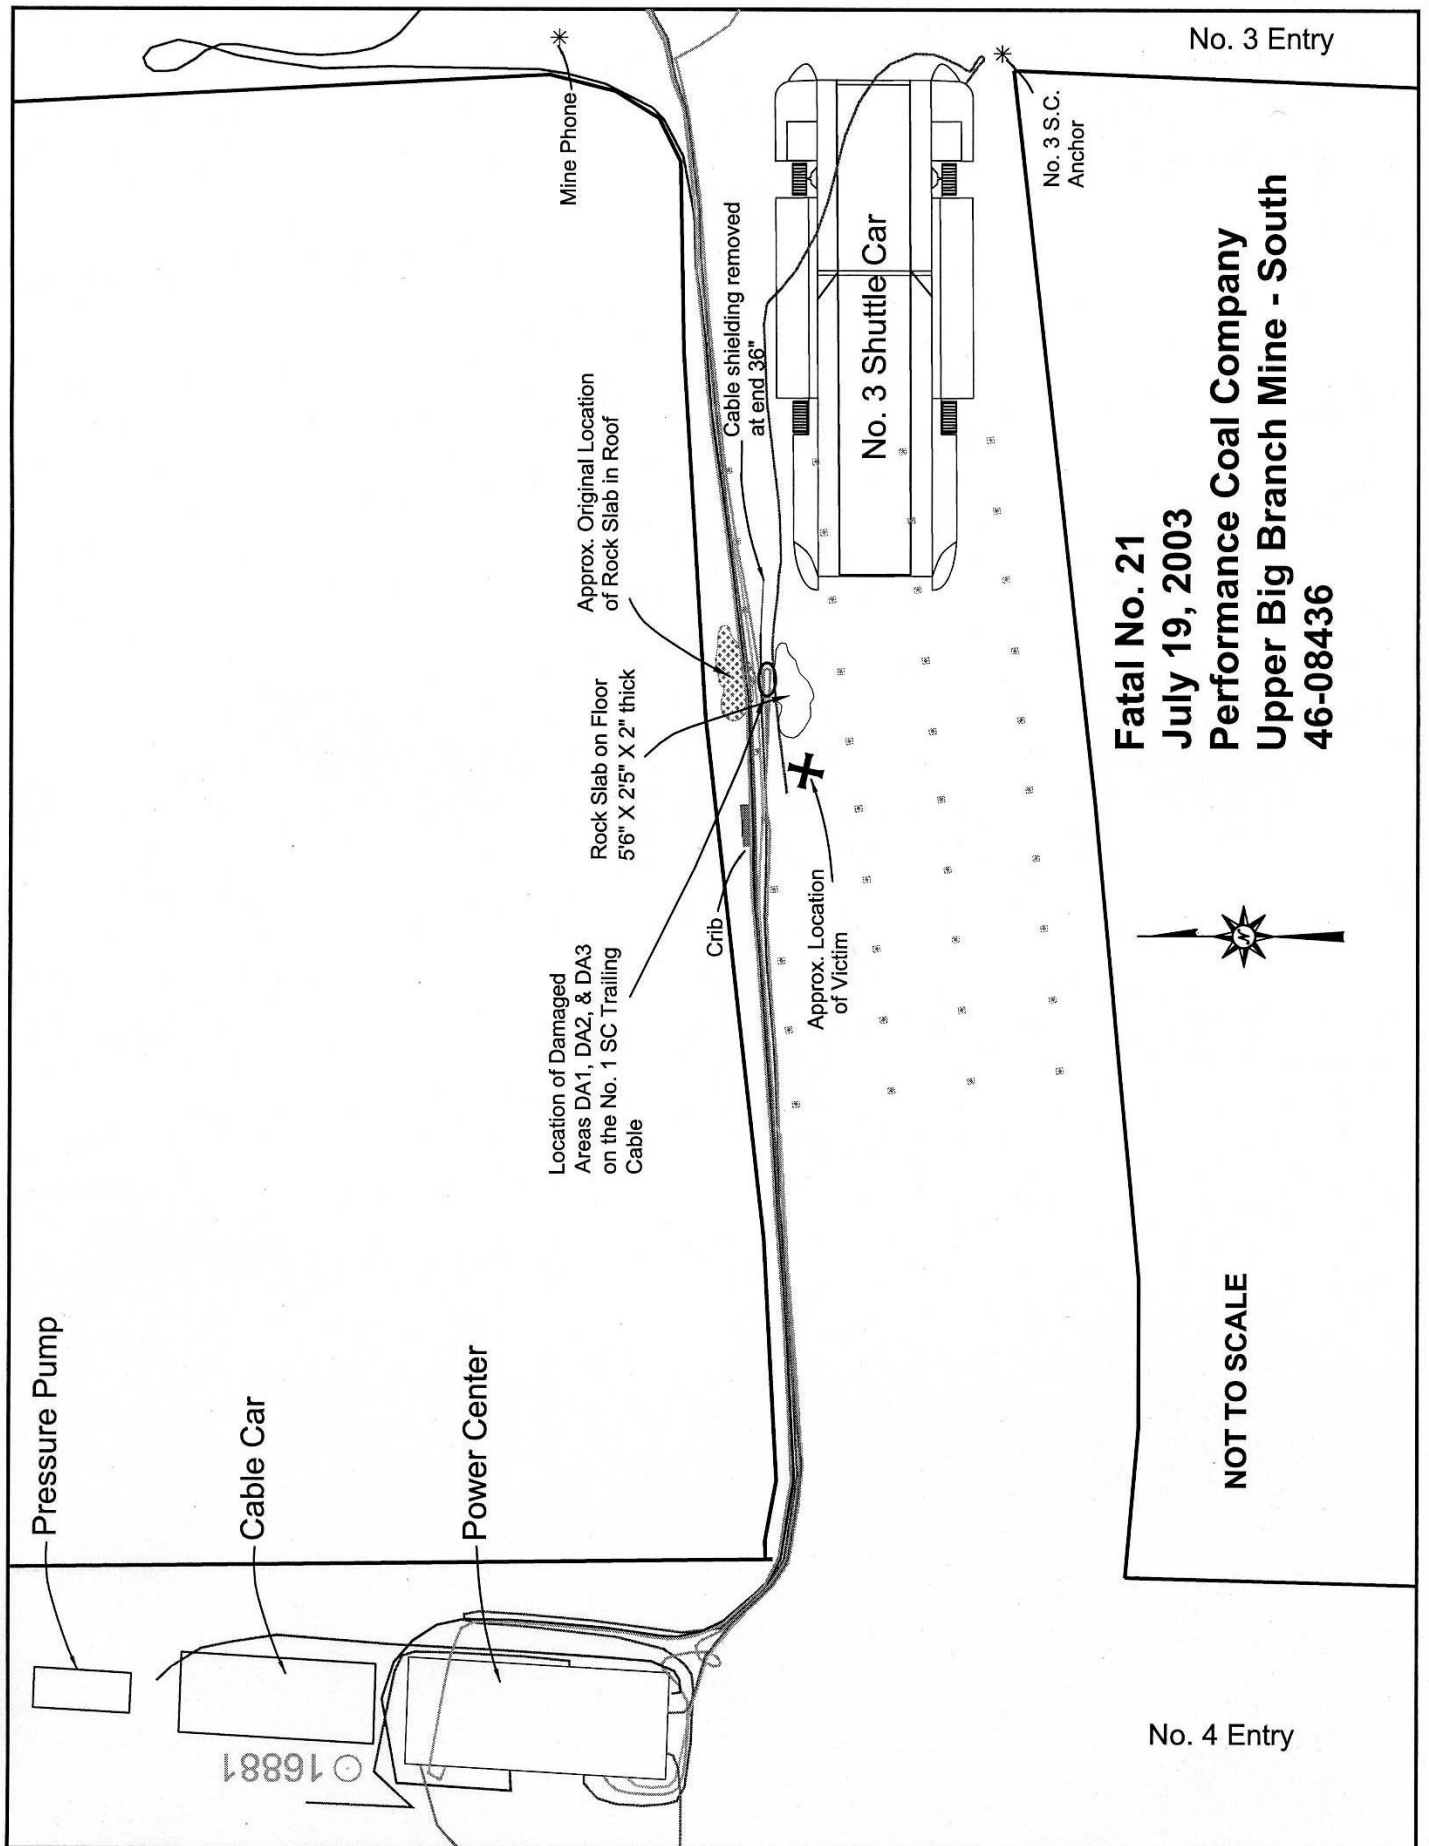
Fatal No. 21
July 19, 2003
Performance Coal Company
Upper Big Branch Mine - South
46-08436

Location of Damaged Areas DA1, DA2, & DA3 on the No. 1 SC Trailing Cable

Rock Slab on Floor 5'6" X 2'5" X 2" thick

Approx. Original Location of Rock Slab in Roof

Approx. Location of Victim

Cable shielding removed at end 36'
