National Transportation Safety Board

Marine Accident Brief

Accident No.: DCA-97-MM-028
Vessel: Bahamian-registered passenger ship, *Vistafjord*, Lloyd's No.7214715;
built in 1973; 24,116 gross tons; 626.9 by 82.2 by 55.0 feet
Accident Type: Fire
Location: Atlantic Ocean near Grand Bahama Island, Bahamas,
Latitude 26° 14.1'N, Longitude 79° 00.0'W
Date and Time: April 6, 1997, at 0112
Owner: Cunard Lines Ltd., Nassau, Bahamas
Property Damage: Estimate of \$684,845
Injuries: Fatal, one crewmember; minor, six passengers and nine crewmembers
Complement: 422 crewmembers with 569 passengers

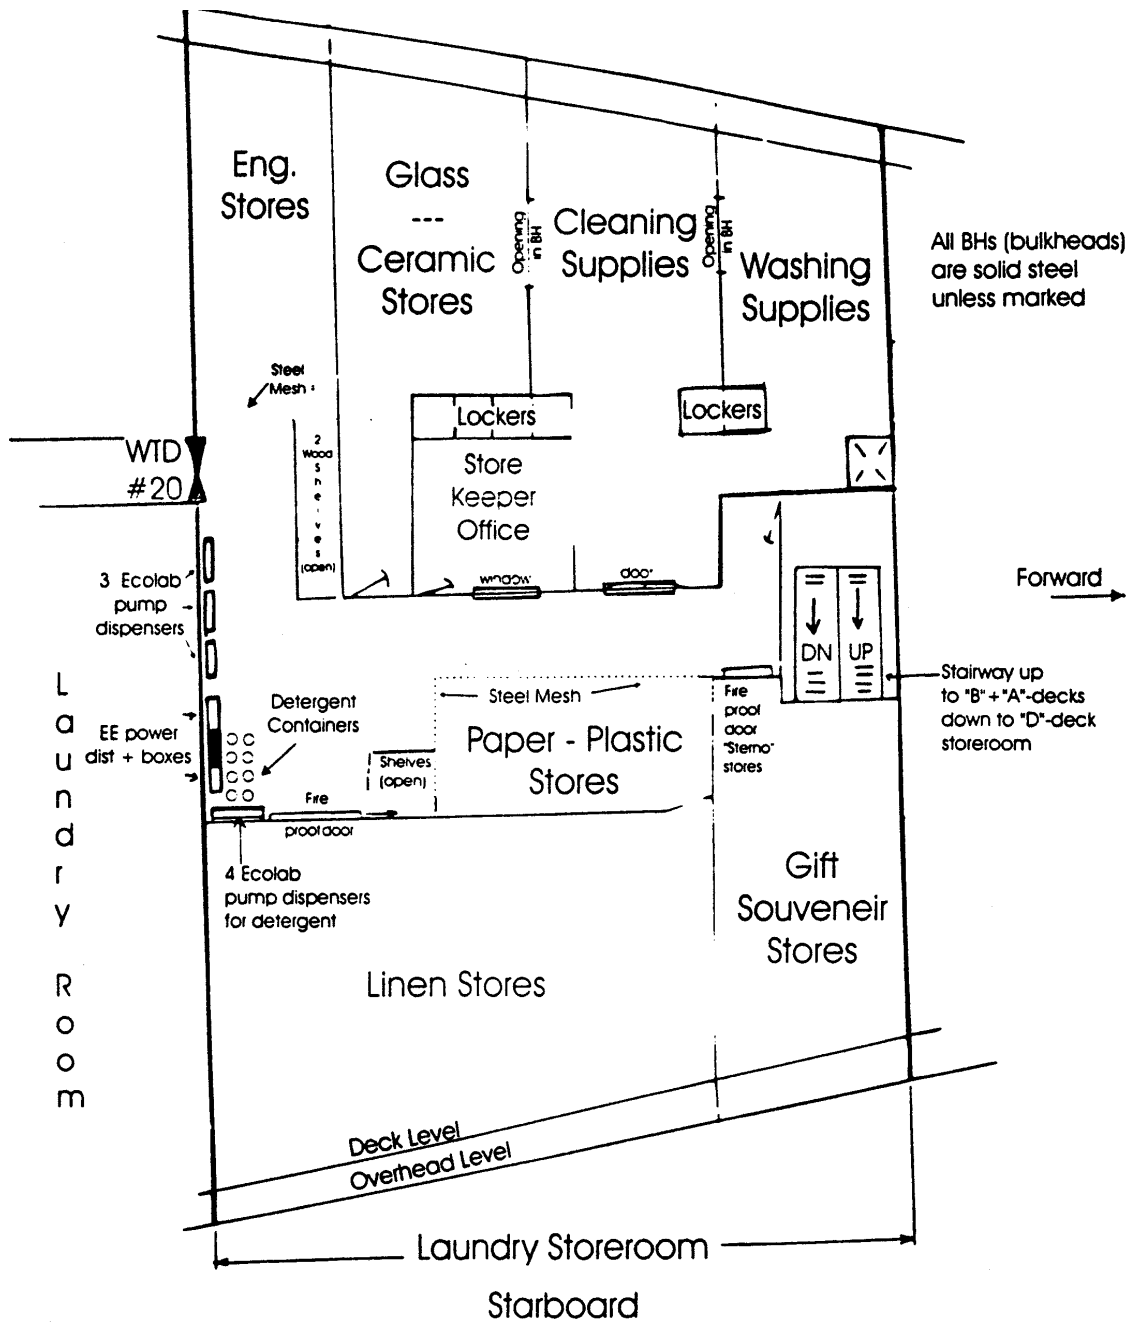
The C-deck laundry storeroom is forward of the laundry in the forward section of the vessel. The laundry storeroom is accessed from aft through a watertight door (WTD) on the common bulkhead between the C-deck laundry and the storeroom and from forward by a stairway that leads down from the B- and A-decks. This stairway also leads down to the forward D-deck storeroom below the laundry storeroom. (See figure 1.) The laundry storeroom and the D-deck

Figure 1 – Layout of fire area on C-deck.

Laundry supplies, paper and plastic products, and electrical stores had been stowed behind steel bulkhead partitions or in locked steel mesh cages on the port and starboard sides of the C-deck laundry storeroom. Laundry supplies behind a fireproof sliding door were undamaged. The paper and plastic products on shelves in the caged area were burned and melted. About 30 boxes, each containing 72 cans of Sterno, were stored behind a fireproof locked door, and none of the cans ignited. The heavily smoke-damaged stairway area appeared to have had fire damage from the C-deck up to the A-deck. Smoke damage occurred on the forward B-deck (crew) area above the laundry storeroom.

The four electrical pump-dispenser panels, which supplied liquid detergent to washing machines, were mounted above the deck on the starboard bulkhead aft corner and sustained fire damage. The third pump panel up appeared to have the most fire and heat damage. The three electrical power distribution panel boxes on the aft bulkhead sustained fire and heat damage. Port of the WTD, the electrical stores inside a steel mesh cage were smoke damaged. Forward of the WTD were wooden shelves holding 5-gallon plastic pails containing laundry products. The upper

Because the fire debris had been disturbed or removed during firefighting operations, an examination for discarded tobacco-related smoking materials could not be made. The burn pattern in this fire showed evidence of two potential ignition sites, which were on the pump-dispenser panels starboard aft and in the paper-plastic supplies storage area starboard forward. The observation that the sites were between 10 and 15 feet apart makes it highly unlikely that carelessly discarded tobacco-related smoking materials started the fire. Because it seems unlikely that a fire would originate from accidental sources in two separate locations and no evidence of any other cause was found, it appears highly probable that the fire was purposely set.
