Appendix A

Site Information and Photos

WDFW Fish Passage and Diversion Inventory Database
Site Description Report

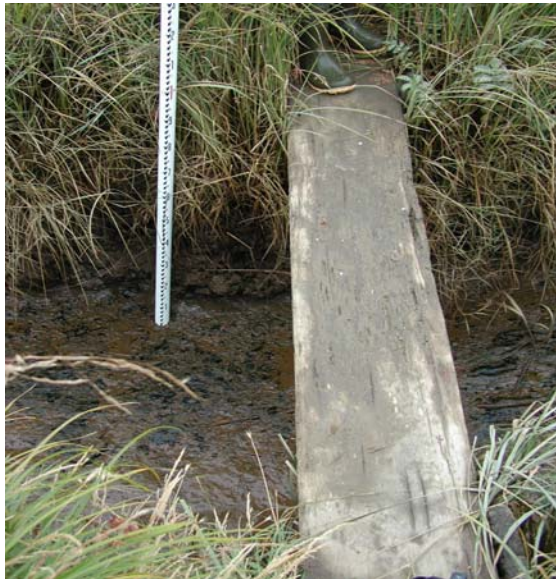
Small footbridge on small trib flowing through breach in dike approx. 10m wide. Wood planks anchor both ends of footbridge to the banks, and there is no bank cutting or erosion behind these planks. Complete tidal influence, w/natural channel meanders.

Barrier:	No	Passability (%)	100	Repair Status:	OK
----------	----	-----------------	-----	----------------	----

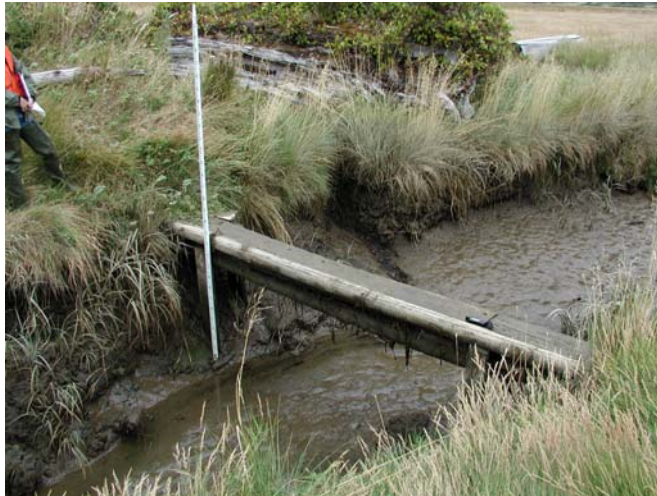
Small footbridge anchored on both banks with wood planks. Channel is not eroding behind these planks. Dike breached approx 15m US of footbridge. Current water running is freshwater stream- all mud substrate. Natural channel meanders US and DS of dike.

Barrier:	No	Passability (%)	100	Repair Status:	OK
----------	----	-----------------	-----	----------------	----

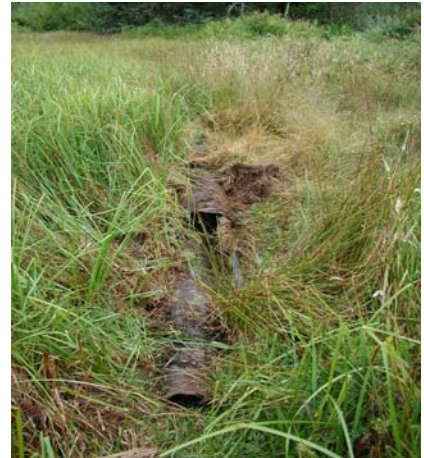
Culvert in middle of floodplain/seasonal wetland. No stream channel. No road evident. Second portion of smaller culvert wedged inside PVC culvert at (DS?) end and is approx 0.15m x 0.15m and is CST. 2 other culverts lie parallel in the field.

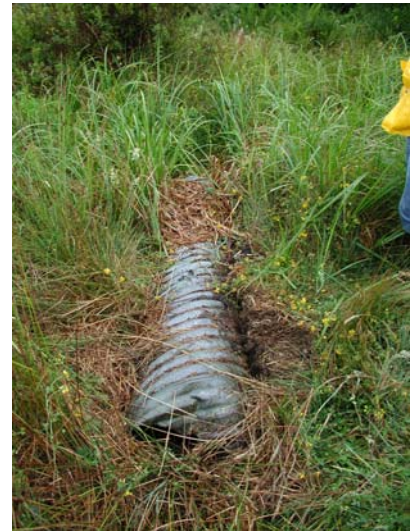
No stream channel- No road evident- Culvert is galvanized steel. 2 other culverts lie parallel in the same wetland/floodplain, and none are sunk into the ground at all, but there is dirt/grass throughout each culvert.

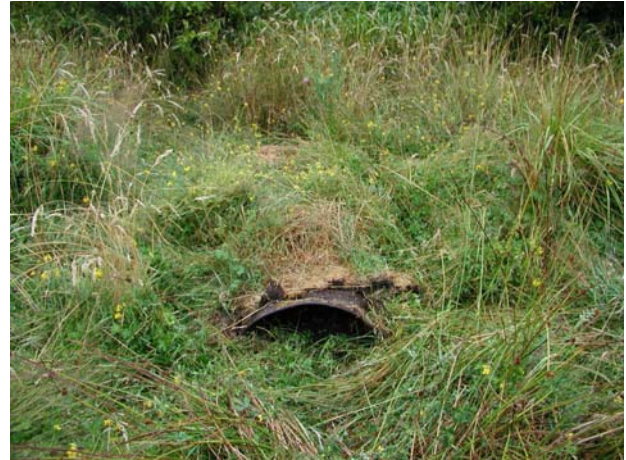
Culvert in middle of seasonal wetland/floodplain with no road evident- and no stream channel. 2 other culverts lie parallel in the same field, none are sunk into the ground, but all have dirt/grass inside the culverts.

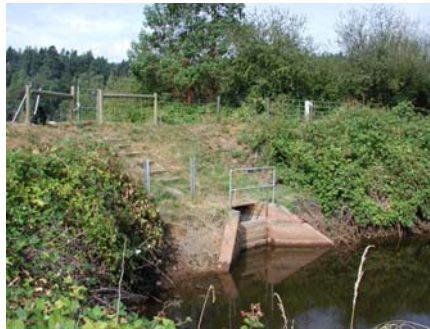
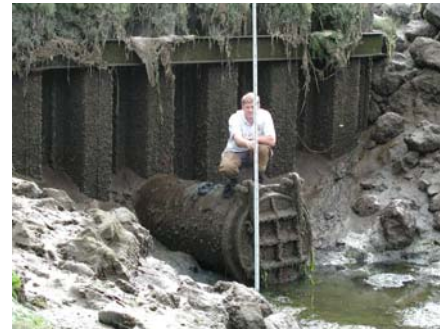
Barrier: Yes Passability (%) 0 Repair Status: UD Method: LA
Problem: tidegate, water control planks

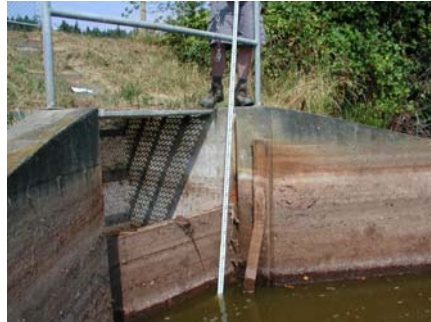
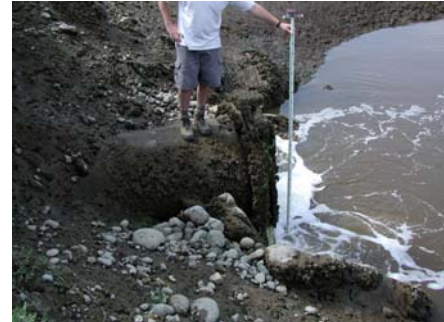
Barrier: Yes Passability (%) 0 Repair Status: UD Method: LA
Problem: tide gate, wood planks

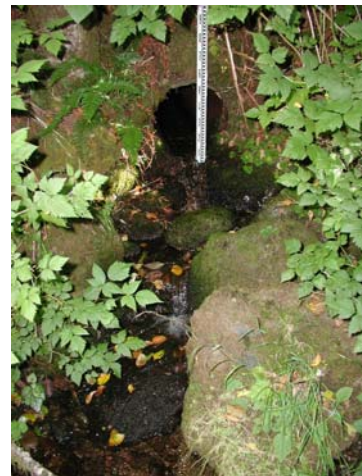
Barrier: Yes Passability (%) 33 Repair Status: NG Method: LA
Problem: slope, outfall

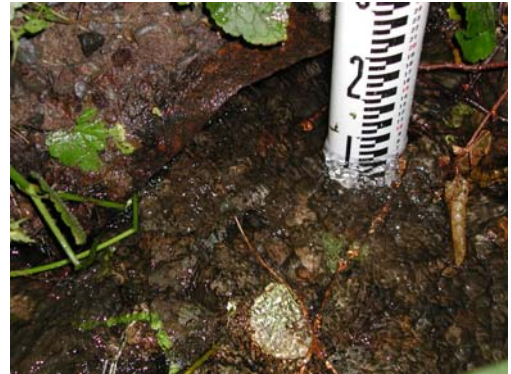
Crushed DS, and slightly crushed US. Seasonal wetland area DS of culvert. Will be replaced summer 2004.

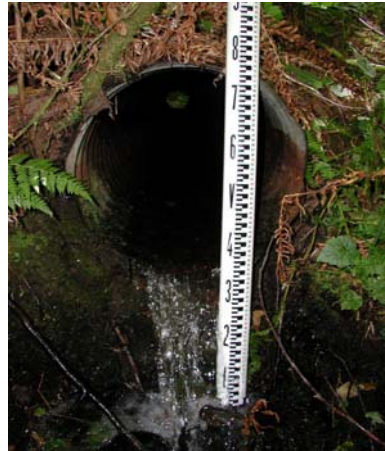
Barrier: Yes Passability (%) 33 Repair Status: NG Method: LA
Problem: outfall, slope

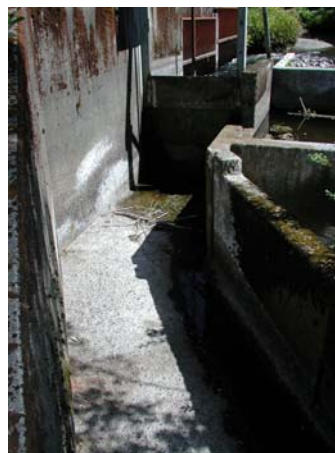
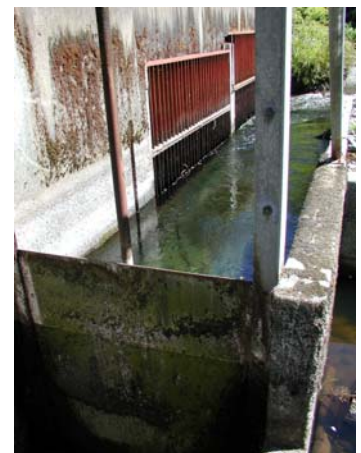
At end of Intake Rd. If wood weirs were in place, head differential would be approximately .30m, which is a barrier to juvenile fish passage. Lack of water currently below the dam is also a barrier.

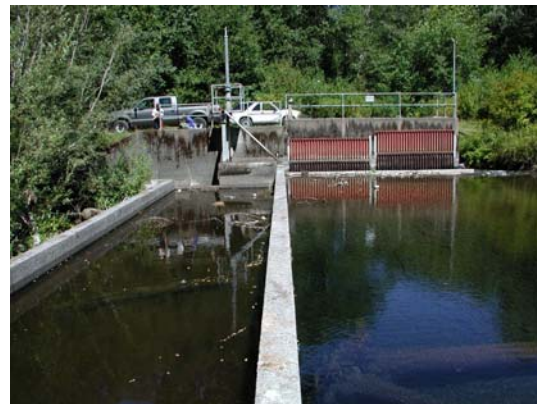
Barrier: No Passability (%): FW Repair Status: OK
Problem: No water flowing over dam, all is directed into intake for hatchery off RB side of dam.
Fishway on RB side can have wood weirs placed to facilitate fish passage. Stream is

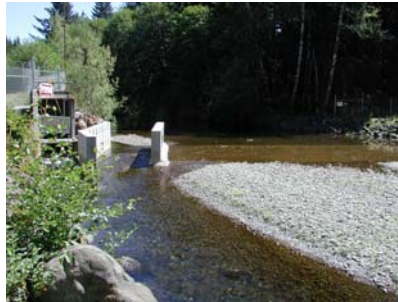
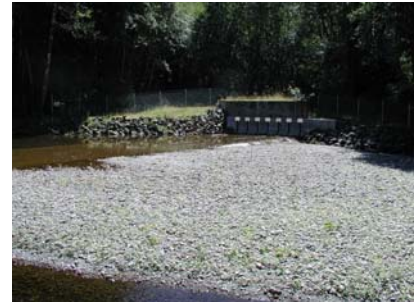
Barrier: Yes Passability (%): 0 Repair Status: UD

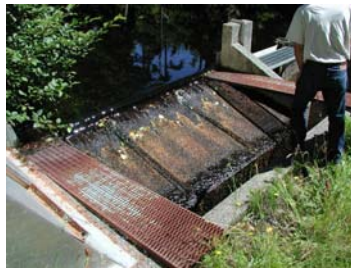
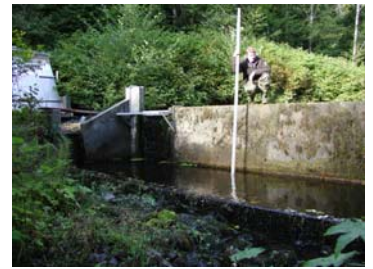
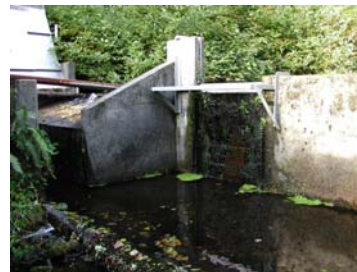
Barrier: Yes

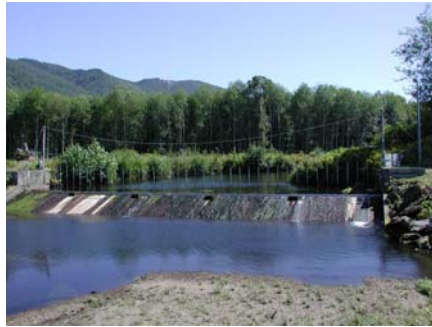
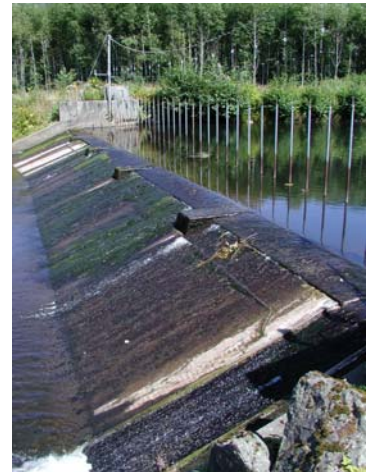
Barrier: Yes Passability (%): 67 Repair Status: UD
Problem: Weir off from mid Feb- Mar for native Steelhead run. Small constructed spillway on LB side for salmonid passage. Top of dam to bottom at low tide is approx 3m. Weir and

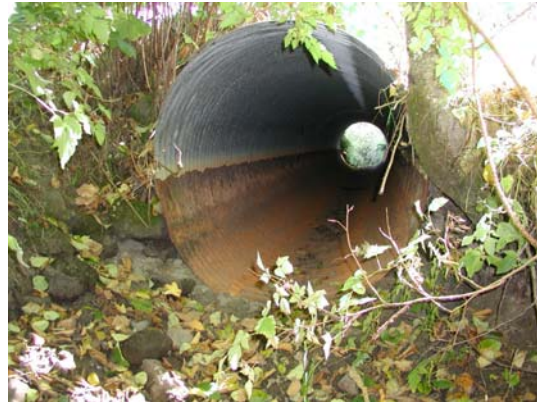
Barrier: Unk Passability (%) Repair Status: UD Method: LB
Problem:

Appears to have periodic high velocities due to the size of the plunge pool, no bed material, and a high rust line within the culvert. No toe because of braiding and wetland influence, and no downstream control so the barrier status is unknown.

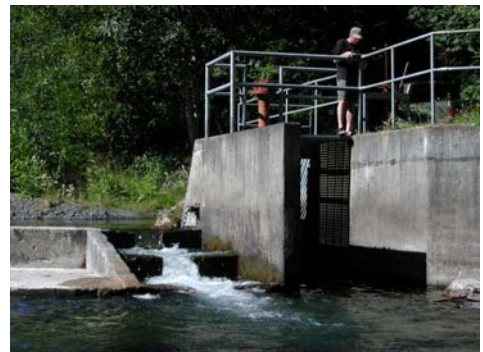
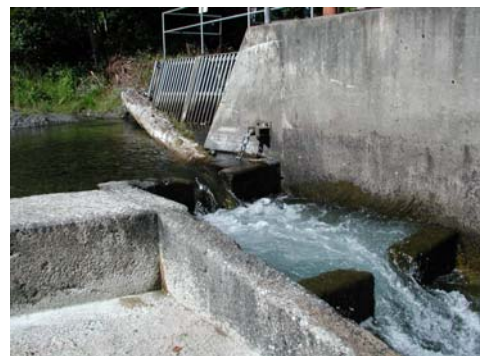
Dam at moderate to high flows would pass water over the top; at low flows it dries up much of the river directly DS. Grating for intake structure is on LB side of fishladder

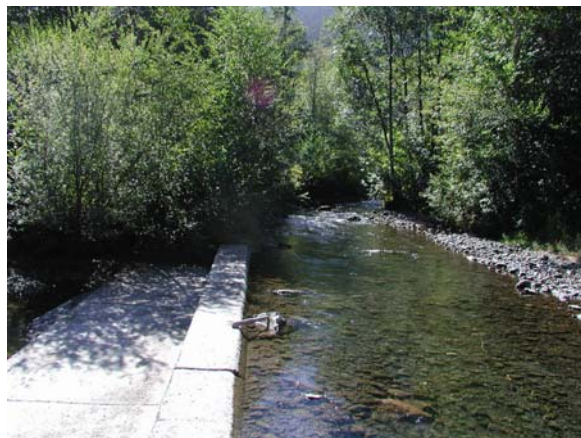
Barrier: No Passability (%): 100 Repair Status: OK
Problem: Water currently only flows through fish ladder (or is directed into hatchery intake), and is moderate velocity. Slots at tops of weirs allow fish to swim up through the ladder.

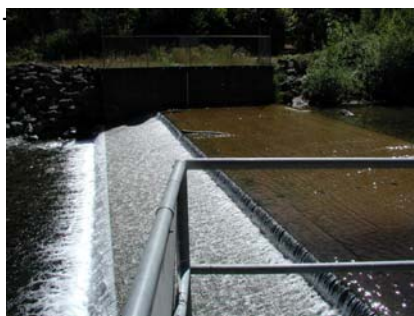
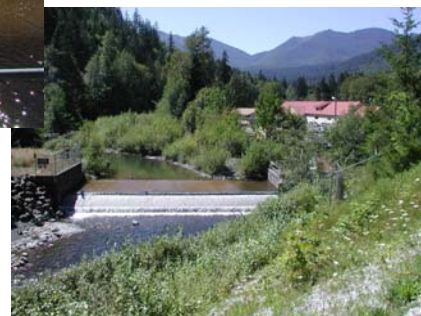
Barrier: Yes Passability (%): 33 Repair Status: RR
Problem: Slanted weir w/2 tiers- initial drop is .6m, and second drop is .45m with a 2.44% slope surface in between. Inoperable fish ladder on LB side of weir (sedimented in- put in for

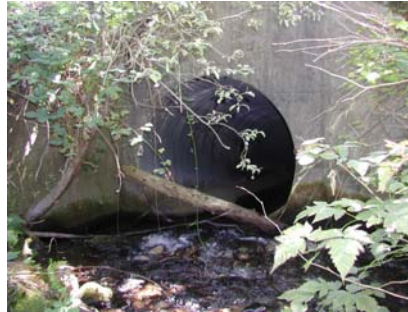
Barrier: Yes Passability (%) 0 Repair Status: RR Method: LA
Problem: slope, outfall

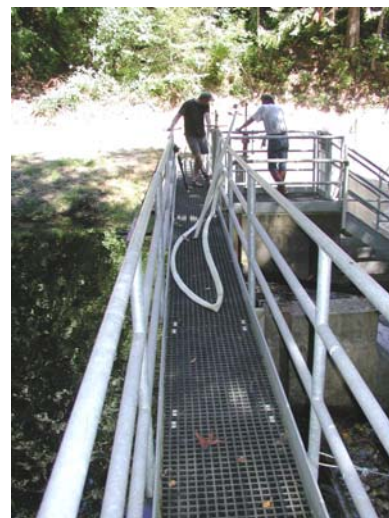
Barrier: Yes Passability (%): 33 Repair Status: UD

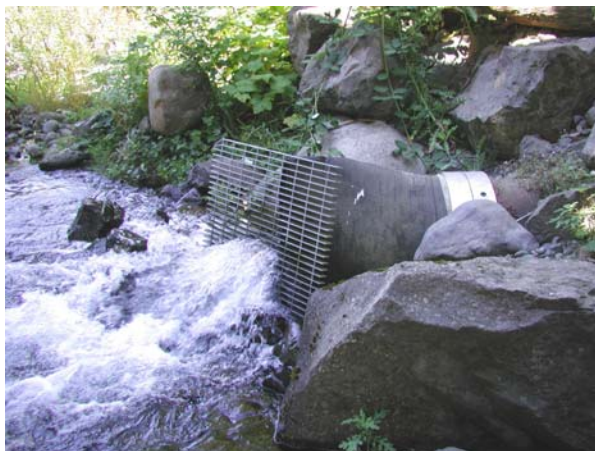
Occasionally fish have come up this culvert- grate in front should prevent this now. Culvert dimensions inaccessible. Water is coming through the boot at fairly high velocity as it is constricted. Not intended to be accessible for fish.

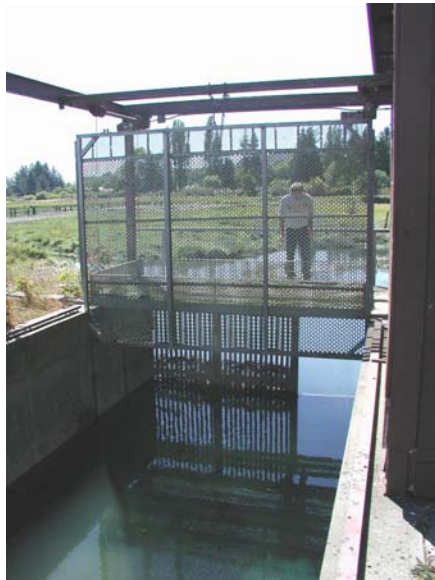
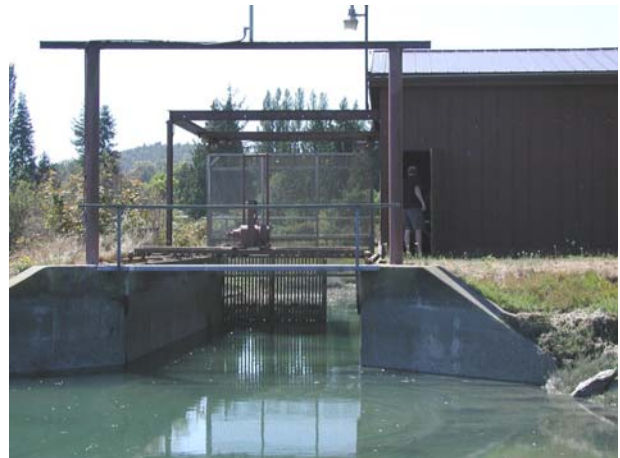
Old trap and haul for Quilcene fish hatchery- still in place, with metal grating within channel. This grating would block an adult from passing at low flows, but there are other channels that would take the fish around this obstacle. Juv fish can pass.

Barrier:	No	Passability (%)	Repair Status:	OK
----------	----	-----------------	----------------	----
