Engineering Analysis Report

Smoke Detector Operability Survey

Engineering Laboratory Analysis

**Julie I. Shapiro
U.S. Consumer Product Safety Commission
Directorate for Engineering Sciences
Division of Engineering Laboratory**

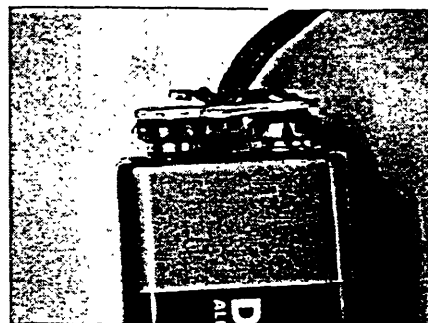
In three detectors, battery terminal contacts were loose. Two of these detectors failed the Low-Battery Alarm Test, but otherwise they functioned properly. In two additional detectors, corrosion was found on the battery terminals. One of these detectors failed the Low-Battery Alarm Test. The other functioned properly. Another detector did not originally respond because the negative battery terminal (see Figure 9) had a cold solder joint to the battery connector that came loose. The unit functioned properly after repair.

Figure 9. Cold solder joint.
