# **SIGNIFICANT SAVINGS FROM PHASED INVESTIGATION AND DESIGN APPROACH TO LANDSLIDE REPAIR**

**Khalid T. Mohamed<sup>1</sup>, P.E., Thomas Shifflett<sup>2</sup>, P.E. & Scott A. Anderson<sup>3</sup>, Ph. D., P.E.**

**Abstract:** In July 2001 a series of severe storms with extreme rain and winds resulted in heavy flooding in West Virginia. The flooding caused damage to several roads and bridges in six counties. A significant landslide developed along a 600-foot section of Cunard River Access Road on the New River Gorge National River creating an 85 feet high sheer face. Flood water reshaped a 27-foot high waterfall located at the base of the slide and formed a large scour pool. Removal of material at the slope face and water flowing through the slope contributed to the slide movement.

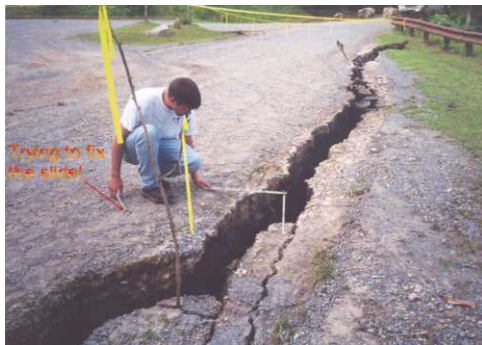
The landslide occurred along a 600 feet section of Cunard Road located near the beginning of the upper end of the 1.5 mile long road. Cunard Road is a narrow gravel road with grades of up to 15%, which runs nearly parallel to Coal Run, a tributary to the New River. A large volume of material consisting of soil, weathered rock fragments, coal slag from previous mining operations and trees had slid from the face of the slope into Coal run creating an 85-foot high scarp and slip surface. A long crescent shaped crack extending a few feet from the centerline had also developed along the roadway (Figure 2).

**Figure 2.** Initial Landslide crack developed through the roadway embankment

The initial crack width which was measured in the morning of the landslide event varied from 1/8<sup>th</sup> of an inch to a maximum of 4 inches with a maximum settlement of 3 inches. The crack width progressed within a short period of time to a maximum width of more than 1 foot and maximum settlement of 4 feet. Soils continued to slough from the face of the slope for several months.

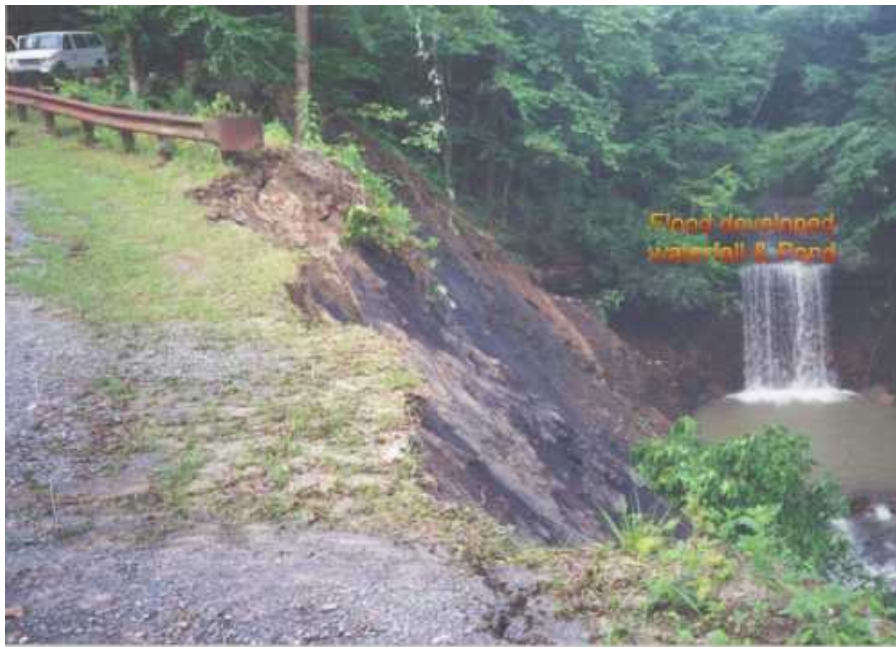
A waterfall located near the upstream side of the slide area was reshaped by the action of the flood water. The newly developed 27-foot high waterfall face now consists of a 5-foot upper layer of horizontally bedded sandstone underlain by weathered shale and residual soil. A deep scour hole developed at the bottom of the waterfall within the weathered shale of the stream bed. The pool that was created by the scour hole had a maximum depth of 12 feet (Figure 3).

**Figure 3.** Flood reshaped waterfall located near upstream end of landslide

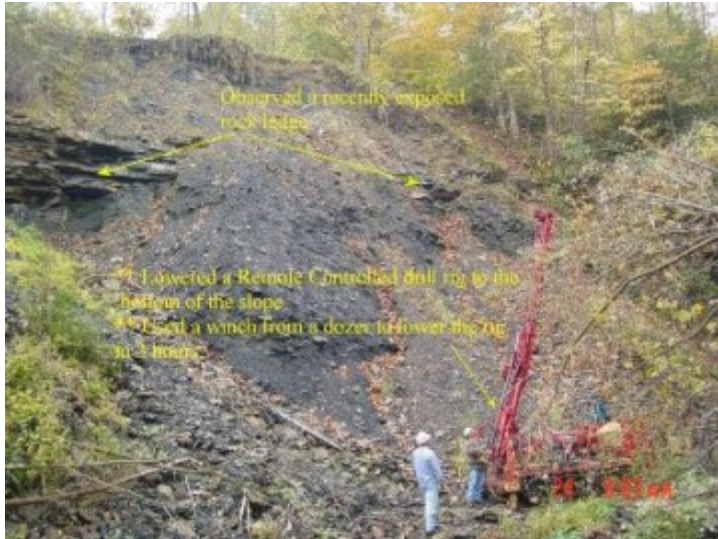
**Figure 4.** Slope toe retaining wall borings drilling operation

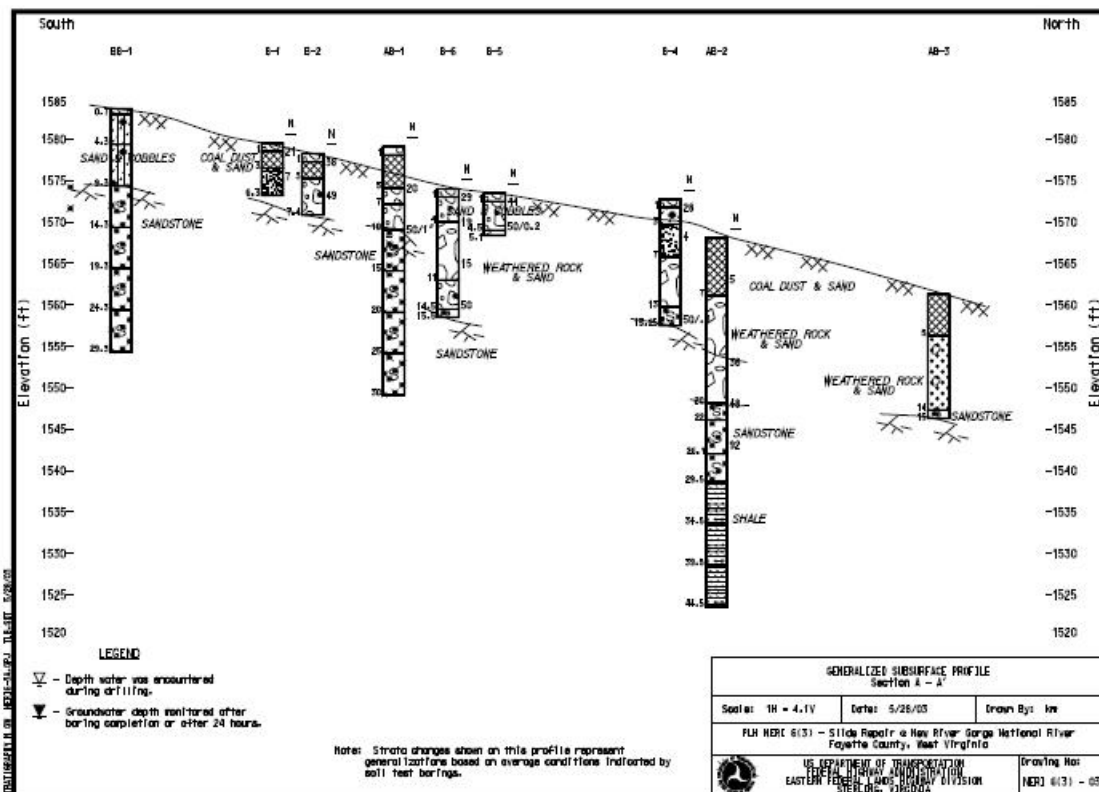
**Figure 5.** Generalized subsurface profile along roadway embankment

Borings drilled along the proposed roadway embankment alignment during phases I, II and IV encountered dark gray and black weathered rock fragments and sand with coal and some clay

to depths varying from 1.5 to 15 feet. Beneath the sand and coal layer, weathered sandstone fragments and boulders were encountered to depths varying from 7 to 20 feet. This layer was underlain by brown and gray, coarse grained, medium hard to hard, weathered to highly jointed sandstone to depths varying from 10 to 24 feet. Rock quality designations (RQD) measurements within the sandstone ranged from 0% to 64% indicating poor to fair rock structural quality. Jointed to relatively sound sandstone with RQD values between 74% and 100% was encountered to depths varying from 20 to 29 feet. The measured RQD values indicate fair to excellent rock structural quality. Gray and dark gray, highly jointed to jointed and relatively sound to sound shale with occasional sandy clay seams was encountered between depths of 29.5 and 44.5 feet. RQD's calculated within the shale varied between 63% and 100% indicating fair to excellent rock structural quality.

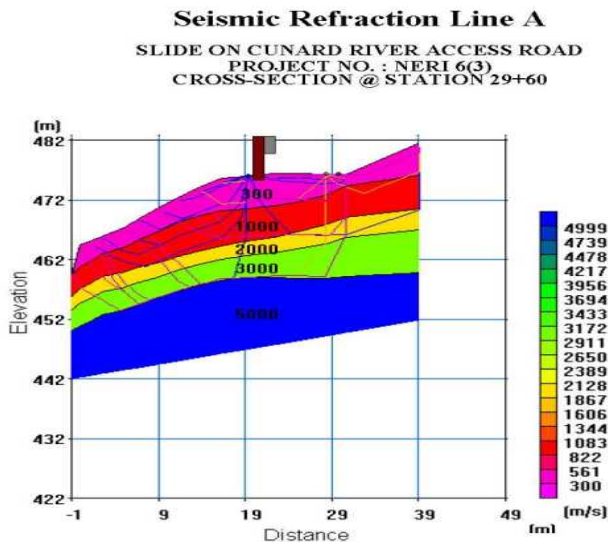
**Figure 6.** Seismic Refraction Line A @ Station 29+60

Seismic refraction surveys were generally found to be in agreement with the results obtained from the borings performed along the seismic refraction line. Depth to rock varied between 10.0 and 15.0 feet along the outer line. Rock quality (velocity) was found to improve with depth from 9800 ft/s (3000 m/s) at depths between 10.0 and 15.0 feet to 16000 ft/s (5000 m/s) at depths between 18.0 and 20.0 feet. Sound rock was encountered at shallow depths in some of the borings. An example of a seismic profile along a line perpendicular to the roadway centerline at Station 29+60 is presented in Figure 6.

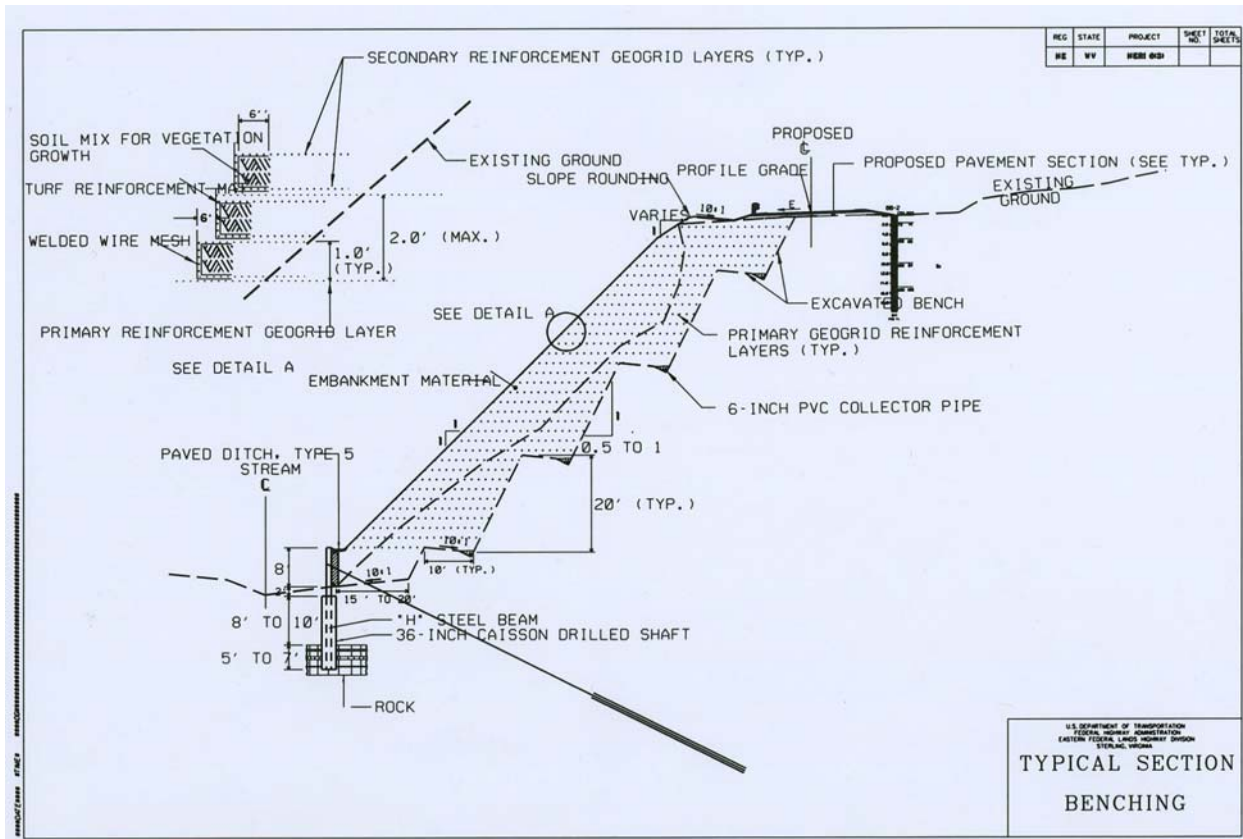
**Figure 7.** Proposed design typical section detail

The wall was required because of the constraint against realigning Coal Run, and the need to protect the reconstructed slope from future flood scouring. In addition, the wall was designed to resist a calculated 3 feet of scour depth.

Based on the available subsurface soil and rock information from Phases I and II of the subsurface field investigations and project design requirements, a landslide design consisting of excavating the remaining amount of loose soil and coal mix from the slope face, installing a retaining wall at the toe of the slope and constructing a geosynthetic reinforced soil slope (RSS) from top of the toe retaining wall to establish the original alignment of Cunard Road. This proposed design was adopted because it involved minimum or no disturbance of the ground and no clearing of trees and vegetation outside the limits of the landslide area.

The design of the toe retaining wall design consisted of anchored soldier pile wall with concrete lagging. The preliminary design analysis of the toe retaining wall was performed using the methods from Principals of Foundation Design (Das 1998). A final design check was

performed using the methods from FHWA (Mohoney, 1994) and (Sabatini *et al* 1999). The proposed design typical section detail is presented in Figure 7.

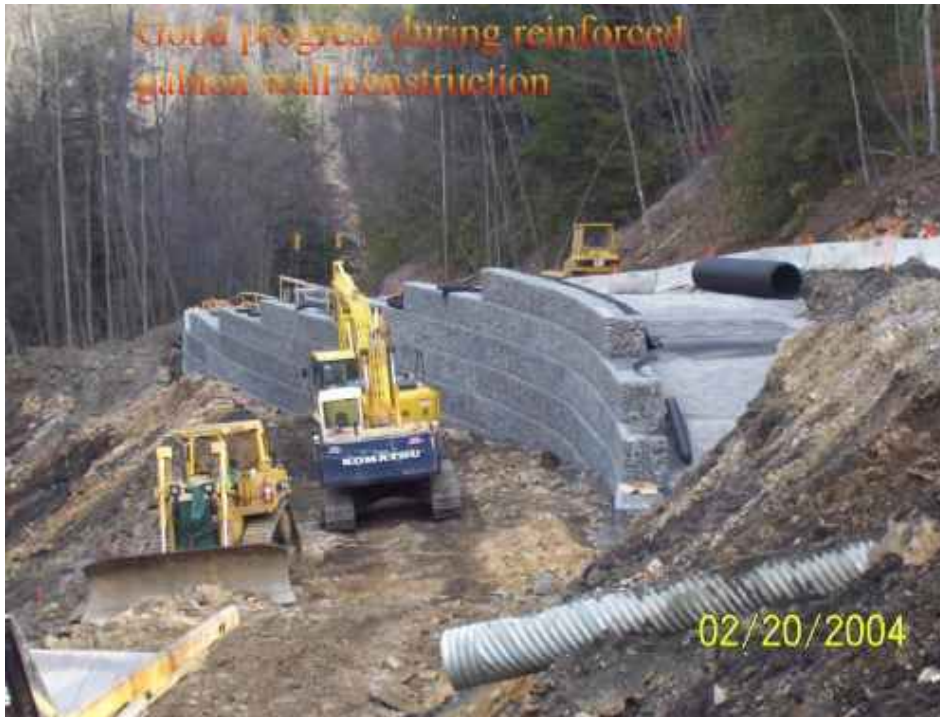
**Figure 9.** Construction progress

Construction of the alternate design was completed as planned, meeting design assumptions and exceeding estimated cost savings (Figure 9). The phased investigation and design approach adopted during design of the landslide repair in this project proved to be a successful design method. Phased type of designs that are based on considering all possible risk factors, alternative plans and performing additional supporting field investigations can result in construction cost and time savings and hence an economical design.
