MEMS reliability in shock environments

Danelle M. Tanner, Jeremy A. Walraven, Karen Helgesen, Lloyd W. Irwin,
Fredrick Brown, Norman F. Smith, and Nathan Masters

Sandia National Laboratories, P.O. Box 5800, MS 1081, Albuquerque, NM 87185-1081
http://www.mems.sandia.gov
email: tannerdm@sandia.gov

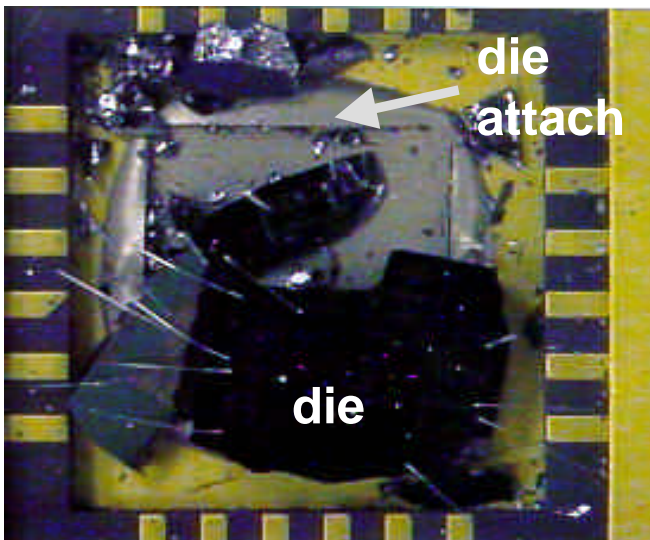
Figure 9. The interior of the package subjected to 10,000g from top impact shows the broken die and the imprint of the die in the die attach.

The two failures at 10,000g were on the same die subjected to top impact. The die actually broke away from the package and slammed into the metal lid. The broken die and package interior is shown in Figure 9. Note the imprint of the die in the die attach material. Each die was treated with a coupling agent to prevent stiction after the release. The failure occurred because the coupling agent weakened the adhesive strength at the die-package interface. This die attach failure was observed in only one package out of three subjected to top impact. Removal of the coupling agent from the back of the die before packaging should eliminate this problem.

The coupling agent used to prevent stiction in the release may also pose a reliability concern in packaging these dice. The coupling agent weakened the bond between the die and the package. These failures can be reduced by removing the coupling agent from the backside of the die prior to packaging.

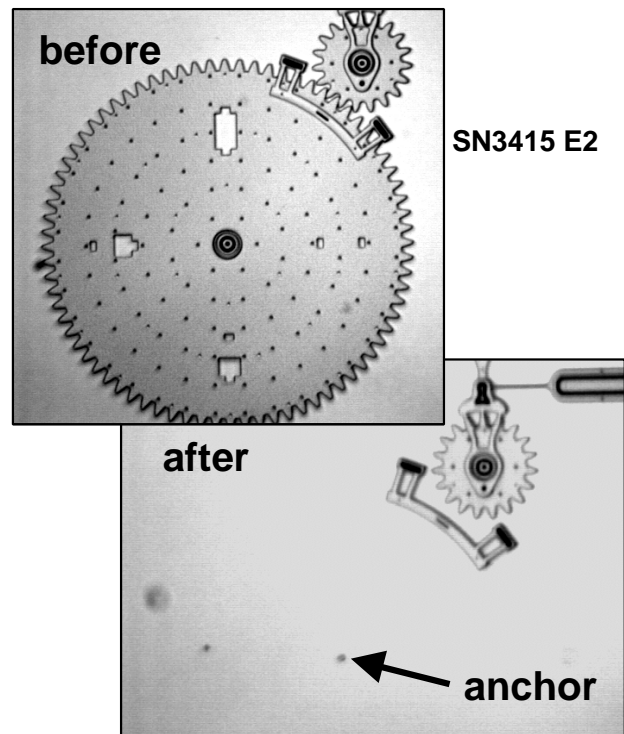
Following shock testing at 20,000g, 13 out of 19 microengines were functioning, but we began to observe structural damage. Three large gears (320- μ m diameter) broke away from the substrate as shown in Figure 10 due to a bottom impact. The microengines still

Figure 10. A bottom impact of 20,000g broke the anchor of the large gear. The microengine still functioned in this case.

functioned after test, but this would have been a system failure if the large gear were necessary. A simple design change to make the anchor for the large gear larger and thus stronger would prevent the loss of the gear. The anchor diameter is now 14 μm , which is the same as the drive gear.

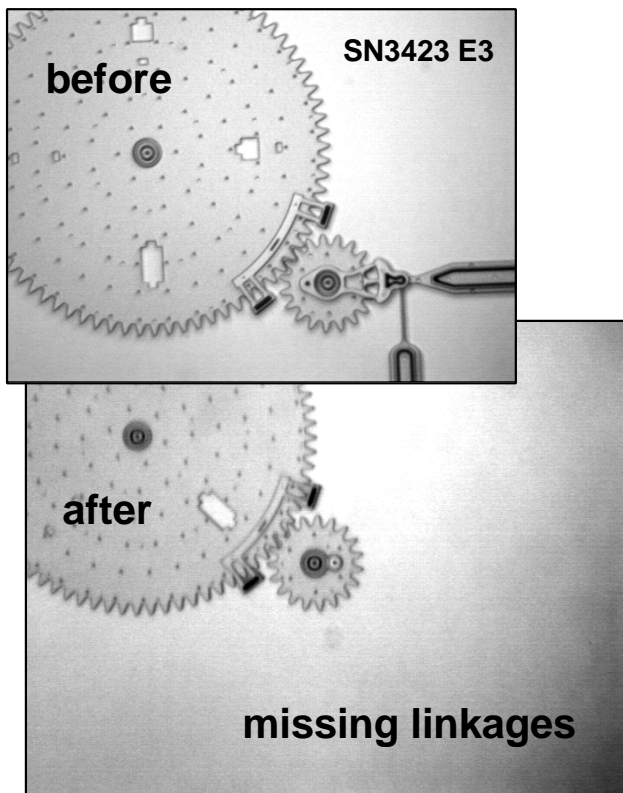
Figure 11. The linkage arms on one of the microengines broke with a 20,000g top impact.

One set of linkages was lost (Figure 11) in a top impact producing a failed microengine. Here the shock was strong enough to fracture both the pin joints and the flexures between the linkage arms. The flexures are only 2 μm wide and 40 μm long and allow bending of the linkage arms to move the gear. Illustrated in Figure 12 are the pin joint and flexure respectively. A small piece of debris is located near the pin joint. It is unknown at this time if both regions failed simultaneously, if the pin joint fractured as a result of fracturing of the flexures, or vice versa. It can be stated that this level of shock is capable of breaking the thinner, more fragile regions of the microengine.

Simple design changes such as larger anchors for large gears or wider flexures should strengthen the structure of these parts and allow high-g shocks to be routinely survived.

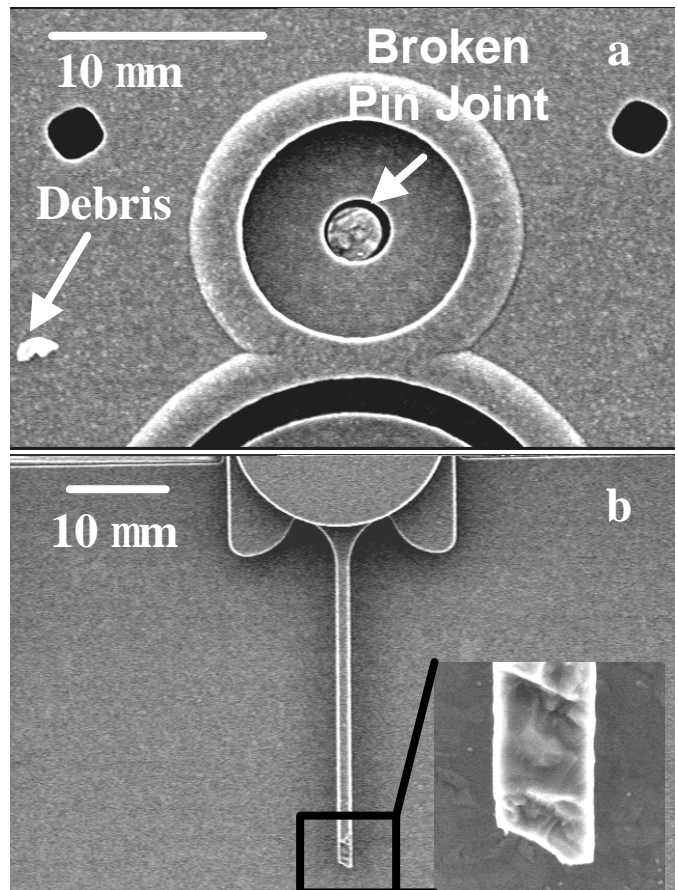
Figure 12. The broken pin joint (a) and fractured flexure (b) resulting from 20,000g top impact shock are shown.

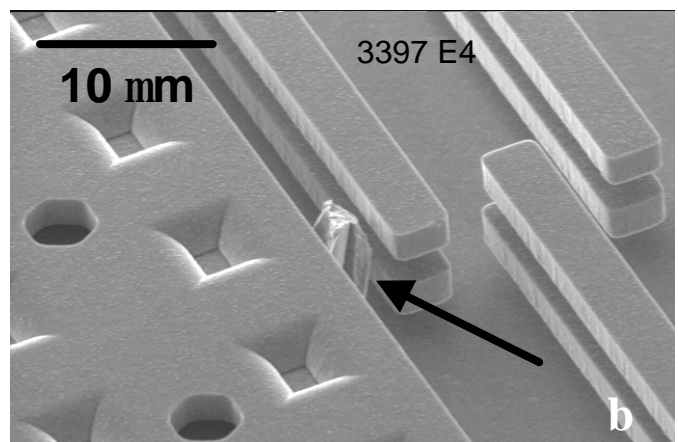
One of the microengines at 20,000g subjected to top impact failed due to debris shorting out an actuator to the ground plane. Removal of the debris by careful probing eliminated the short. Removal of this debris permitted the microengine to function, indicating that it was the source of the short.

Figure 13. Particle contamination was found within the actuator region of the microengine subjected to a 20,000g top impact. Note the contact between the particle, stationary comb fingers, and the shuttle resulting in electrical short of the drive signal to the ground plane.

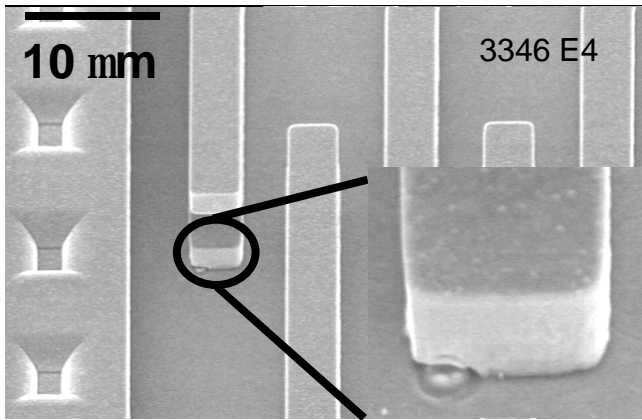
The second shorting phenomena observed in this experiment, is a comb finger contacting the ground plane. This led to a direct short of this actuator. Electrical probing revealed the presence of the short, and visual inspection using the SEM revealed the bottom comb finger adhered to the ground plane as illustrated in Figure 14.

Figure 14. This stationary comb finger was observed stuck down to the ground plane after a top shock impact at 20,000g. Note the contact at the tip of the comb finger and the ground plane in the expanded image.

Could the shock have bent and adhered the fingers? If we examine a single lower comb finger with a length of 48 μm , width of 4 μm , and thickness of 2.5 μm , we can calculate a mass of 1.1 ng. The force from a 20,000g shock could be 0.22 μN . Now, we use an equation similar to equation (3) except it is for a uniform load on a beam,

where w is the load or F/L . A deflection of 2 μm where the tip of the finger would touch to ground plane requires a force of 117 μN . The force from the shock is almost three orders of magnitude below the force needed to bend the finger implying that the shock impact was not the cause of the short.

Additionally, after observing this short at 20,000g, we tested our controls that were kept in a benign nitrogen environment during the shock tests. Four out of nine microengine controls had failed, by exhibiting rocking behavior. Electrical probing revealed shorting of the operational voltages to the ground plane. SEM examination of the controls revealed the same signature of one or more fingers adhered to the ground plane. This result suggests that this failure mechanism was not induced by shock.

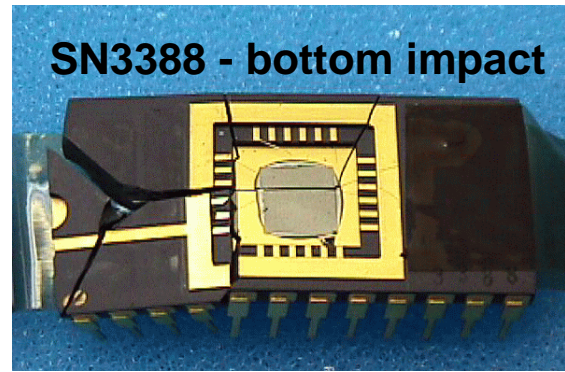
The extreme level of 40,000g shattered all four of the ceramic packages. An example of package fracture after bottom impact is shown in Figure 15. The mounting method in the fixture may have contributed to the fracture. All 8 microengines stressed in a top impact were destroyed due to die attach failure. Surprisingly, two dice survived (one from bottom impact and one from side impact) and were lifted from the fractured packages. One is shown in Figure 16 where the bond wires are visible along the edge of the die. After careful removal of the bond wires, two microengines actually functioned, one from each die. There was a large amount of debris on the surfaces of each die (Figure 17), partly from the cracked packages.

Figure 15. The 40,000g impact from the bottom fractured the package. The die was removed and tested.

A more global concern for MEMS reliability at these shock levels resides in the package. As shown in Figure 15, the limiting factor in overall functionality will reside in the survival of the package itself. Utilizing plastic or non-ceramic packages may reduce or prevent these failures from occurring.

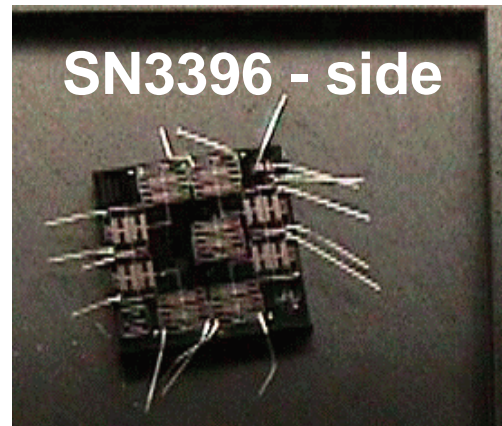
Figure 16. This die was removed from a fractured package subjected to 40,000g-shock impact.

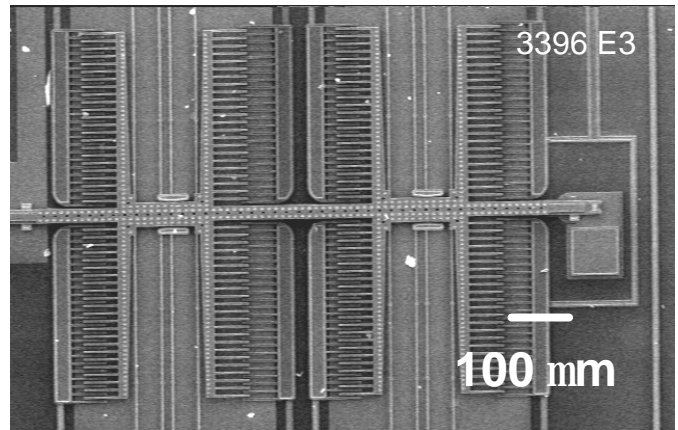
Figure 17. The particle contamination shown in this SEM image was characteristic to both dice that survived the 40,000g impact. Specifically, this is the y-axis actuator from a side impact.

two of the microengines failed as rockers, and the other microengine was shorted due to debris. Closer inspection of the four microengines on this die revealed a significant amount of particulate contamination.

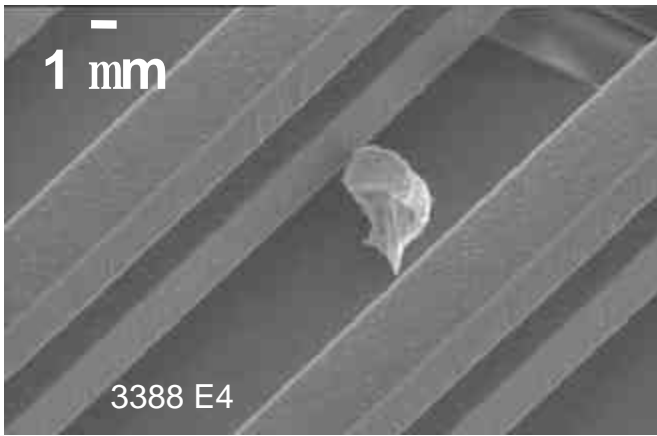
Characterization of the two microengines that failed as rockers revealed shorts between the operational voltage and the ground plane. One of the microengine failed due to debris contamination. The particle was located between the comb fingers and is illustrated

Figure 18. This particle was the short between the stationary comb finger and the ground plane. The shock impact was from the bottom at a 40,000g level.

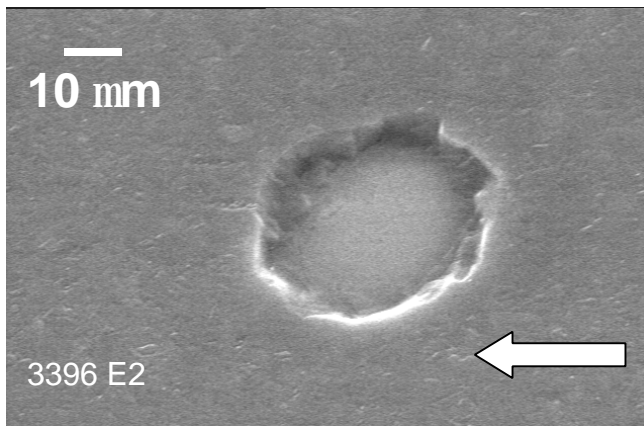
Figure 19. This crater resulted from a load gear anchor being ripped out of the polysilicon ground plane by a side shock impact of 40,000g. The arrow indicates the shock direction.

The one microengine that functioned had its load gear ripped out of the ground plane. As illustrated in Figure 19, the crater left by the missing load-gear hub is charging up in the SEM. The surrounding ground plane is polysilicon and grounded through the bond wire. For this area to charge, the silicon nitride underneath the ground plane would have to be exposed. This would indicate the hub delaminated from the silicon nitride, but fractured around the perimeter of the hub.

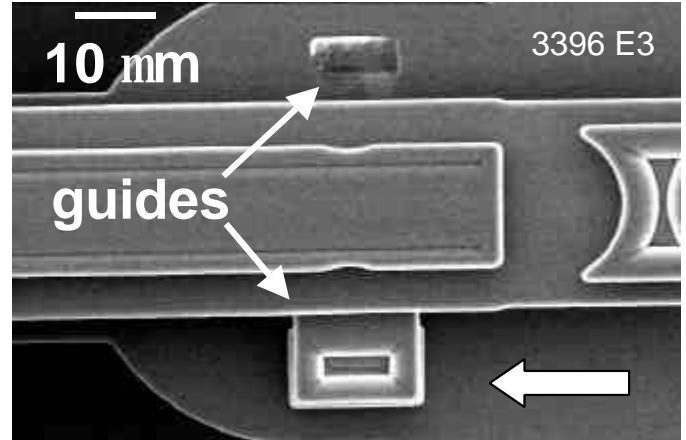
One microengine failed with a broken drive gear hub also had a broken rear guide as shown in Figure 20. Of particular interest in this microengine was the observation that the shuttles along both x and y actuators are on top of the guides. We suspect that the combination of an unanchored drive gear and the lack of a guide removed some of the constraint and the shuttle could move within the x and y plane (plane of the microengine). The residual ringing in the shock

Figure 20. The 40,000g-shock impact broke one of the rear guides of this X-axis shuttle. The shuttle now rides on top of the remaining guide.

wave may have caused motion or vibration of the linkage arms, leading to the shuttles landing on top of the guides.

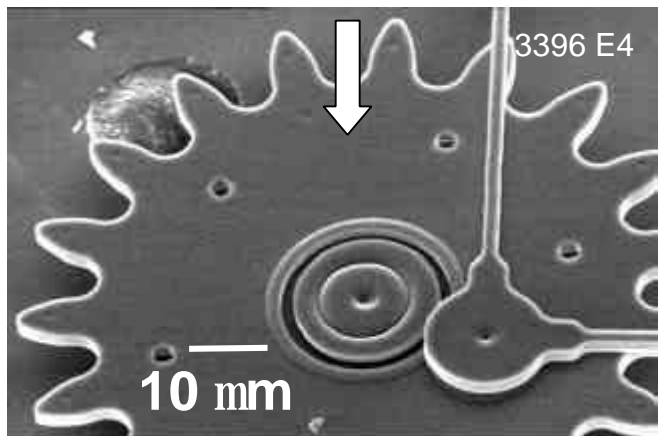
Figure 21. The drive gear anchor was broken by a side impact shock of 40,000g. The arrow indicates the direction of the impact.

The second microengine that failed due to a broken drive gear anchor (the actuators still worked) is shown in Figure 21. Note that the fracture did not expose the silicon nitride layer in this case. In this microengine, the shuttle also worked its way out of the guides, but only on the y actuator.

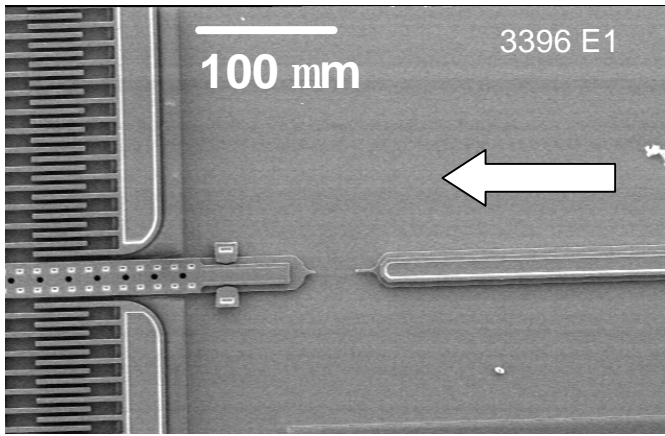
The fourth microengine subjected to side impact failed due to a broken flexure in the linkage arms (again, the actuators work) and is shown in Figure 22. The flexure had a width of 1.7 μm , a thickness of 2.5 μm , and a length of 40 μm . Assuming that the massive comb structure pulled the flexure lengthwise, we calculated the force exerted on the flexure. With a 40,000g shock and a 1.06- μg comb structure, the force could be as high as 415 μN . The estimated force, P , to break the flexure due to tensile loading is

which is much closer to that calculated from the shock. There was ringing associated with this shock which could have led to additional buckling allowing the flexure to fracture.

Figure 22. This SEM image shows the broken X flexure occurring after side impact of 40,000g. The arrow indicates the direction of impact.
