# **Critique of Electric Shock Incident at X1**

**September 10, 2004**

**Nicholas F. Gmür and W. Robert Casey**

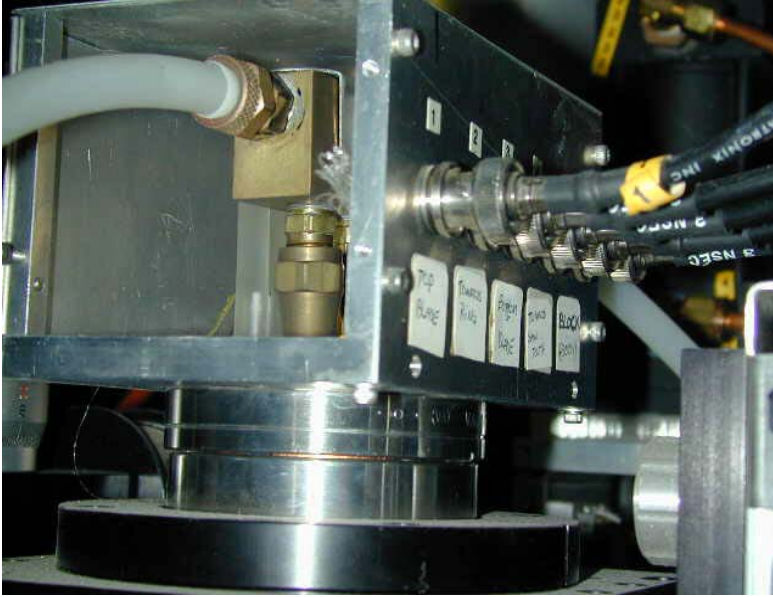
however, remember discussing the shock after the event with the Control Room supervisor, and assisting in restricting personnel access and helping to assemble an electrical team to investigate.) The Utilities Tech Supervisor was told that the PBPM was associated with X1 and to get in touch with the Local Contact. It was identified as a photon beam position monitor (PBPM). The LC agreed with the supervisor to help with the hose replacement. By the time this determination had been made, the work had to be postponed until the August 10-11 Maintenance period. On August 9, the day before the Maintenance was to begin, the supervisor contacted the LC once again. The LC agreed to be available the morning of August 10. At 08:00 hrs, the LC met with the technician who was to replace the hoses. The LC, with assistance from the tech, removed the front aluminum plate of the box around the top of the PBPM. This was necessary to access the hose connection inside that box. The LC informed the tech that the PBPM motors were off (this meant that the motor power supply and motor drivers were powered down; the motor cables at the rear of the motor driver crate were disconnected). The LC also looked at and confirmed that all cables connected to the box in question were BNC cables. The LC left to obtain a step stool to assist the tech. The tech assumed that the system was in a safe configuration to begin work. The tech placed a 9/16" wrench inside the aluminum box, made contact with the nut securing one of the hoses, and received an electric shock. The tech's other hand was holding onto the aluminum foil surrounding the X1 beam pipe.

View of X1 PBPM water hose connection and adjacent BNC cables

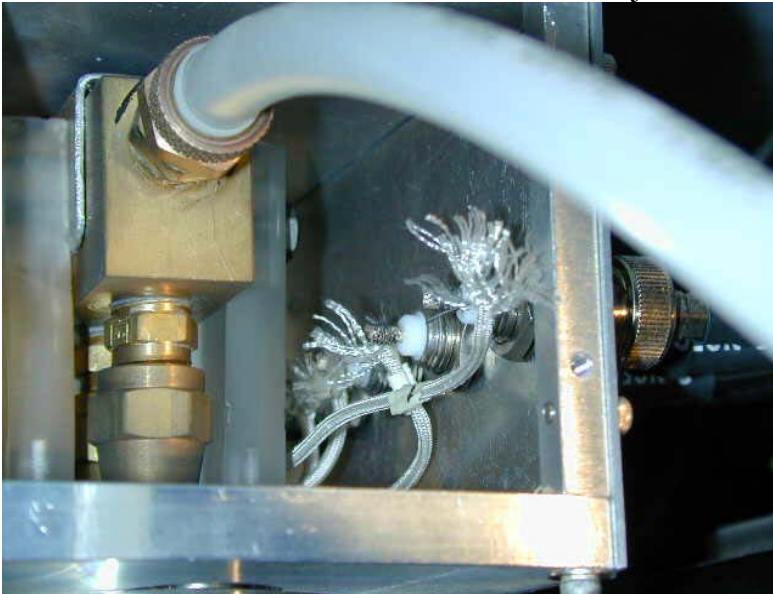
View of X1 PBPM water hose connection and adjacent BNC cables

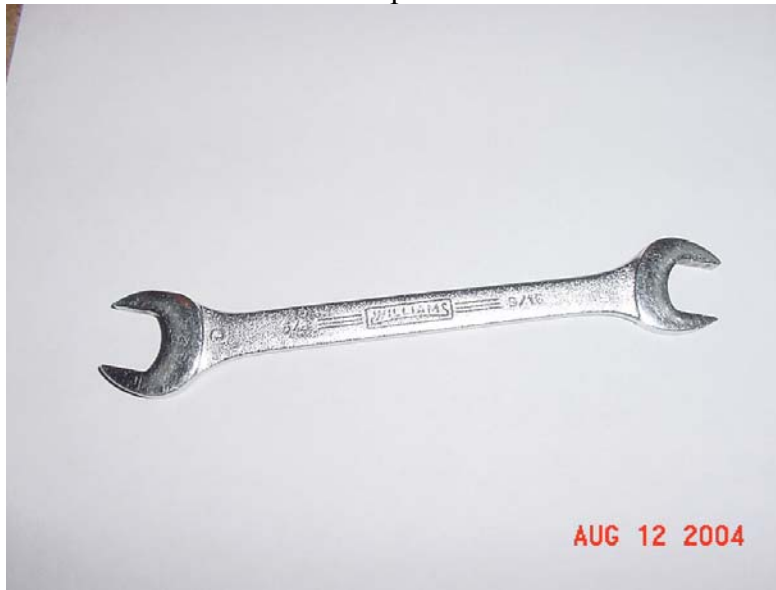
The tech immediately dropped the wrench and pulled his hands away. He informed a Utilities technician who was working nearby and the LC. The LC, in turn, informed the Control Room supervisor. The tech also informed his supervisor who was working in a mechanical equipment room. Access to the X1 beamline front end area was restricted using Caution tape. The supervisor escorted the tech to the BNL Occupational Medicine Division (~08:20 hrs) where the tech was given an examination by the medical staff, including an EKG. The tech was released and given permission to return to work.

View of wrench used in attempt to disconnect water hose
