RE: Dead River Hydroelectric Project (FERC Project No. 10855)

Silver Lake Dam:  
Root Cause Report on the  
May 14, 2003 Operation of the  
Fuse Plug Spillway and  
Subsequent Channel Erosion  
Resulting in the Uncontrolled  
Release of Silver Lake

**DEAD RIVER  
HYDROELECTRIC  
PROJECT**

**Upper Peninsula Power Company**  
Federal Energy Regulatory Commission  
Licensed Project No. 10855

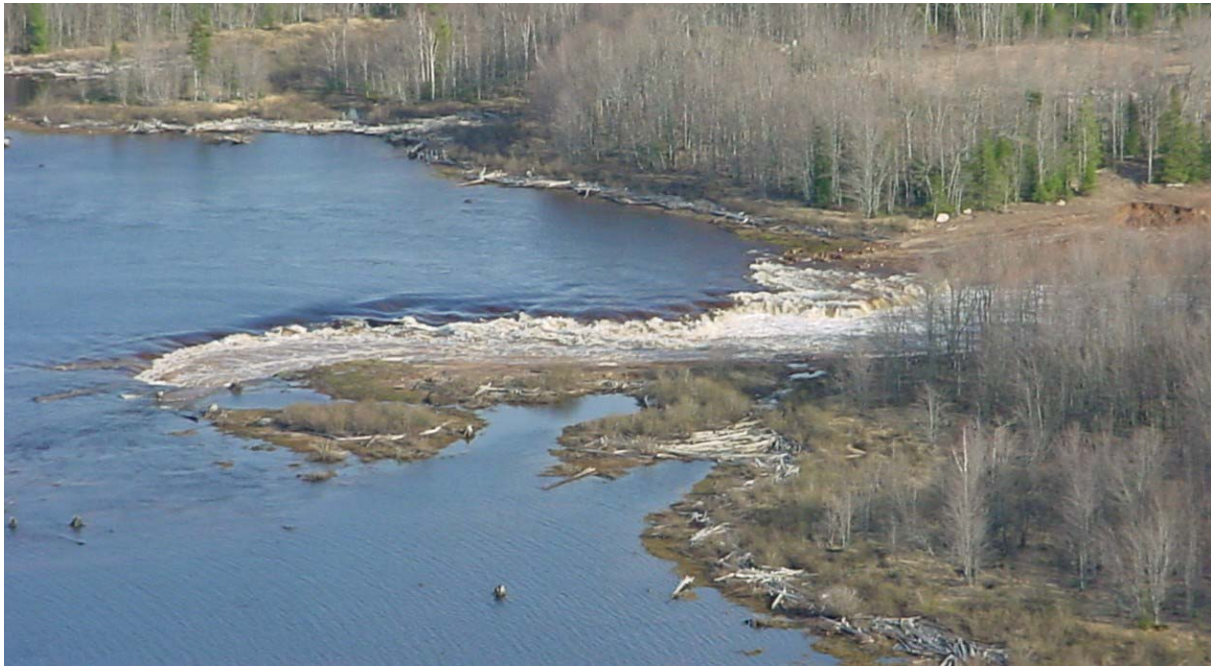
embankment was designed to wash out only to El. 1481.0 ft, forming an emergency spillway. Instead, the ground beneath the fuse plug eroded downward an additional 12 to 25 feet.

Headcut propagation in Silver Lake - About 7 pm on May 14, 2003

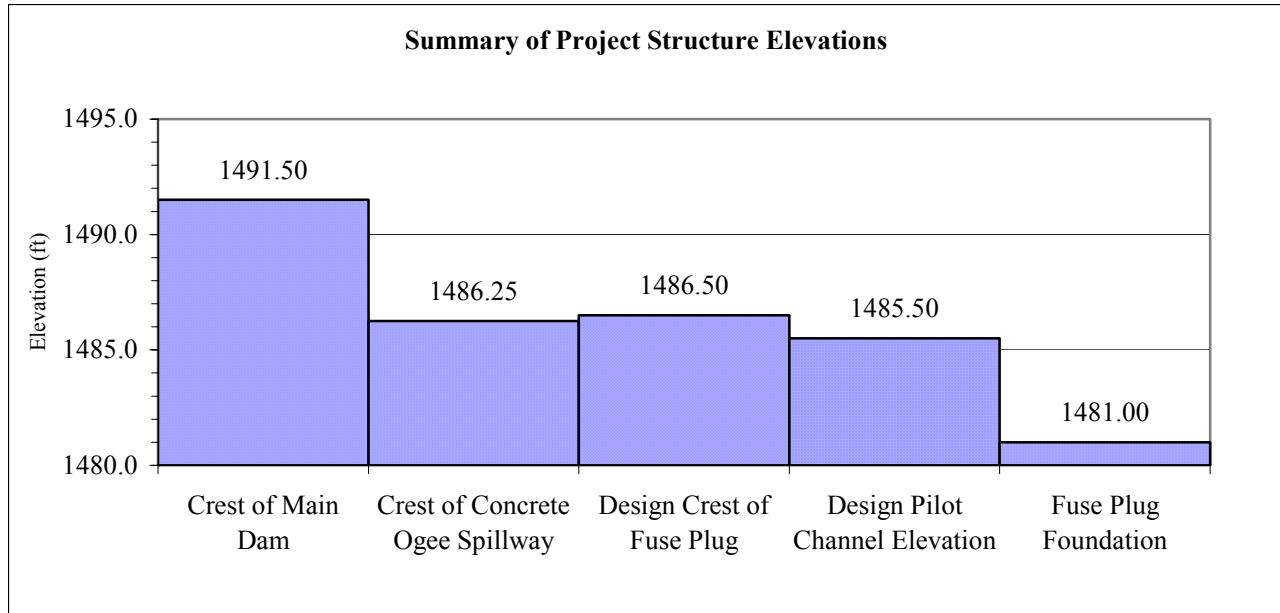
Relevant design elevations for the project structures are summarized on the chart below. From this summary it is immediately apparent that the pilot channel elevations were set 0.75 ft below the crest of the concrete ogee spillway. The pilot channel elevation should have been set above the elevation of the concrete ogee spillway crest. Chapter II of the FERC Engineering Guidelines for the Evaluation of Hydropower Projects (FERC 1993) defines an emergency spillway as “a spillway that is designed to provide additional protection against overtopping of dams and is intended for use under extreme flood conditions or mis-operation or malfunction of the service spillway.” The elevations established for the fuse plug design as stated in the Design Report (MWH 2002) resulted in operation of the fuse plug spillway as the service spillway.

There are other potentially functional designs that could have been considered with pilot channel elevations above the crest of the concrete ogee spillway. The purpose of this discussion is not to present alternative designs, but rather to illustrate that the proper elevations for any design would have to be determined using engineering evaluations to accomplish the objectives of the design – but in any case the pilot channel elevation should be above the crest of the concrete spillway. For example, one design would involve setting the fuse plug pilot channel elevation some established height above the service spillway crest to allow the service spillway to provide initial discharge capacity. If lake levels continued to rise and exceed the pilot channel elevation, the fuse plug spillway would have provided the additional capacity, as suggested by standard design practice (USBR, Pugh 1985). In addition, if hydrologic and hydraulic studies indicate that large storm events (i.e. PMF) cause lake levels to continue to rise and the embankment dam sections are in danger of overtopping, then the embankment dams should be raised to accommodate the required storage and freeboard. The elevations established for this selected fuse plug design resulted in operation of the fuse plug spillway during a flood event with a probability of exceedence in any year of 10 to 20 percent.

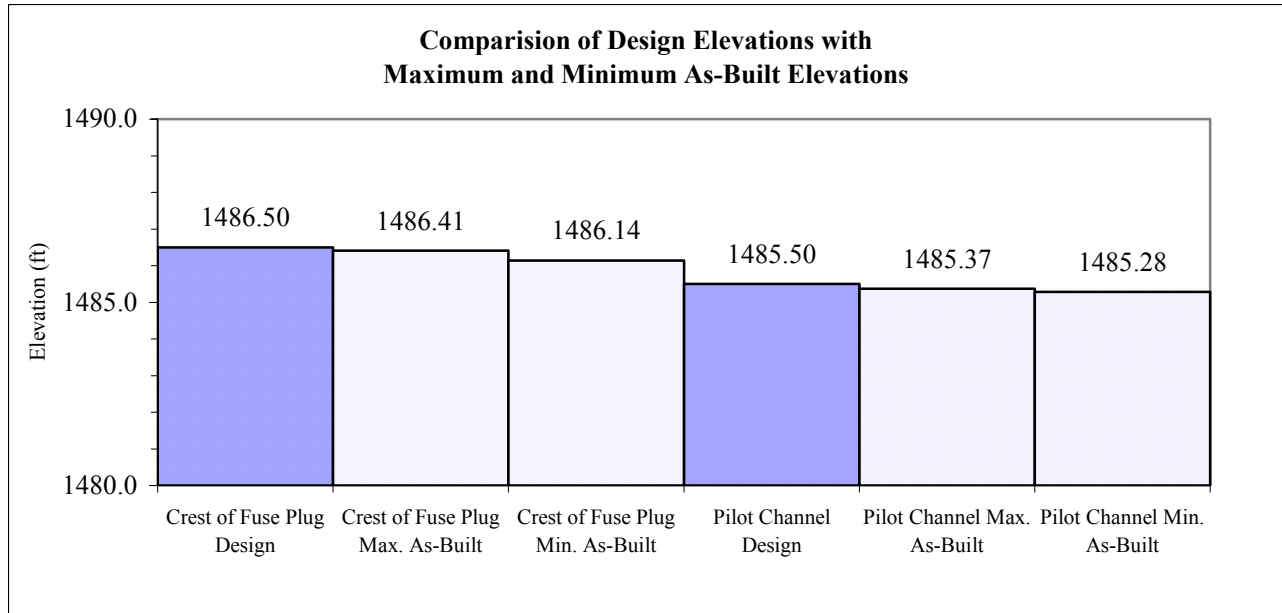
As previously discussed, pilot channel elevations are critical to the proper function of the fuse plug. As-built surveyed elevations were documented on Coleman Engineering drawing WSK745-S1 prepared for Moyle Construction (the contractor who built the fuse plug) dated November 5, 2002. The as-built drawing indicates the actual pilot channel elevations were slightly lower than the design elevations. A comparison of the design elevations with maximum and minimum as-built elevations for the fuse plug is presented below.

The survey data indicates all elevations were constructed lower than the design elevations. The lower pilot channel elevations result in less available storage; and therefore, breach of the fuse plug occurred at a slightly lower lake elevation than the design breach elevation. There is no record indicating the pilot channels elevations were raised, subsequent to the as-built survey, to correct the elevation deficiency.
