7.4.6 Coaxial Transfer Switch Fails

7.4.7 Failure to Establish UHF Link Between the Lander and Mars Global Surveyor

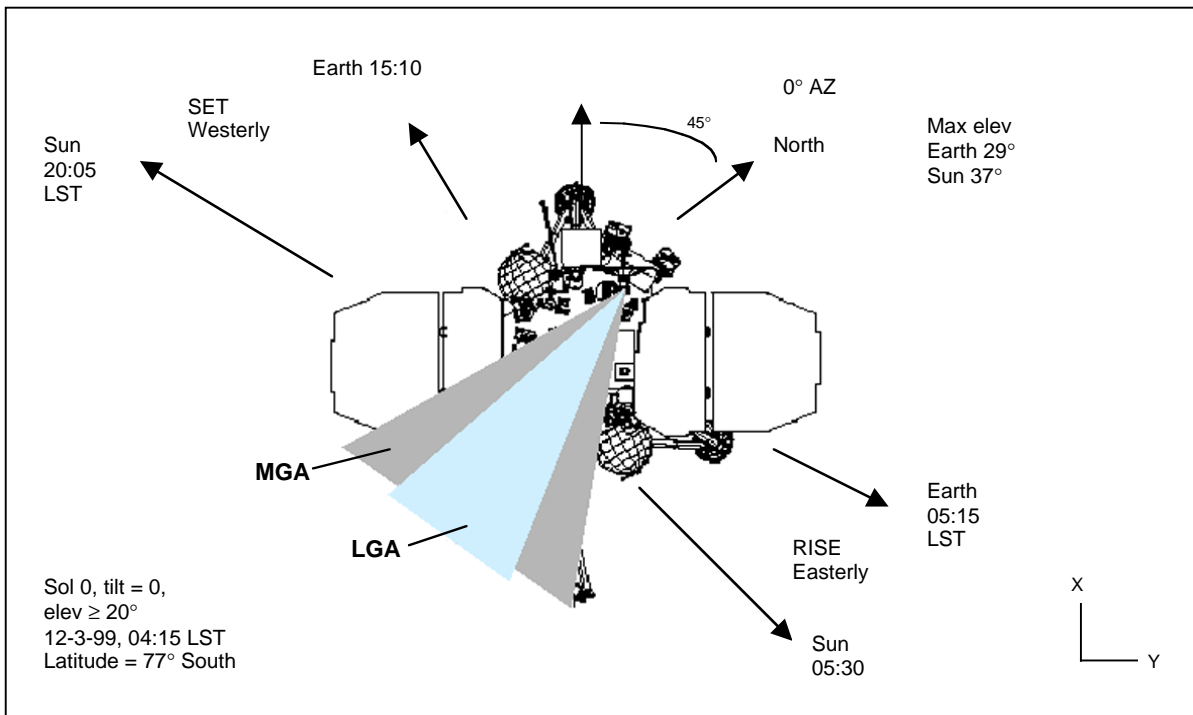
Figure 7-6. Command-Blind Zones in Azimuth for MGA (125 bps) and LGA (7.8125 bps)

The LGA is fixed and pointed at the approximate center of the nominal Earth azimuth range. In elevation, the LGA boresight is pointed approximately 43 degrees above the lander deck and the nominal horizon line. The mean Earth elevation angle is approximately 17 degrees above the horizon. In the worst-case azimuth orientation (180-degree error), the mean Earth would be 120 degrees off boresight. At 7.8125 bps, an uplink can be received by the spacecraft at up to 135 degrees off boresight. So there is at least a chance of getting an uplink into the spacecraft in the worst-case azimuth orientation. However, since Earth is frequently at lower than mean elevation, it is probably more realistic to consider a region of ± 16 degrees (elevation error) around the worst-case landing azimuth error to be a “command blind” zone.

Only if the onboard sequence is cancelled (stopping the nominal UHF pass) *and* the landing azimuth error puts the lander in the “command blind” zone (see above) would the lander be in a configuration that would not support either an X-band or UHF link. UHF is not especially azimuth sensitive, as long as there is a reasonable elevation angle. The peak elevation angles for the Sequence C UHF passes were 82.8 degrees on DOY 341, 56.5 degrees on DOY 342, and 86.6 degrees on DOY 343.

There is a landed orientation in which an X-band uplink cannot be established through the MGA or the LGA. Precluding the establishment of an uplink path requires either a malfunction of the gyro compassing function or a severe rotation of the lander at touchdown.

Review the antenna coverage and determine under what possible landed orientations a telecommunications link can be maintained. Maximize the configuration to obtain initial link acquisition and engineering health and safety data return.

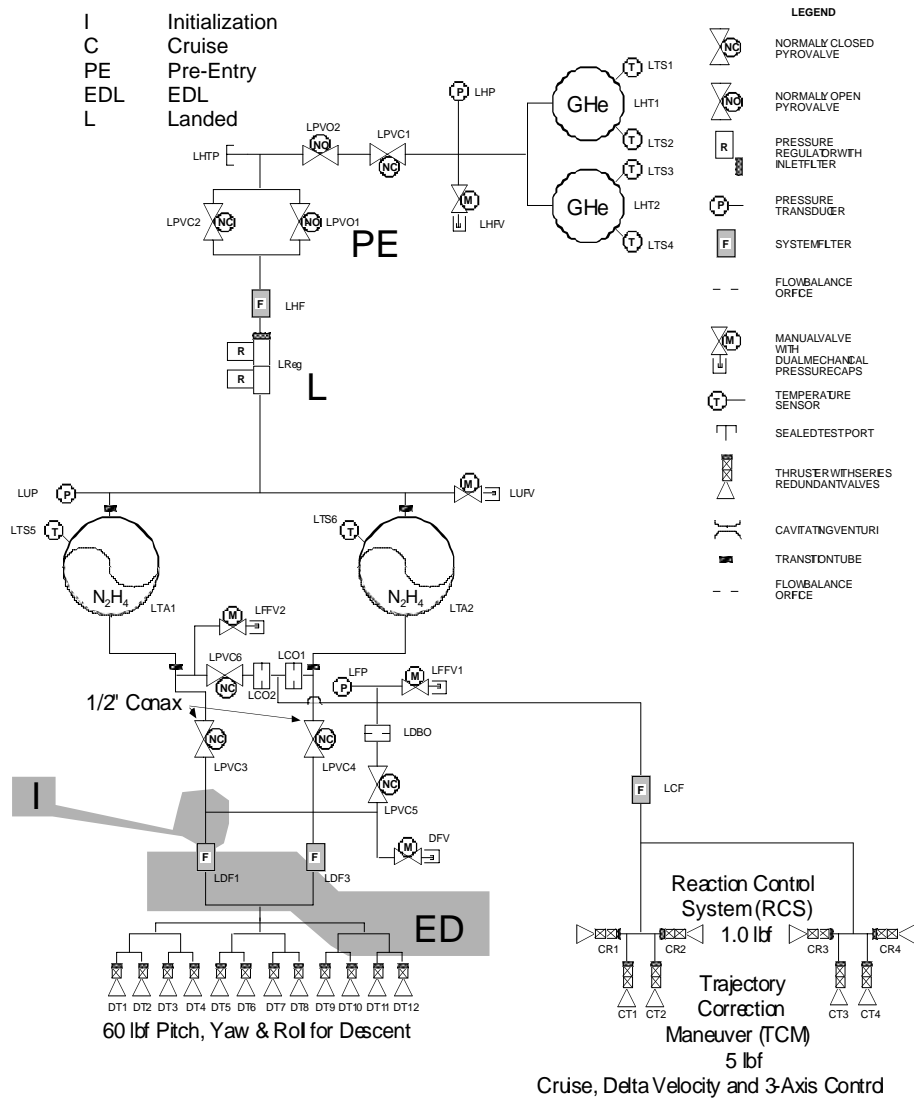
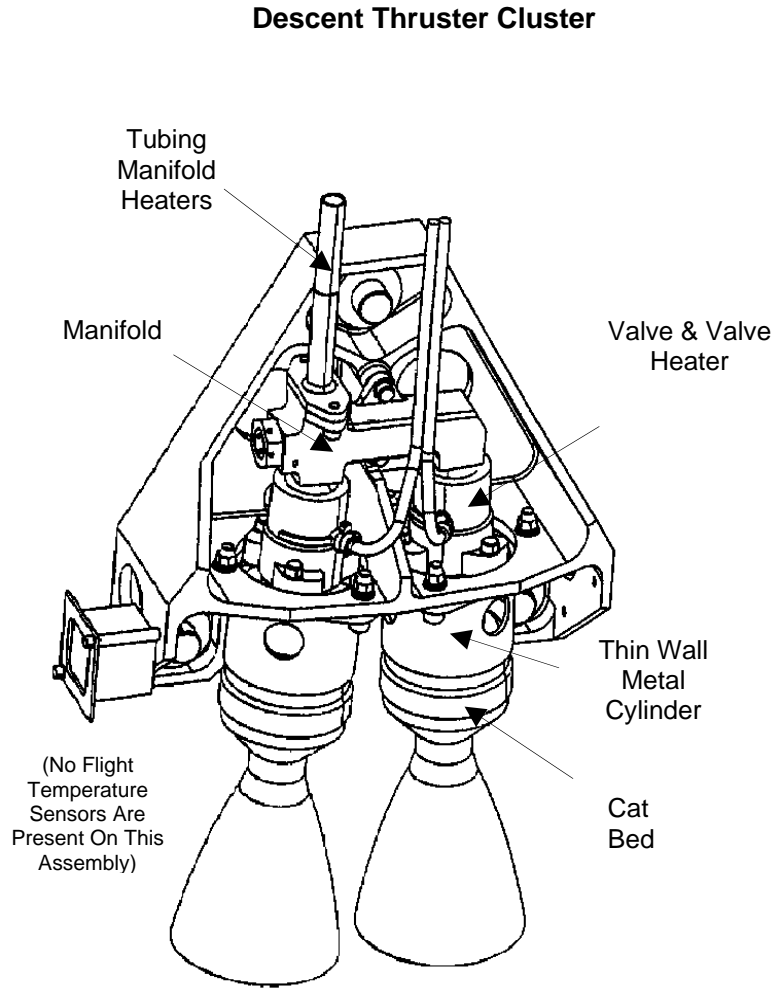
Figure 7-7. MPL Propulsion Subsystem Schematic

Propellant migration between tanks due to differences in the stiffness of the tank diaphragms could shift the spacecraft center of mass by enough to adversely affect the angle of attack of the aeroshell during hypersonic entry. This could cause large displacements in the landing location or, if severe enough, excessively high terminal velocities and/or heat loads.

There were some 60 seconds during parachute descent when the 1/2-inch pyro valves (LPVC3 and LPVC4) were open, providing a low-resistance path between the liquid sides of the two tanks. Any center-of-mass offset in the lander at the beginning of parachute operations would have tipped the lander until the center of mass was aligned with the parachute center of pressure along the deceleration vector. This tipping would result in a hydrostatic head developing across the two tanks, resulting in propellant flow in the direction of the initial offset. If the initial offset were due to a propellant center-of-mass offset, the propellant center-of-mass offset would be further exacerbated by the flow. The maximum propellant imbalance was 8.66 kilograms (from consumption during cruise). This corresponds to a maximum center-of-mass offset of approximately 18 millimeters at the start of powered descent.

The use of parallel tanks on systems for missions with tight center-of-mass constraints should be avoided. If this cannot be accomplished, isolation ought to be provided between tanks. This can be done on the gas side during all periods other than pressurization or long burns or on the liquid side, whichever is more practical. Gas-side isolation will prevent any significant amount of “zero g” migration from occurring; however, this is not totally straightforward because large tank-temperature imbalances will cause some limited propellant transfer. State-of-the-art active or passive thermal control can be used to keep the temperature difference between tanks to within acceptable limits.

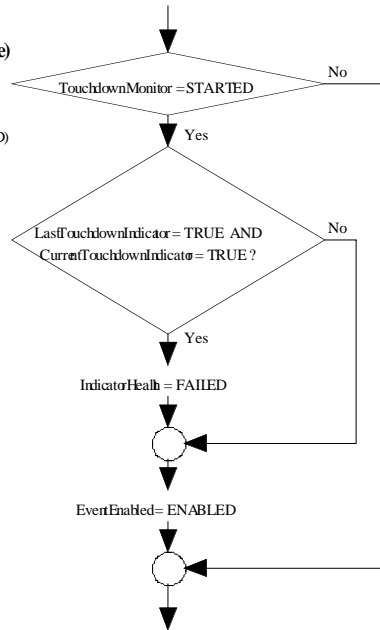
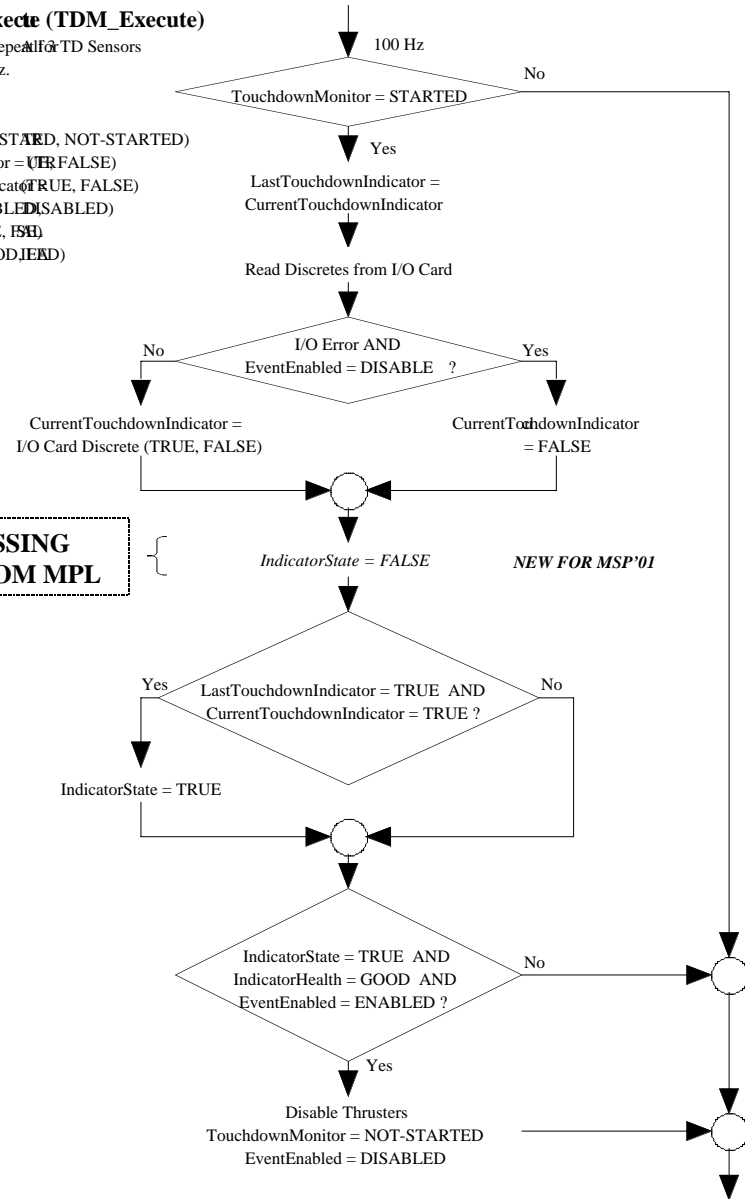
Figure 7-8. Touchdown Monitor Functional Flow Diagram

MISSING FROM MPL

IndicatorState = FALSE **NEW FOR MSP'01**
