Figure 1. Davis-Besse RPV Top of Head Section View

Figure 7. Locations of Cracks and Corrosion on Davis-Besse RPV Head at 13RFO

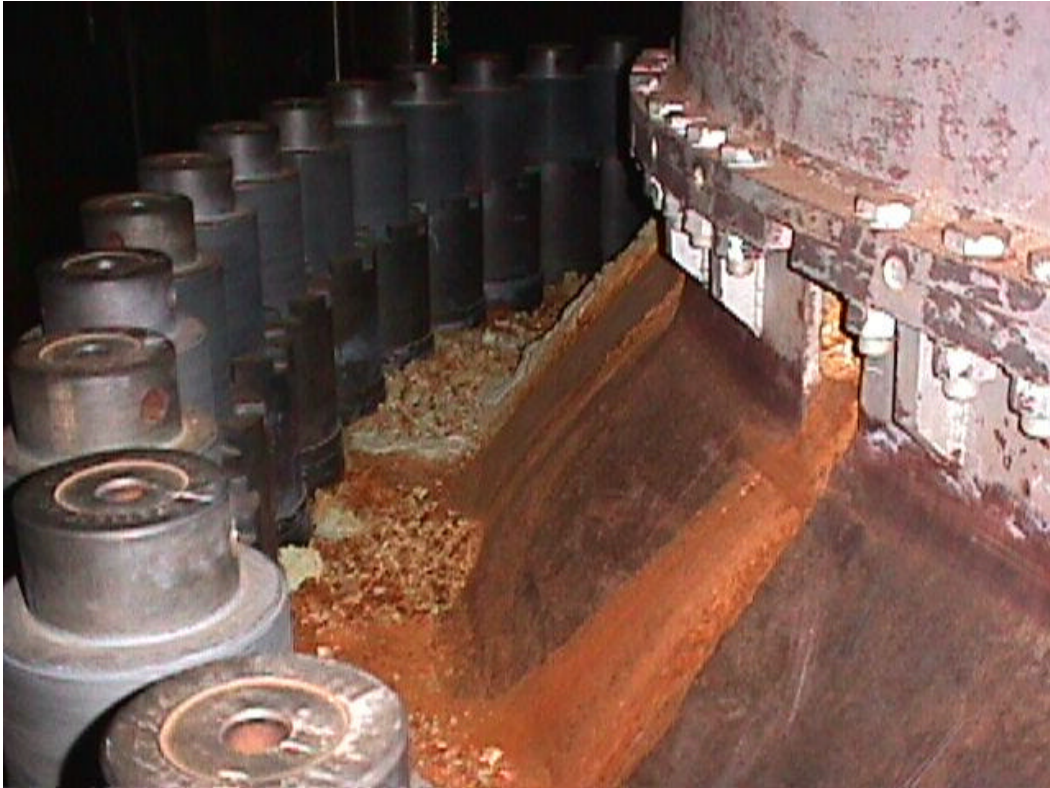
Figure 4. Boric Acid and Iron Oxide on Vessel Flange at 12RFO

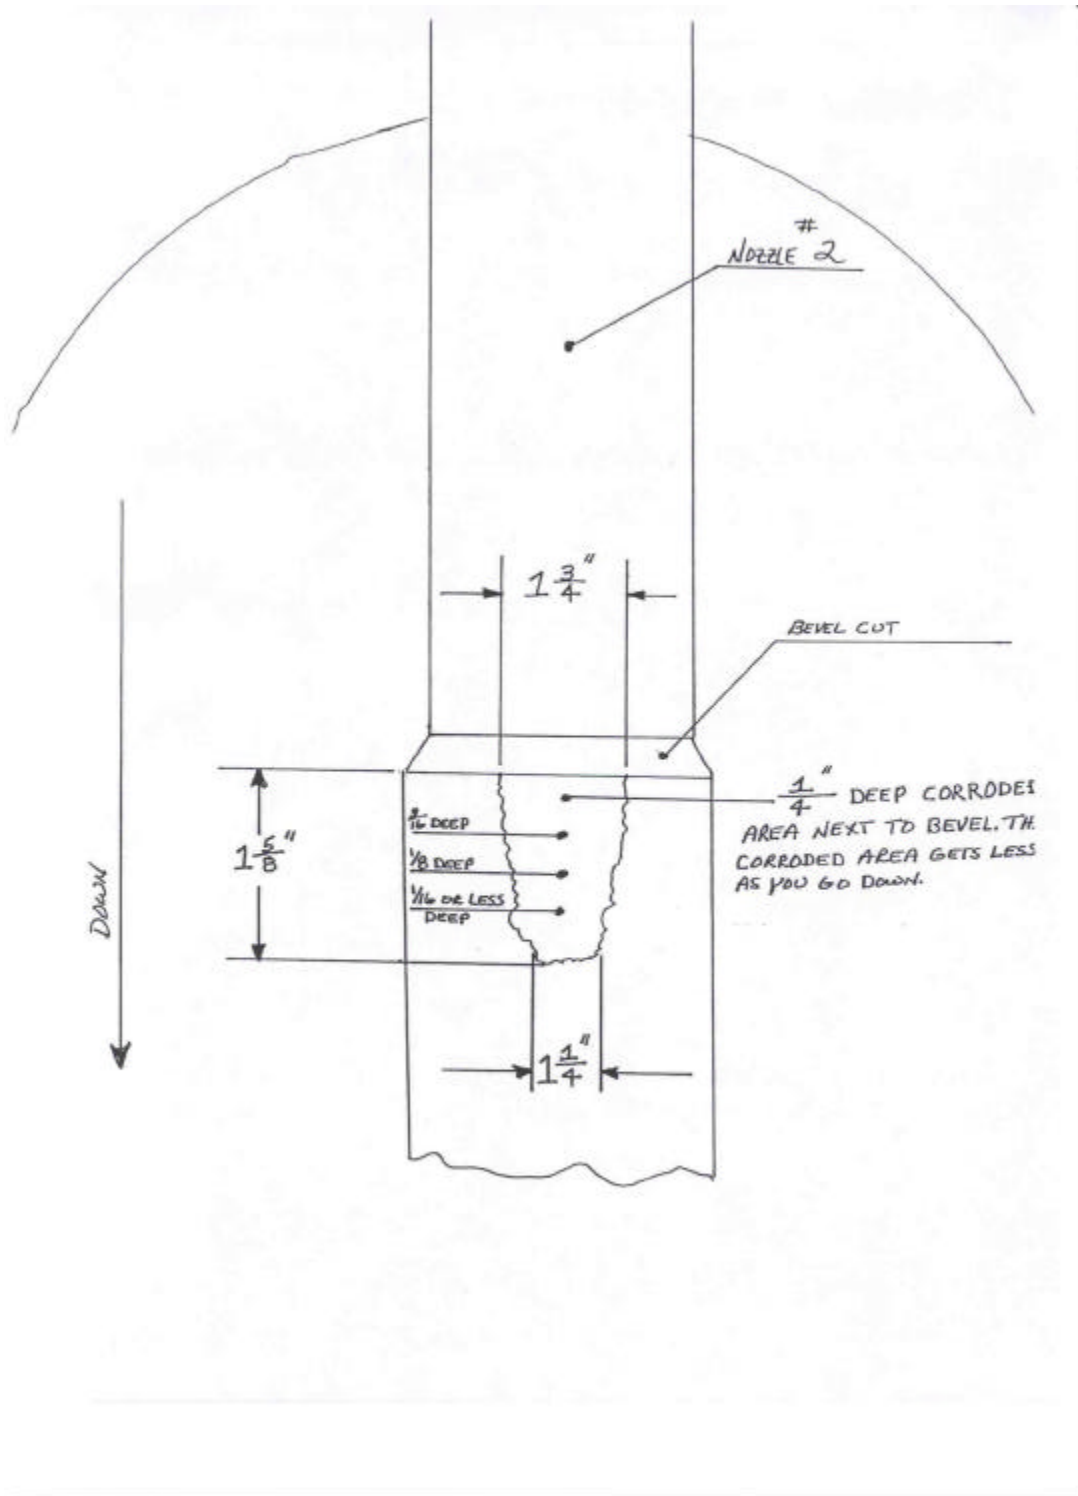
Figure 5. Corrosion at Nozzle 2 Drawing Side View

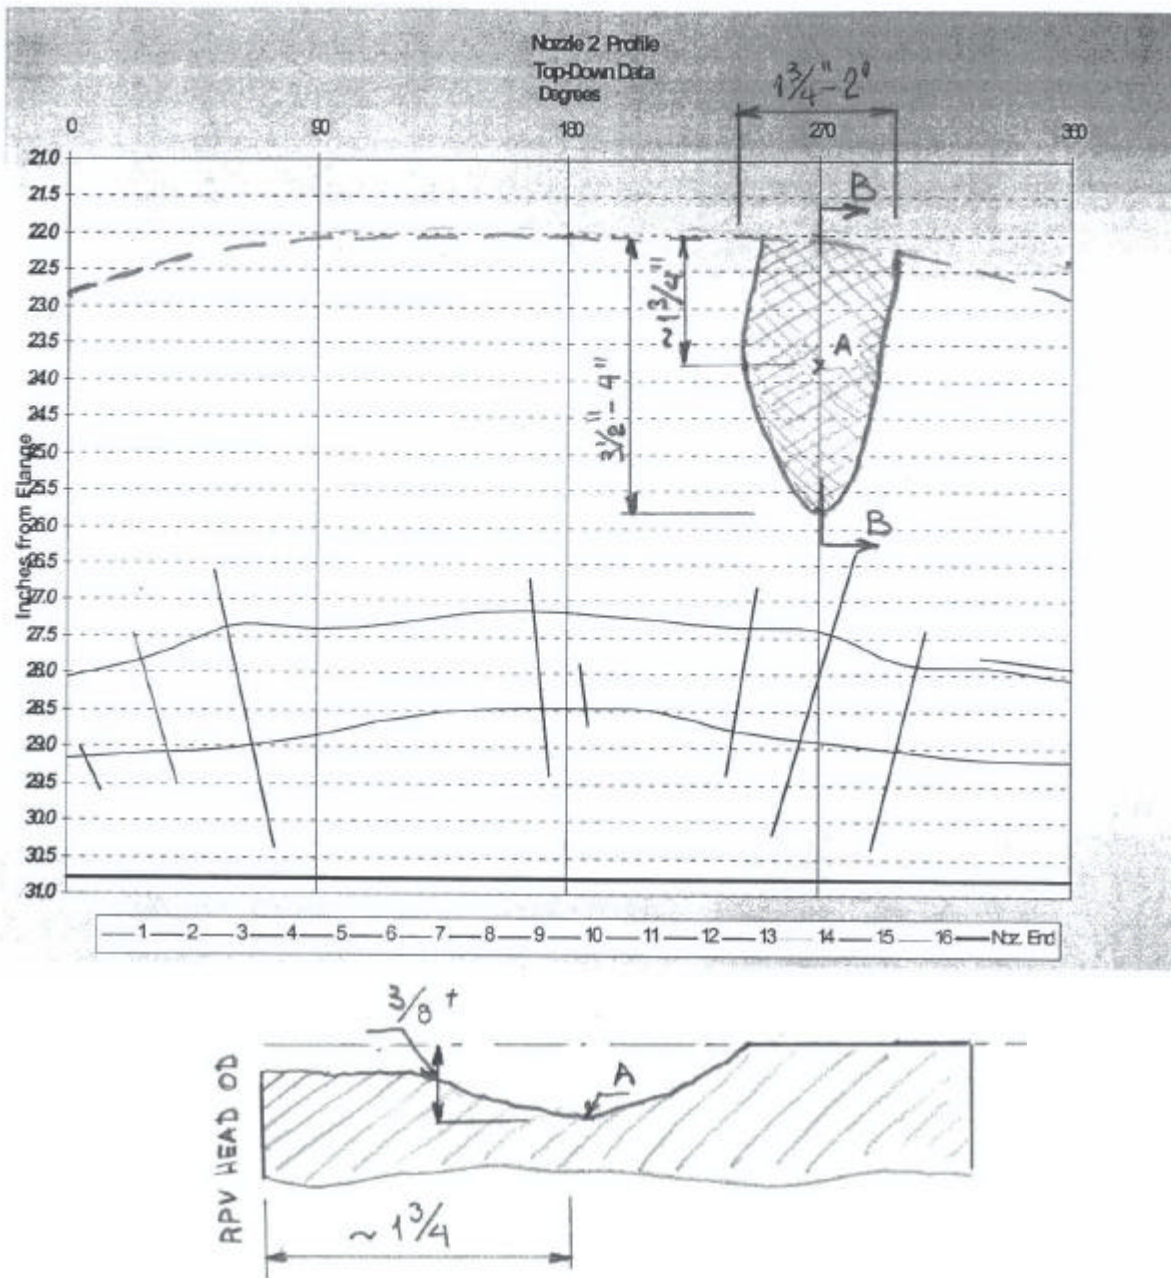
Figure 5a. Nozzle 2 Corrosion Area Location, Size, and Profile.

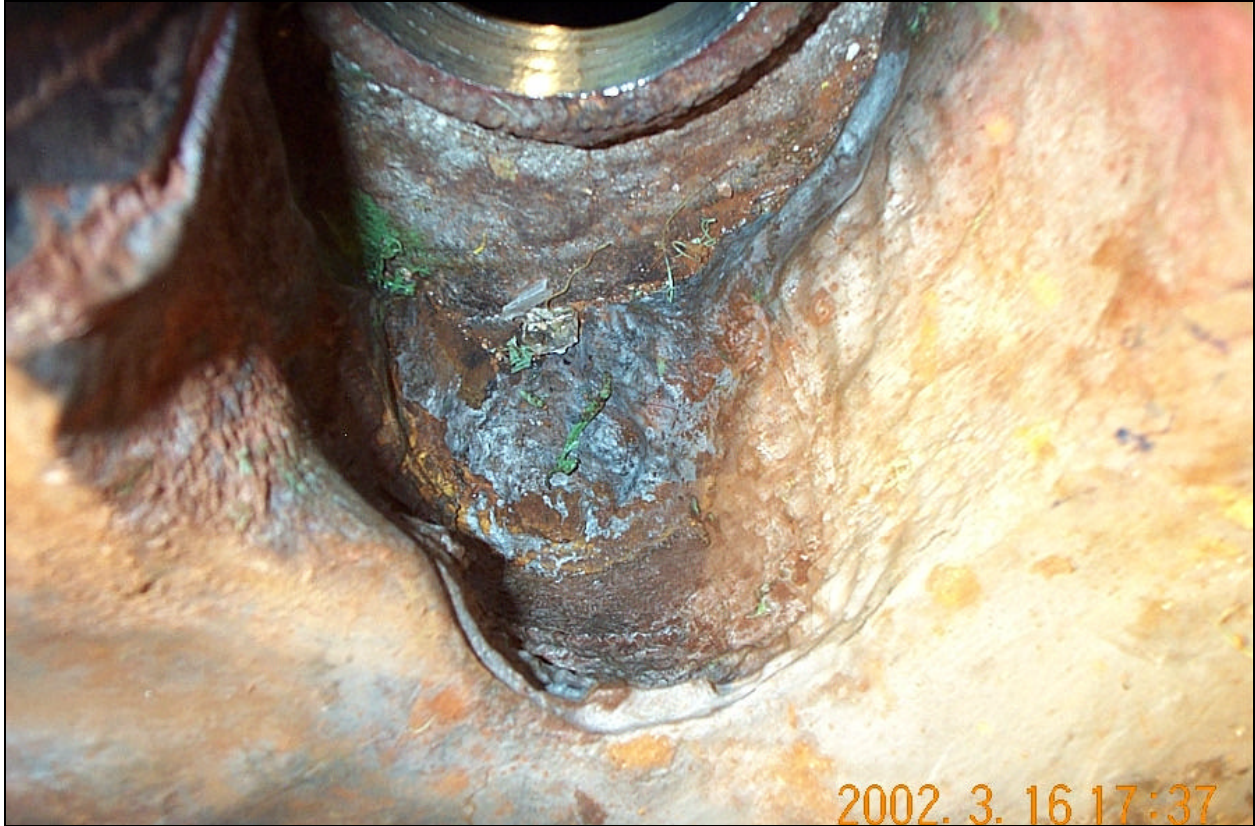
Figure 6. Cavity in Reactor Vessel Head Between Nozzle 3 and 11

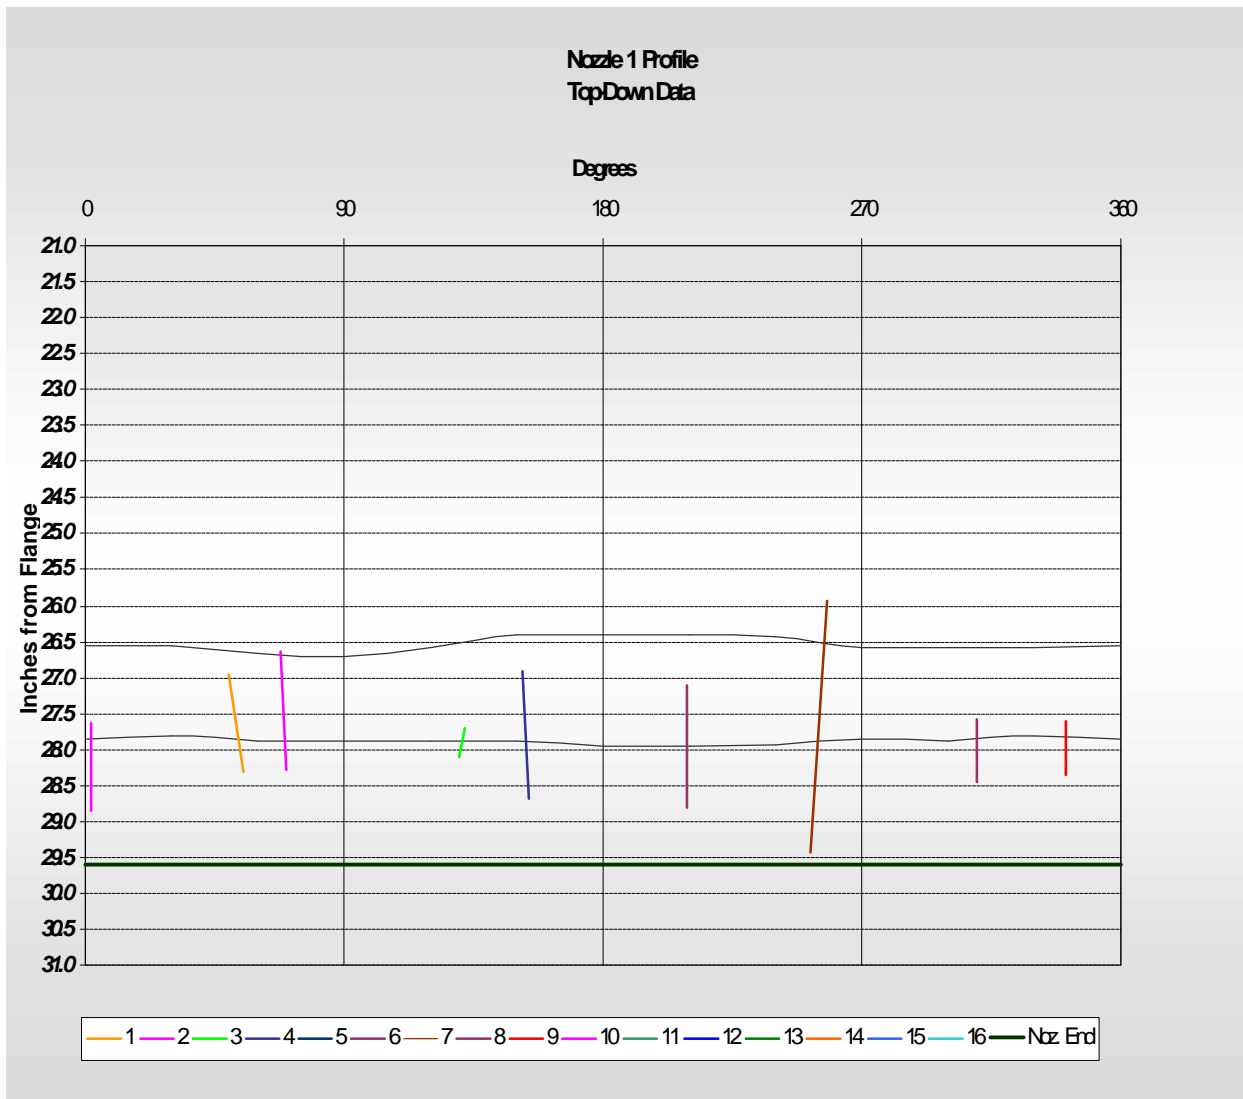
Figure 8. Nozzle 1 Crack Locations and Sizing

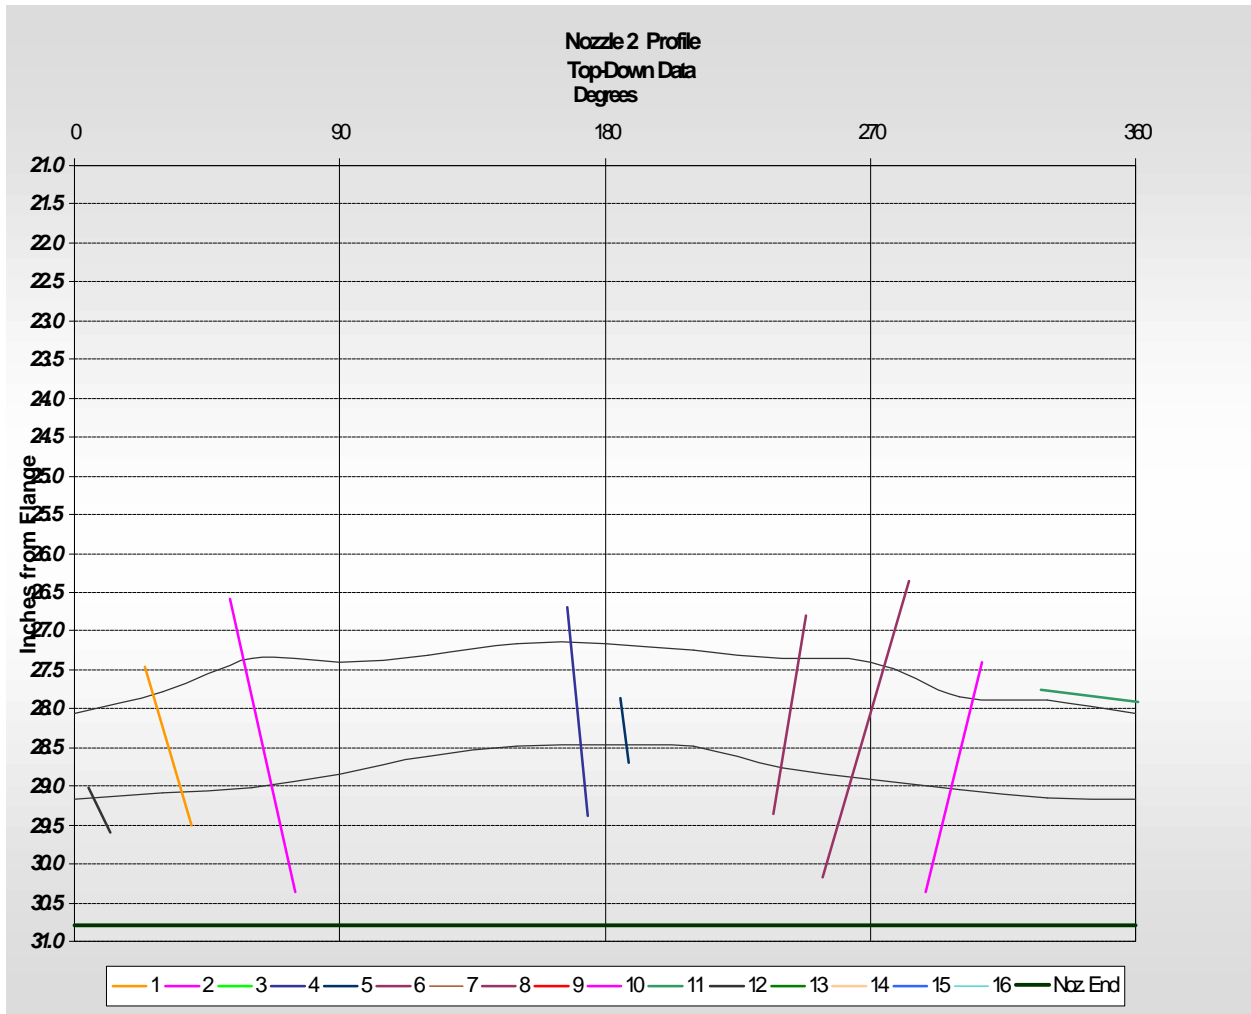
Figure 9. Nozzle 2 Crack Locations and Sizing

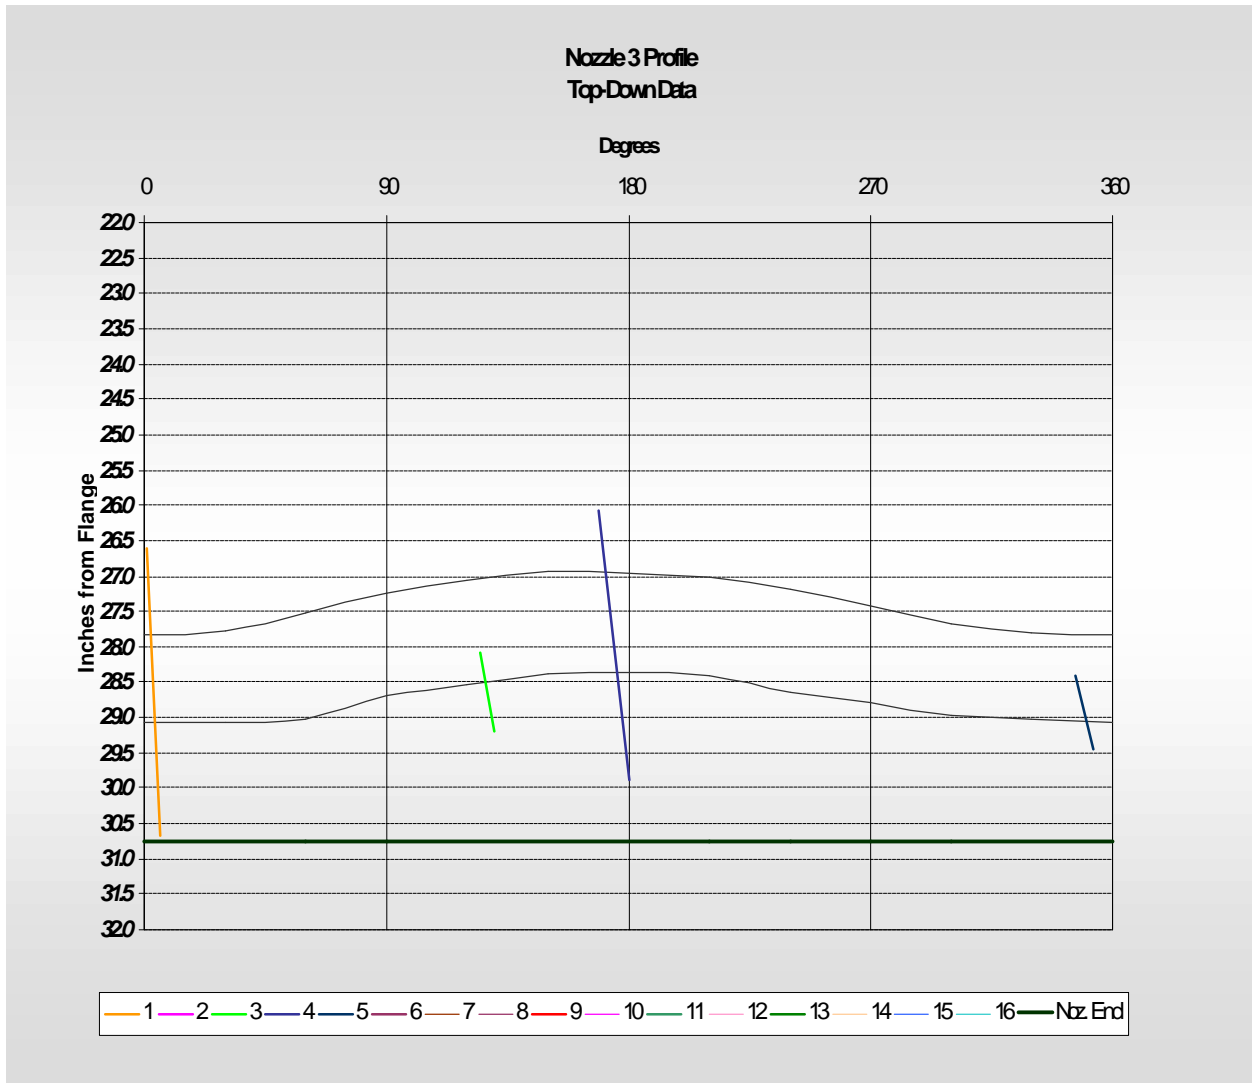
Figure 10. Nozzle 3 Crack Locations and Sizing

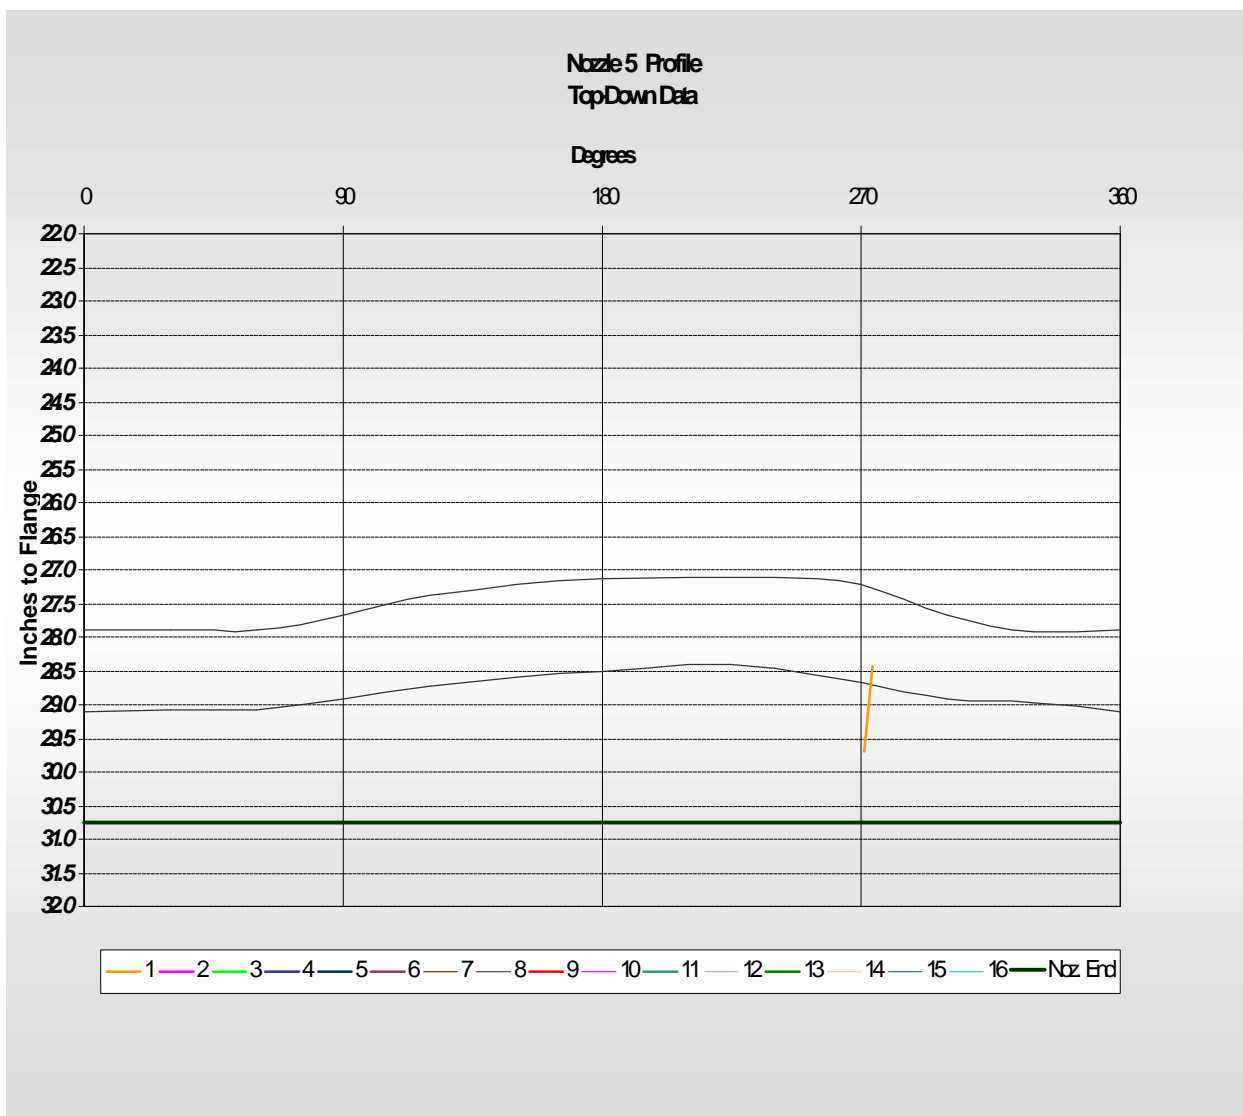
Figure 11. Nozzle 5 Crack Locations and Sizing

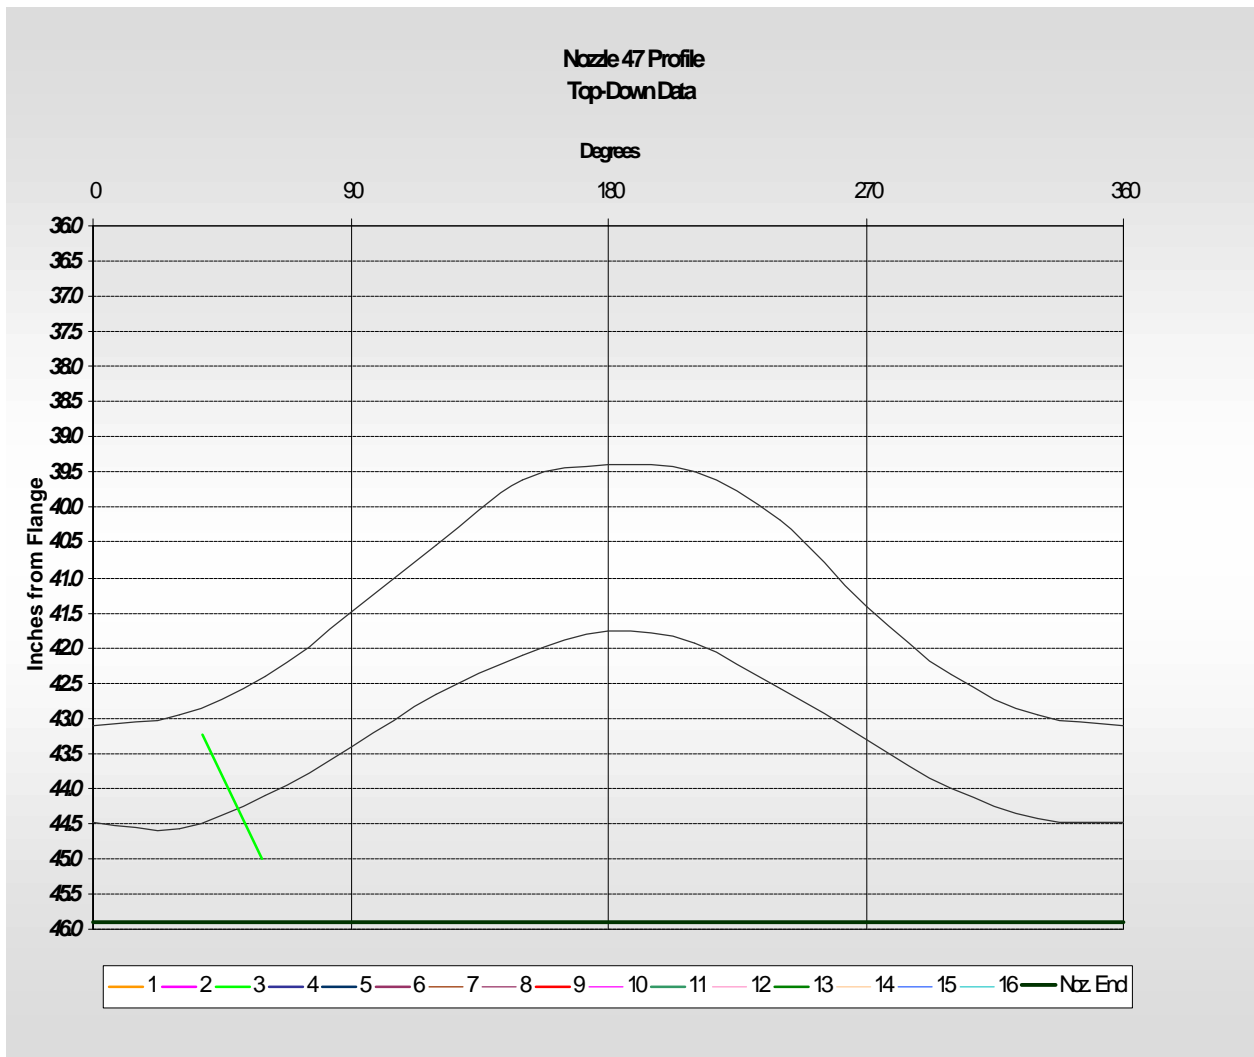
Figure 12. Nozzle 47 Crack Locations and Sizing

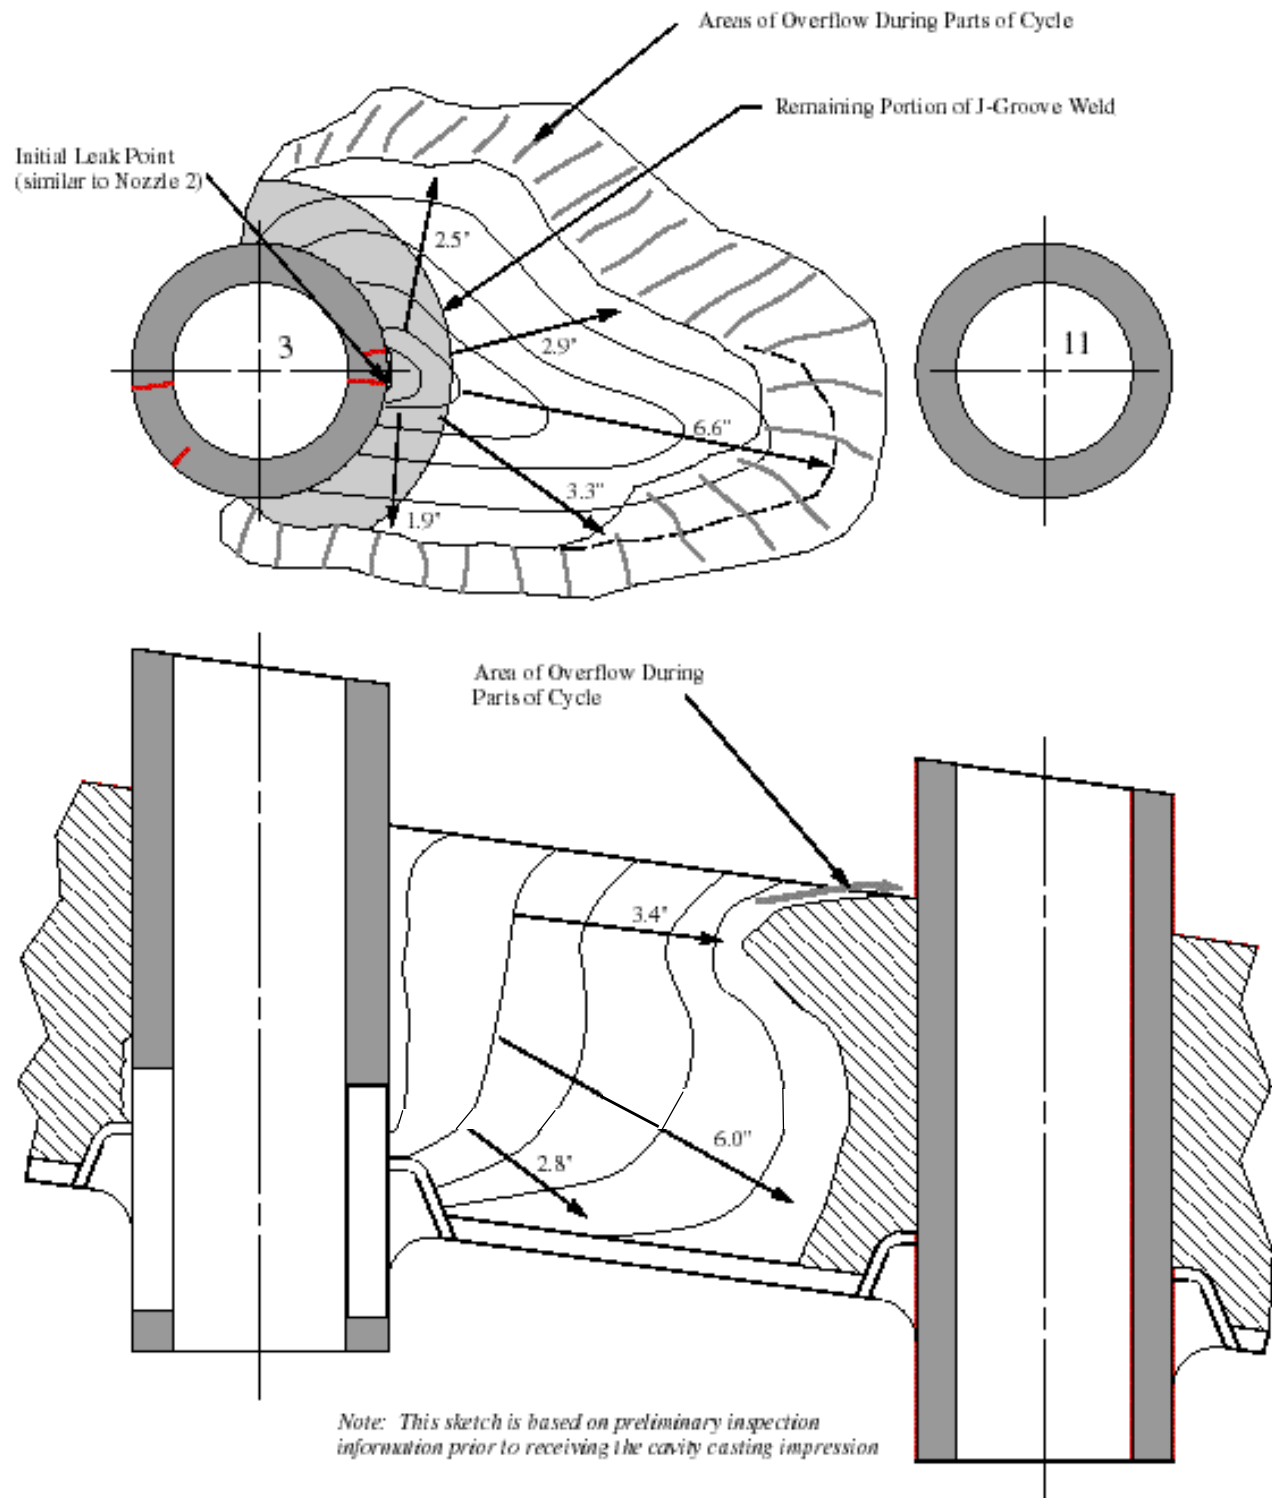
Figure 13. Characterization of Corrosion and Impingement at Nozzle N-3

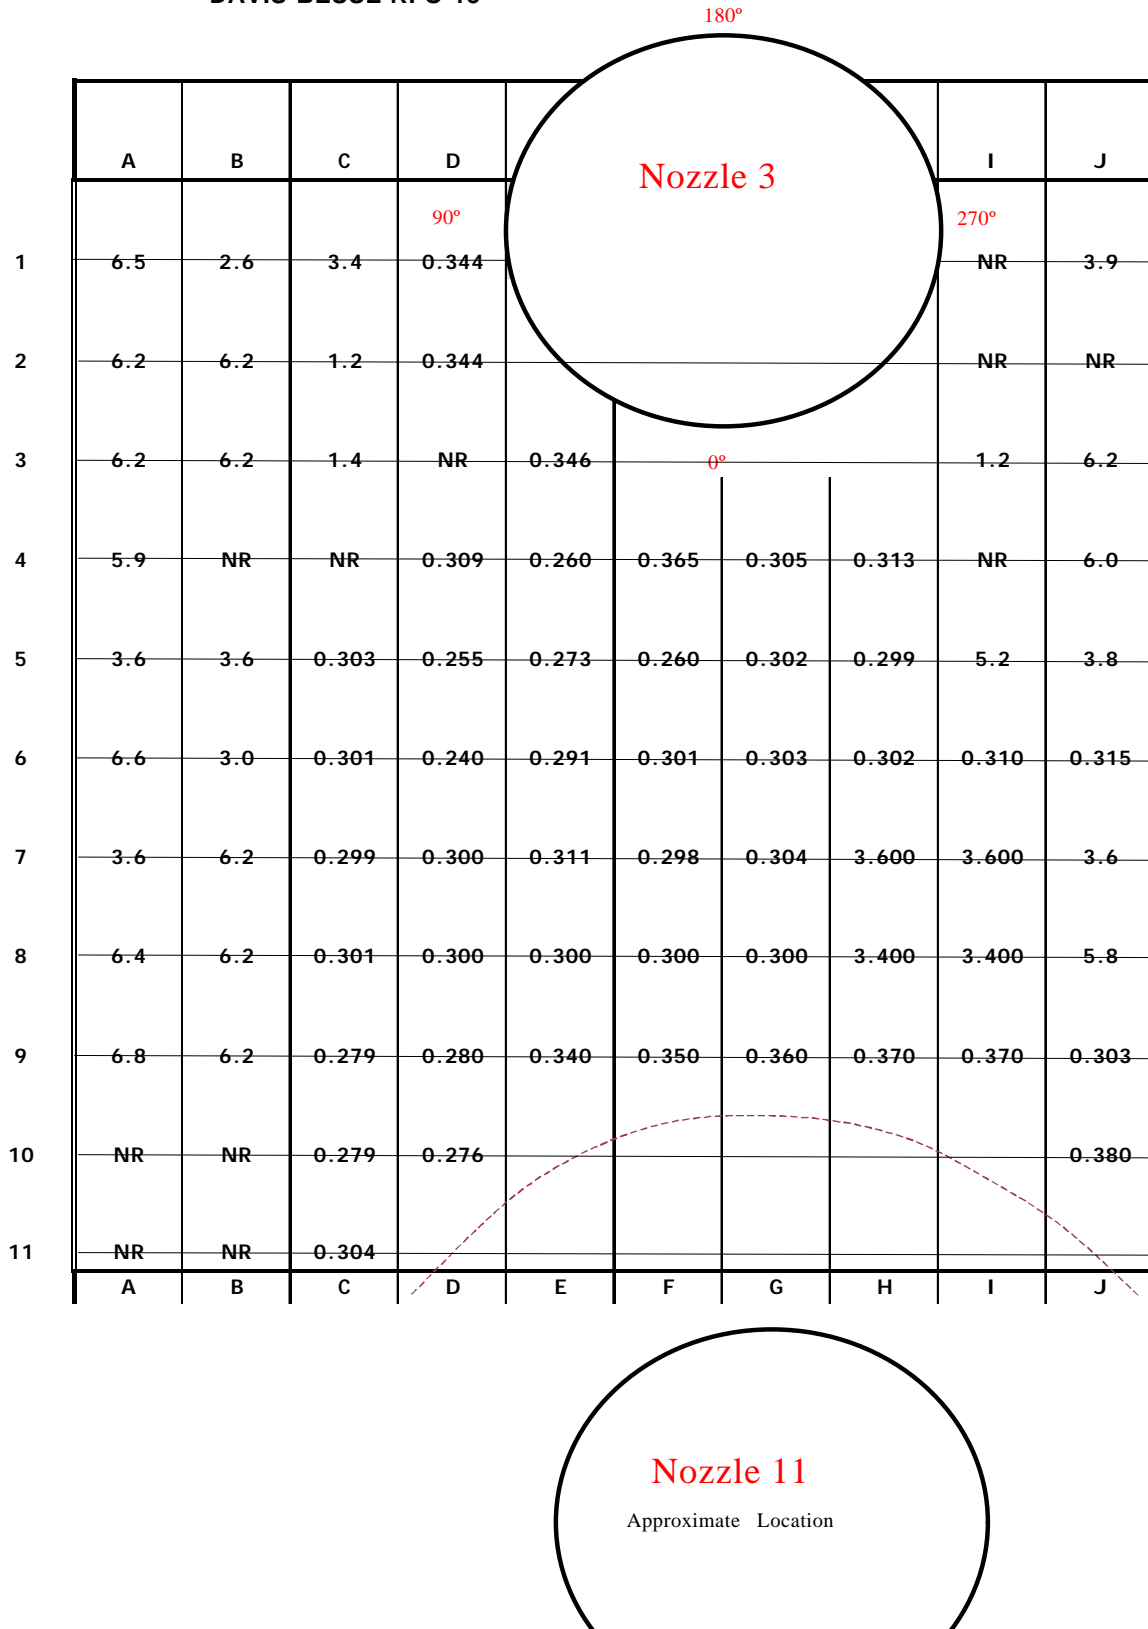
Figure 14. Nozzle 3 Clad Thickness Measurements

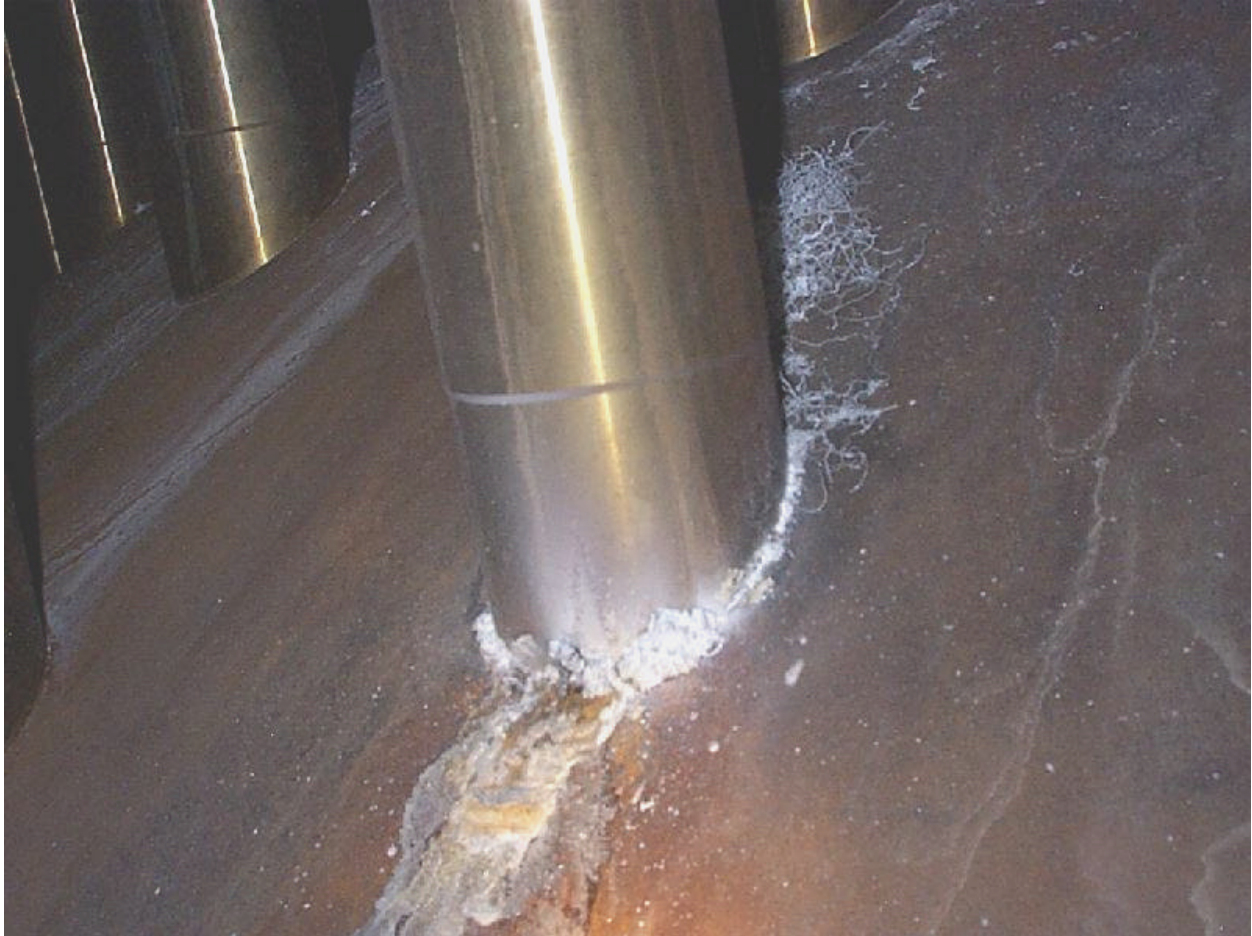
Figure 18. CRDM Nozzle Leakage Observed at Oconee 3

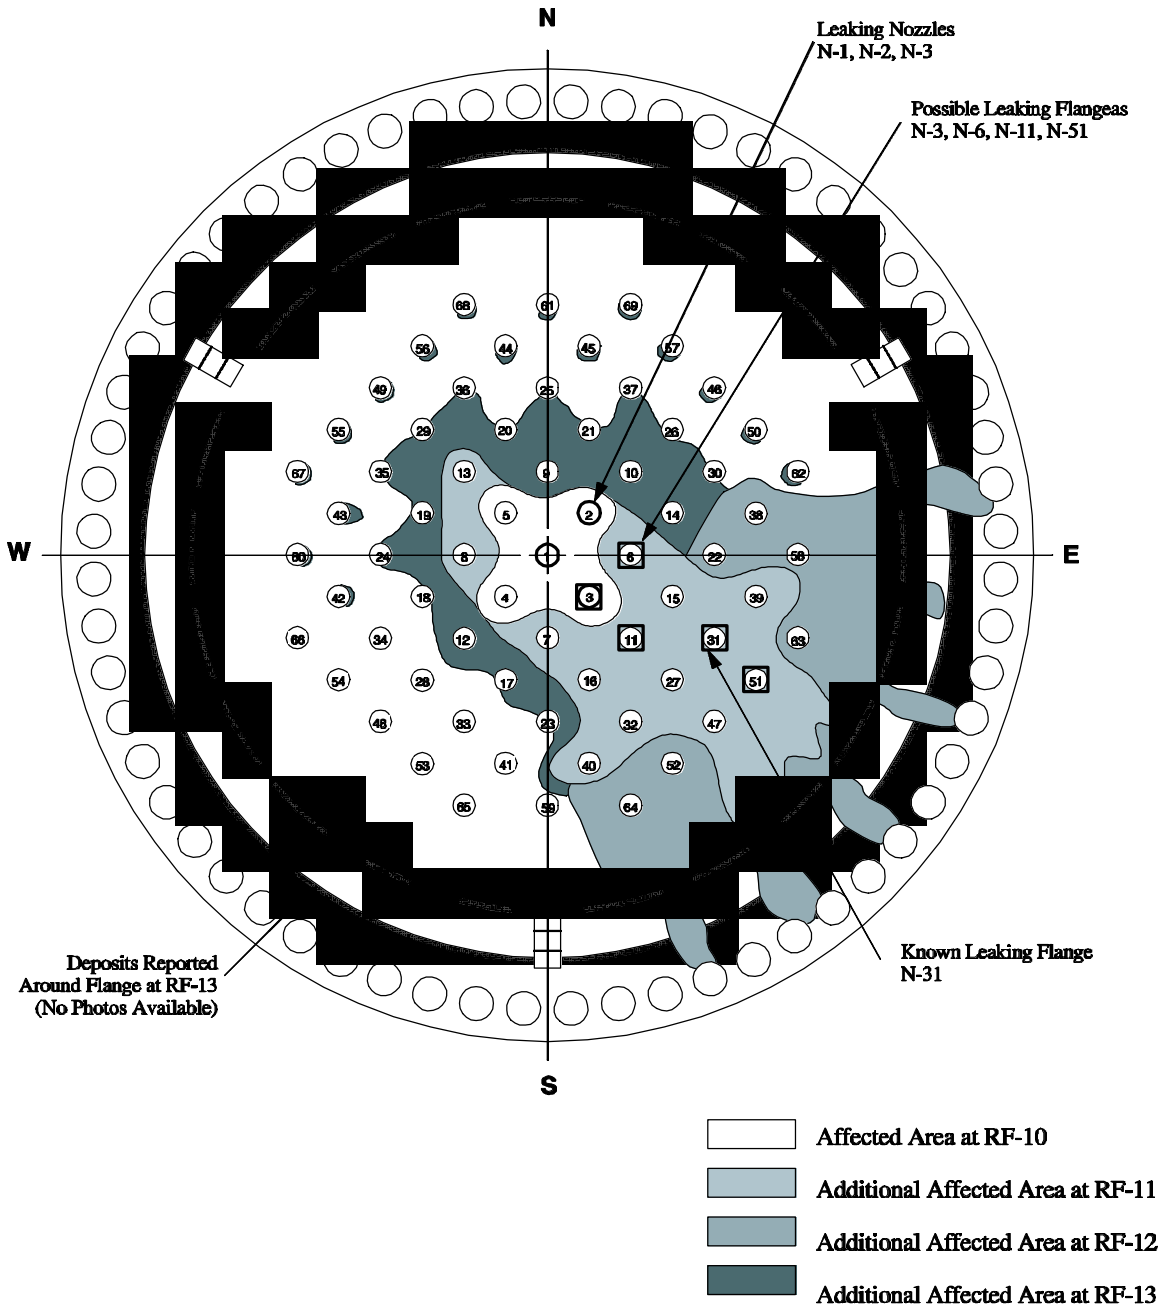
Figure 20. As Found Locations of Boric Acid Deposits on Davis-Besse Vessel Head (10RFO to 13RFO)

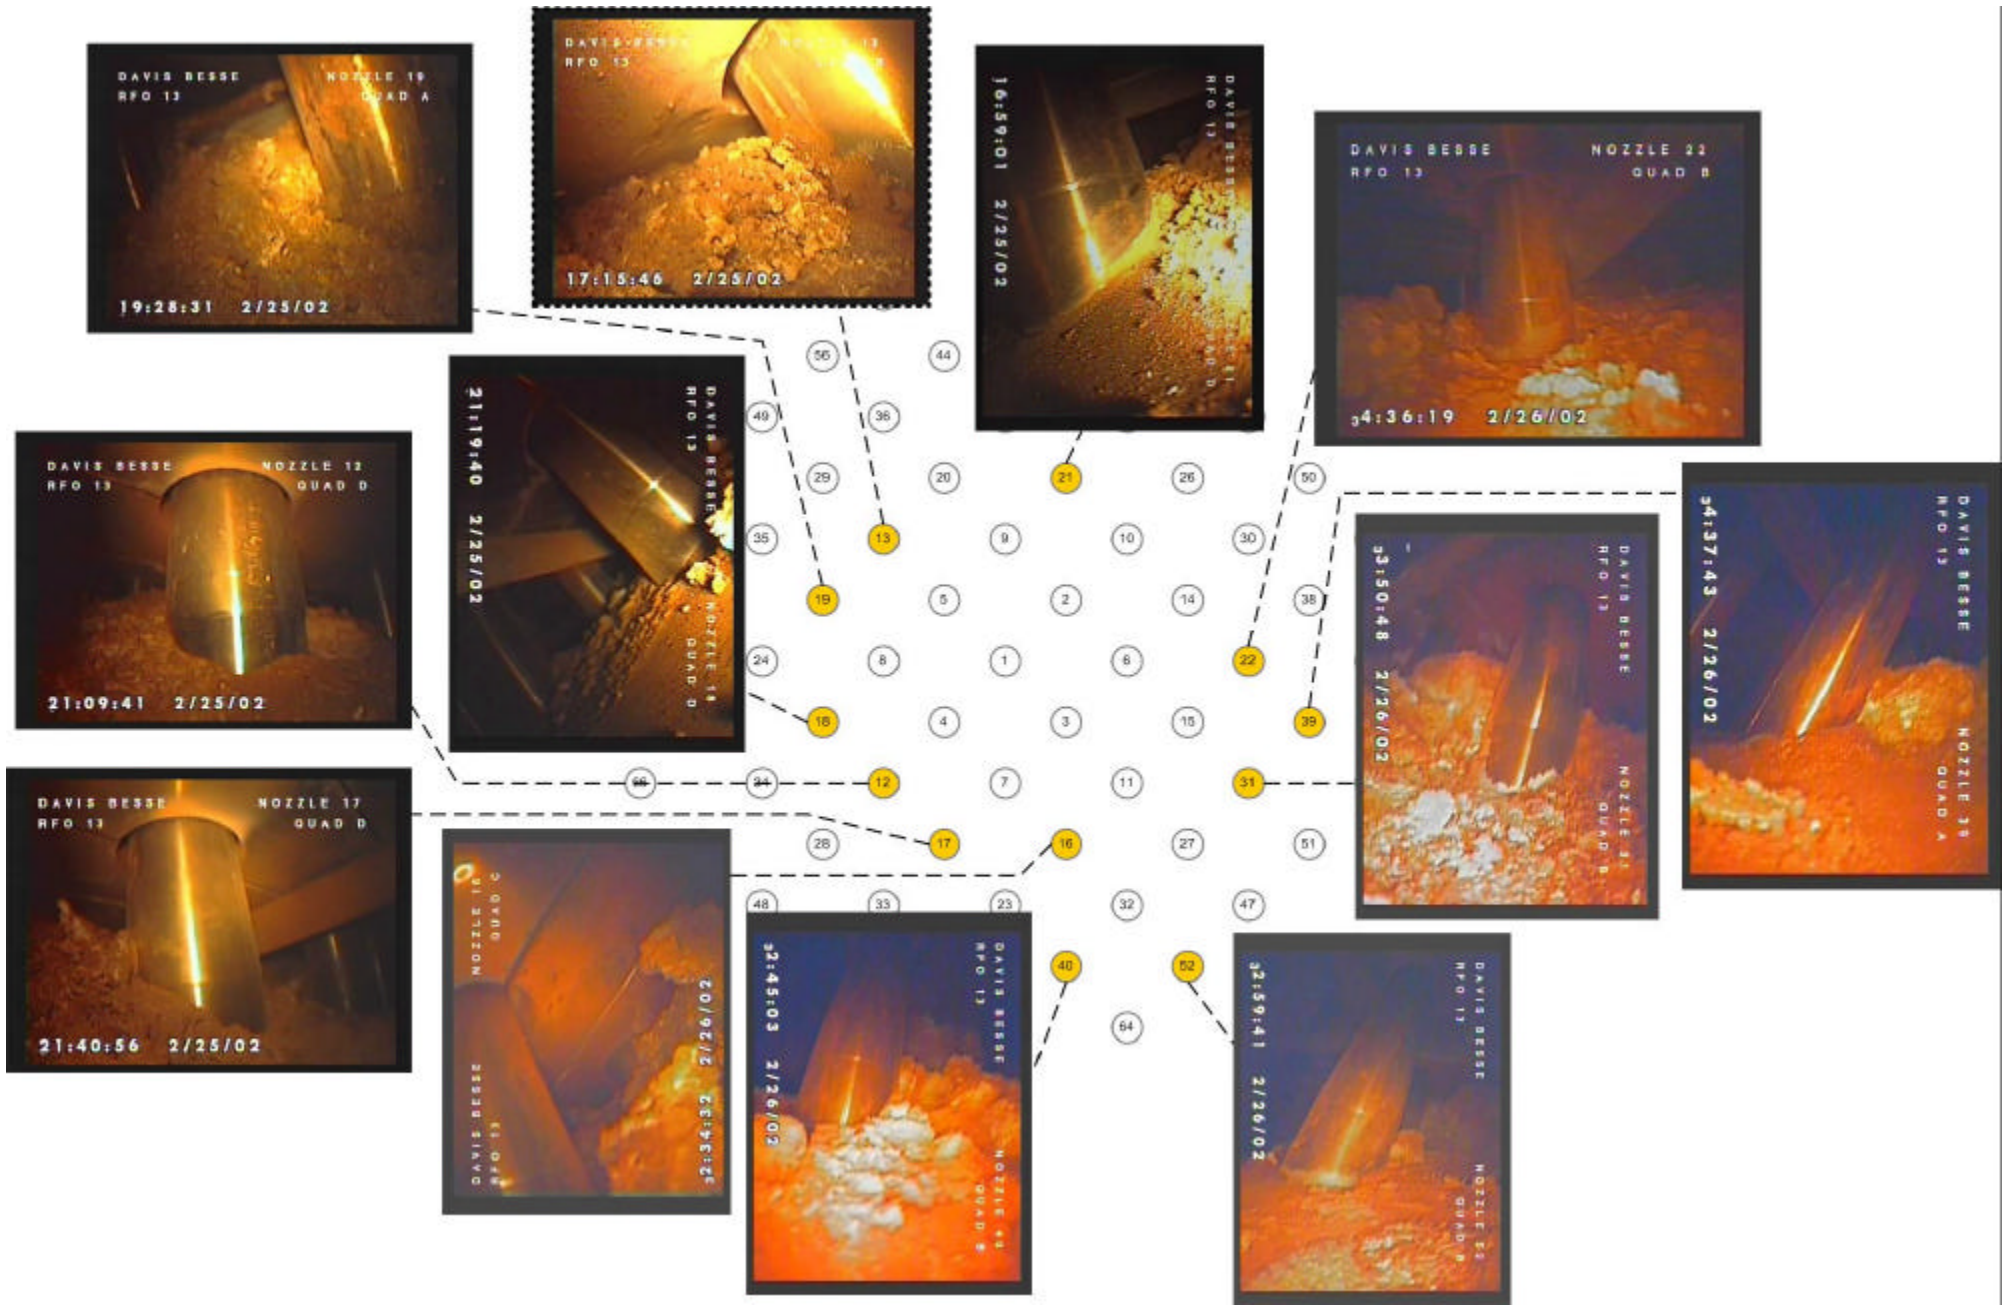
Figure 24. Boric Acid Deposits on Top of Head at Start of 13 RFO

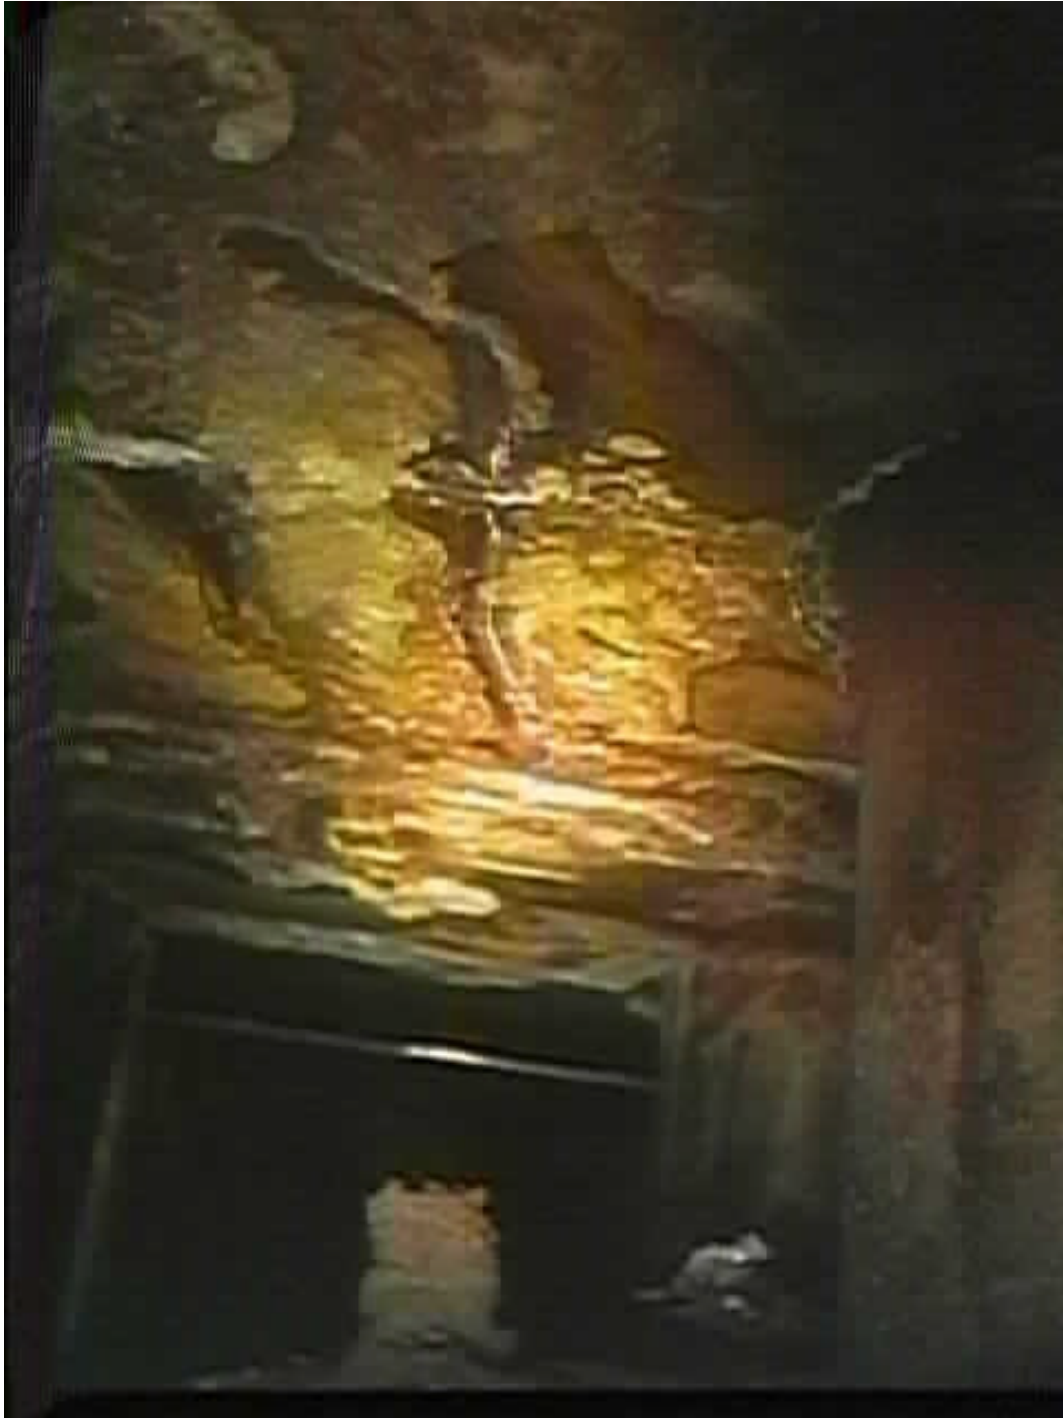
Figure 29. Flange Leakage with Stalactite Formation from Insulation and Stalagmite Formation on top of Reactor Vessel Head (8RFO)
