Figure 1. Davis-Besse RPV Top of Head Section View

Figure 7. Locations of Cracks and Corrosion on Davis-Besse RPV Head at 13RFO

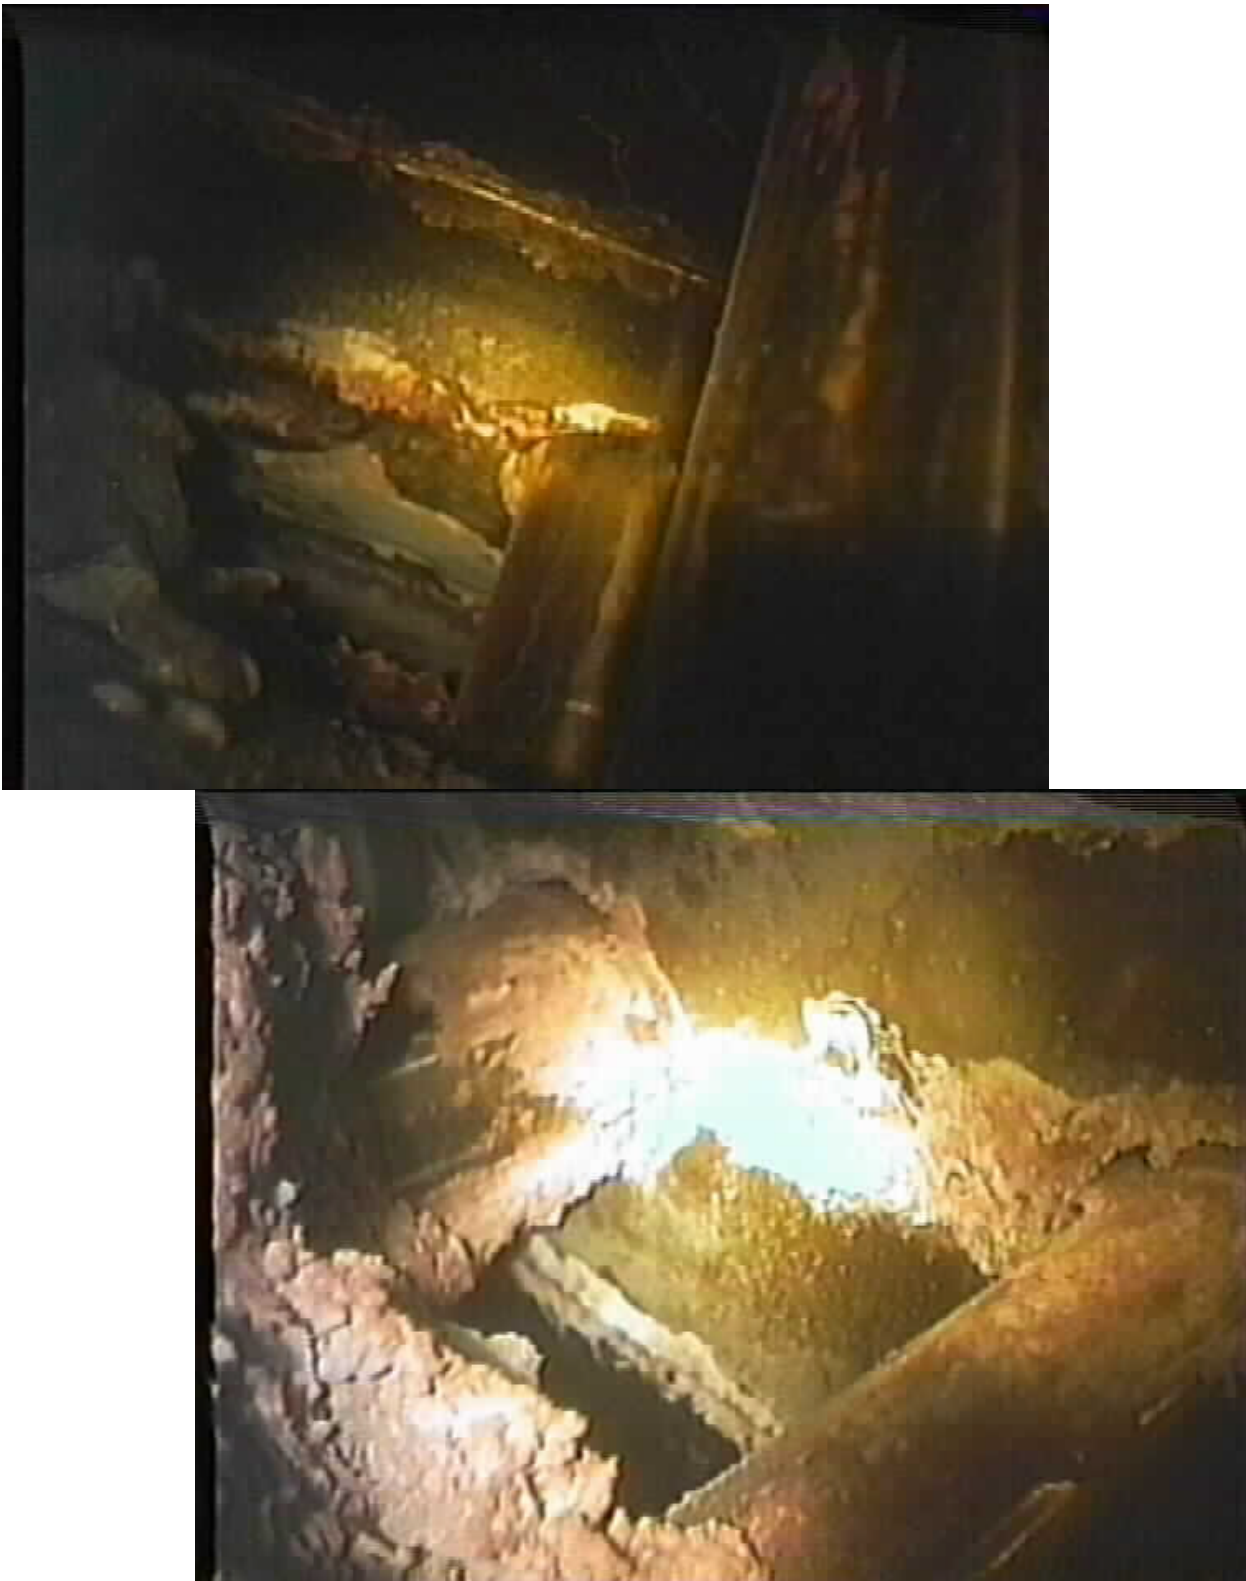
Figure 30. Flange Leakage Crusted On Side of Nozzles and Stalactites from Gaps in Insulation (8RFO)

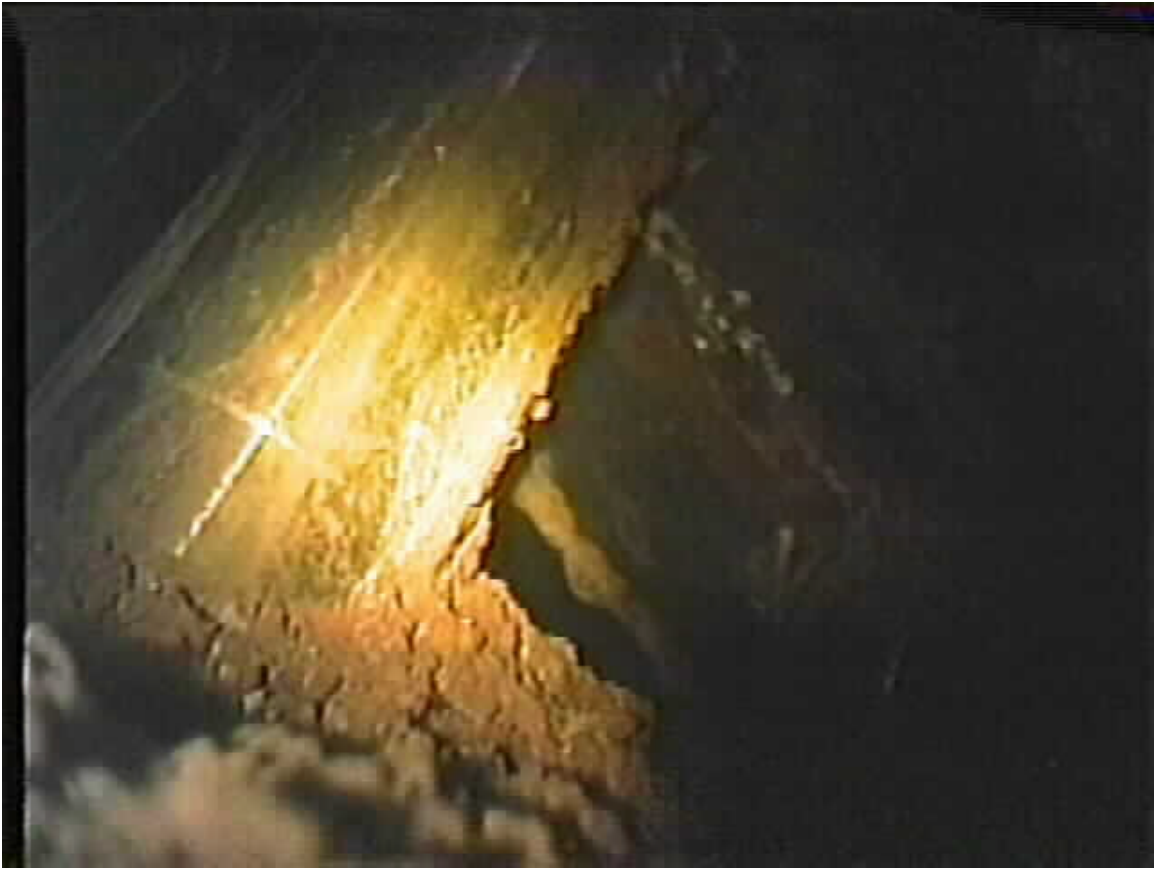
Figure 31. Reddish Brown Boron Deposits Crusted on Side of Nozzle (8RFO)

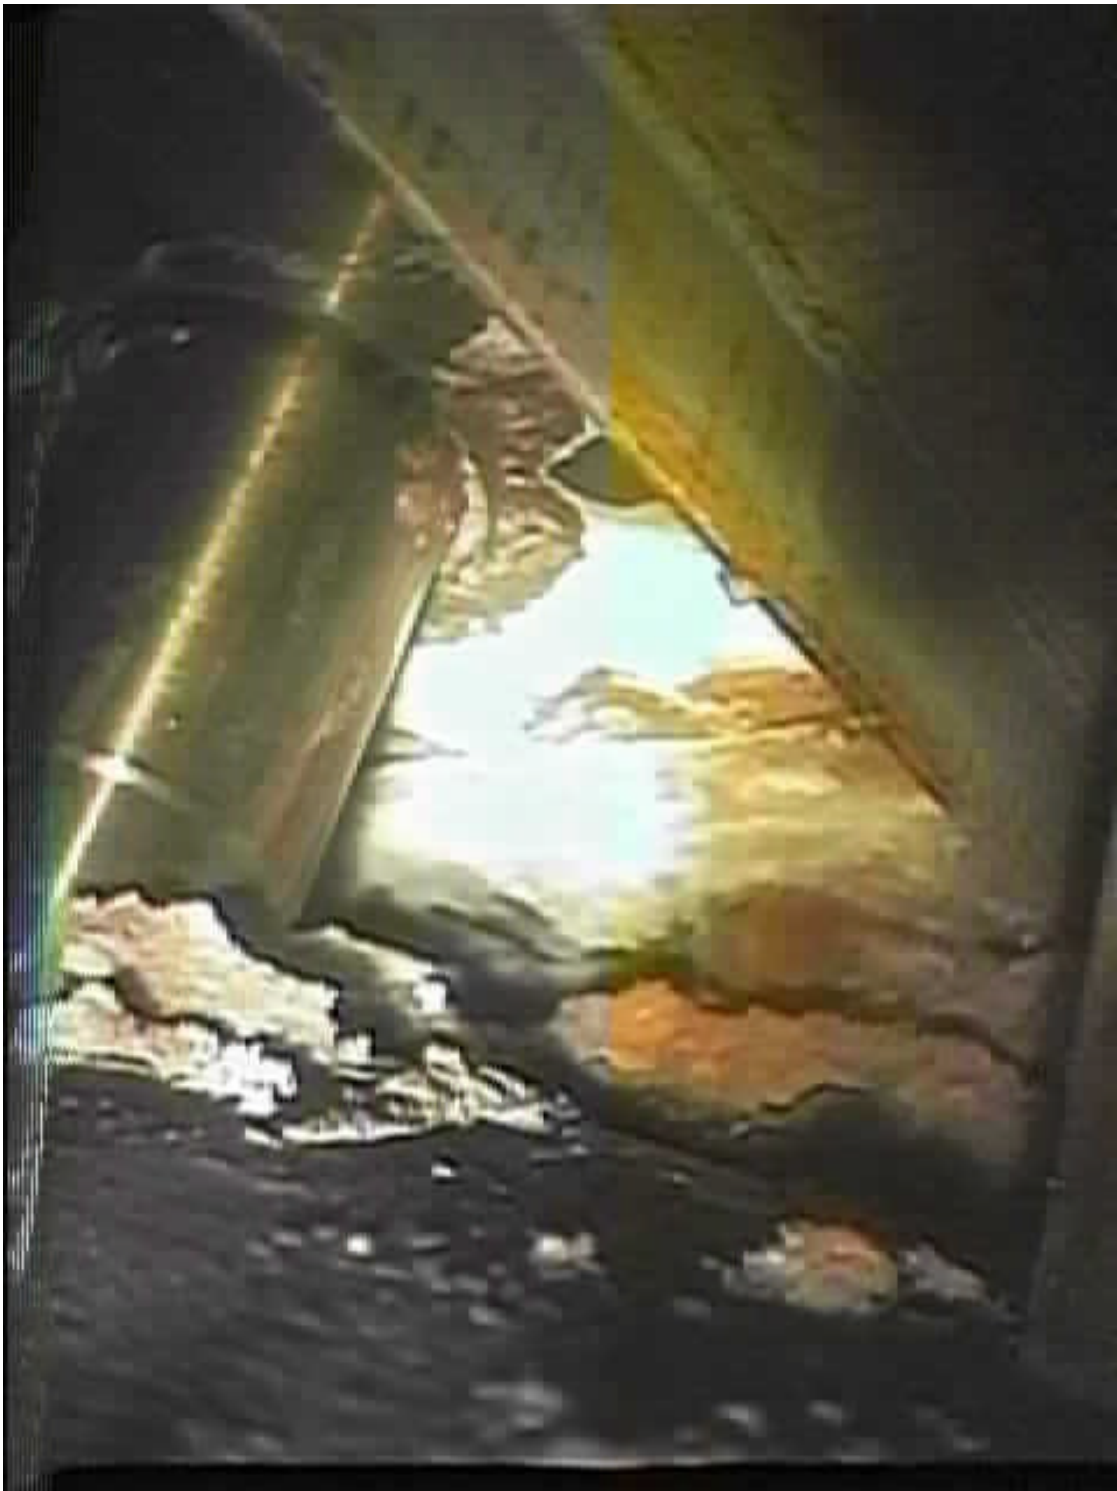
Figure 32. Boron Deposits – Source Unclear (8RFO)

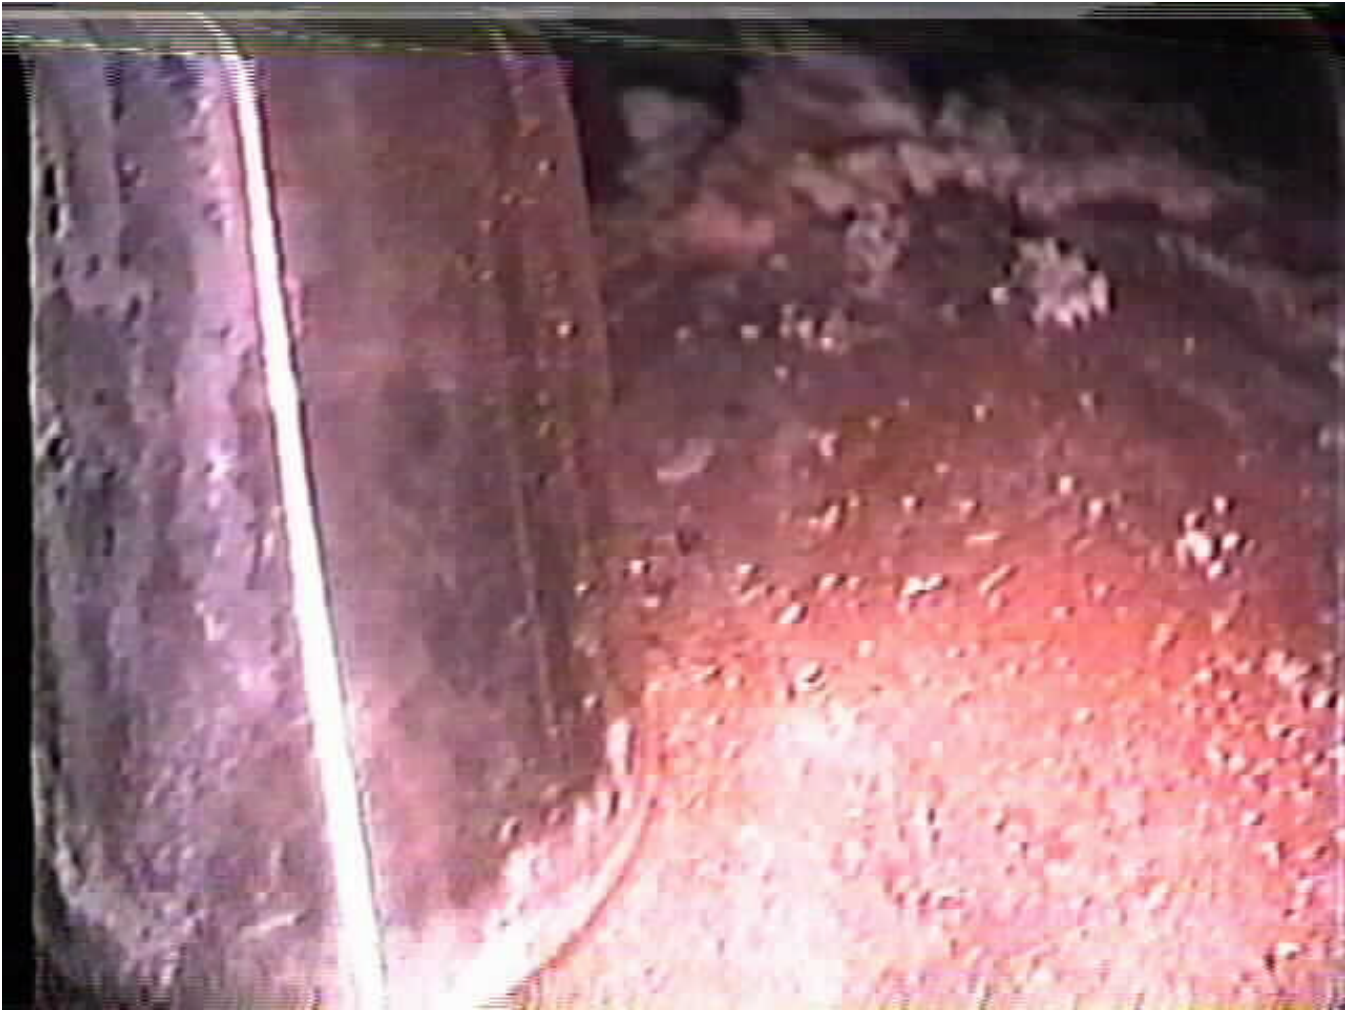
Figure 34. Boron Deposits Near Top of Reactor Vessel Head (10RFO)

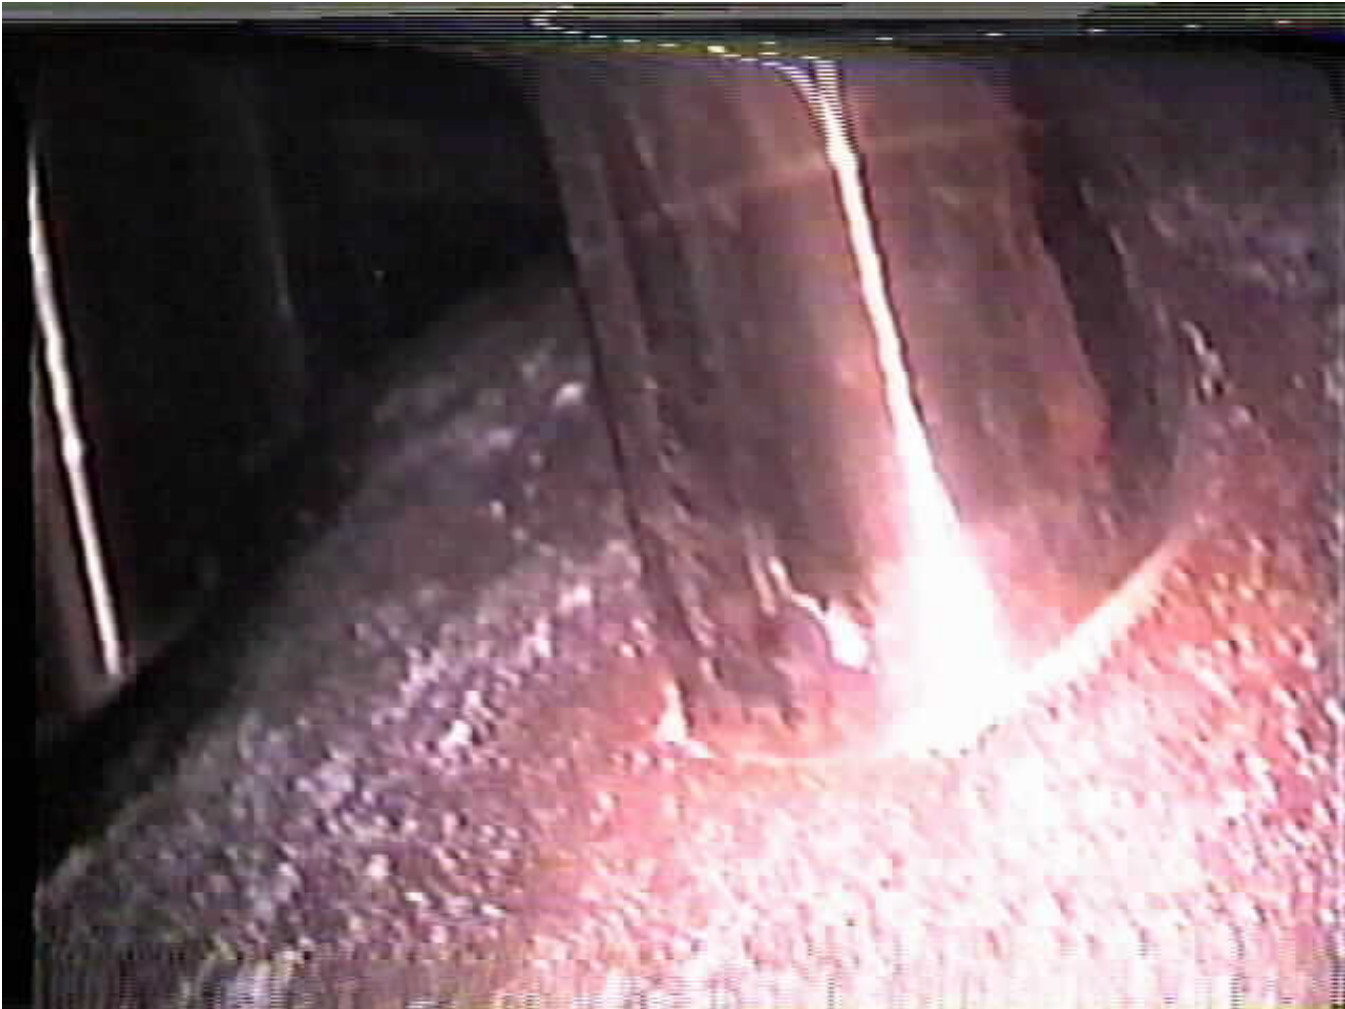
Figure 35: Typical Deposits for Periphery (10RFO)

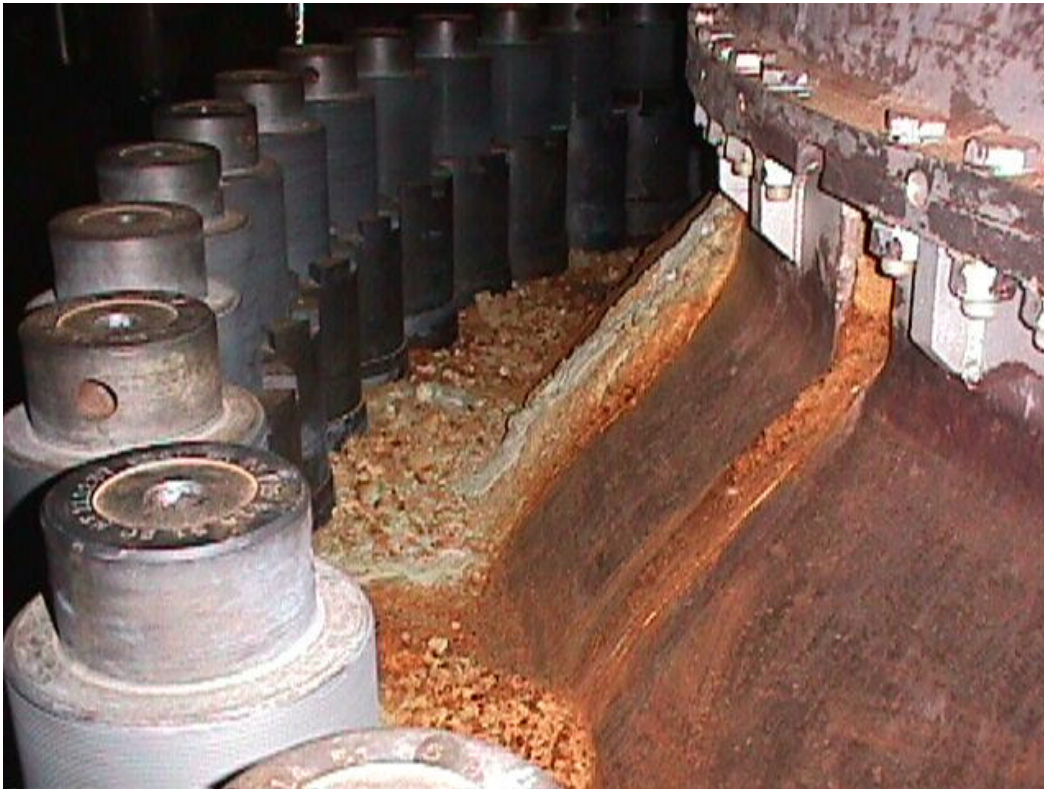
Figure 36. Red Rusty Boric Acid Deposits on Vessel Flange (12RFO)

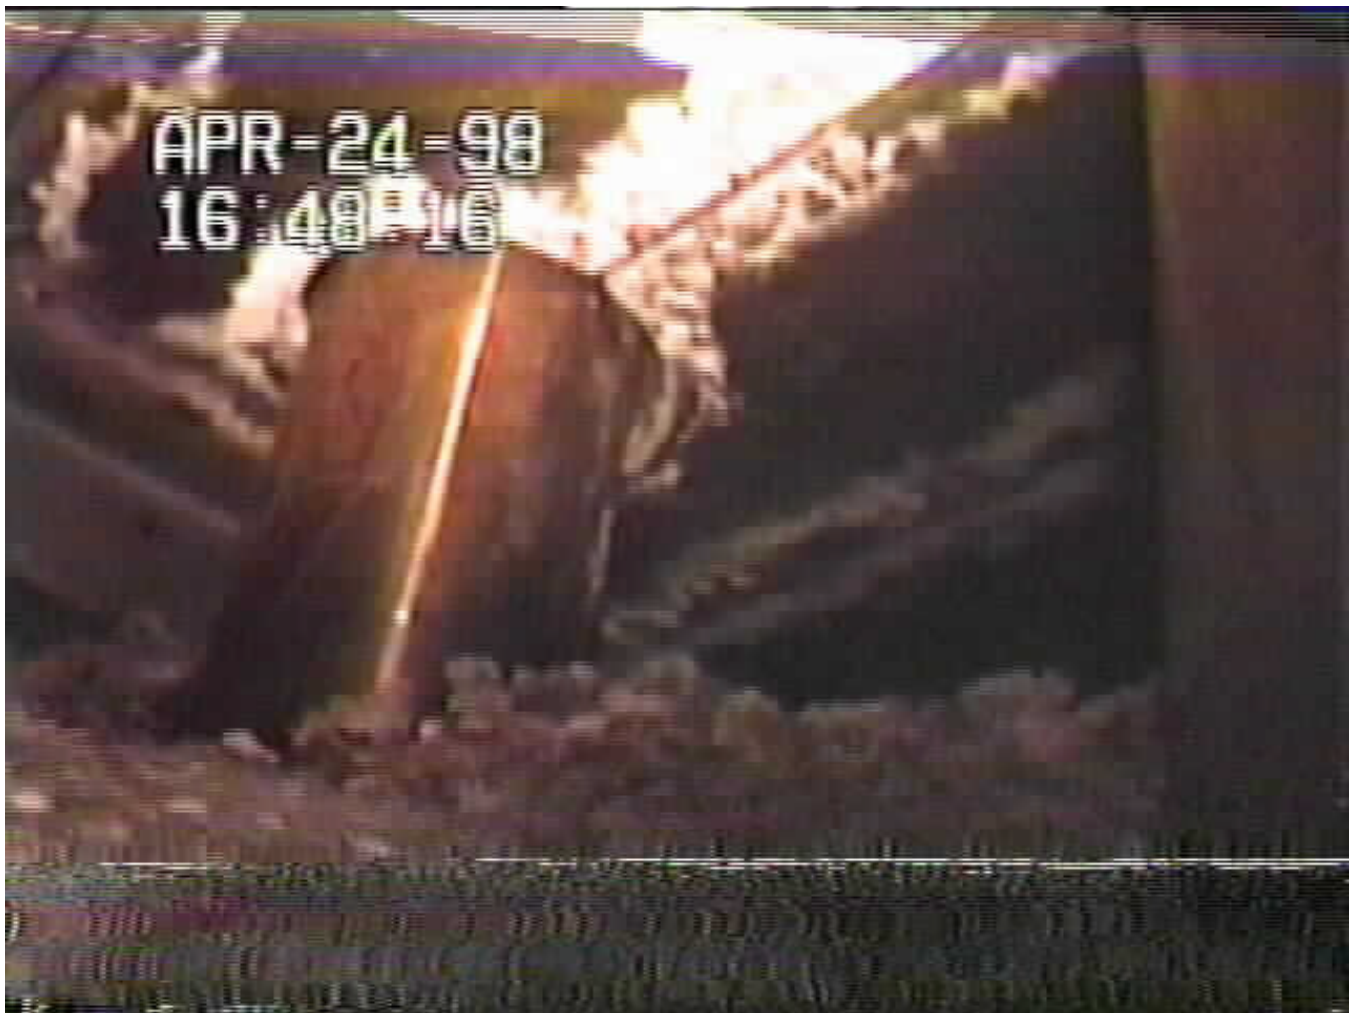
Figure 37. Boron Piled Under the Insulation (11RFO)

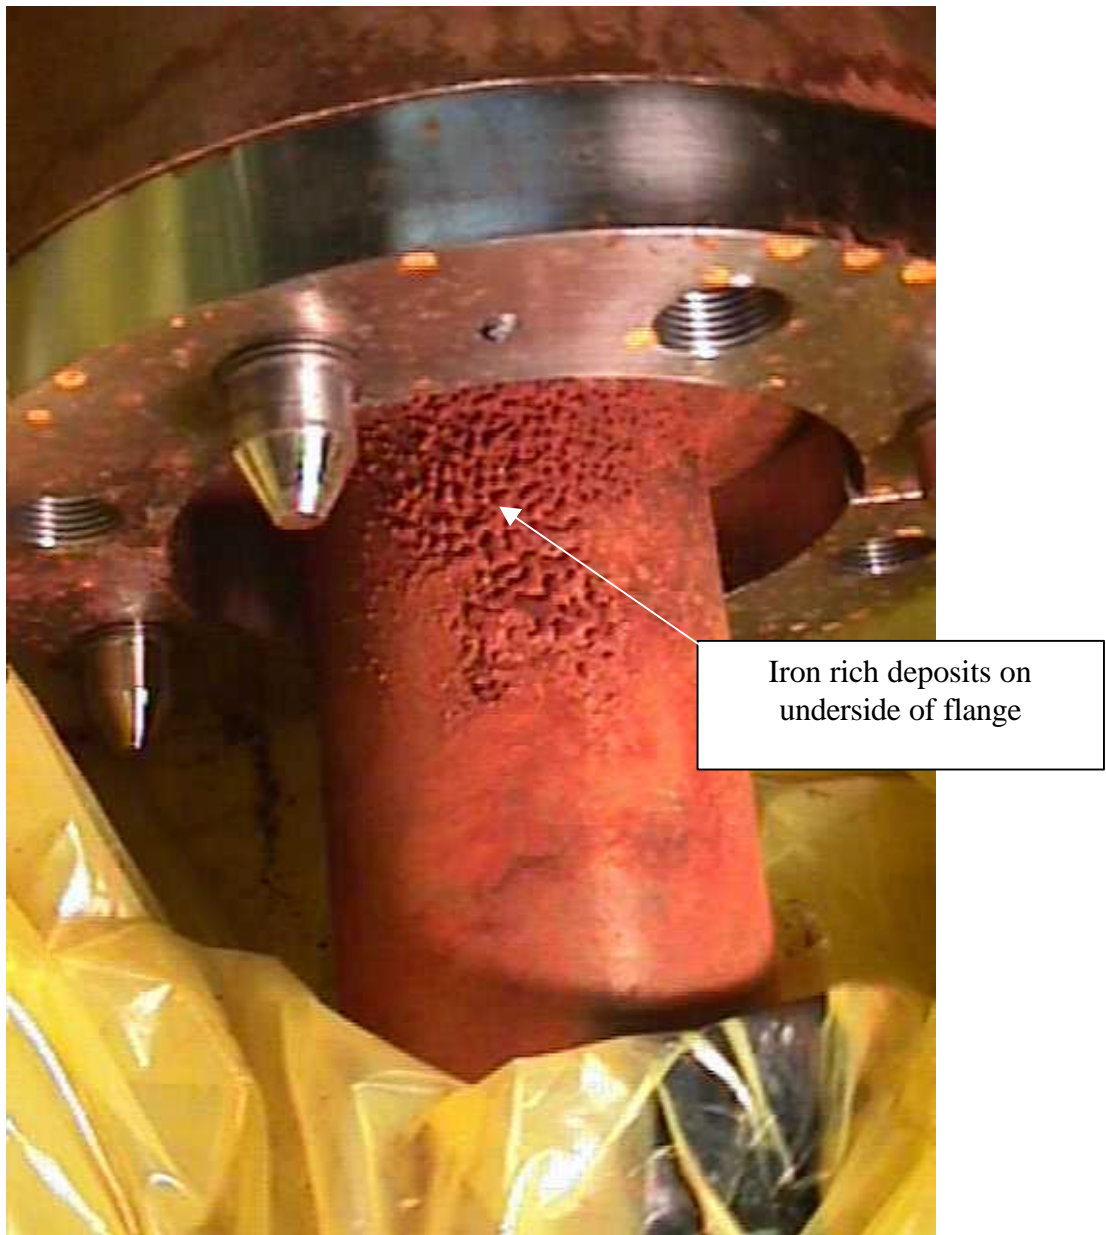
Figure 38. Boric Acid Deposits with Heavy Iron Concentration on Underside of Nozzle 3 (13RFO)

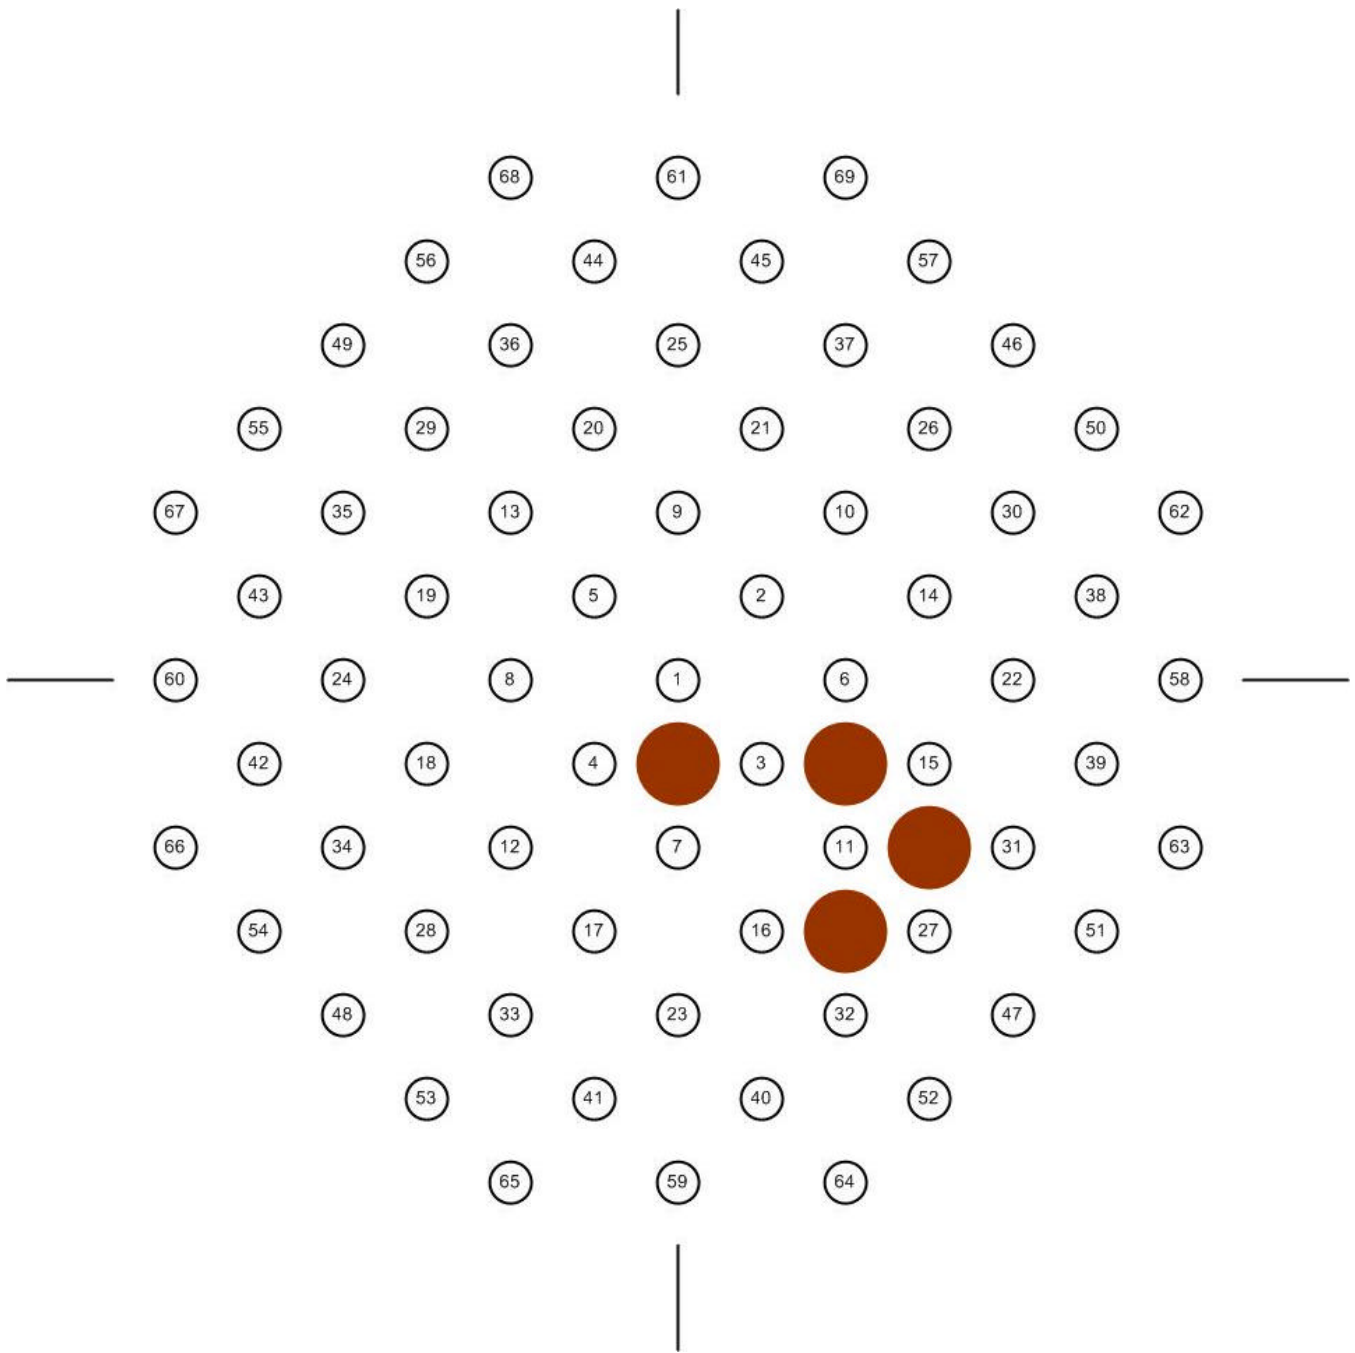
Figure 39. 2000 Interferences with CRDM Flange Inspection
