R-00-01

CANAL-LINING DEMONSTRATION PROJECT 2000 SUPPLEMENTAL REPORT

January 2000

**U.S. DEPARTMENT OF THE INTERIOR
Bureau of Reclamation**

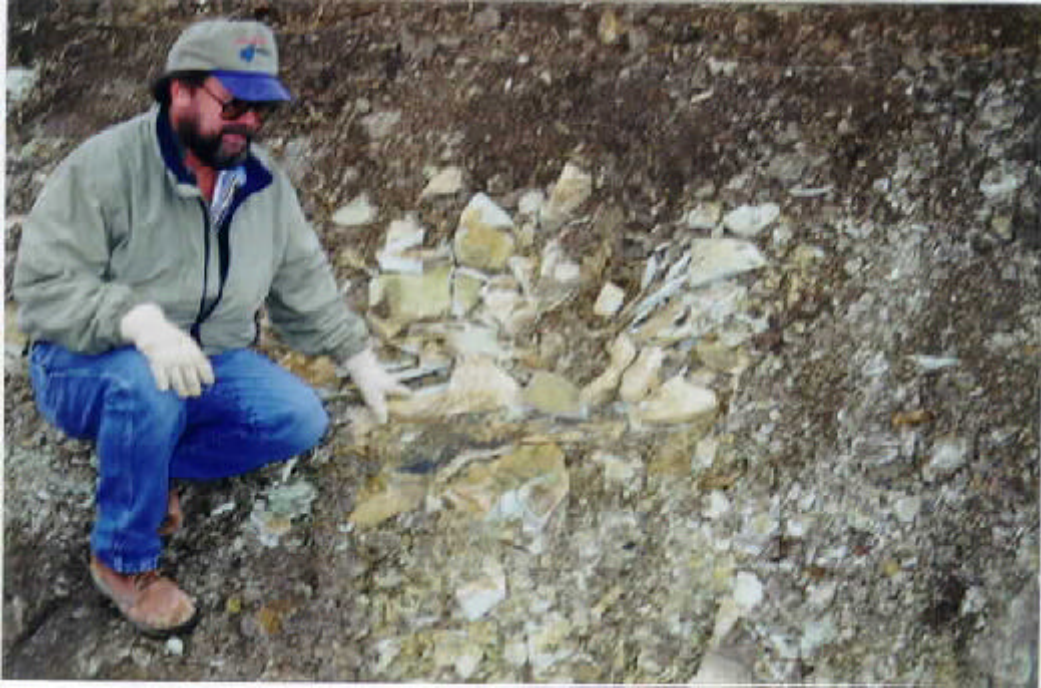
Photograph 3.—Deposits of Ochoco “Tuff” are most prevalent on the sideslopes.

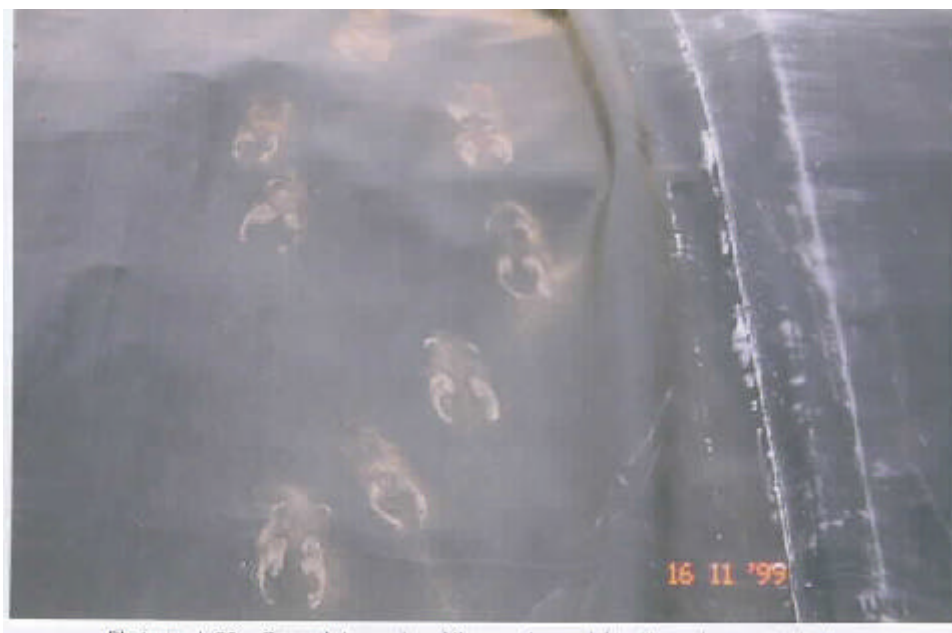
Photograph 20.—Several deer entered the canal overnight with no damage to the liner.
Also note the close-up of the vulcanized factory seam on the right.

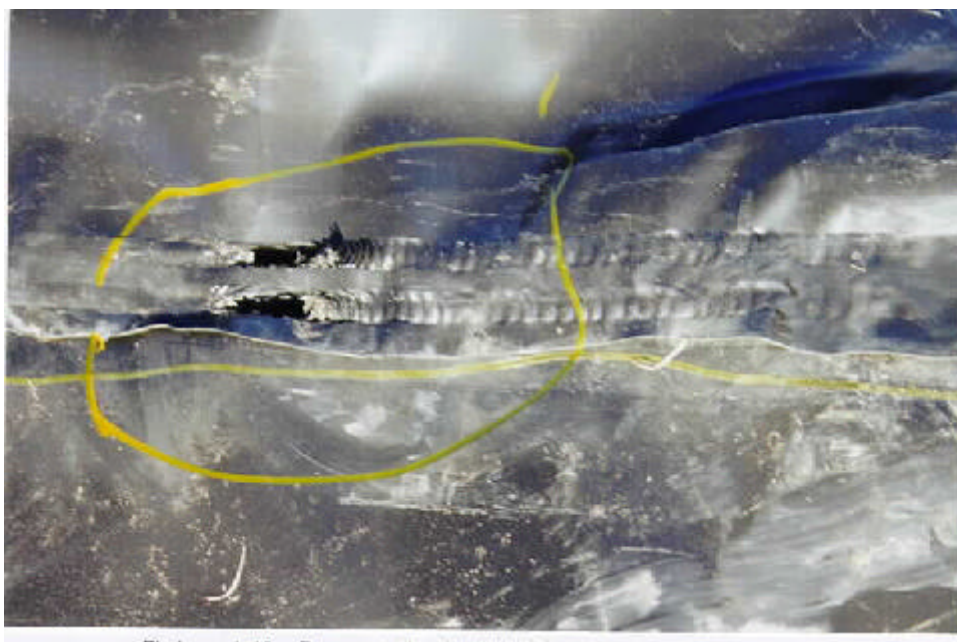
Photograph 10.—Damage to the 30-mil LLDPE caused by the wedge welder. Thicker liners are less easily damaged and easier to weld.

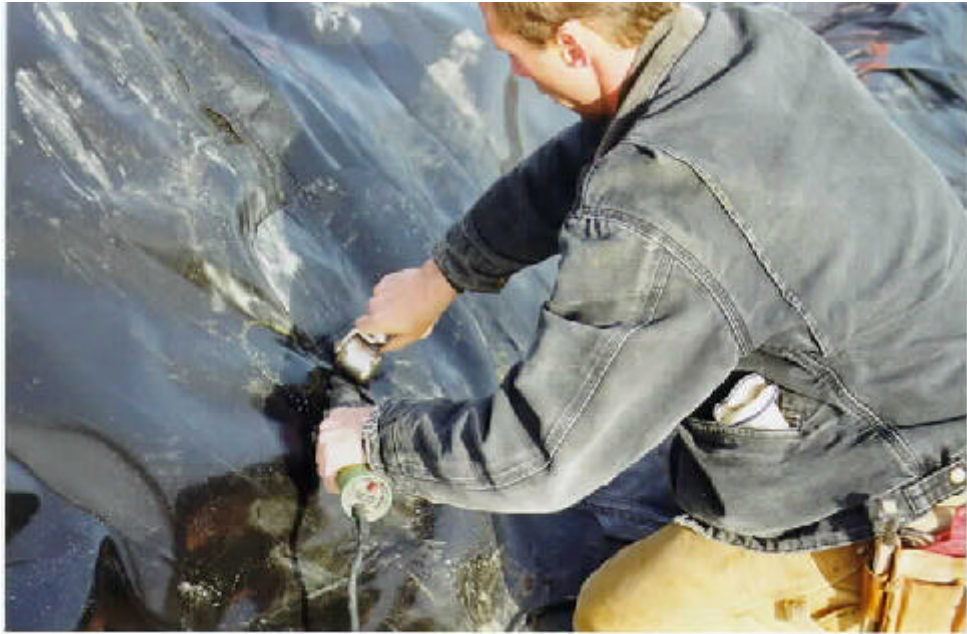
Photograph 11.—Welding technician patches the liner with hot-air welder.
