ADVISORY CIRCULAR

43-16A

AVIATION MAINTENANCE ALERTS

**ALERT
NUMBER
356**

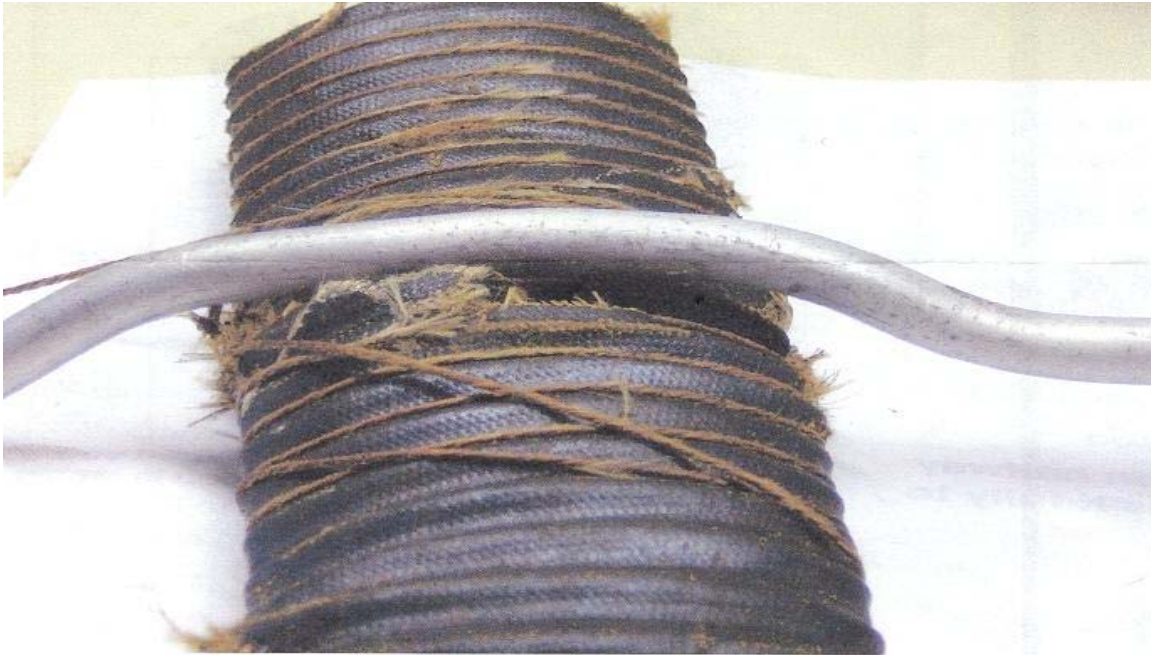
“While in process of checking the individual O2 (*oxygen*) masks during an Annual/5 year O2 bottle re-certification, I heard a very faint sound of a gas leak in the overhead (*interior paneling*) of the aircraft. It was nearly inaudible, almost disappearing when you turned your head from side to side. I began the search for the leak by pulling the O2 outlets in the suspect area, and checking the B-nuts—all were secure. The only course left to me was pulling the headliner for a closer inspection. By plumbing in low pressure nitrogen (*using for troubleshooting*) I was able to narrow down the ‘hiss’ to a line in the overhead—just forward of the cabin door which carries the O2 from the L/H side of the aircraft to the R/H side. This line is P/N 5100107-46; item 30; figure 06-40; page 1 of the Cessna 421C IPC (*internal parts catalog*). I have included a picture of the line. (At this stage of disassembly, all I could see was the B-nut on the L/H side, but by wiggling it I could (*effect and detect...*) a change in the sound of the hissing. To access this line (which passes through a structural beam in the overhead) it was necessary to drill out approximately 40 CherryMax Rivets securing a thin honeycomb panel to the overhead (*structure*). This panel is about 9 feet long by 18 inches wide, running the length of the aircraft cabin. Above this panel are the Scat ducts (P/N F229900) that supply the cabin Wemacs (*duct/vents*). (These ducts are made like Scat but have an oval cross section.) With the honeycomb panel and insulation bats removed I was able to extract this O2 line (P/N 5100107-46). This line as pictured has been cleaned up, and the products of corrosion removed for clarity. The corrosion on the ‘humps’ of the line occurred where the ducting passed under it. The ducting was removed to facilitate line removal, and was found to be totally deteriorated. The picture I included is a typical example. It pretty much exploded in a cloud of fibers and rusted wire when removal was attempted. The spiral wound wire supporting the duct was completely rusted to fragments. It came out in small chunks—(*I estimate 30 feet of ducting*). Everywhere this ducting touched an O2 line there was products of corrosion. Some very light—some like the line (*pictured*). These lines were replaced by new parts from Cessna where required, and all the Wemac flex ducting was replaced with new.

This is how the LINE LAYS ON
The ducting. It is inside a beam
& can't be seen. The LINE AS AN
ASSY LOOKS LIKE THIS.

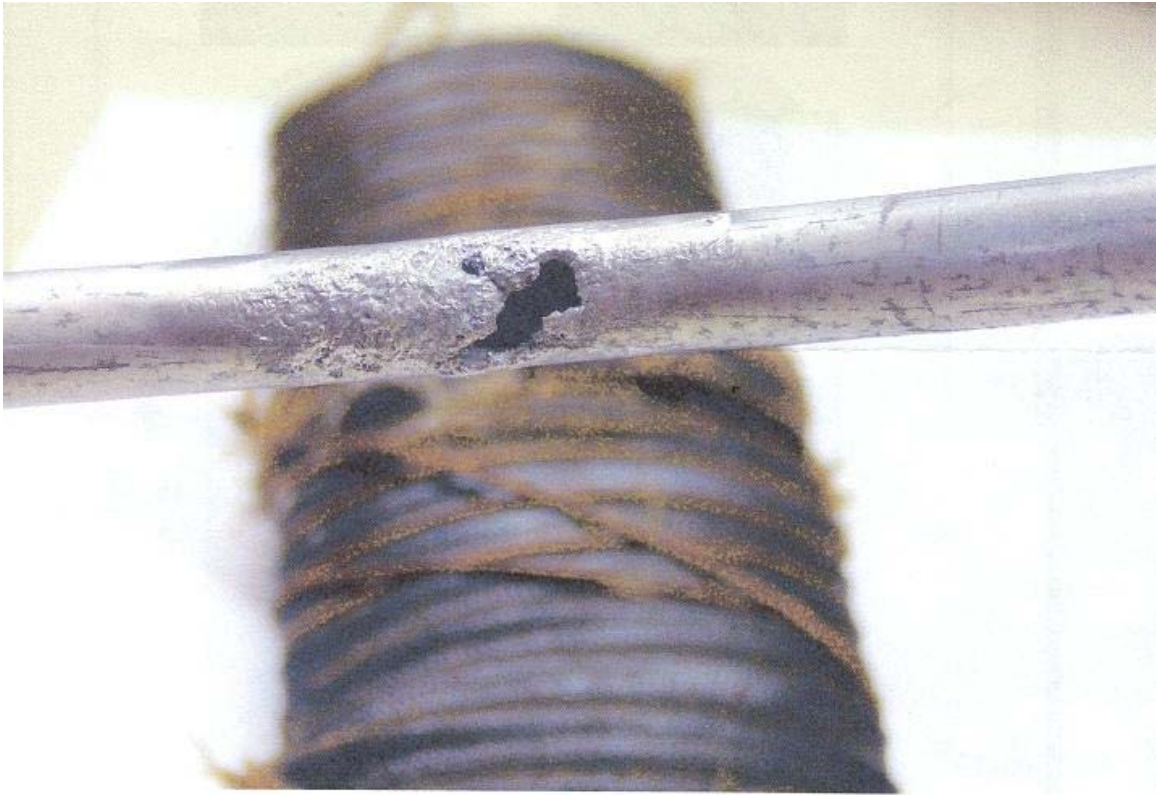
corroded O2 line

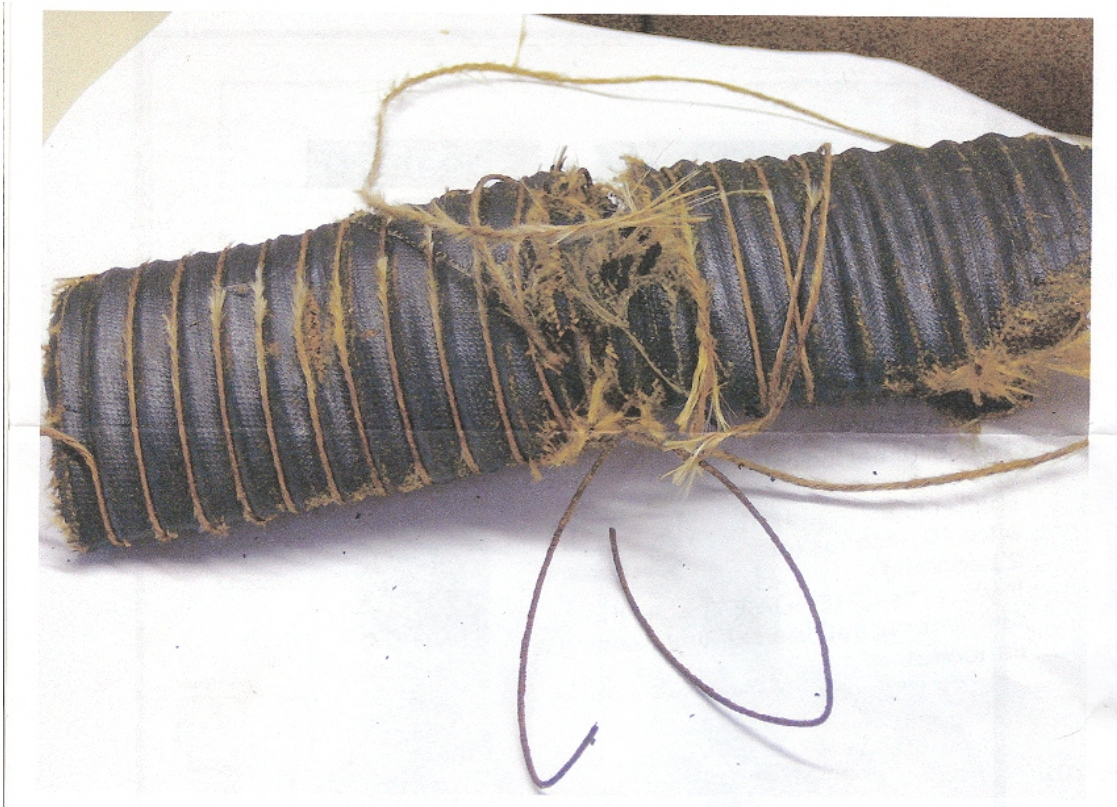
looking at the lower portion of
the "Hump"

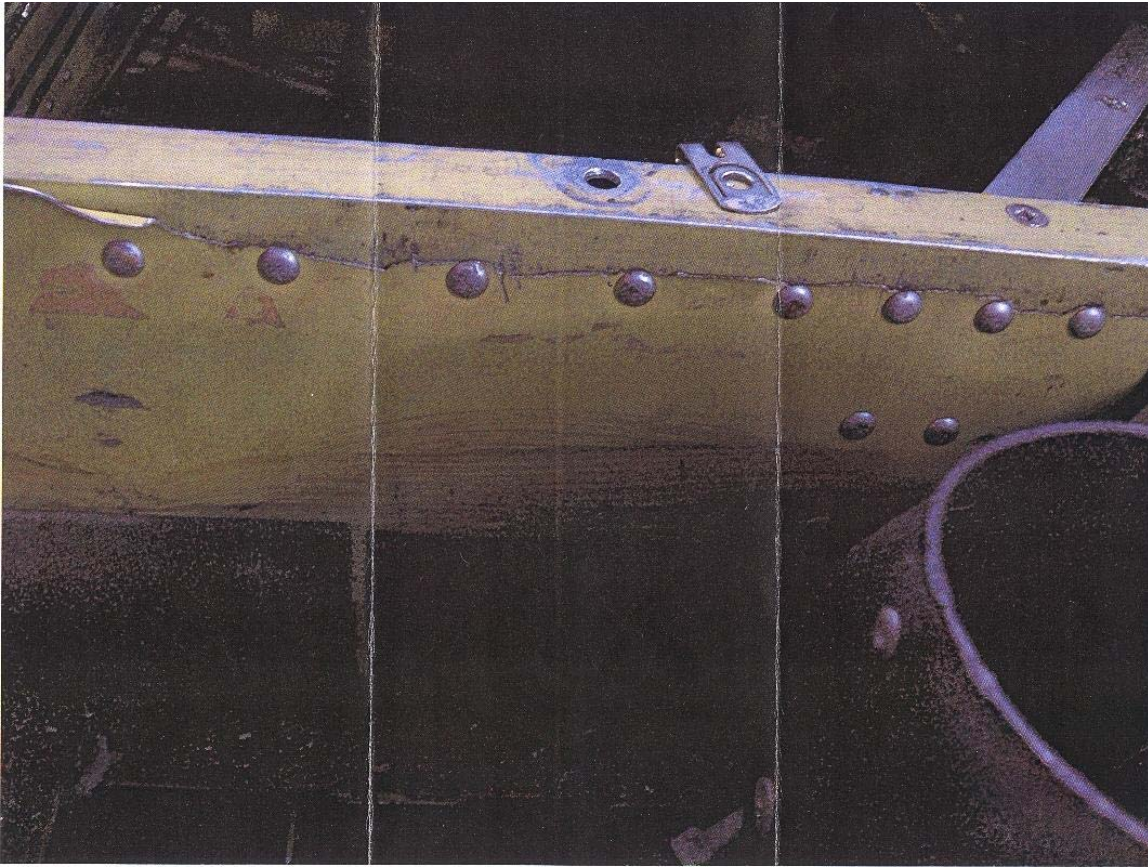
A repair station technician writes, “The cabin floor support web is cracked and broken at fuselage station 151...found during a phase inspection.” *(The submission includes a note indicating he was having trouble finding the part number for this item in the parts catalog. That’s okay—look at the crack he found!)*

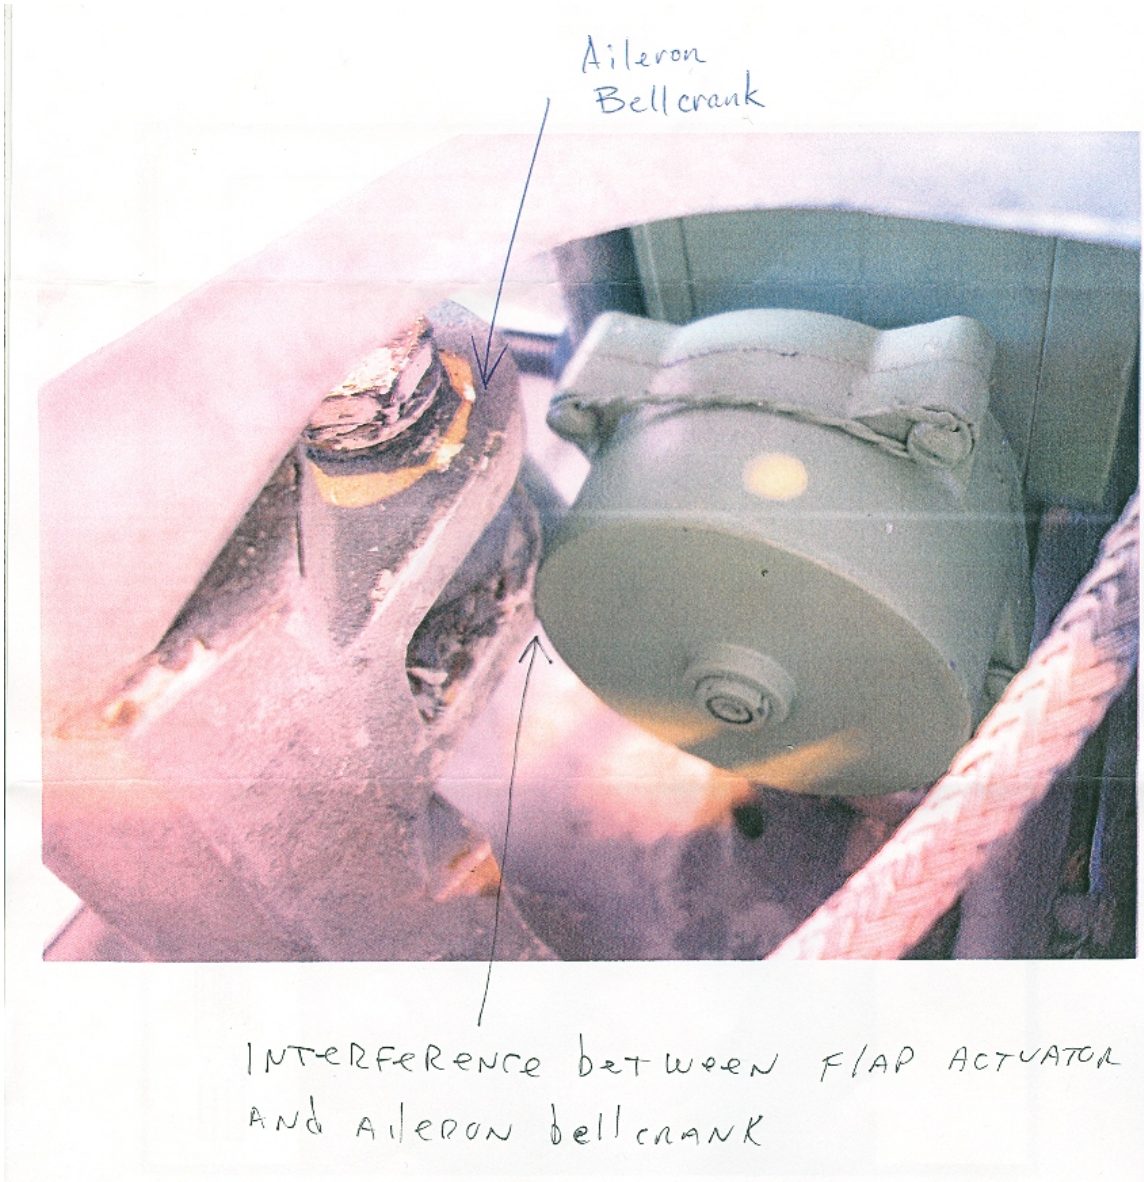
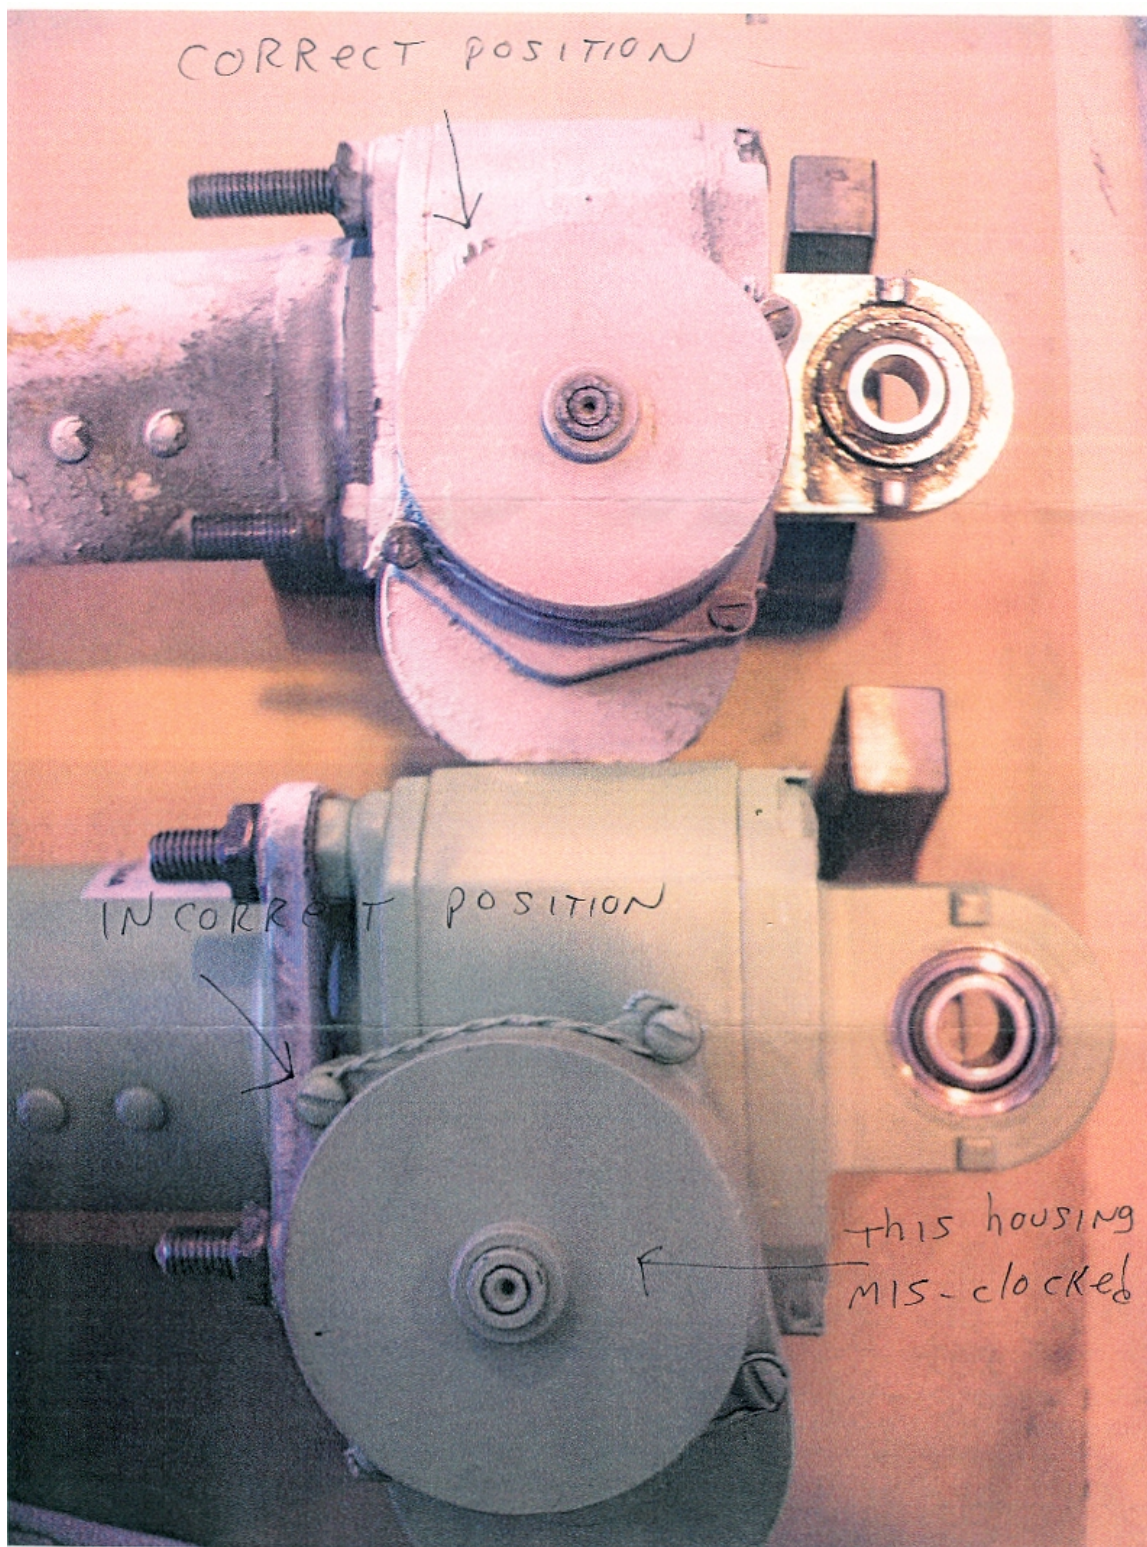
A technician for a repair station writes, “(I) installed a rebuilt flap actuator in the R/H outboard position (P/N 1391T100-8). Flap operation (*subsequently*) was normal. While checking aileron travel it was discovered the aileron (*movements*) were limited by the rebuilt flap actuator. A cover plate on the flap actuator had been indexed incorrectly and was interfering with the aileron bell crank. Probable cause: incorrect assembly of the flap actuator.”

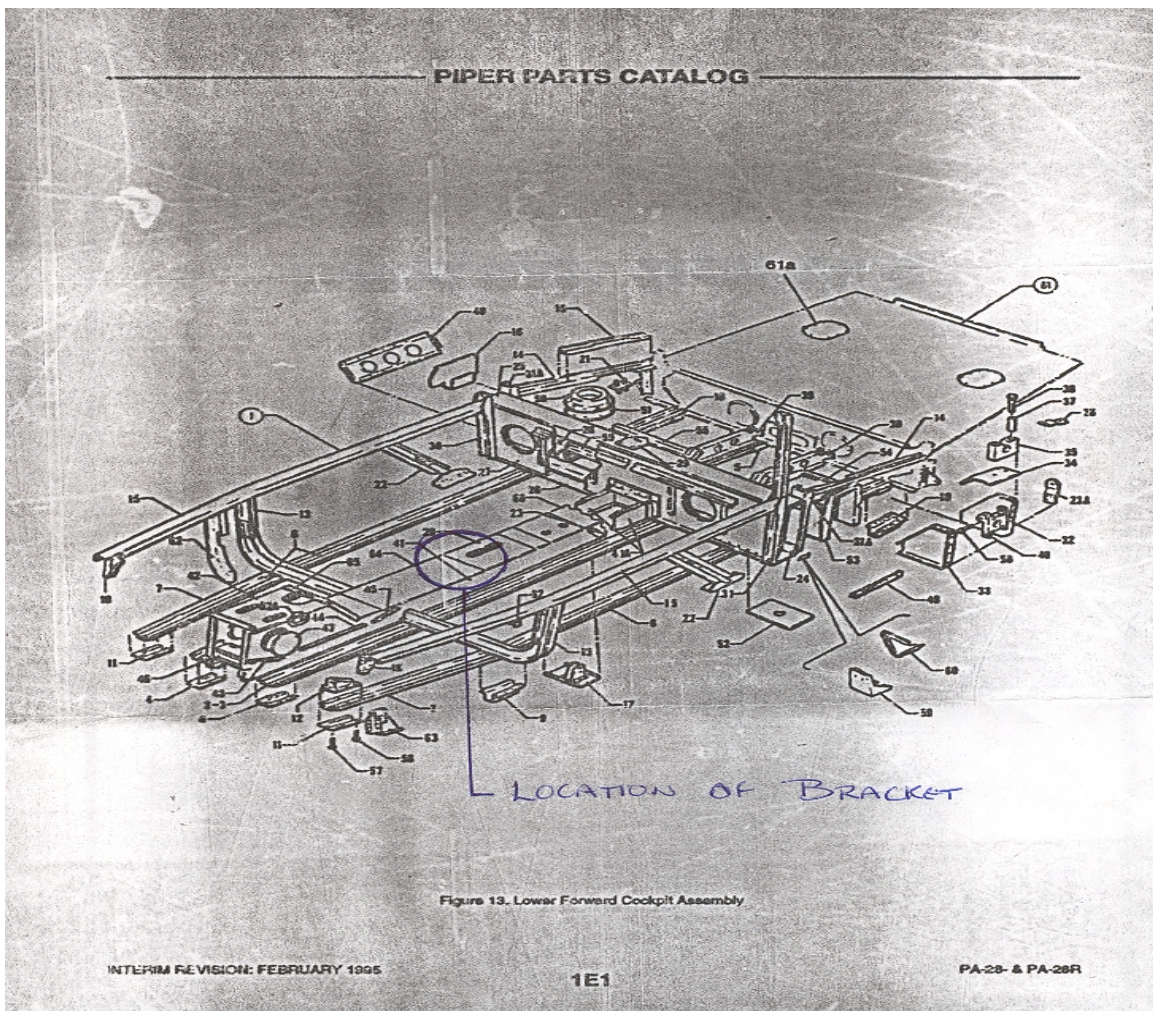
An A&P mechanic cautions operators and technicians not to miss the possibility of a cracked flap handle support mount bracket (P/N 62679-000) on this aircraft. “This bracket is riveted in the center tunnel and accepts two bolts at the forward side of the flap handle support mount. This is a difficult area to see, even with a mirror. We have found six cracked brackets to date. (I) suspect fatigue and air loads are causing the cracks.”

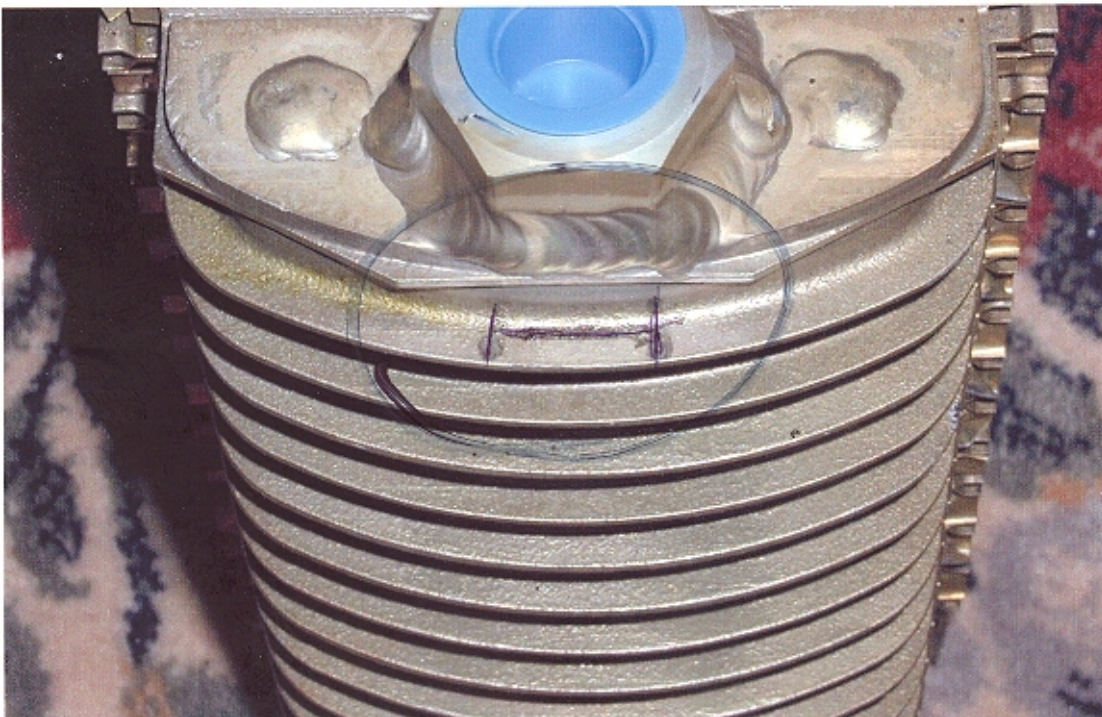
This submission is provided by a helicopter pilot who holds an A&P with an IA. He states, “*(During)* a 100 hour inspection on a Robinson R22-A helicopter, I installed a new oil cooler (P/N 20006A)—replacing the old oil cooler. While flying *(after the installation)* I noticed the oil temperature rising and the oil pressure dropping. I made an unscheduled landing and discovered the tail boom covered with engine oil. I traced the oil back to the oil cooler. I removed *(this new unit)* and pressure tested it—I found a $\frac{3}{4}$ inch crack in the cooler core.”

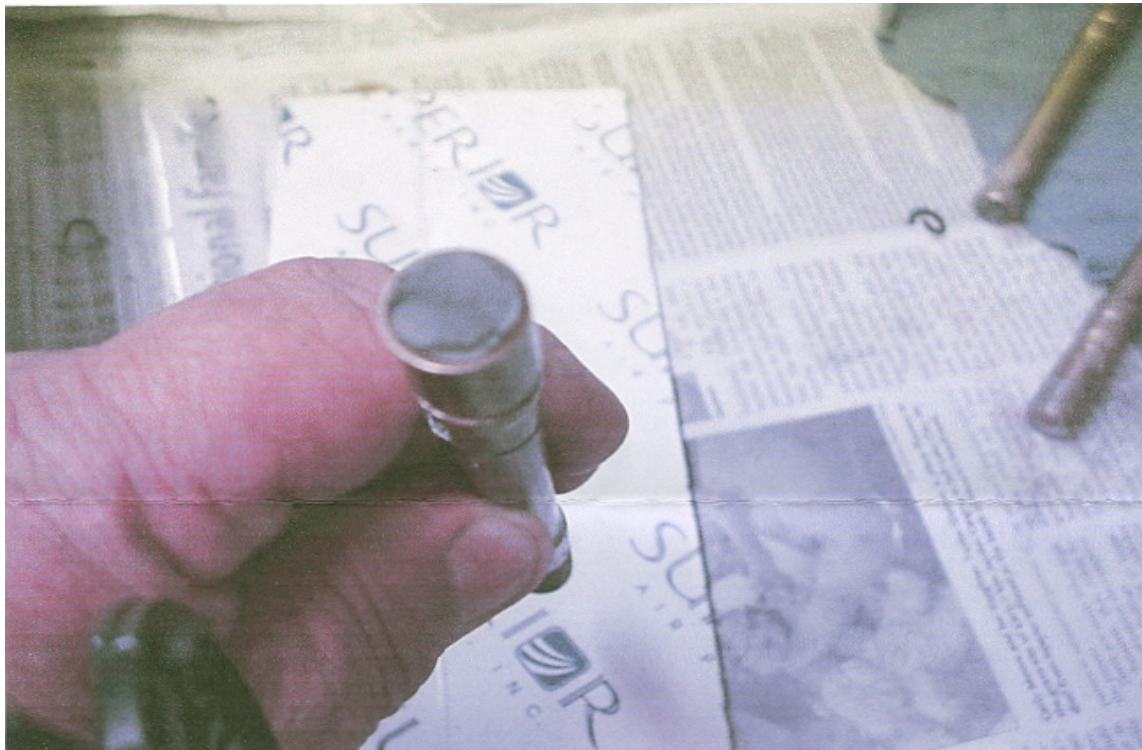
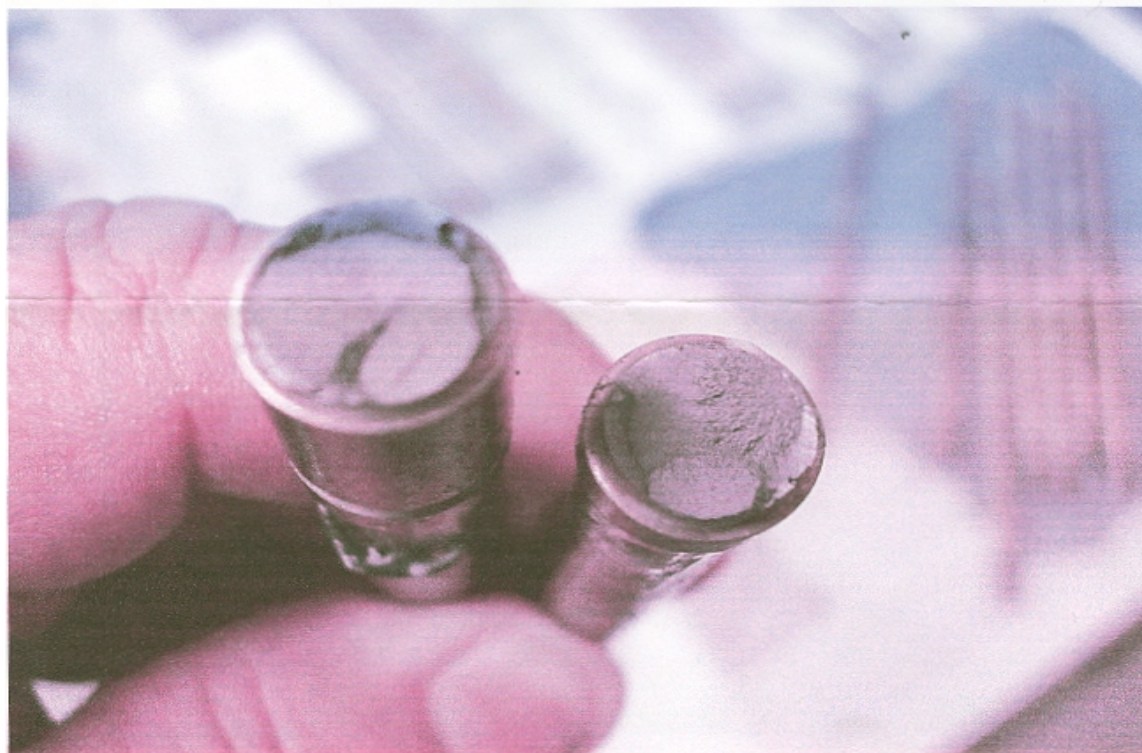
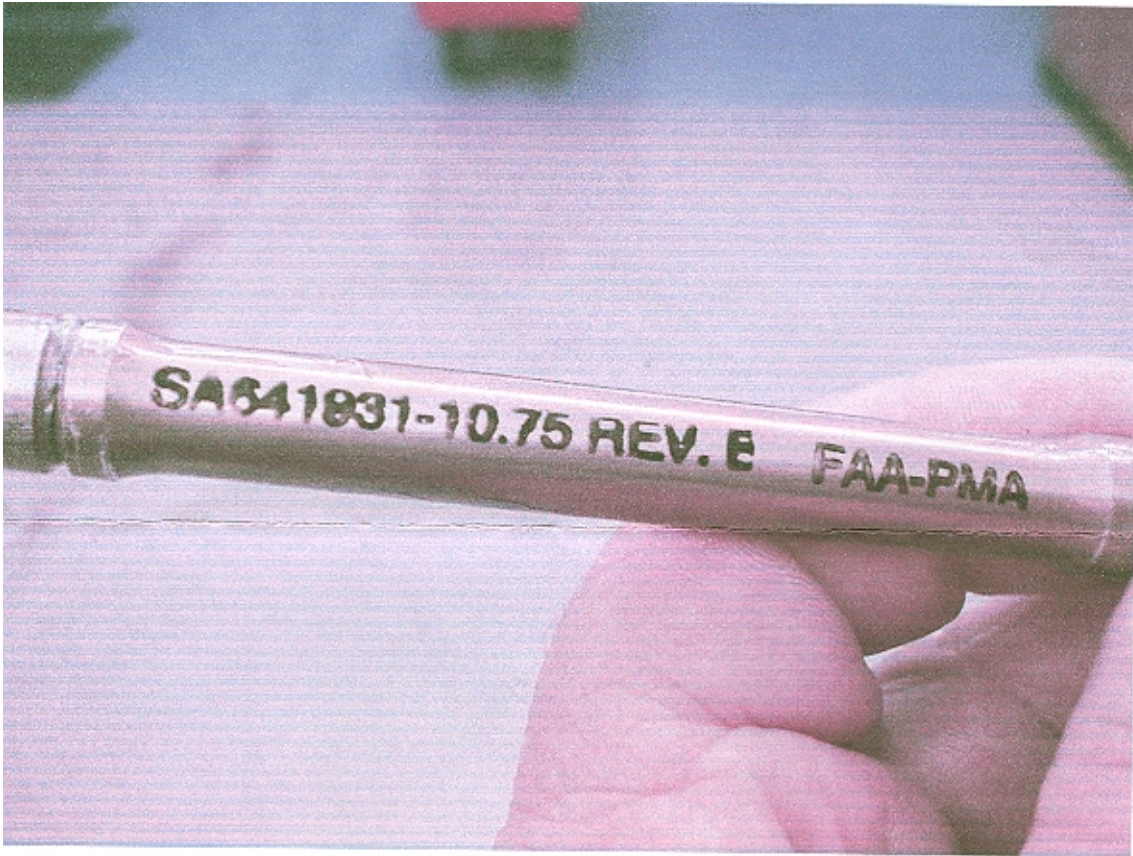
A repair station technician says, “*(I)* was installing all new through-bolts in this engine (Superior Air Parts: SA641931-10.75; lot number K070059179 rev. E). Within a few hours after torque, the through-bolt snapped at the oil ring groove. This is the third through-bolt that has snapped after setting for awhile *(after the final torque application)*. Attached are pictures of the *(broken)* bolt. Probable cause: *(suspect)* improper heat treatment during or after plating.”

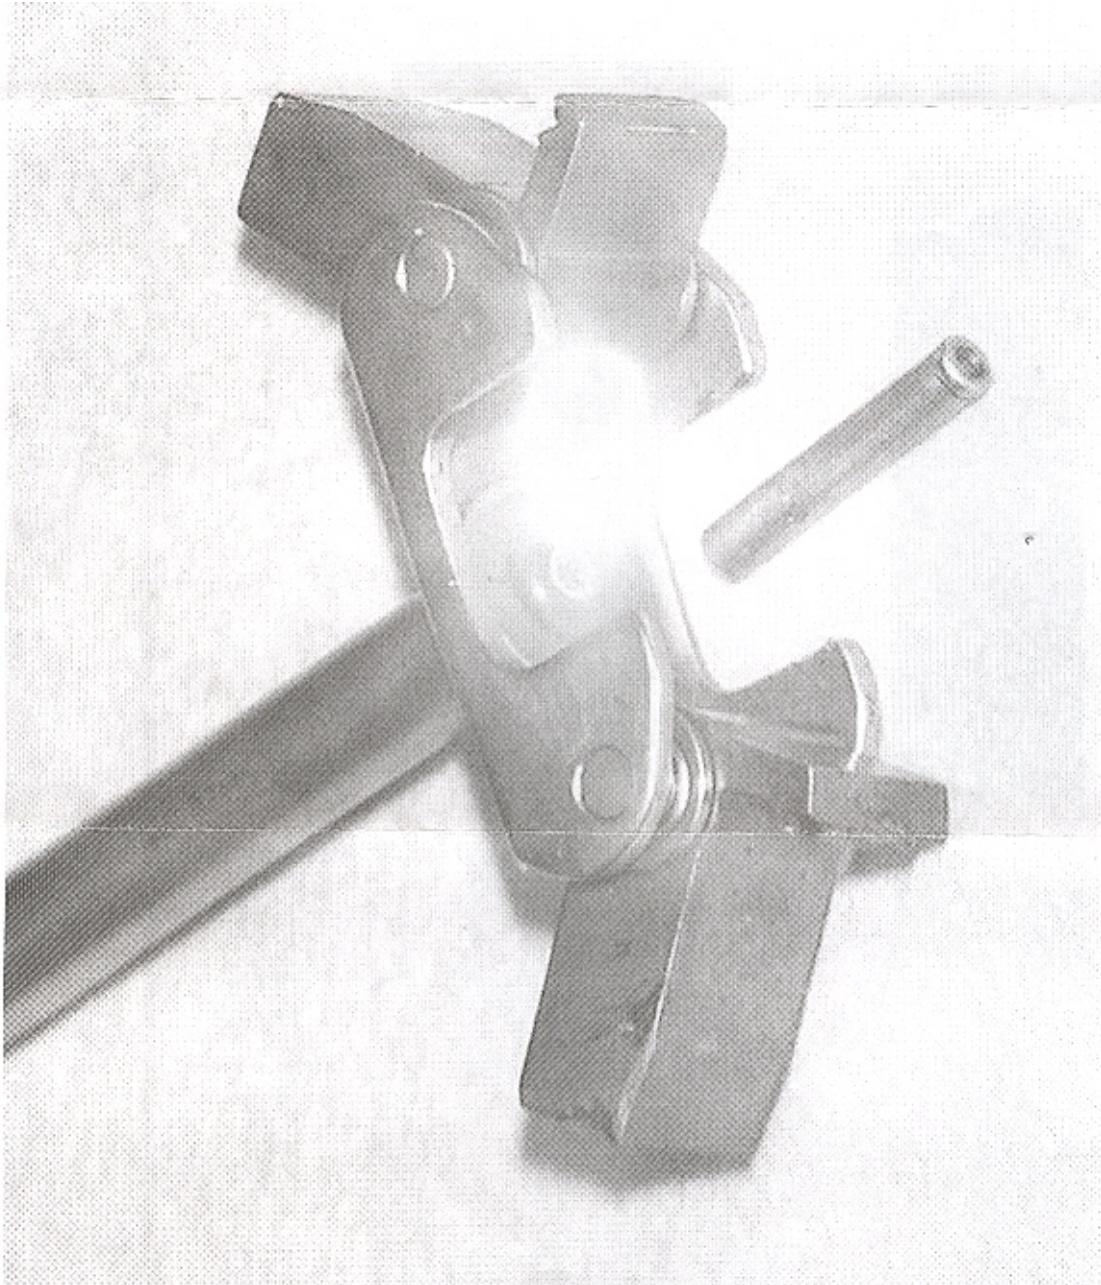
“While climbing through 13,000 feet,” states a mechanic, “the number 2 engine (*on this Cessna S550*) unexpectedly over-spun and the ITT (*turbine temperature*) exceeded the limit of the indicator. The pilot tried pulling the throttle back to idle but (*this action*) had no effect. The pilots were forced to shut the engine down in flight.” (*Subsequent investigation and the attached picture show this defect to be caused by a failed fuel control drive shaft (P/N 2525472).*)
