**UNITED STATES
DEPARTMENT OF LABOR
MINE SAFETY AND HEALTH ADMINISTRATION**

REPORT OF INVESTIGATION

**Fall of Face, Rib, Pillar or Highwall
August 17, 2004**

**McElroy Mine
McElroy Coal Company
Glen Easton, Marshall County, West Virginia
I.D. No. 46-01437**

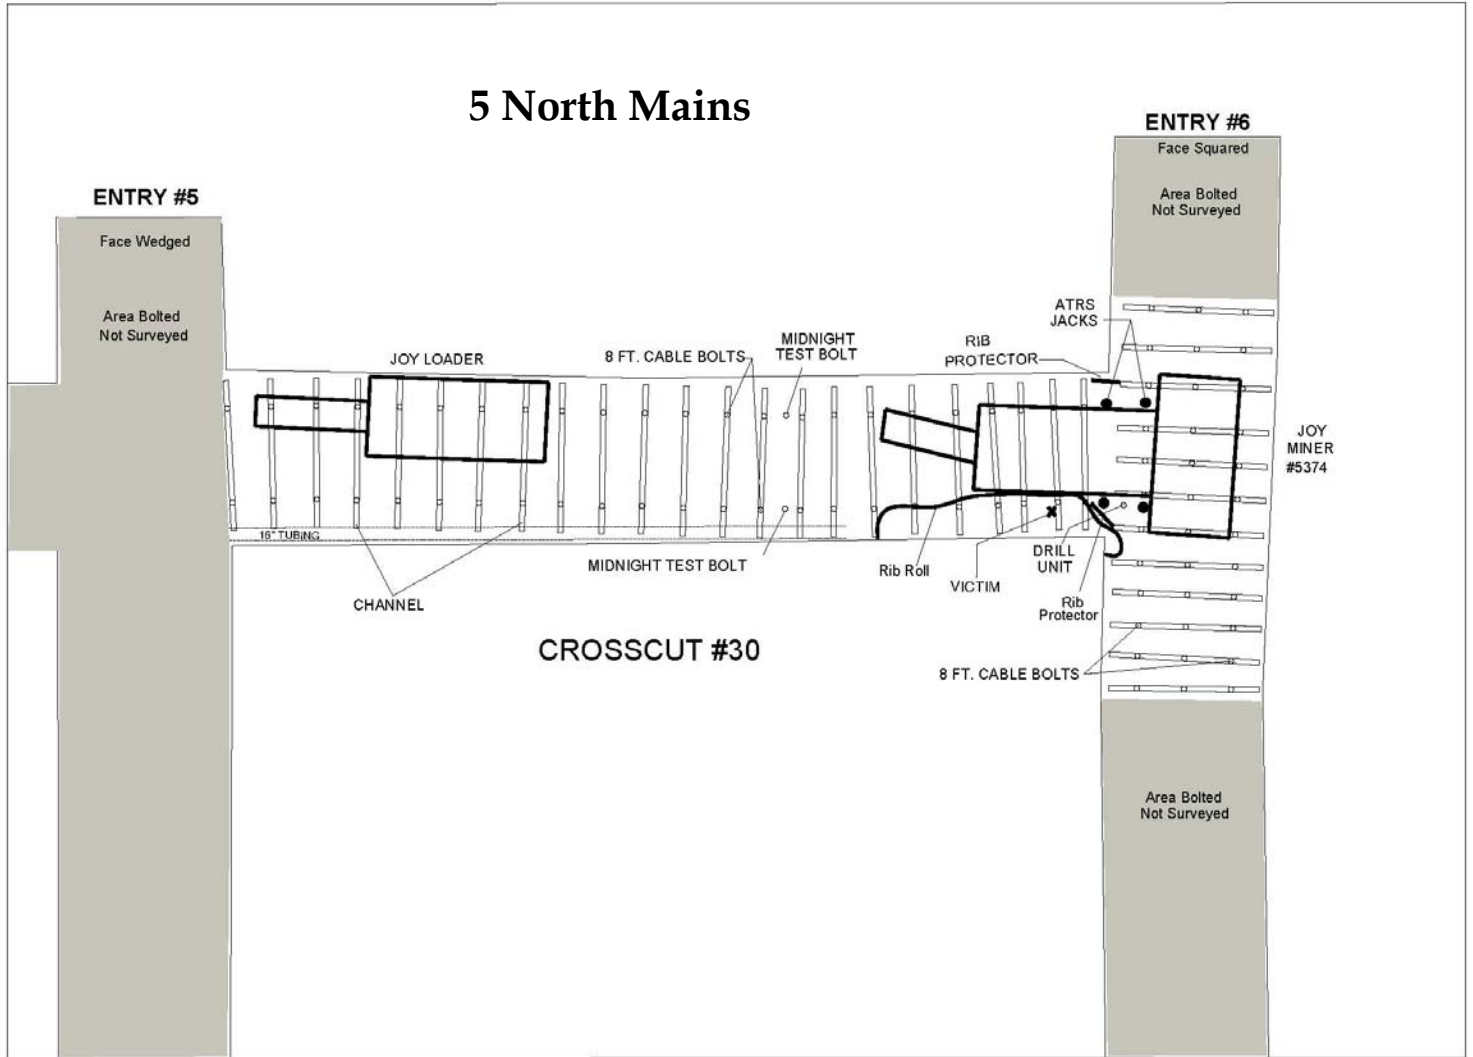
5 North Mains

The rib roll which fatally injured the victim consisted of coal, mudshale, and claystone measured approximately 20 feet long by 5 feet wide and up to 10 inches thick. The rib fell from the top of the 7.5 foot high right side pillar rib. From the right rear of the mining machine, the rib roll extended 11 feet inby and 9 feet outby.

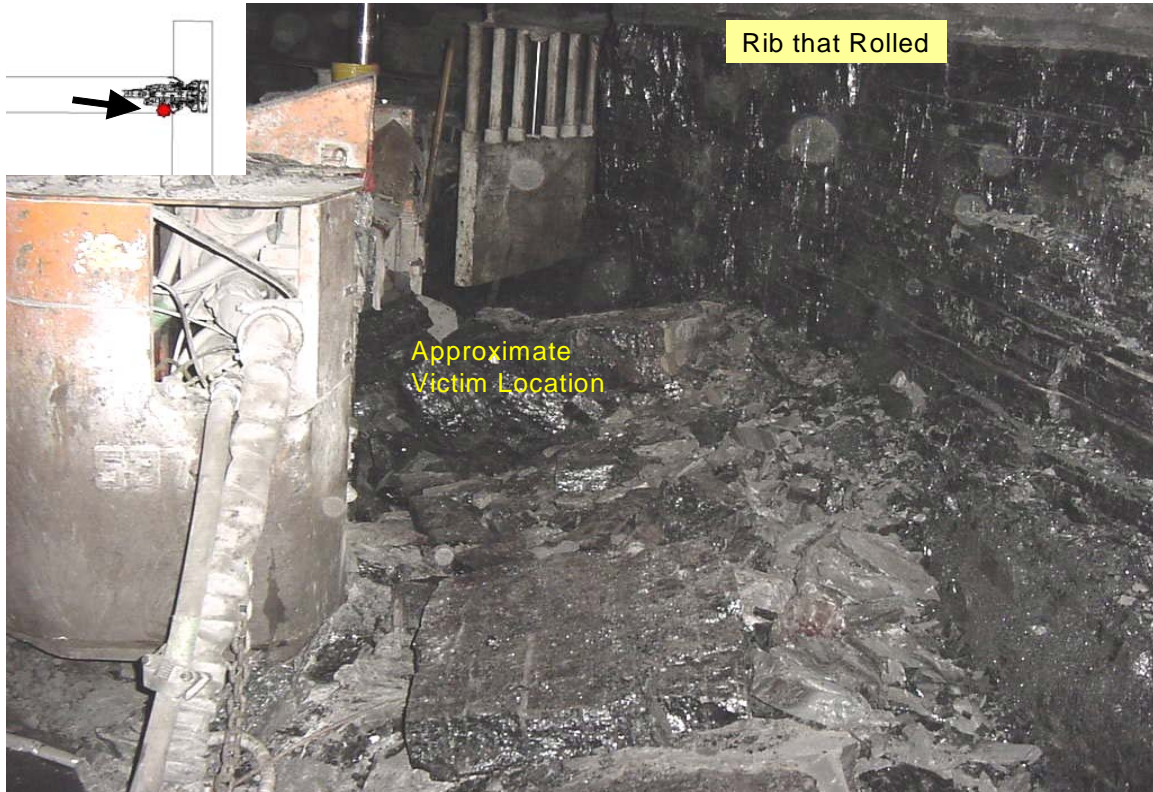
Appendix B

On August 17, 2004, at approximately 4:15 a.m., Joseph F. Sabo, a 57-year old Continuous Mining Machine Roof Bolter Operator was fatally injured in a rib roll accident on the right side of the 5-North Mains section. The crew had mined through the No. 30 crosscut between the No. 5 and No. 6 entries when the roof bolters started to install the last strap. The miner operator warned Sabo the rib was beginning to work. Sabo withdrew approximately 3 feet toward the No. 5 entry (rear of the mining machine) when he stopped and placed his hand on the rib. The coal and rock rib (approximately 20 feet long by 5 feet wide and up to 10 inches thick) collapsed and pinned Sabo against the continuous mining machine (Appendix B) causing fatal injuries.

Corrective Action: The approved roof control plan was revised to include rib bolting as mining advanced.

Corrective Action: The approved roof control plan was revised to include rib bolting as mining advanced. The continuous mining machines were retrofitted

with rib drills to install rib bolts in accordance with the approved roof control plan.
