System Failure Case Studies

Volume 1 Issue 6

INNOVATION PUSHED TOO FAR TOO FAST

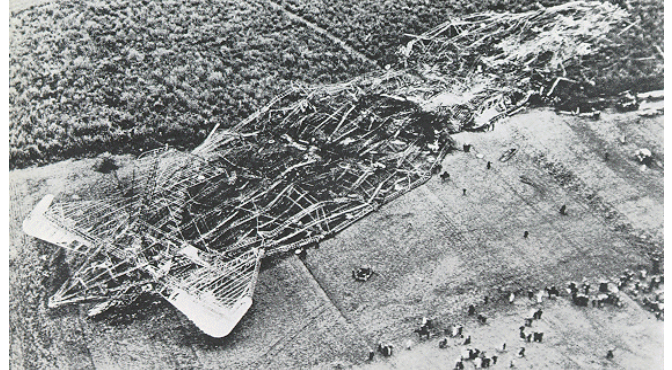
The charred remains of R101 near Beauvais, France.

Survivors reported that there was no violent movement upon impact and that the ship bounced slightly and then leveled. The force of the crash twisted the starboard forward engine around on its struts, bringing it into contact with and igniting hydrogen from the ruptured forward envelope. Flames quickly engulfed the R101, killing 48 of the 54 passengers and crew aboard.

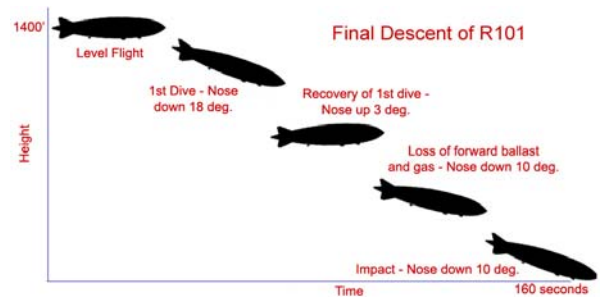
R101 then made a steep dive, causing many crew members to lose their balance and furniture to slide across the floor. The accident investigation suggests that severe weather caused a tear in the nose area, exposing a hydrogen envelope that rapidly deflated and started to accumulate rain water. The loss of hydrogen buoyancy combined with added weight of the rain-soaked nose section caused R101 to pitch down at an angle of 18 degrees for up to 90 seconds.

At an altitude of only 530 feet (R101 was 777 feet in length), the ship went into a second dive as the crew tried unsuccessfully to steady the ship. The Captain called for an emergency landing and sounded the bells to alert the passengers onboard. R101 impacted the ground at a relatively gentle 13.8 mph leaving a trench two feet deep and nine feet long where the nose touched down.

After the first dive, the R101 crew was able to regain control and steady the flight pattern. They were unable to do so after the second dive and crashed.
