# Operating Experience Summary

U.S. Department of Energy  
Office of Environment, Safety and Health  
OE Summary 2006-10  
August 25, 2006

### Equipment Labeling Error and Inadequate Zero-Energy Check Result in Electrical Arc Flash

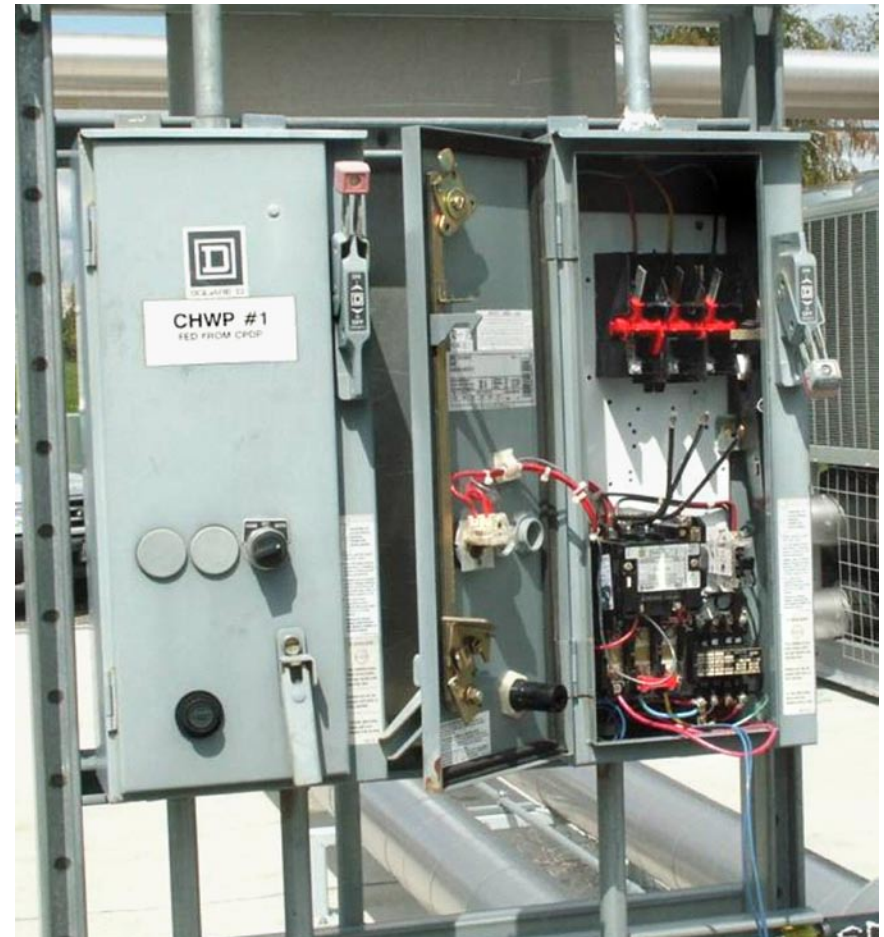
Figure 1-1. CHWP #2 cabinet with open door

suppressor (measuring phase to phase and phase to ground). While performing these checks, corrosion was observed on some components, as was some water in the bottom of the cabinet. Figure 1-1 shows the combination motor-starter cabinet for CHWP #2.

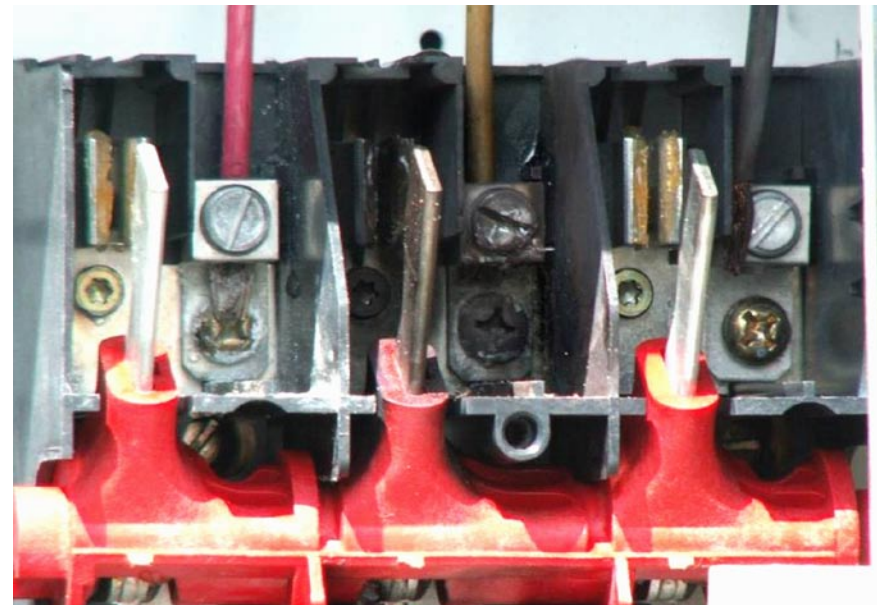
**Figure 1-2. Closeup of the burned B-phase lug (center)**

The electricians determined that a control power transformer had failed. They removed a mounting plate holding the transformer and then removed the transformer. The first electrician had to leave, and the second electrician obtained a replacement transformer. While repositioning the mounting plate with the new transformer attached, the line-side C-phase conductor came out of its lug and contacted the B-phase lug resulting in an arc flash. Figure 1-2 shows the burned B-phase lug.

An investigation team was formed to identify causal factors. They determined that the labeling error dated from the time of system construction in the summer of 2000. The labeling on the 25-amp circuit breakers at the distribution panel for the two chilled water pumps was reversed. They also determined that

the design of the arc suppressor on the line-side disconnects restricted access and visibility of the phase lugs during zero-energy checks.

Recommendations included revising the following procedures:

- Engineering and operations procedures that address new or modified electrical systems need to include verification of correct component labeling and confirmation that the labeled isolation point correctly isolates the identified component; and
- Electrical safety and LOTO procedures and personnel training, which need to include verifying electrically de-energized conditions by 1) observing the test meter probe as it contacts the component to be tested; and 2) observing test meter indications falling when the component is de-energized.

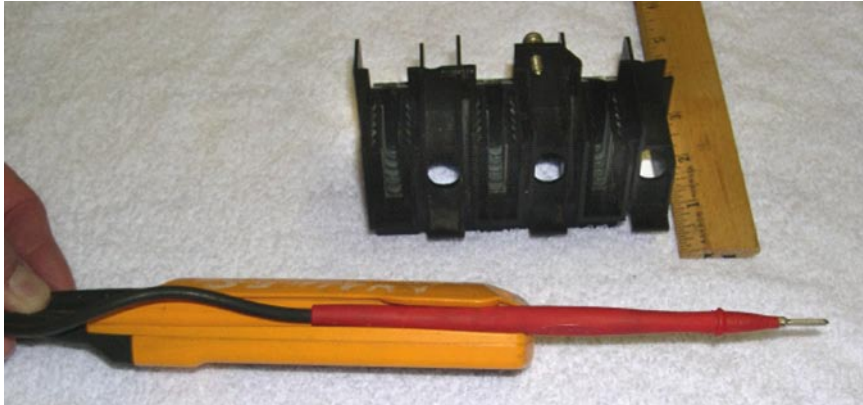
**Figure 1-3. Fluke T-2 meter with test probe in holder (arc suppressor shown above)**

1. Use of the probe holder on the meter while positioning the test probe could have resulted in failure of the probe to contact the phase lug. If the probe was not positioned in the meter probe holder correctly, or if it slid back in the holder, the probe might not have reached far enough through the arc suppressor to make contact with the phase lug. (Figure 1-3 shows the meter and test probe.)

2. The electricians could have mistaken contact with the arc suppressor as being contact with the phase lug without any distinct indication on the meter.
3. Corrosion on the phase lugs could have prevented adequate contact between the meter probe and the lug.

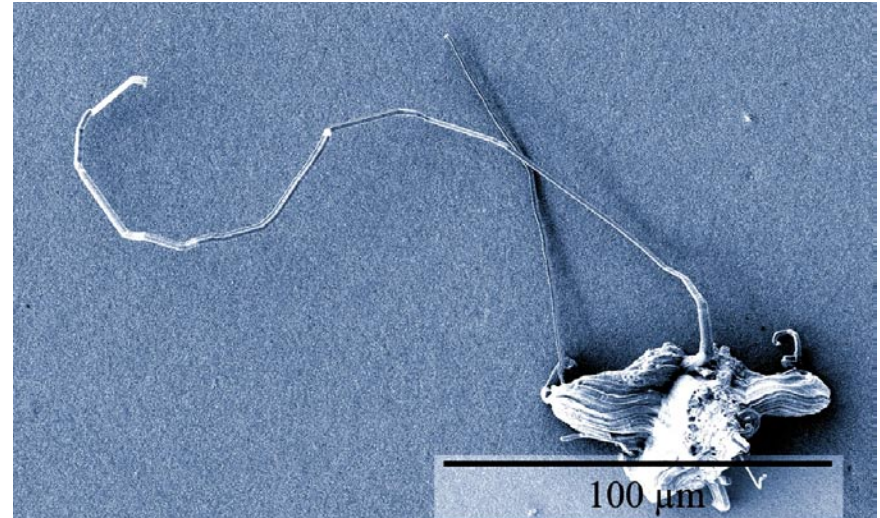
**Figure 3-1. Metal whisker on a tin-copper surface**

Figure 3-1 is a scanning electron micrograph of a whisker growing from a tin-copper alloy surface. Figure 3-2 shows a less-hazardous “hillock” developing from a pure tin surface. These electrically conductive growths can reach several millimeters in length; infrequently, whiskers as long as 10 mm have been reported. The most serious hazard posed by metal whiskers is a metal vapor arc, in which the whisker vaporizes into a cluster of

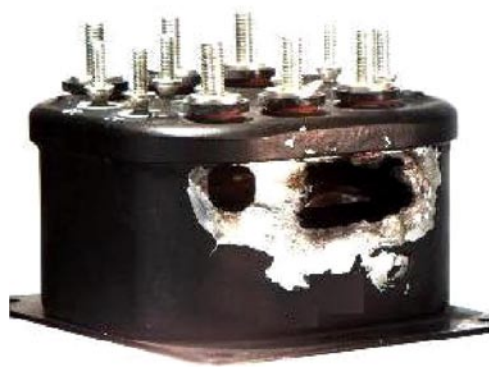
**Figure 3-3. Damage from metal vapor arc**

extremely conductive metal ions capable of carrying hundreds of amperes of current. Figure 3-3 illustrates the damage that can occur from such an arc.
