DOCKET NO. **SA- 516**

EXHIBIT NO. **17A**

**RECONSTRUCTION GROUP CHAIRMAN'S FACTUAL  
REPORT OF INVESTIGATION**

A. **ACCIDENT:** DCA-96-MA-070

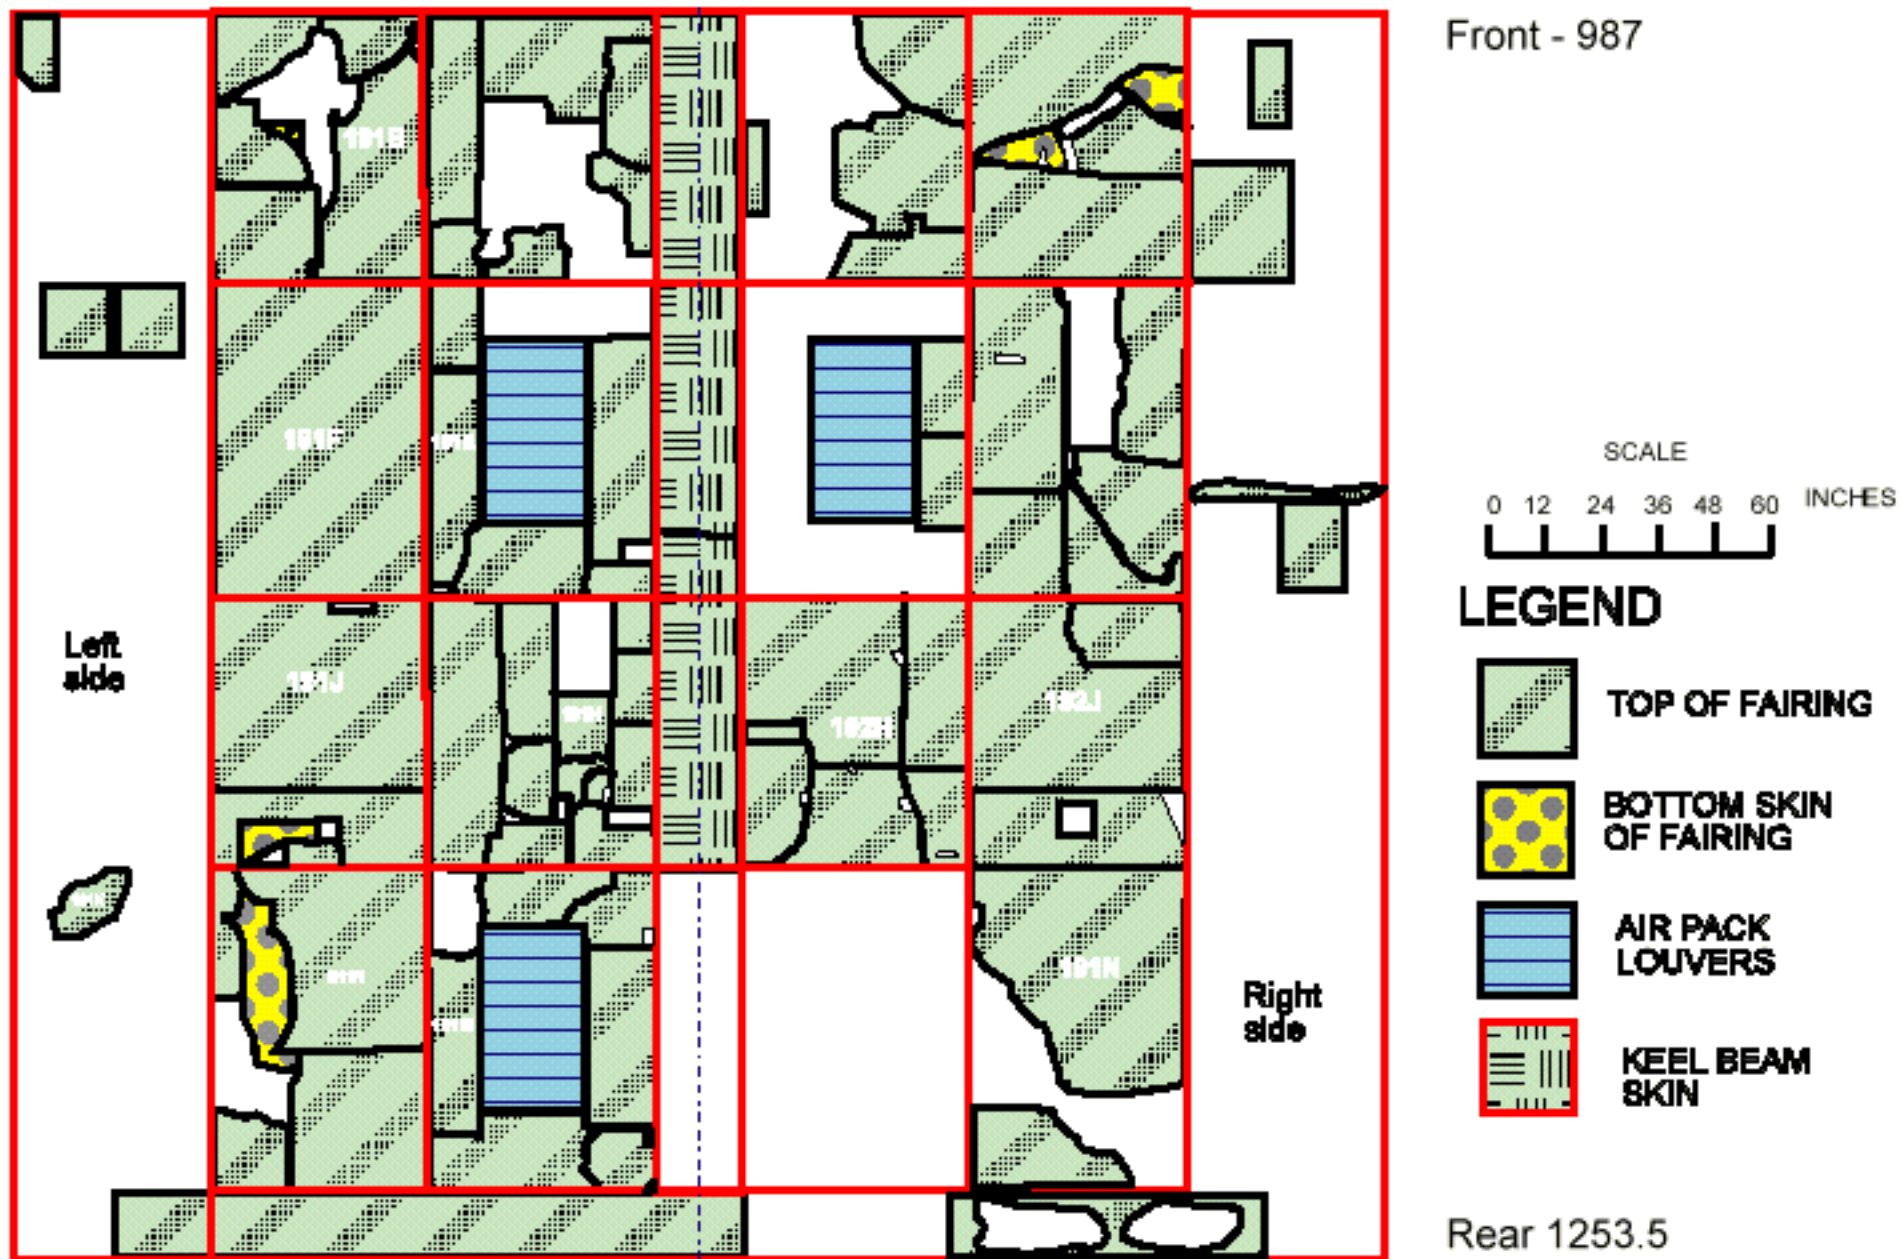
# Figure 3 - Fairings under the center fuel tank

Under the center wing fuel tank, 75.6 percent of the fairings were placed between the 104-inch body line on each side of the centerline. The area that attached under the wing from 104 to 146 inches was thinner and had frequently spaced frames. Very few pieces were identified in this area. When the area under the wing is included into the calculation, along with 15-inch wide band that forms the vapor barrier to the rear of the tank, the percentage of fairings identified and placed under the center wing tank was reduced to 56.3 percent. See figure 3 and spreadsheet 1.

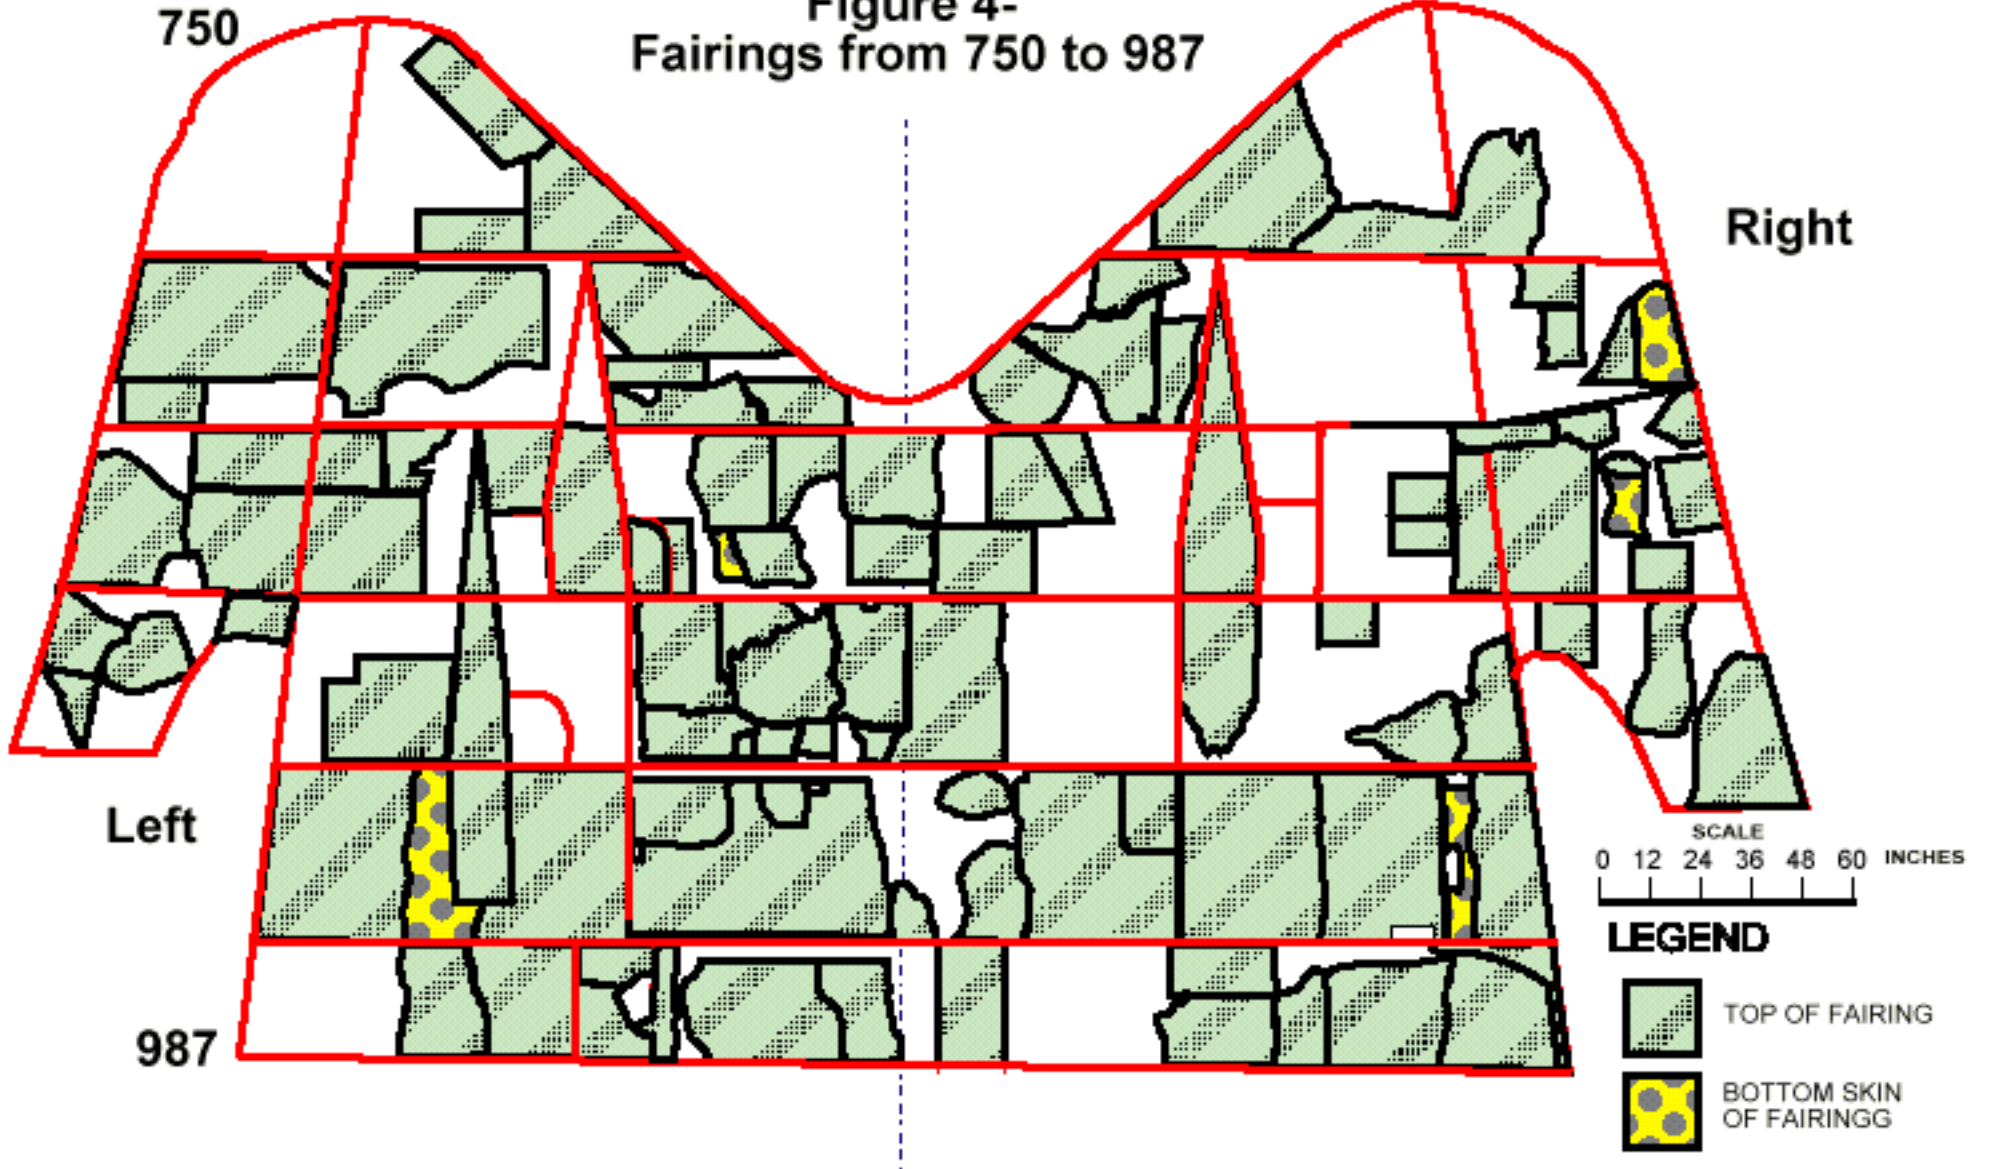
Figure 4-  
Fairings from 750 to 987

The fairings forward of the center wing fuel tank between 700 and 987 were placed and documented as shown in figure 4. About 64 percent of these fairings were identified and placed as indicated in spreadsheet 2.

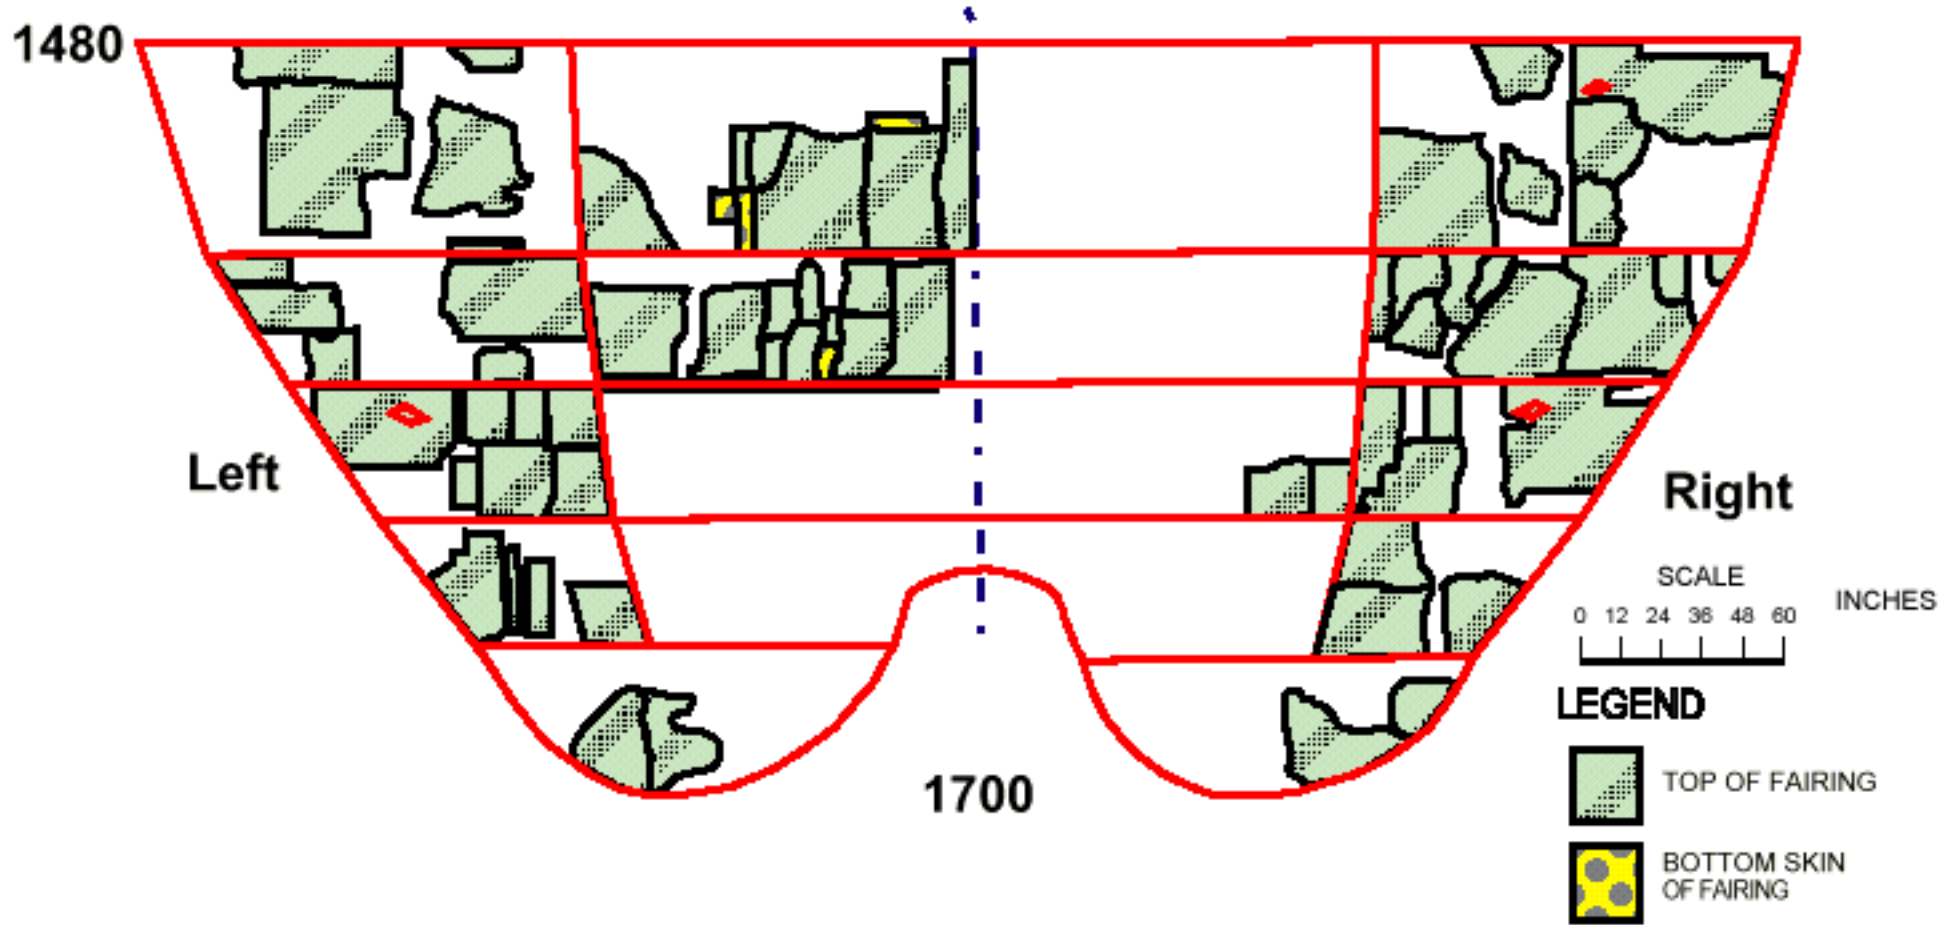
Figure 5 - Fairings from 1480 to 1700

The fairings rearward of the landing gear doors between 1480 and 1700 were placed and documented as shown in figure 5. About 39 percent of these fairings were identified and placed as indicated in spreadsheet 3. The panels between 1480 and 1540 were thicker due to the greater distance

spanned (60 versus 40 inches). Many pieces could be tentatively located into this area, but could not be matched or positively placed as part of the panel. Similarly other thinner parts in the rear compartment areas could not be positively placed.
