OCT 15 2004

**Type B  
Accident Investigation Board Report  
On the August 25, 2004  
Head Injury to Miner  
Waste Isolation Pilot Plant  
Carlsbad, New Mexico**

**Type B  
Accident Investigation Board Report  
of the August 25, 2004  
Head Injury to Miner  
at the  
Waste Isolation Pilot Plant  
Carlsbad, New Mexico**

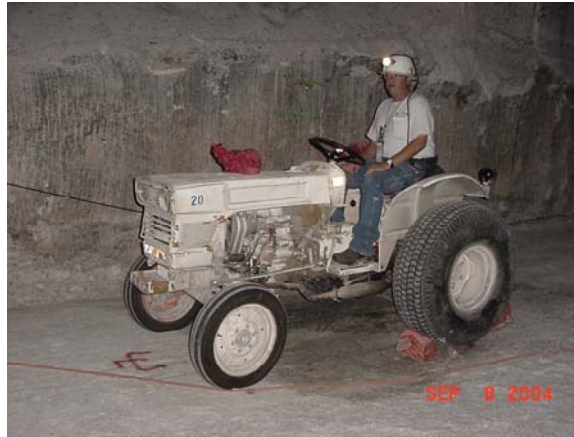
**Figure 4: Kubota Tractor**

Mine Operations employees in the worksite area recognized the Kubota tractor was inadequate to pull heavier metal vent line sections, because the tractor lost traction in

the loose salt and uneven haulage surface. Mine operations employees intended to use the LHD, which was included in the work package, in place of the Kubota tractor. Workers also realized the nylon rope being used had been severely abraded (Figure 5) by being wrapped around the vent line and dragged on the rough floor. Because the rope was abraded when moving the first vent line, a discussion was held among workers under the brow. Some concerns were expressed, but it was decided to attach rope using a C-clamp rather than the timber hitches as on the first vent line. Employees did not utilize stop work.

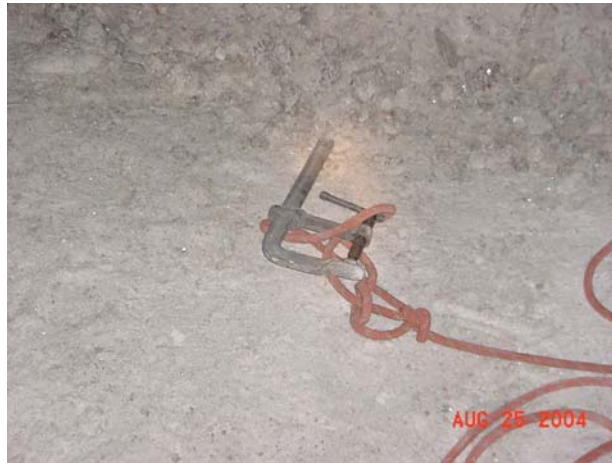
**Figure 6: C-clamp on the floor of E-140 following the accident**

The direct cause of the accident was the impact to the employee's head by a C-clamp pulled from a metal vent line by an attached rope.

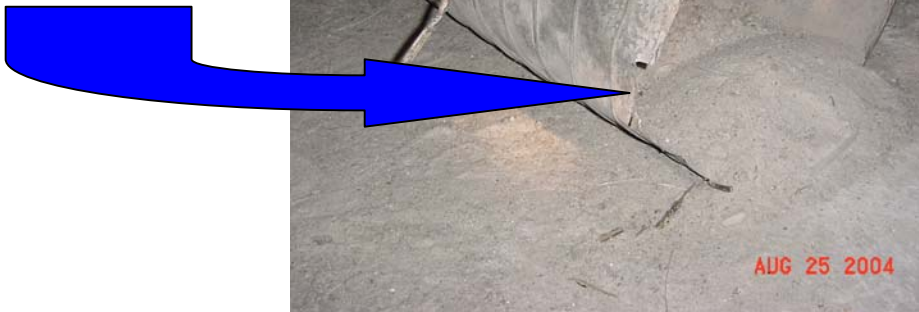
**Figure 9: End of Vent Line 4**

During the pull, E1 was standing at the south end of Vent Line 3. E1 warned Employee 7 (E7) to move away from the rope used for pulling Vent Line 4. At about the same time, Vent Line 4 began to dig into the floor, and E9 saw the C-clamp begin to rip out of the end of Vent Line 4.

Hole in Vent Line 4

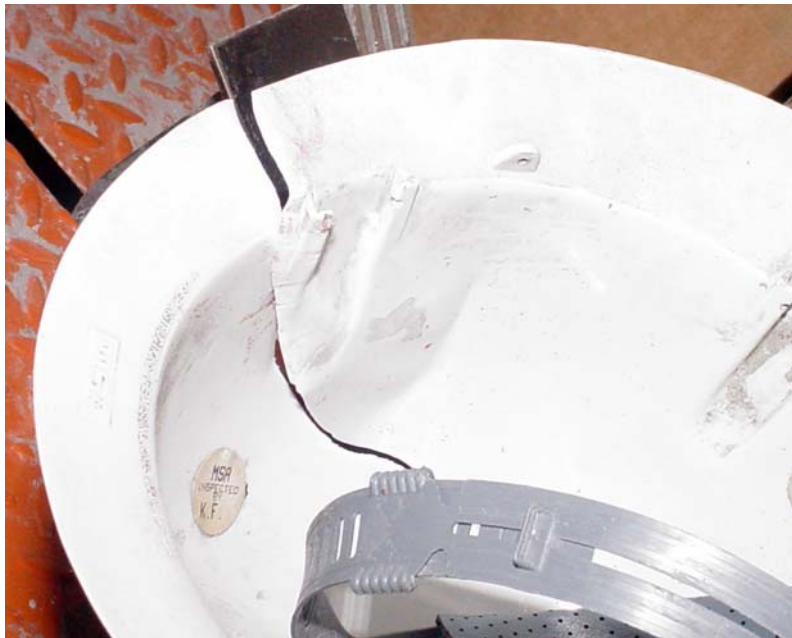
**Figure 11: E1's hard hat**

Although the hard hat (Figure 11) and safety glasses were broken by the impact of the clamp, E1 did not lose consciousness, but was knocked down. Several co-workers got to the injured worker almost immediately. E8 took the back of a leather work glove and placed it over a head wound which was bleeding. Employee 3 (E3), who is a licensed practical nurse, removed his tee shirt and wrapped it around the head of E1 to control bleeding. There were no first aid supplies cached in the area; however, Employee 2 (E2) retrieved gauze and other first aid supplies from his mine rescue gear and brought it to the scene.

The wounds suffered by E1 were sustained by the impact of the C-clamp, which fractured his hard hat, which cut E1s scalp and tore the scalp from his head. The indentation on the hard hat shows the direct point of impact. The discoloration of the skull indicates the indirect contact of the C-clamp on E1’s skull through the hard hat.
