## NONDESTRUCTIVE EVALUATION OF DEFECTS AND OPERATING DAMAGE IN CFCC COMBUSTOR LINERS

J. G. Sun, S. Erdman, R. Russel, C. Deemer, W. A. Ellingson  
Argonne National Laboratory  
Argonne, IL 60439

N. Miriyala, J. B. Kimmel, and J. R. Price  
Solar Turbines Inc.  
San Diego, CA 92186

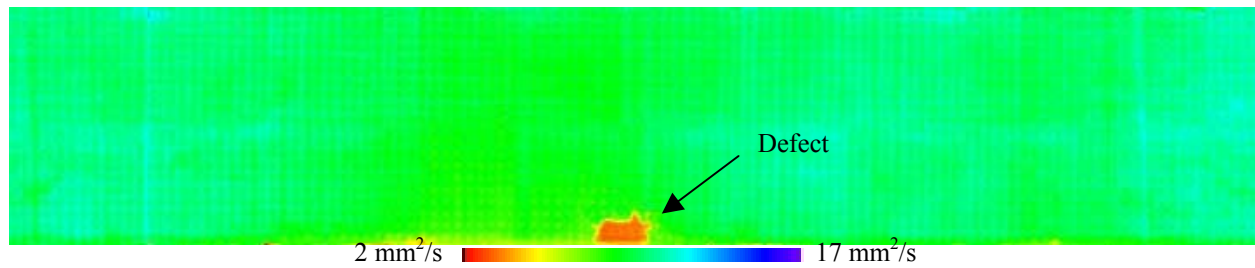
Through-thickness infrared thermal imaging and air-coupled ultrasonic scanning were conducted to assess the conditions of the CFCC liners before the EBC application. The NDE data were presented as thermal diffusivity and ultrasonic transmission (UT) images mapping the entire liners (100% inspection). The data indicated that thermal diffusivity was affected slightly by local thickness variations, as an average thickness was used for each liner to derive the local thermal diffusivity (Sun et al., 1999). The outer liner was found to be generally uniform and free of defects from both thermal diffusivity and air UT tests. However, a major defect area, about 42 x 18 mm, was found at the lower edge of the inner liner.

Figure 2 shows the thermal diffusivity image of the inner liner. The defect region has low diffusivity at ~35% of the normal region. To determine the defect type, X-ray CT and one-sided thermal imaging were performed at this region. Figure 3a shows a 0.5-mm-thick CT slice covering the depth range of 0.5-1 mm from the outside diameter (OD) surface, and Fig. 3b is a one-sided thermal image taken at 0.1 s after the thermal flash. The defect region shows lower density in the CT image and higher surface temperature (brighter gray scale) in the thermal image. These results indicate that the defect is a delamination type. The one-sided thermal

Fig. 2. Thermal diffusivity image of Hi-Nicalon/SiC-Si MI inner liner.

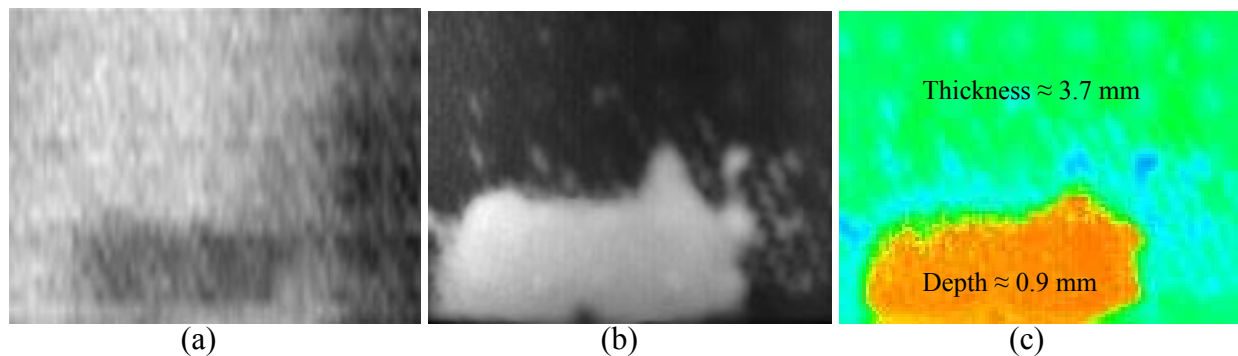
imaging data were further processed to determine the delamination depth. Figure 3c maps the predicted depth of the defect region. The delamination depth was about 0.9 mm from the OD surface, in agreement with the CT data.

Fig. 3. (a) X-ray CT image, (b) one-sided thermal image, and (c) predicted depth map for the defect indicated in Fig. 2.

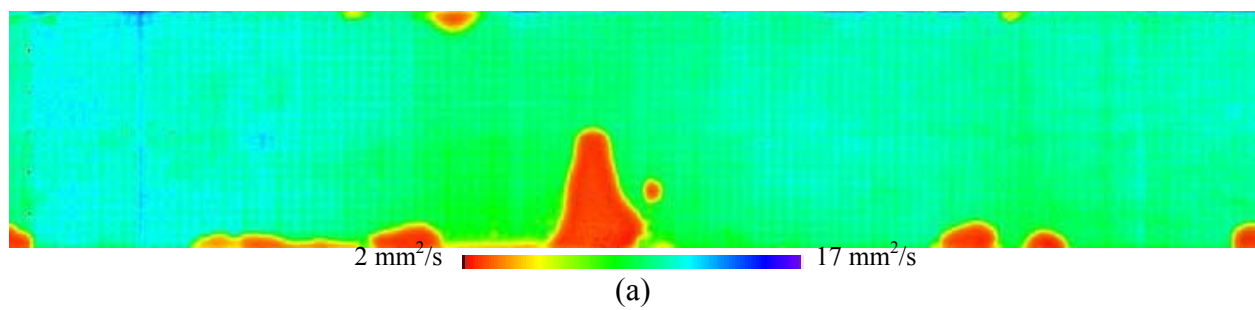
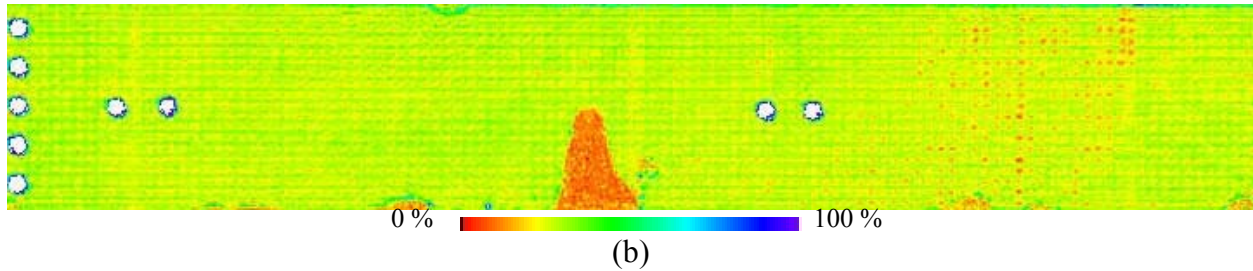
Thermal imaging and air UT tests were conducted on the CFCC liners after the EBC application. While there was no apparent change in the NDE data for the outer liner, the data for the inner liner showed expanded areas of low diffusivity and low ultrasound transmission, as shown in Fig. 4. These results indicate delamination/dedonding of the EBC layers, where the EBC appeared to be intact according to visual observation. The EBC layers in the defect regions spalled off during the first borescope inspection, after approximately 900 h of engine operation. However, the test was continued until a hole in the inner liner was observed in an EBC spalled area, shown in Fig. 5, after 13,937 h of the engine test.

Fig. 4. (a) Thermal diffusivity image and (b) air-coupled UT image of Hi-Nicalon/SiC-Si MI inner liner after the EBC application.

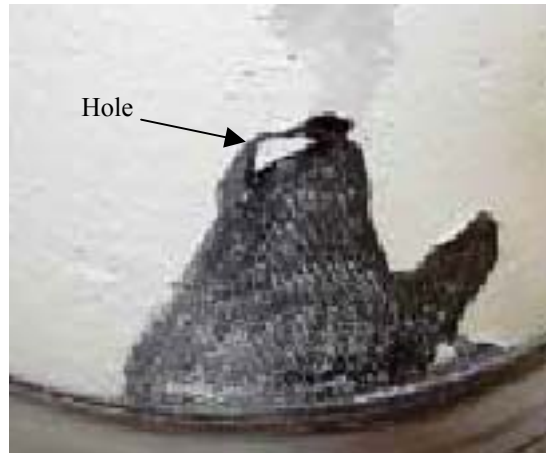
Fig. 5. Hole in an EBC spalled area of the inner liner that formed after 13,937 hours.

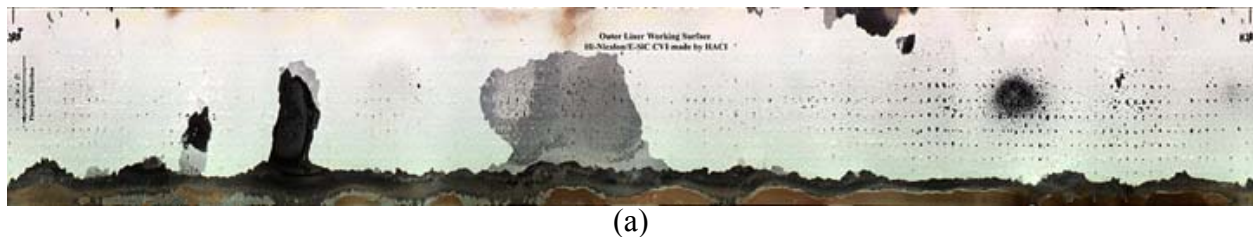
Digital images of the EBC-coated (hot side) surfaces of the outer and inner liners are shown in Fig. 6. It is evident that the EBC was still present on large sections of the liners. However, EBC loss occurred at the aft-end edge (lower edge) and in the middle on both liners. The EBC loss in the middle of the liners occurred in areas where fuel injectors were located, i.e., the hottest areas. The location, size, and geometry of the defect regions after EBC application (Fig. 4) correlated with the EBC spalled areas (Fig. 6b) for the inner liner.

Fig. 6. Digital images of the EBC-coated surfaces of (a) outer liner and (b) inner liner after the 13,937-h field test.

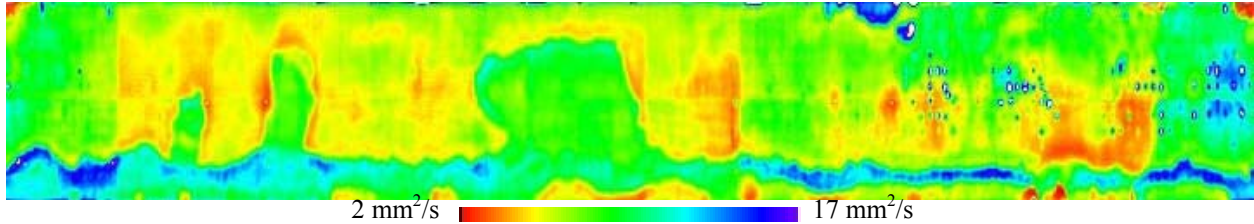
Thermal imaging and air UT tests were again conducted on the engine-tested liners. Figure 7 shows the thermal diffusivity image of the outer liner. The regions around the EBC spalled areas were found to have lower diffusivities. Close examination of these regions indicated that the EBC had debonded from the CFCC liner and could be easily scratched off.

Fig. 7. Thermal diffusivity image of Hi-Nicalon/SiC CVI outer liner after the 13,937-h field test.

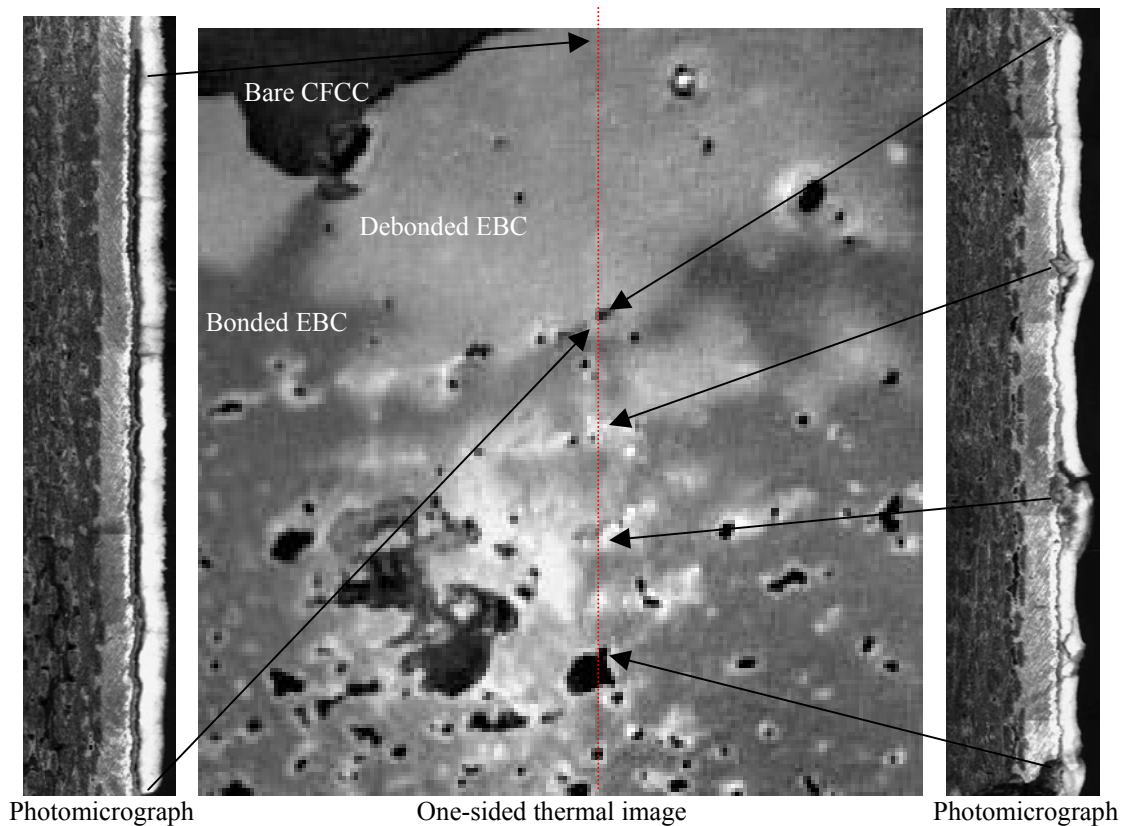
Both liners were sectioned for microstructural analyses after the 13,937-h engine test. Additional NDE data were taken on a few sections for detailed correlation with the microstructures of the CFCC and the EBC. Figure 8 shows the correlation of one-sided thermal imaging data with cross-sectional photomicroscopy of the outer liner. The thermal image was taken before the sample was cut. It contains three gray-scale levels: the black (low surface temperature) regions represent the bare CFCC surfaces where EBC has spalled; the intermediate gray-scale regions indicate where the EBC has relatively good bonding with the subsurface CFCC; the bright (higher surface temperature) regions, extensively shown in the image with large and small areas, are the locations where EBC has debonded from the subsurface CFCC. Most of the EBC-debond areas surround regions/spots where EBC has spalled. Cross-sectional photomicrographs shown in Fig. 8 clearly indicate the EBC debond under a large surface area at the top and many pinhole areas at the bottom. The formation of the EBC pinholes was attributed to the surface asperities in the as-processed CFCC liners, which causes vertical cracking in the EBC (Kimmel et al., 2001).

Fig. 8. Correlation of cross-sectional photomicrographs with one-sided thermal image showing locations where EBC debonding and pre-spall occur.
