Marine Accident Report

Collision Between the U.S. Coast Guard Patrol Boat *CG242513* and the U.S. Small Passenger Vessel *Bayside Blaster*, Biscayne Bay, Florida January 12, 2002

**NTSB/MAR-02/05
PB2002-916405
Notation 7454A
Adopted December 17, 2002**

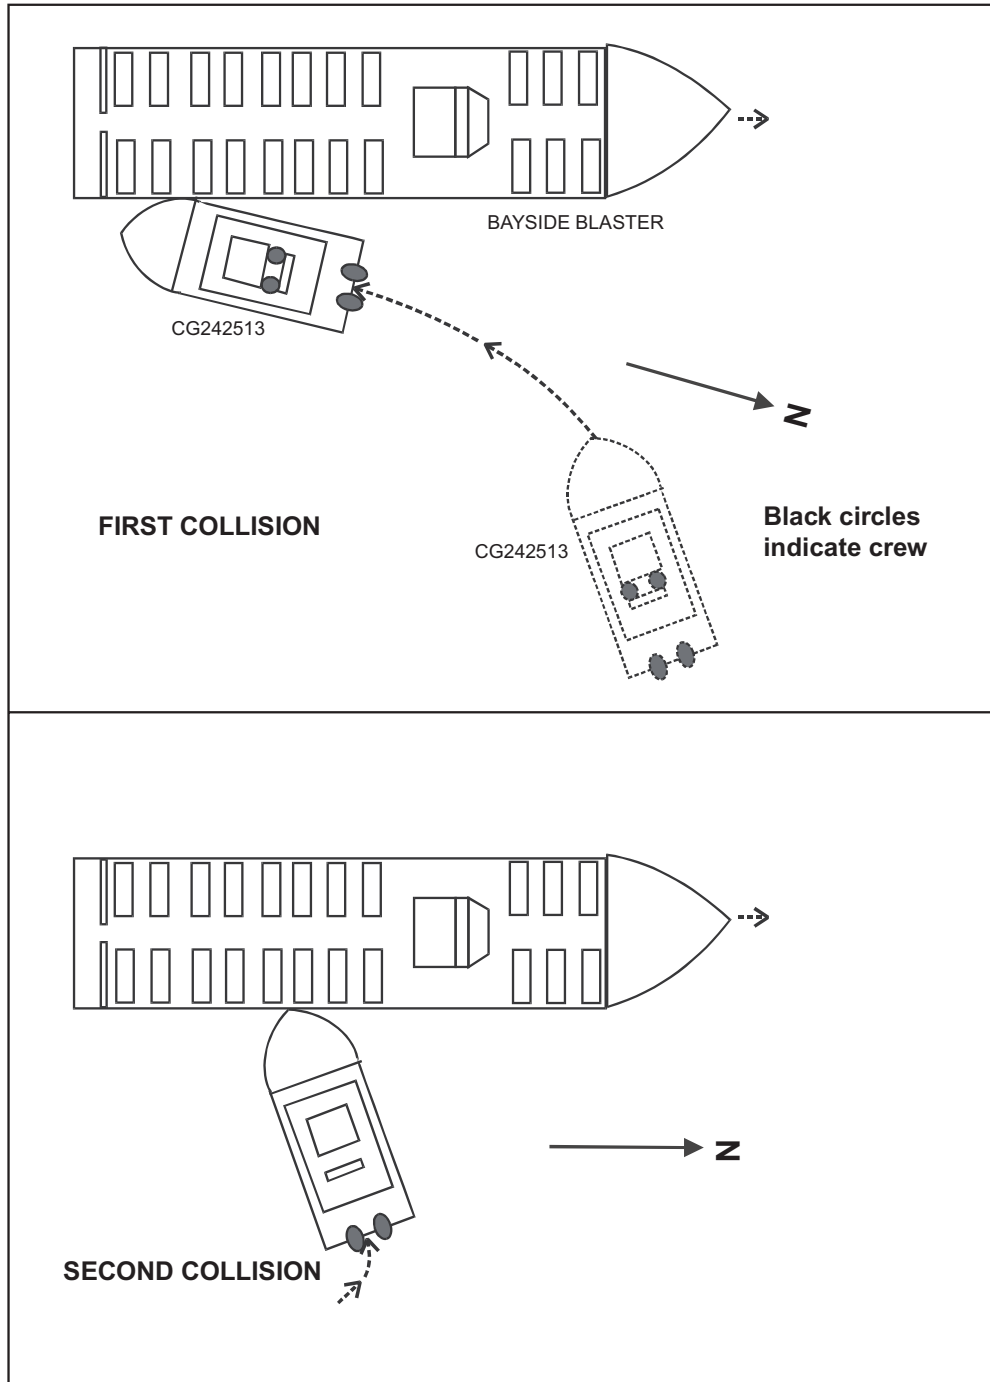
Figure 4. Approximate collision angles between the Coast Guard patrol boat and the *Bayside Blaster*.

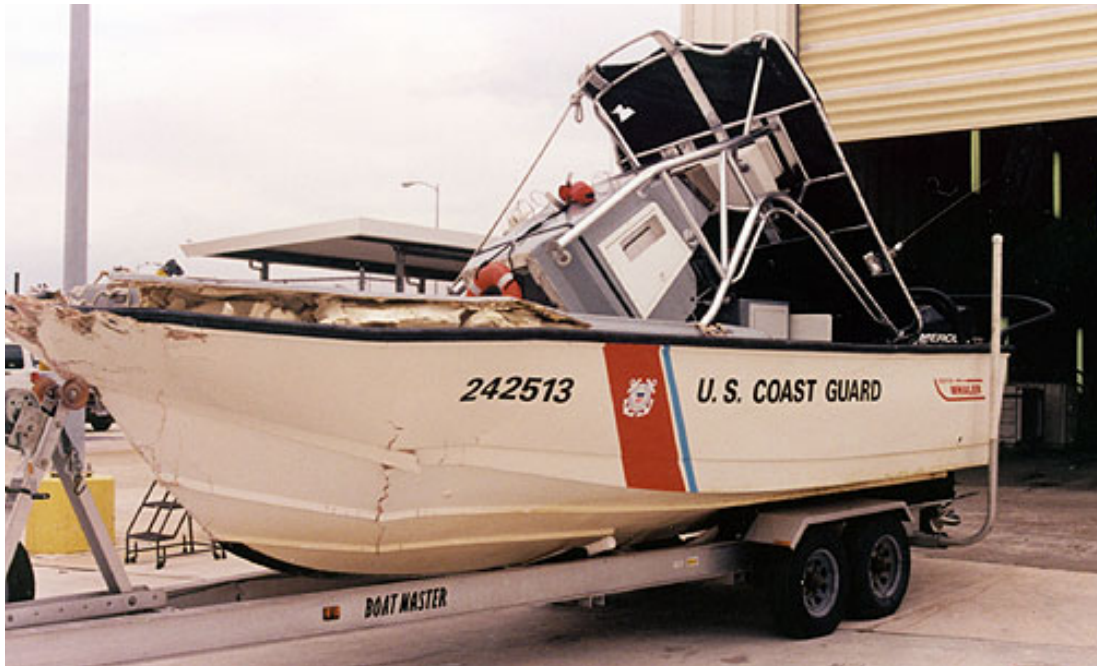
Figure 6. Damaged Coast Guard patrol boat.

The bow section of the Coast Guard patrol boat was crushed back about 4 feet, with evidence of buckling on the inside and outside of the hull (see figure 6). The stainless steel trailer eyebolt was broken and bent downward. The T-top and center console assembly was torn loose from the deck plate mounting attachments. The aft mounting plates were torn upward, and the forward mounting plates were bent forward and torn out. The port forward frame of the T-top was crushed rearward. The starboard engine propeller shaft was broken, as evidenced by the freely rotating propeller. The starboard side of the outboard engine's lower gear housing and one of the propeller blades had fresh contact marks. The red plastic assembly of the port running light was missing, but the starboard running light was present and undamaged. A Safety Board investigator took possession of both lights from the commanding officer of Coast Guard Station Miami Beach and delivered them to the Safety Board's Materials Laboratory for examination (see "Test and Research" section for more information).

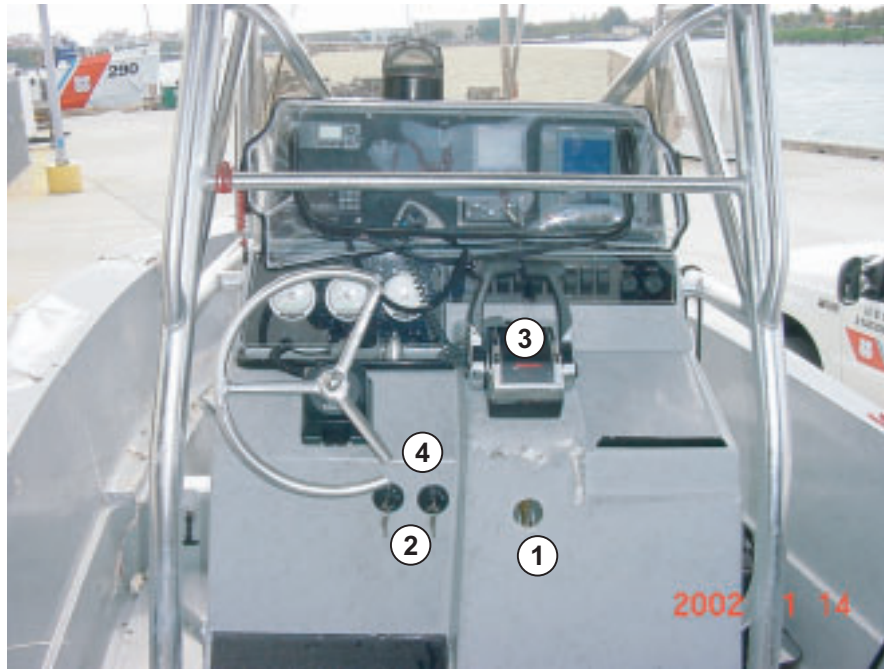
Figure 7. Postaccident photograph of Coast Guard patrol boat console.

1. Kill switch location
2. Engine ignition keys
3. Throttles
4. Damaged steering wheel

The ignition switches on the center console were found in the off position, with the keys inserted in the switches. The kill switch assembly was destroyed. The actual switch was found in the deck drain on the port side, along with, but not connected to, the kill switch lanyard. Inspection of the wiring harnesses inside the console showed that a connection was pulled apart. The connection was traced to the remains of the wiring to the kill switch. The steering wheel was broken and about a third of its circumference was missing, along with the knob on the wheel used for steering.

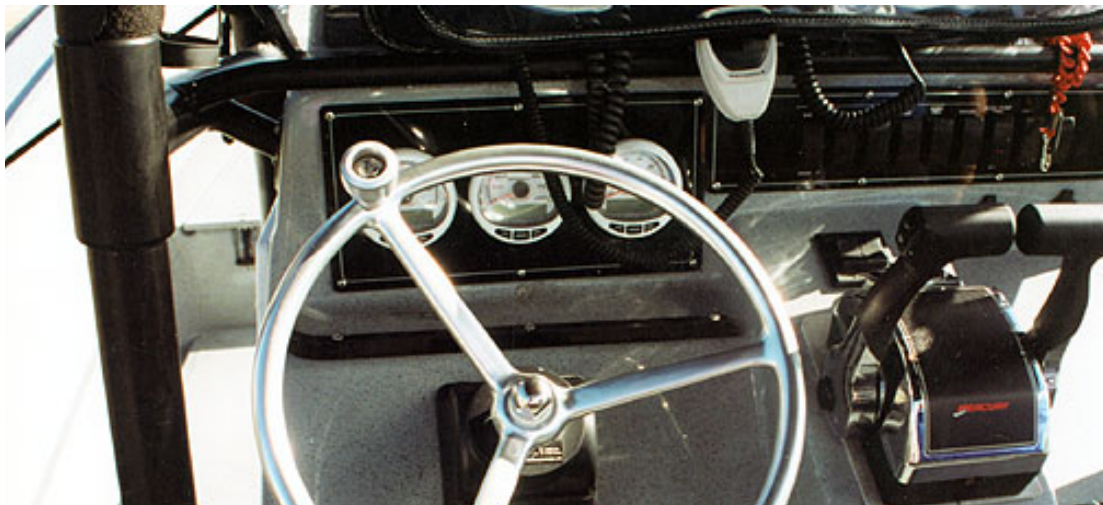
Figure 8. Patrol boat steering wheel, with steering-assist knob.

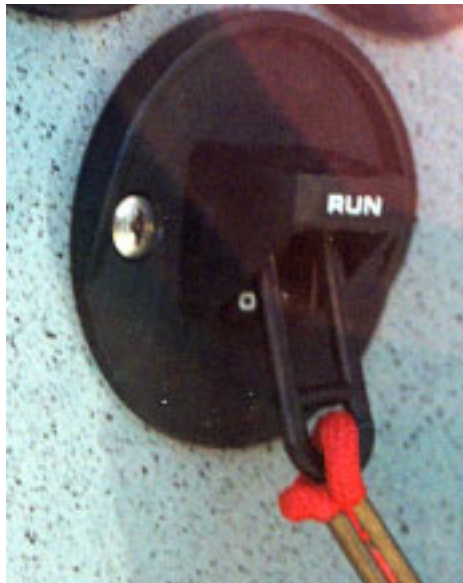
The Coast Guard patrol boat was equipped with a toggle-style engine kill switch (see figure 9), provided by MerCruiser, the engine's manufacturer. The kill switch was mounted on the aft vertical face of the center console, to the right of the engine ignition

Figure 9. Kill switch with lanyard attached.

The system is designed so that if the plastic loop and lanyard are pulled in any direction from the kill switch (when, for example, the operator inadvertently moves away from the console), the engines should stop. In such a system, the kill switch maintains an open circuit while the engines are operating. When the lanyard-and-loop assembly is pulled from the switch, the toggle closes the switch, which grounds the ignition circuits and shuts down the engines. When the kill switch is in the on position, the engines can be started regardless of whether the lanyard-and-loop assembly is in place.

The Coast Guard message also stated that kill switches must be used at all times while such boats are under way, and that kill switch lanyards must be attached to a metal D-ring on the coxswain's lifejacket or survival vest. The Coast Guard message equated the wearing of the kill switch lanyard to putting on a seat belt when operating an automobile. Further, the message required that the kill switch and lanyard be inspected daily, incorporated into a daily checklist, and tested weekly. It also stated that Coast Guard headquarters intended to have kill switches installed on all nonstandard boats, and that boats less than 40 feet long are to have kill switches installed within 24 months. Finally, the message mandated inspecting kill switch and lanyard configurations for condition and switch location, and making changes if necessary.

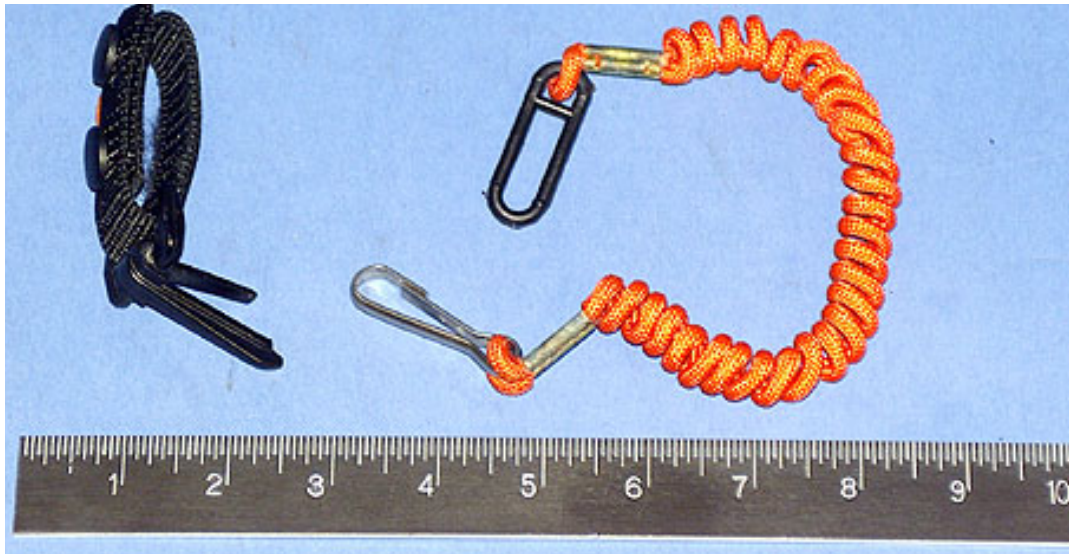
Figure 10. Belt loop with broken clip (left) and lanyard with metal clip and plastic loop (right).

The inside surface of the recovered part of the plastic clip from the belt loop showed several areas of damage and two smeared surface areas, each displaying a similar arced shape that matched the end of the lanyard’s metal clip. A V-shaped impression was observed where material had been displaced upward and outward. The V-shaped impression was deepest at the edge, and its direction was across the width of the clip, stopping just past the center. The edges of the fracture face were sharp and well-defined. The fracture intersected a void containing a series of surface lines emanating from the void. The void was located at the maximum material thickness of the section of the clip. According to the Materials Laboratory, the void was typical of a shrinkage void in an injection-molded product.
