# SNAG POINT EMERGENCY WATERSHED PROTECTION PROJECT

Dillingham, Alaska

## SUCCESS STORY

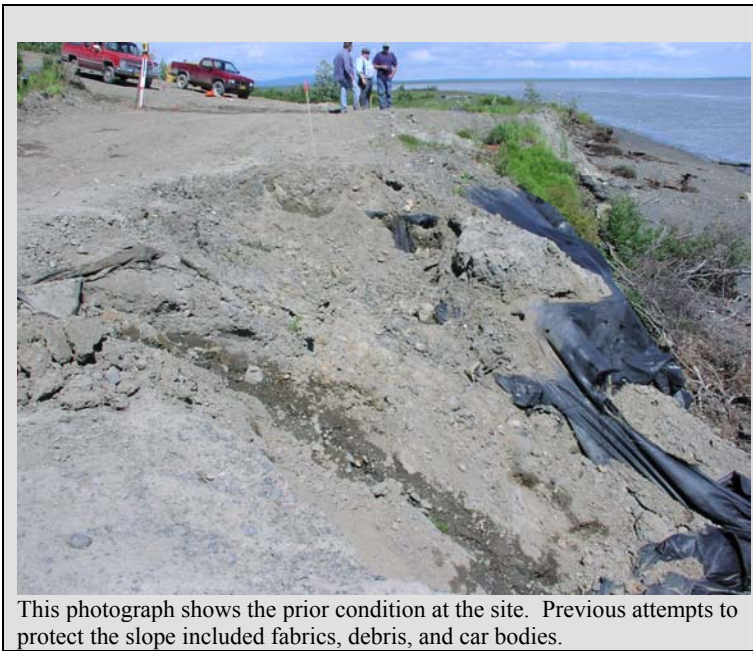
During a storm event November 11 – 13, 2000 approximately thirty (30) feet of bank along the Nushagak River was lost adjacent to a \$1.8 million sheet pile wall which was installed in 1999. The wall protects several homes, a church, fish processing plant and the city docks from a severely eroding bluff. In addition to the eroded bank, the upstream key of the sheet pile wall had material washed from behind it.

Temporary measures were authorized to check the erosion. Crushed car bodies and parts were used to armor the slope.

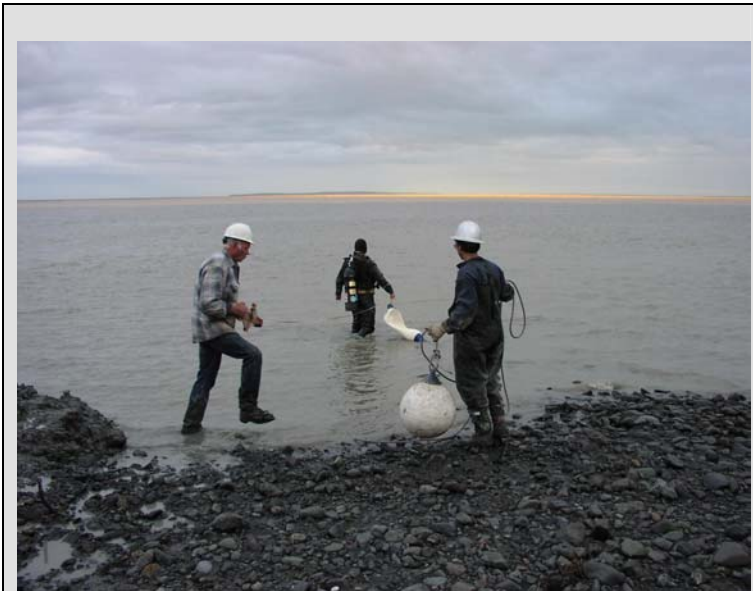
A diver wades into the Nushagak River to plug the end of the sewer outfall.

The City of Dillingham was responsible for replacing approximately 250 feet of the sewer outfall pipeline. It was buried significantly lower to protect the pipe. HDPE pipe was used for the sewer outfall due to its long life and durability.

Construction began by replacing the sewer outfall. The new section had to be spliced into the existing outfall. The existing outfall had to be plugged in

order to prevent the water from flowing back up the pipe with tidal changes while connecting the sections. This required sending a diver down to seal the end.

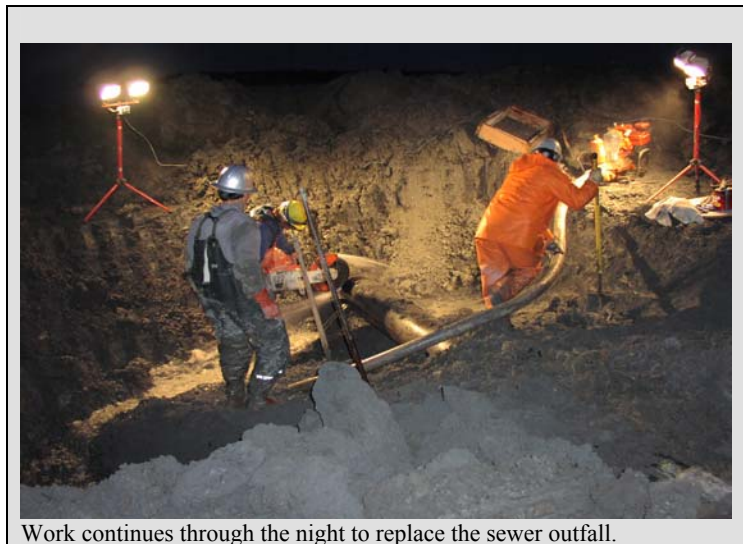
Work continues through the night to replace the sewer outfall.

Laying the pipe had to be completed during the lowest of low tides. The tides occurred late and required a flexible work schedule, including working through the night.

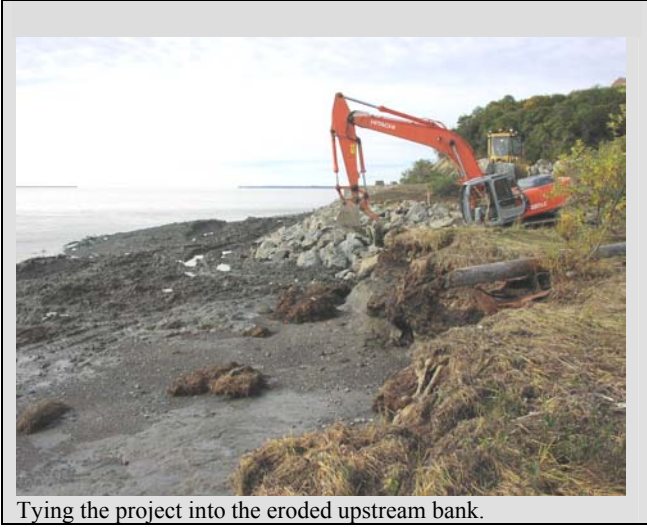
Tying the project into the eroded upstream bank.

Approximately 12 feet of shoreline was washed away upstream of the project.

This necessitated adjustments in order to tie in smoothly with the new landscape. The project withstood the storm with no damage.

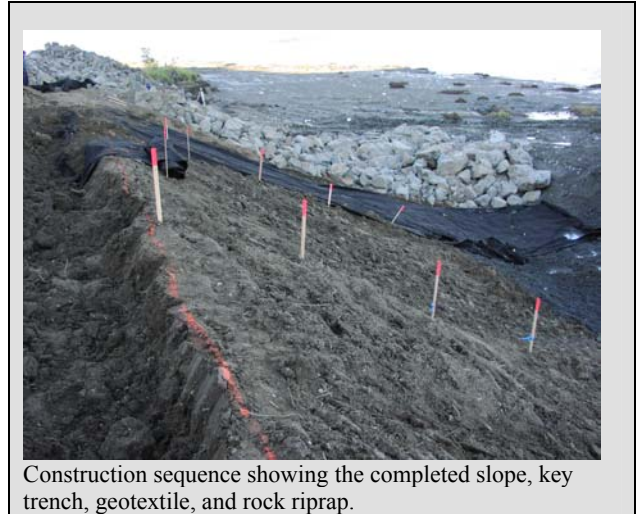
Construction sequence showing the completed slope, key trench, geotextile, and rock riprap.

After the sewer outfall was in place, work began on the rock riprap. A geotextile was placed followed by nine (9) inches of bedding material and six (6) feet of primary and secondary rock riprap.

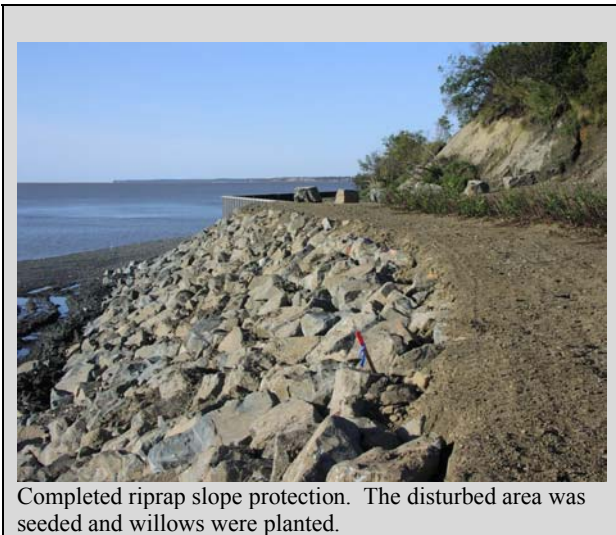
Completed riprap slope protection. The disturbed area was seeded and willows were planted.

As a final step, the construction area was graded and seeded. Willows were also planted behind the riprap. Vehicular access was blocked to protect the seeding and willows.
