REPORT OF INVESTIGATION

Underground Bituminous Coal Mine

Fatal Powered Haulage Accident
June 16, 2004

No. 7 Mine
Jim Walter Resources, Inc.
Brookwood, Tuscaloosa County, Alabama
I.D. No. 01-01401

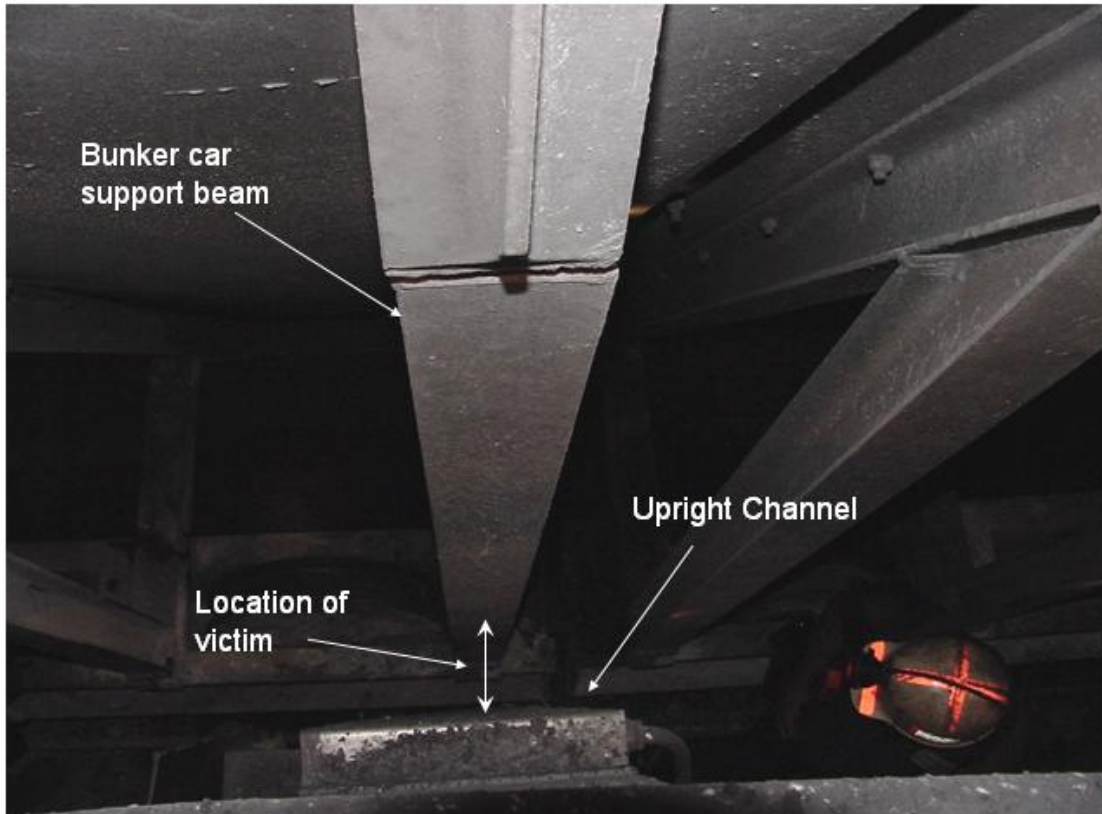
APPENDIX C
Photograph

The channel on which the automatic car position sensors were installed was attached to the pocket structure and extended upward and angled over to the elevated control room structure. The space between the upright channel and the bunker car support beams ranges from four inches to six inches. Ample walkway and work space were provided to the north, east, and west of the upright channel.

The victim's normal work duties included cleaning the area around the bunker and he was performing his normal job activity when the accident occurred. The victim was washing loose raw coal material away from the discharge end of the 60-inch wide bunker seal belt beneath the bunker car system and into the pocket. The victim was observed to be working from a position just east of the upright channel shortly before the accident and was likely working from this position when the accident occurred (see Appendix D). This was the best vantage point for seeing the discharge and for washing material away from the discharge into the pocket. The victim was likely leaning forward in the direction of the discharge with his right side and/or shoulder against the upright channel.

The bunker cars were being moved westward. A steel bunker car support beam likely contacted the victim's back. Due to the probable forward lean of the victim, the steel beam caused the victim to be trapped such that he could not back out of his position. The victim could not move forward due to the tight space (four to six inches) between the bunker car structure and the upright channel.

View from the catwalk in front of the production shaft control room above the accident site.

1. *Causal Factor:* The upright channel on which the automatic car location/position sensors were installed was not removed from the area though the system had been inoperative since shortly after installation.

Corrective Action: The mine operator removed the upright channel.

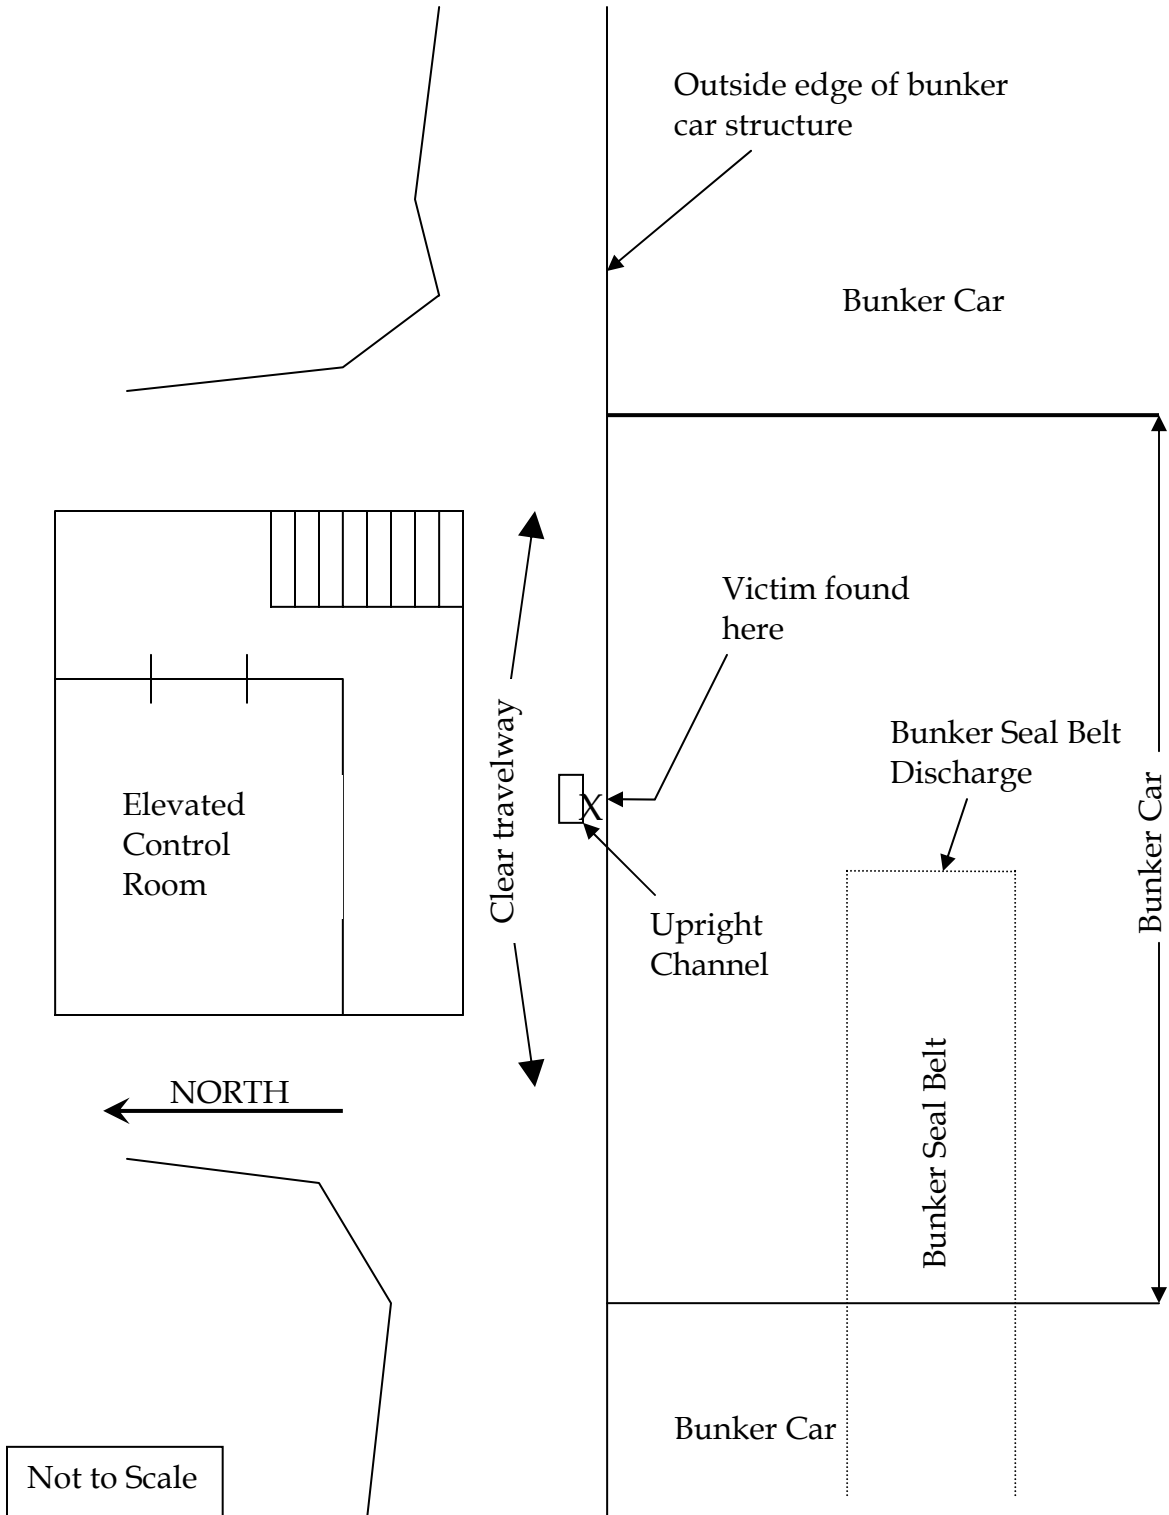
APPENDIX D
Diagram

The discharge end of the bunker seal belt is located southwest of the upright channel. The best vantage point for viewing the bunker seal belt discharge was on the east side of the upright channel facing the southwesterly direction. The most advantageous work position for washing material away from the bunker seal belt discharge into the pocket was on the east side of the upright channel due to the angle and visibility.

The continued westward movement of the bunker cars likely caused the victim to become entrapped between the upright channel and the steel bunker car support beam. When found, the victim was facing westward. There were no eye-witnesses to the accident.
