Type B Investigation Board Report
Worker Fall from Shoring/Scaffolding Structure
at the
Savannah River Site
Tritium Extraction Facility -
Construction Site
April 2, 2002

SAVANNAH RIVER SITE OFFICE
MAY 2002

May 13, 2002

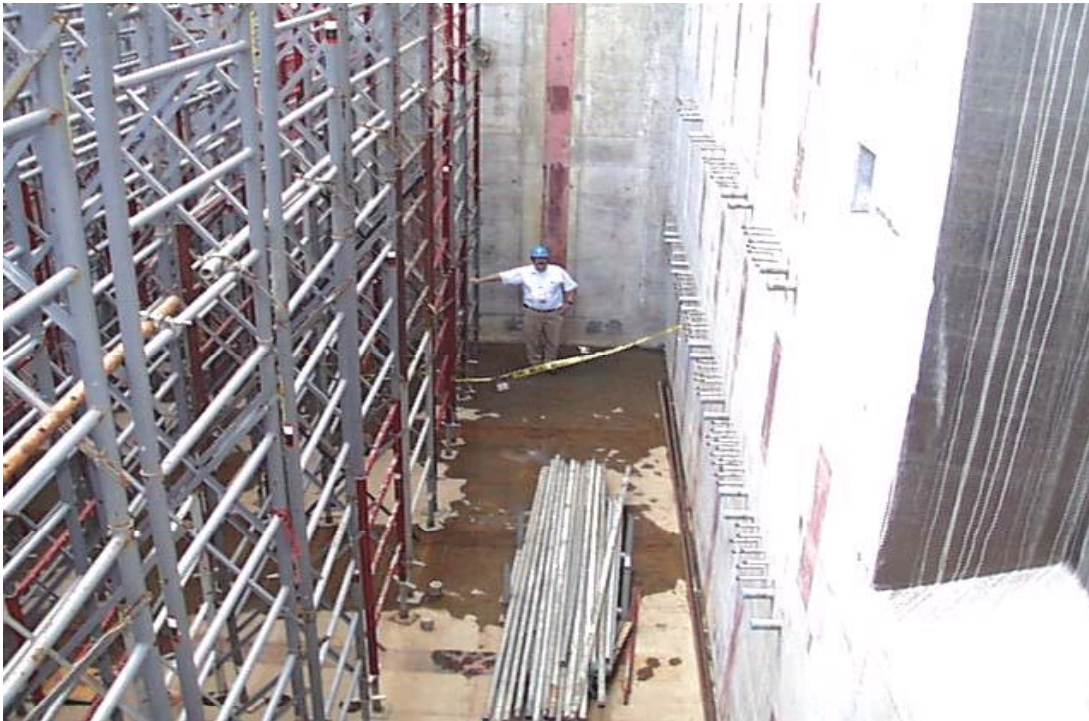
The BCSP stated that at some point after the carpenters had begun erecting the shoring/scaffolding, the WSRC Fire Department had toured the TEF construction site. One purpose of the tour was to evaluate possible challenges to the timely rescue of injured workers. The Fire Department personnel commented specifically on difficulties posed by rescues from the Furnace Room. The depth of the room, the close quarters imposed by the shoring/scaffolding system, and the height of the surrounding rebar all complicated potential rescues from the Furnace Room. (See Figure 3) Response and evacuation drills had also been

Figure 3 – Accident site (single person stairway out of view in foreground)

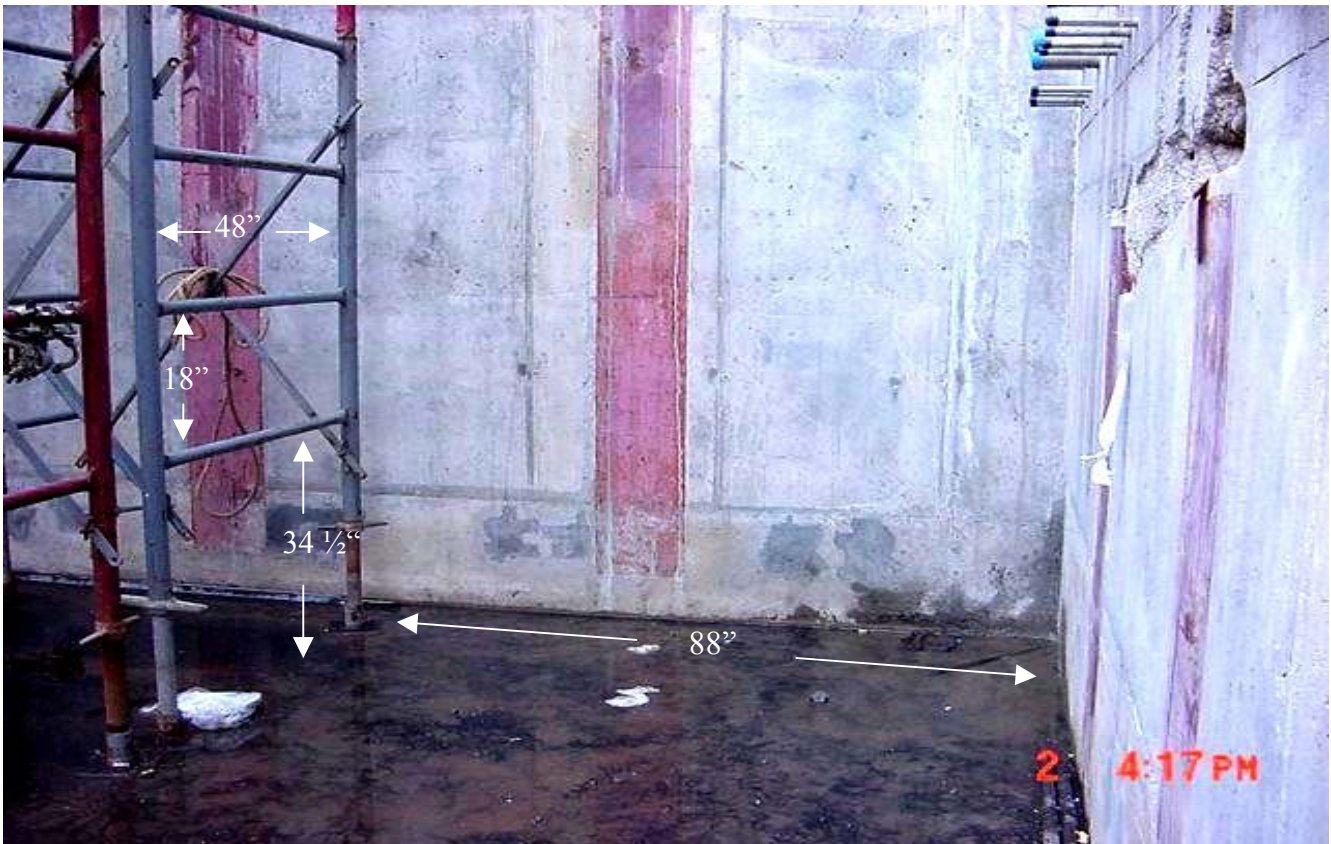
Figure 6 - Actual Accident Scene

The Board believed that C1’s head hit the wall first and that the broken right ankle may have been caused when his body landed on the leg. Although C1 could have landed on his feet, broken his ankle, and then fallen back into the wall (C1 is 70” tall and the distance to the wall is 88), the Board based its belief on the severity of C1’s head injury and on C3’s statement that C1’s head struck the wall before he fell to the floor. Falling to his feet first would most likely have reduced the force of the fall. Although the fall probably occurred as C1 was raising himself to the second rung and his right foot was no higher than 52”, a severe injury could result if his full weight (200 lbs + 25 to 30 lbs of tools) was behind the blow to his head. Similarly, the severity of the head injury together with C3’s impression of C1’s body position and impact point on the wall, does not suggest that C1’s feet slipped before his hands. The Board believed that if C1’s feet had slipped and then he broke his ankle, his fall would have positioned him closer to the scaffolding and he would have been less likely to strike his head with sufficient force to produce the head injury sustained.

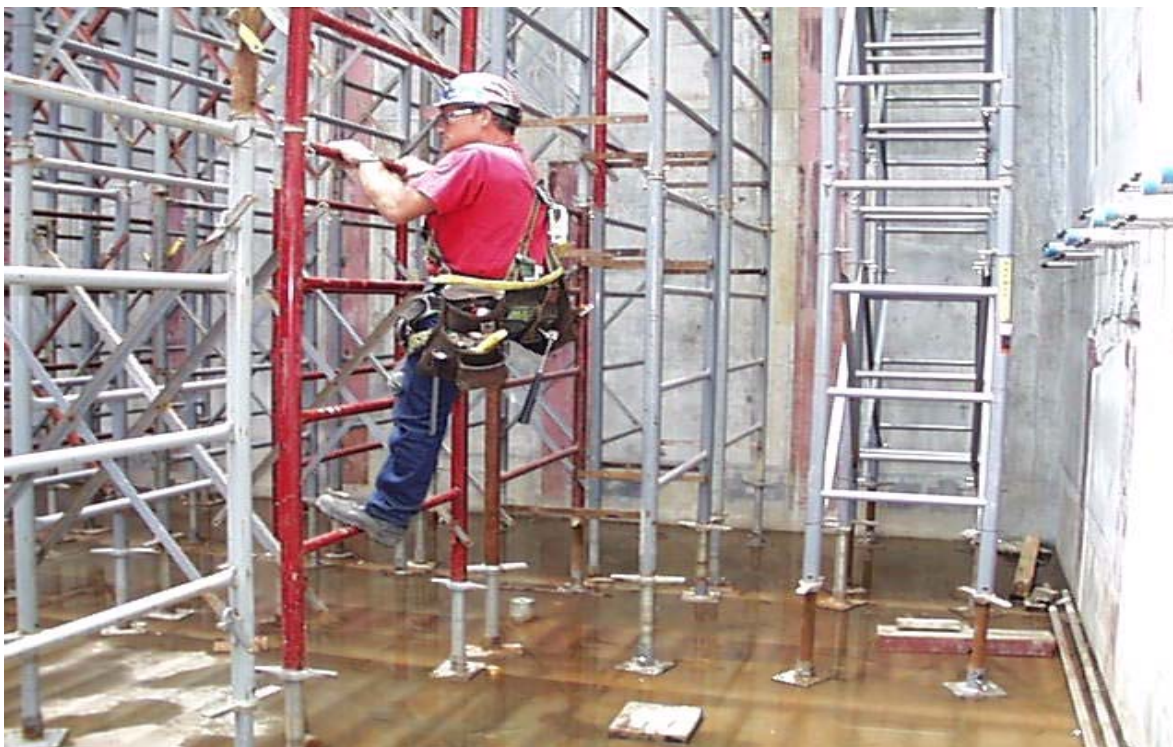
Figure 7 - Re-enactment of C1's position on shoring at time of fall

The shoring standard is silent on the topic of access to the structure. The scaffolding standard requires that a competent person determine a proper means of access and also states that, during erection, the end frames may be climbed. The Board’s examination of the shoring/scaffolding structure found that the distance between the Furnace Room floor and the first rung on each tower varied depending on needed adjustments to the screw jacks. The height to the first rung of the tower in question was found to be 34½”. The distance between individual rungs in the end frames was 18”. The scaffolding standard specifies a maximum of 24” to the first access point for workers using a work platform, but does not specify a maximum height for erectors. During a re-enactment of C1’s climb of the end frame of the tower, the worker stepped onto a jacking nut to get a boost to the first rung.

The structure was found to be stable for climbing at C1's position at the time of the accident, regardless of confusion generated by the designation of shoring versus scaffolding. The design of the structure was a rectangular array grounded on a level concrete slab, straight up to the floor level above, and assembly was uncomplicated. There were no special assembly or safety instructions, only general instructions for all applications. Although the construction of the structure was not under the supervision of a competent person from the beginning, this fact was not relevant to the accident. At the Board's request, Bell's competent person evaluated the shoring/scaffolding structure and confirmed the Safeway designer's opinion that the shoring met or exceeded the scaffolding requirements for structural stability.

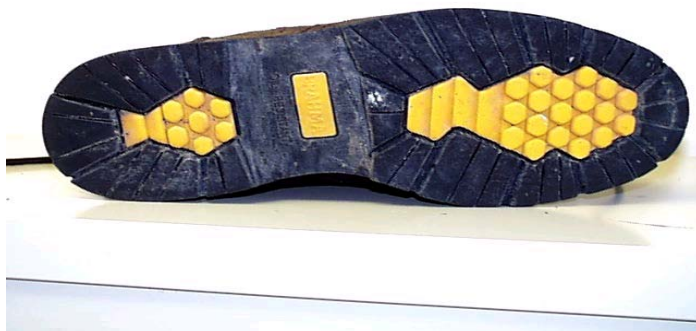
The uppers of C1's boots were made of thick leather for protection from scuffing and abrasions. For traction, the soles incorporated an improved slip resistant plastic insert at the ball of the foot and the center of the heel. The arch contained a label insert of the same plastic material. The outer edge of the sole was of durable material with radial configured tread seams. The soles were also oil-resistant as indicated on the arch of the sole. (See Figures 8 and 9) The boots showed some minor signs of wear but were still in very good condition.

Figure 9 - C1's boot showing oil resistant sole in good condition

Sturdy work boots with slip resistant soles were a good choice for the potentially slippery conditions that would likely be encountered for the combination of a general construction worksite, which may become wet and/or muddy, and for climbing on shoring or scaffolding. C1's footwear could also have been wet, and even though the boots were suitable for this use, traction could have been diminished.

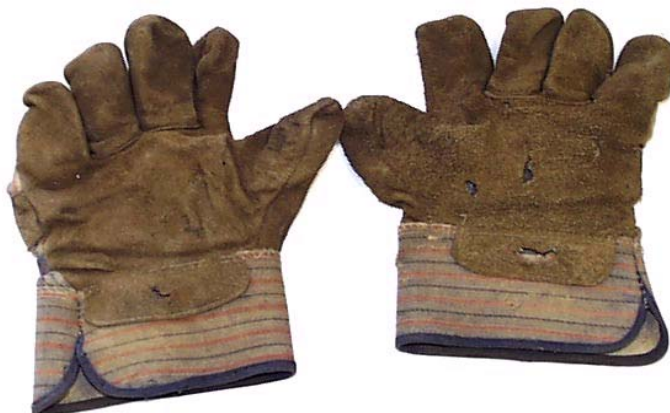
Figure 10 - C1's Gloves

Bell had provided gloves appropriate for general protection of the hands while handling steel shoring sections, as well as for climbing. C1's gloves were made of heavy leather with a rough outer surface for gripping. Generally, the gloves were in good condition although each had 3-4 small holes (less than the size of a dime) in the palm. There were no holes from the base of the fingers to the tips. The outer rough side of the leather was still well defined showing no significant signs of wear. (See Figure 10)

C1's work gloves may have been wet. Residual moisture on the shoring components and bracing materials was likely and C3, in an interview, reported that C1's gloves were wet. Even wet, however, these gloves were well suited for climbing and handling of shoring equipment and may actually have allowed for a better grip than dry stiff gloves. C3 stated that he sometimes removed his gloves prior to climbing scaffold or shoring, because he got a better grip on the painted steel with his bare hands. He then put his gloves back on to handle ropes and other materials. Bare hands might not always be the better choice either, particularly when it is wet and cold.
