System Failure Case Studies

DECEMBER 2006

SUBMARINE DOWN

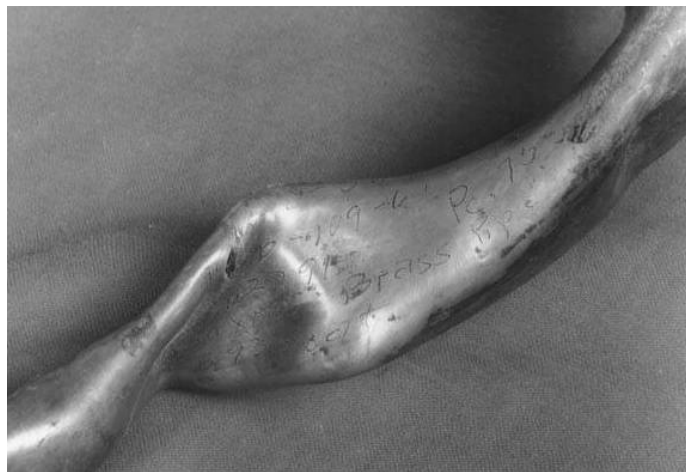
A section of brass sea water piping recovered from the USS Thresher.

According to published reports, there were perhaps several factors that came together to destroy the USS THRESHER and its crew. The leak itself probably occurred because of faulty brazing of the piping at the shipyard. Prior to the USS THRESHER loss, the installation procedure for pipes less than four inches in diameter was to put a silver ring at the joint between two points and braze it with a torch.

Subsequent investigation of other ships after the accident showed that, though joints created in this manner appeared solid, when broken apart there was no silver in them, indicating that they were much weaker than had been previously estimated. In general, the design and

As a result of the loss of the USS THRESHER, a major new initiative was undertaken by the Navy, called "SUBSAFE," to reform design and manufacturing processes (similar in many ways to changes at NASA following the Apollo 1, Challenger and Columbia disasters). Part of this initiative was to end the practice of brazing smaller pipes, and to instead start welding and doing x-ray inspection of joints to verify their integrity. It also resulted in changes in designs of the system that blows out the ballast tanks, providing a capability to do so seven times faster than the system used in the USS THRESHER.

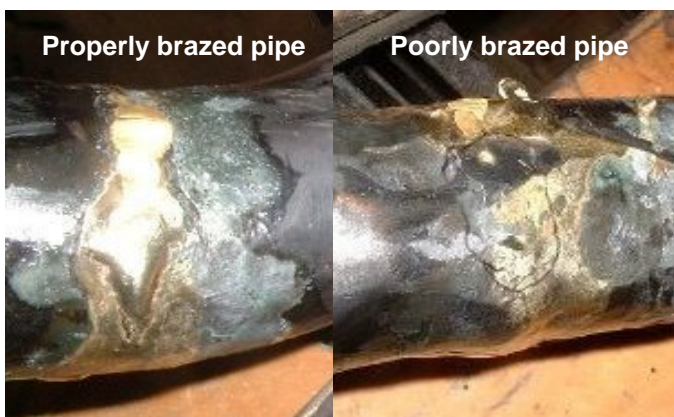
Poorly brazed pipes led to the electrical shortage that led to the loss of the USS THRESHER.

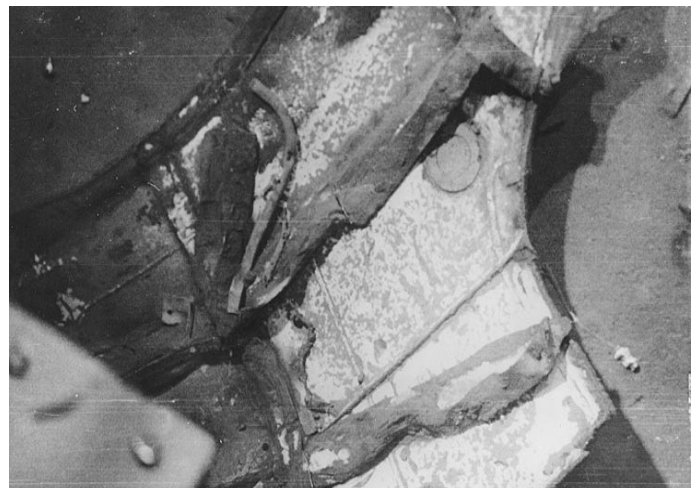
From this point on, the only sounds picked up by the open microphone were the distinctive and dismaying creaks of straining metal and fasteners as the craft sank deeper and started to crush under the unimaginable external pressure. The submarine eventually broke into several pieces, killing almost instantly all 129 crew and observers aboard. It continued to sink, falling almost two miles to the floor of the Atlantic, prematurely ending the career of the most advanced submarine built to that date.

Wreckage from the USS THRESHER's sonar dome can be seen on the ocean floor.
