ISS Fiber Optic Failure Investigation

Root Cause Report

August 1, 2000

**ISS Fiber Root Cause Investigation Team
Lead organization NASA GSFC
Sponsored by: NASA JSC and the Boeing Company**

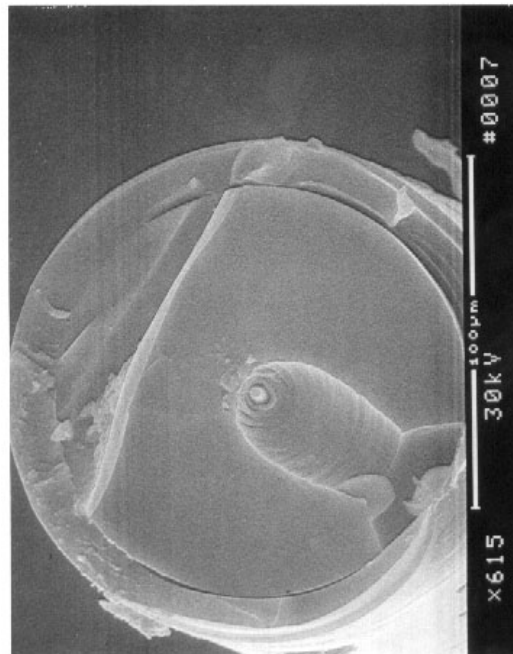
Figure 1 “Rocket Engine” Defect

In mid-1999 Boeing engineers were finding multiple failures of 1999 vintage NFOC-2FFF-1GRP-1 optical cable being used to fabricate harnesses for the International Space Station (ISS) program. This cable was used in U.S. Laboratory module, an element of the International Space Station, a deliverable under contract NAS15 10000. Not only were fiber breaks being detected during handling, but breaks were found over time with no handling (sitting on the shelf). This was believed to be a much different experience than was encountered during population of the U.S. Lab module with 6982 feet [ref-1] of 1996 vintage cable of the same part number. The Boeing materials and processes engineers performed destructive physical analysis (DPA) on the fiber at the break locations. Figure 1 shows one of the first images resulting from the DPA. The cone and bulb shape of the defect earned it the name “rocket engine”. This description replaced the term “bubble” which according to the fiber manufacturer, is associated with a topology that is unique and not represented by Figure 1.

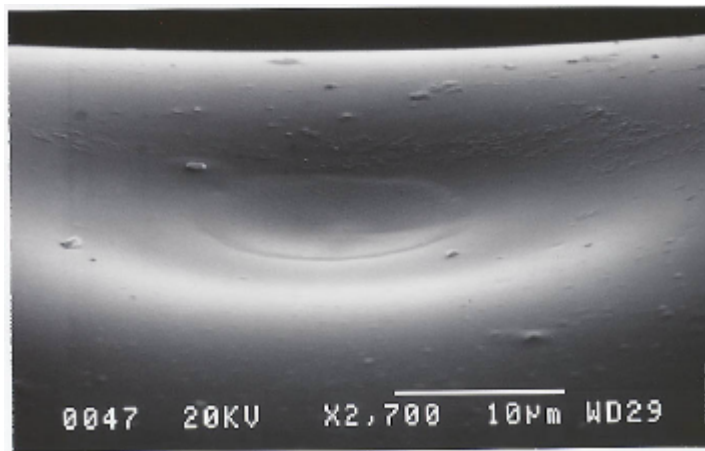
Figure 5 Sink in the Polyimide Coating

Figure 1 above is one of the very first images of a rocket engine defect made available by Boeing-HB. Subsequent DPA's found other important features, which ultimately led to the HF etching theory. These are shown in Figures 5 through 10.

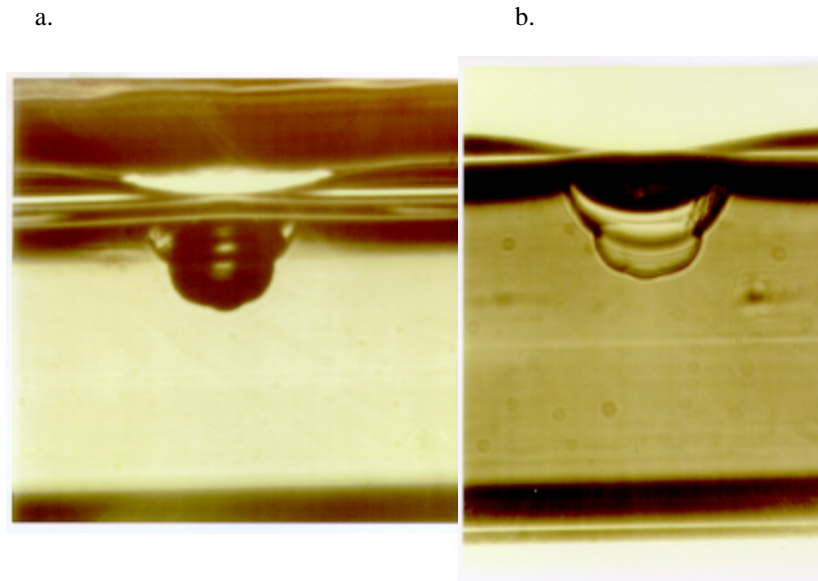
Figure 11 Defect Inspection Using Index Matching Oil

The use of index matching oil and backlighting during imaging was found to greatly enhance the optical microscope images. After submersion of an intact piece of fiber in index matching oil and having left the sample overnight, the oil was found to have filled the “rocket engine” void (Figure 11a and 11b). This indicated that the surface of the “rocket engine” defect was exposed to ambient atmosphere.

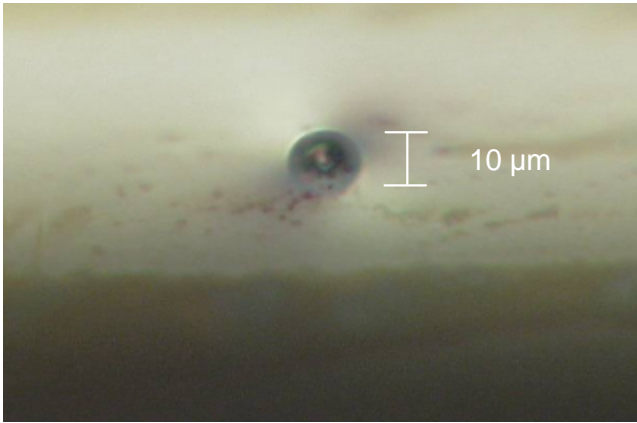
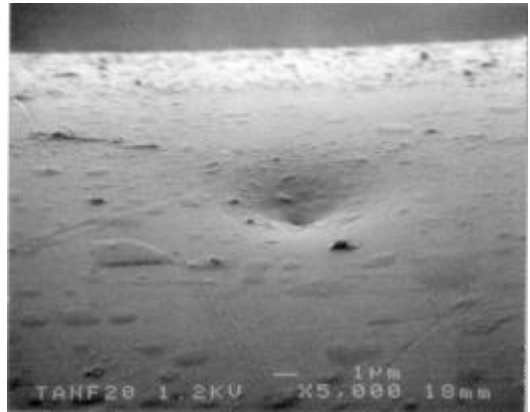
Figure 12 Depressions and Bubble in Polyimide Coating in Fiber CD0588XD

Optical inspection was used to examine the polyimide surface of fiber containing “glows”. Features were found resembling depressions and buried bubbles (Figures 5-8, 10, and 12). Field emission scanning electron microscope (FE-SEM) inspections were also performed on 6” samples from two lots of fiber which had never been cabled by BICC (Figure 13) [ref 8]. The samples were from reels CD0588XD and CD0384XB. Though both lots were found to weaken due to the cabling processes, the CD0588XD fiber was found to be more dramatically weakened than the CD0384XB (see Section 7.0). Sixteen features were found in the polyimide in the “588” sample and one was found in the polyimide in the “384” sample (four more features were found in an additional sample of “588” fiber). An hour glass-like shape was found to be very common among the bubbles observed, as is shown in Figure 13.

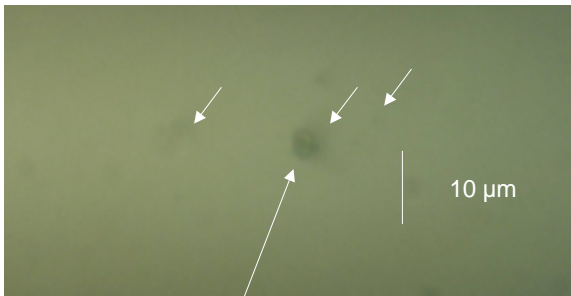
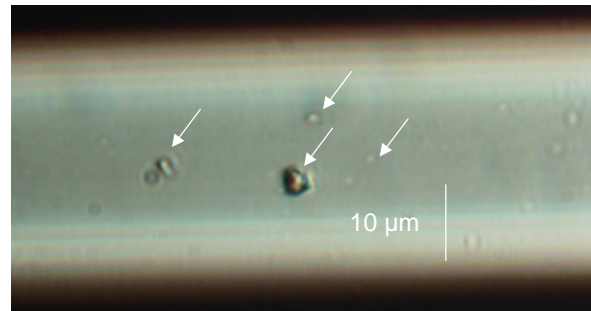
Figure 15 Carbon Defects Seen Below Polyimide on Sample of CD0588XD Fiber

Additional work with these samples was done to catalogue their relationship to breaches in the carbon coating below them. Not only were breaches found below some of the bubbles, but others were found in the vicinity of the bubbles but with no bubble on top of them as seen in Figure 15a and b.

a. Features Below Polyimide Bubble, Reflection Mode 100x, 0.3 μm Resolution

b. Polyimide Etched off with Sulfuric Acid, Multiple Bright Spots at Carbon Coating Surface, Transmission Mode

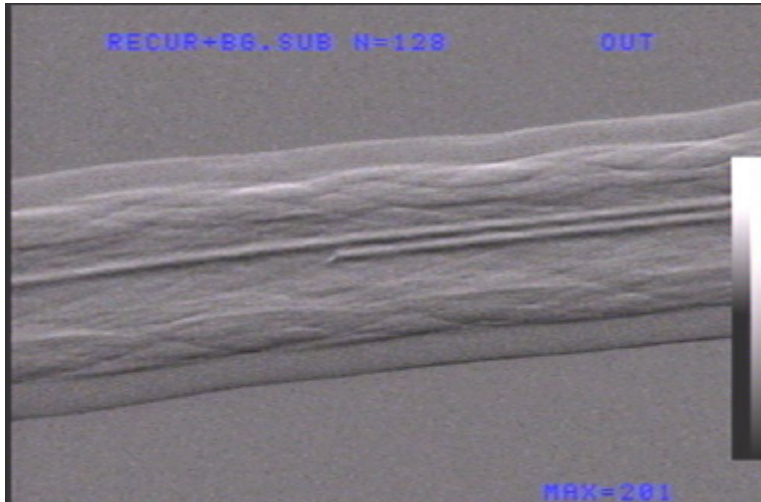
Figure 16 E. Banks' Sample With a Broken Fiber Whose Ends Overlap

X-ray was used to see if defects on the surface of the coated fiber could be detected. Figure 16 shows that X-ray can be used to look at the fiber without removing the cable elements which is useful for inspecting for fiber which may be too long for the jacketing (in cases where the jacket and/or buffer has shrunken).

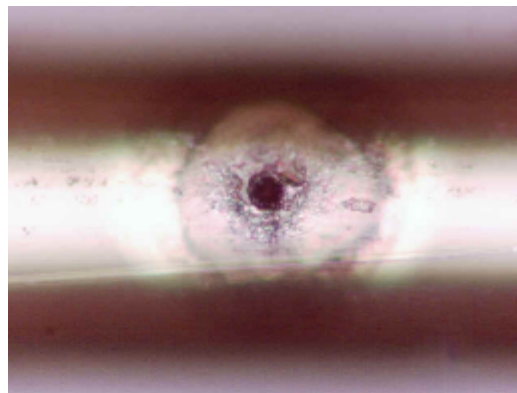
Figure 22 Burn Mark From DWV Testing of “Rocket Engine Defect”- Free Fiber

The final thickness of the polyimide on the BF04515 is 15 μm (0.60 mils). The cure schedule used may make its mechanical and electrical characteristics differ from DuPont's published values [ref-12]. The polyimide coating on a sample of BF04515 fiber, which had never been cabled, was tested for dielectric strength. Several lots were not tested so we do not know how the value may vary on a lot basis. A value of 6.5 kV/mil in 50% humidity [ref-15] was measured (See Section 6.5 below for the test set-up and more discussion about ESD testing). DuPont's published value for fully cured polyimide is 4.0 kV/mil at 50% RH. Burn marks were found on the sample tested (Figure 22).

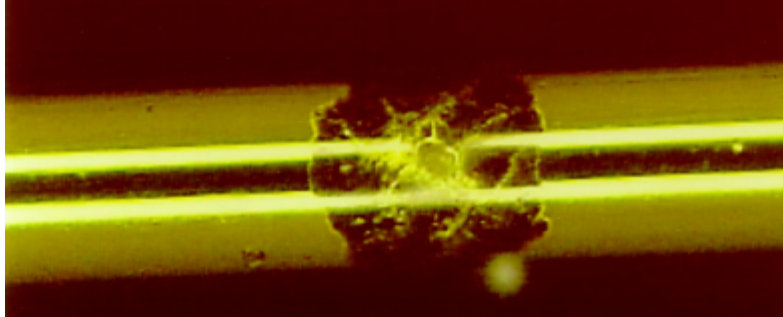
Figure 23 Burn Mark From DWV Testing of Fiber with “Rocket Engine Defects”

Another test was done on fiber that was removed from NFOC-2FFF-1GRP-1 cable that was known to be defective (several “glows” found along its length, at least one of which was DPA’d and found to be a “rocket engine”). A voltage of 1.5 kV was enough to break through the polyimide between two electrode locations and sustain a current down the carbon coating between them. A burn-mark was created when the voltage was raised to 2.5 kV (Figure 23).

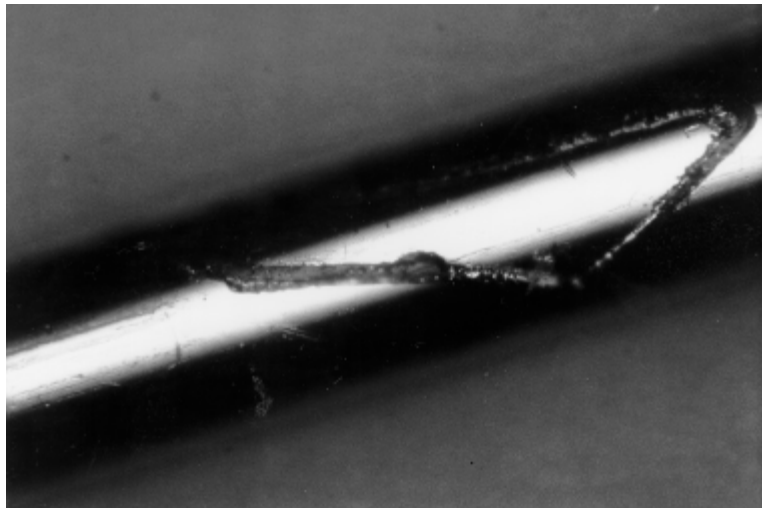
Figure 28 Electrical Discharge Induced Damage on Fiber Surface

Testing was also done with a 30 kV Tesla coil to demonstrate the conducting behavior of the NFOC-2FFF-1GRP-1 cable. When the Tesla coil tip was placed about a centimeter from the cable, the tip of the coil emitted a spark that was drawn to the cable. This spark was drawn along as the tip of the coil was moved along the cable. Upon removal of the fiber from the cable sample, the trench shown in Figure 28 was observed. Though it is not obvious in the photograph, particles believed to be polyimide surround the blackened edges of the trench suggesting that all of the polyimide did not vaporize and some of it was redeposited around the site near the trench. This demonstrated that high electric fields can cause charge travel all the way through the cable layers and damage the fiber coating.
