Report Number NTSB/AAR-86/02

Report Title Air Canada Flight 797, McDonnell Douglas DC-9-32, C-FTLU, Greater Cincinnati International Airport, Covington, Kentucky, June 2, 1983 (Supersedes NTSB/AAR-84/09)

Report Date January 31, 1986

Report Type Aircraft Accident Report June 2, 1983

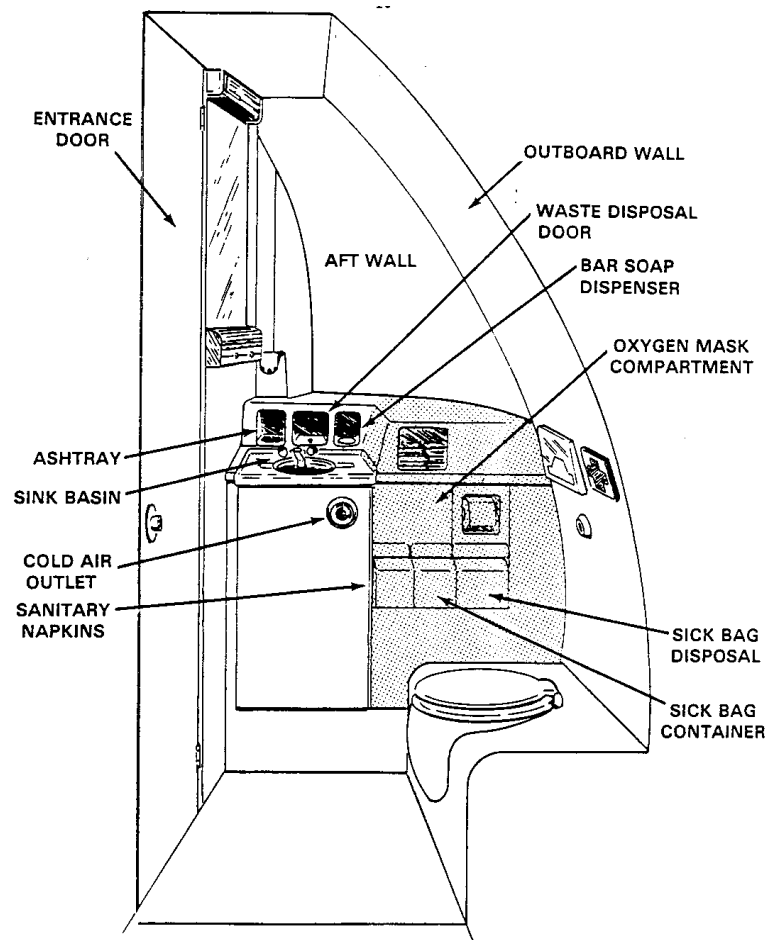
Figure 9.--Diagram of aft lavatory, viewed aft.

The aft lavatory was on the left side of the cabin, and began at FS 965 and extended aft to FS 1019, or just forward of the aft pressure bulkhead. The lavatory's outboard wall conformed essentially to the shape of the airplane's fuselage. There was a vanity section containing a stainless steel sink and amenities located along and extending forward from the aft wall. The commode containing a flushing motor was located along the lavatory's outboard wall. A trash chute and container were located below and behind the sink, and a fresh air supply outlet was positioned below the sink in the door of the vanity. Also, below the trash container, an aluminum shelf was installed. In addition, there was an oxygen outlet located in the oxygen mask compartment in the amenities section. (See [figure 9](#) and [figure 10](#).)

The aft lavatory was damaged extensively by fire and heat. Most of the lavatory's interior walls had been burned away. The entry door, which had been kept closed, was destroyed except within 16 inches of the floor. The aft pressure bulkhead and fuselage skin which comprised the outermost portion of the lavatory enclosure were intact, but were buckled and discolored to dark brown.

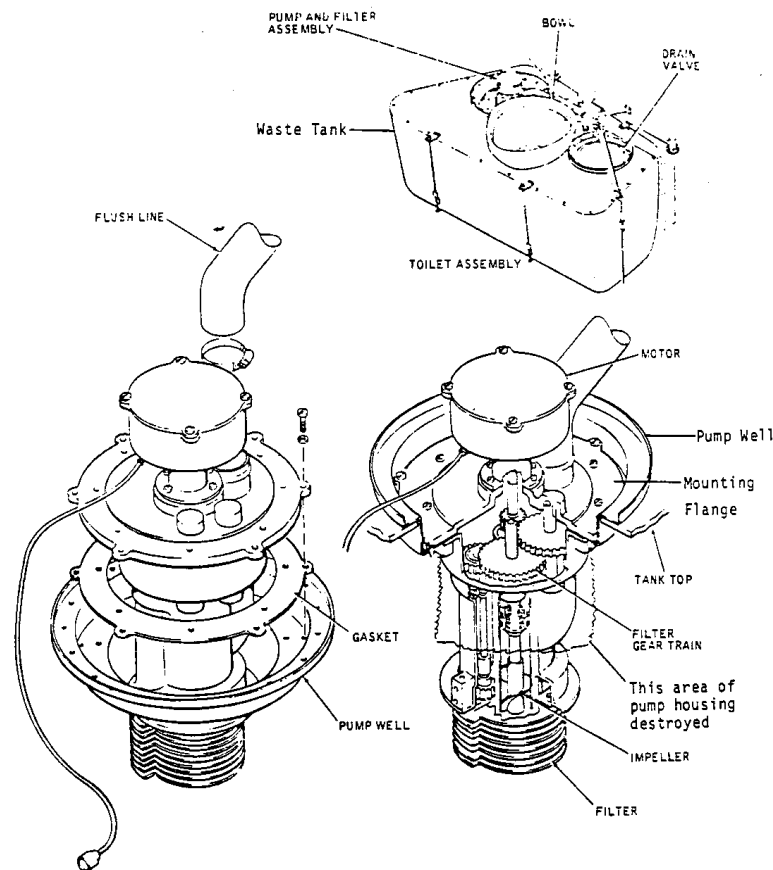
Figure 11.—Lavatory pump and filter system.

The flush motor was found attached to its mounting flange which was attached to the pump well. The flush motor assembly was found in approximately its normal position in the waste tank next to, but detached from, the flush pump and filter assembly. The motor housing was completely melted. Large concentrations of molten metal were found on the forward side of the mounting flange facing the toilet bowl, and on the aft side where the 3-phase electrical leads enter the motor housing. A portion of the wiring harness which supplies a.c. power to the flush timer, flush motor, and flush button was encased in the molten metal on the aft side of the motor. The rotor section of the flush motor was encased in molten metal above the field windings; however, the rotor did not appear to have been damaged extensively by heat. [\(See figure 11\).](#)

The flush pump and filter assembly found in the waste tank was partially intact. The filter and pump mechanisms, which apparently had been located below the water line in the waste tank, were in good condition. Above the water line, the plastic housing for the pump and filter was melted away. This housing also encloses the filter gear train and is part of the assembly used to mount the pump and filter to the pump well. The exposed shaft and gears showed heat damage. The gears, which make up the filter gear train that connects the motor to the pump and filter, were found lying in the waste tank. The plastic mounting ring, which mates the pump and filter housing to the pump well, was found intact among the debris in the waste tank. There was some slight melting of the top surface of the mounting ring. All of the components of the flush motor and pump assembly were removed for further examination.

When the flush motor and its associated mounting were removed from the toilet tank, two wires in the motor harness and all of the wires in the power harness broke just aft of the motor housing due to brittleness. To facilitate removal of the flush motor assembly, the remaining wires of the motor harness were cut a few inches aft of the motor housing and tagged for identification.
