MIFACE INVESTIGATION: #03MI202

SUBJECT: Farmer Died When Crushed Between Tractor Steering Wheel and Enclosed Feed Auger

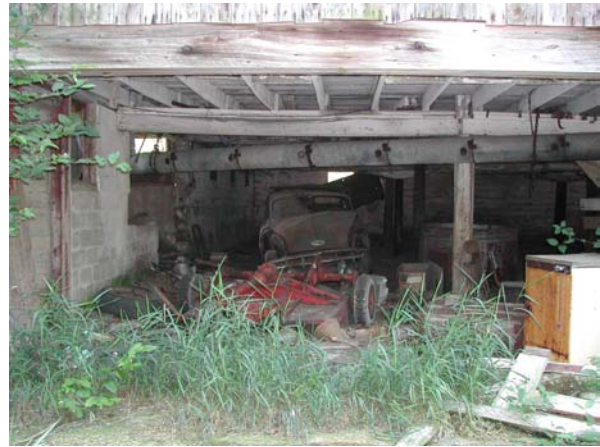
On September 5, 2003, an 87-year-old male farmer died while backing his Oliver Super 77 tractor with an attached 5-foot cut rotary mower into a storage area in a barn (See Figure 1). He placed the tractor in reverse to back the rotary mower into the barn. The sequence of events is unknown. It appears that the left rear tractor wheel tire traveled over a portion of a doorframe on the ground and raised the tractor. This caused the victim to duck his head to avoid the ceiling beam or he did hit his head on the barn beam and then had difficulty engaging the clutch to stop the tractor. At some point, the rotary mower began to jackknife, hit a car also stored in the barn, and continued to the barn wall. The tractor continued in reverse approximately another 12-15 feet. Running the length of the storage area was an enclosed round feed auger which was 71-inches from the ground. The victim, sitting in the tractor seat, was pinned between the enclosed auger and the tractor steering wheel. When he did not return as expected, his wife went to look for him in the fields. Not finding him, she called her son, who found the victim. Emergency response was called, the tractor moved forward, and the victim removed from the tractor seat. He was declared dead at the scene.

Figure 1. Storage area in barn for rotary mower

- Keep floor areas where equipment is stored clear of objects that might impede the positioning of stored equipment.

The broken doorframe limited the maneuvering room the victim had to park the cutter. Keeping storage areas clean, entrances and exits clear, properly storing tools, other items and equipment or materials in their proper storage area, and discarding broken containers and damaged materials are work practices that eliminates clutter and ultimately can reduce the risk of accidents, both to an individual and equipment.

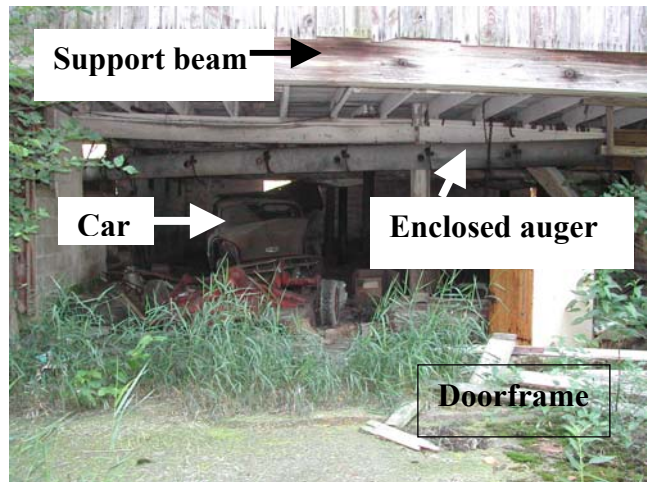
The barn where the victim stored the rotary mower was previously used for his dairy cows and beef cattle. The barn was located on the north side of his residence. The victim stored the rotary mower on the lower level of the barn. The lower level was open the length of the barn. The victim used only one area to store the mower. (See Figure 3) The barn's support beam was 82.5 inches from the ground to the bottom of the beam. Approximately 12-15 feet inside the barn was a round feed auger within in steel enclosure, running along the ceiling of the lower level. The auger enclosure was 71 inches above the ground at its lowest point. Behind the auger enclosure was an old car. On the ground under the barn's support beam was an old, broken doorframe that limited the victim's maneuvering room to a nine foot wide opening to back the rotary mower into the barn's lower level. The grassy area in Figure 3 is the location of a slight incline to enter the barn.

Figure 3. Enclosed auger, doorframe, car, support beam

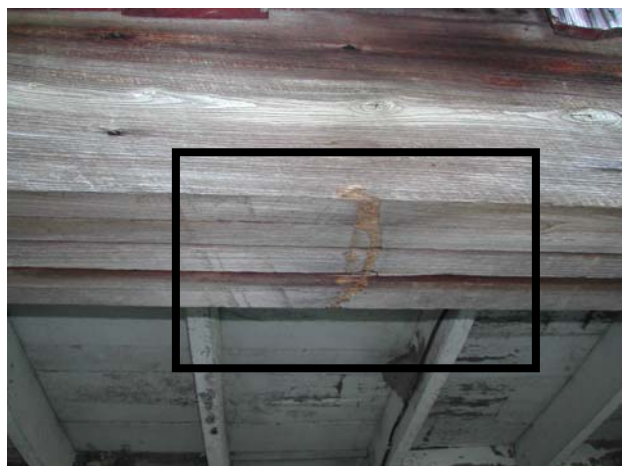
Figure 7. Mark on beam made by muffler

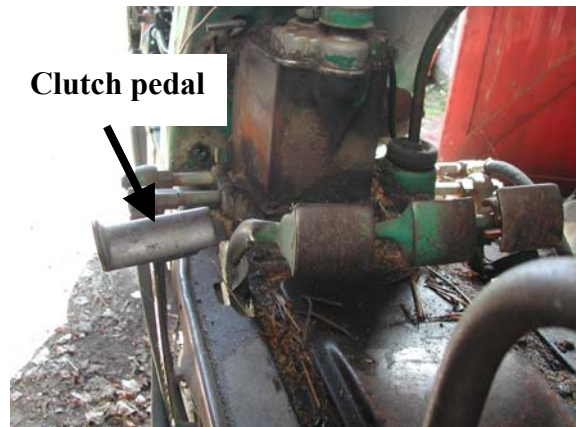
The operation of the Oliver Super 77 tractor clutch makes backing up potentially difficult because of the clutch pedal's relationship to the operator's seat and its lack of aggressive surface. (See Figure 8) A tractor operator's left foot may slip off of the clutch pedal while turning their body when traveling in reverse due to the lack of aggressive tread on the pedal. The tractor's clutch pedal was smooth and may have been a contributing factor in this fatal incident. Newer tractors have incorporated an aggressive surface and, over the years, modified the foot pedal design and placement to increase the operator's ability under routine and/or non-routine working conditions to initiate and maintain contact with the pedal. On older tractors, a possible solution to increase and maintain contact with the foot pedals is to "rough up" (i.e. crosshatch design) the pedal contact surface with a 4-inch portable grinder (See Figure 9). Addition of a non-slip surface, or a rubber pedal cover to the foot pedal surface is another option.

Figure 8. Oliver Super 77 clutch pedal

- Consider adding roughness to smooth clutch or brake pedals by using a 4-inch portable grinder or welding a bead of metal, or cover the pedal with a non-slip surface for added foot pedal control.

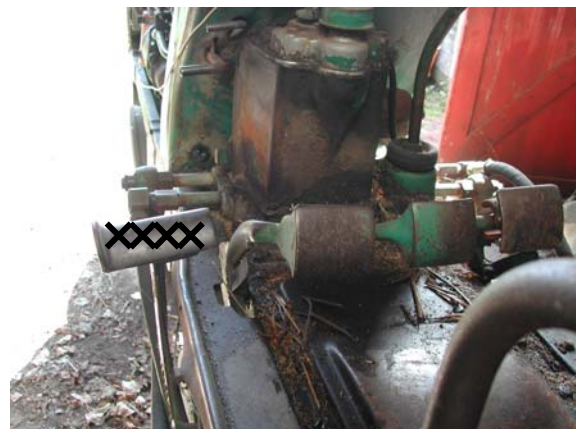
Figure 9. Crosshatch design on clutch pedal
