**2004 Operations, Maintenance,
and Monitoring Report**

Cameron Creole Plugs Project

State Project Number CS-17
Priority Project List 1

May 2007
Cameron Parish

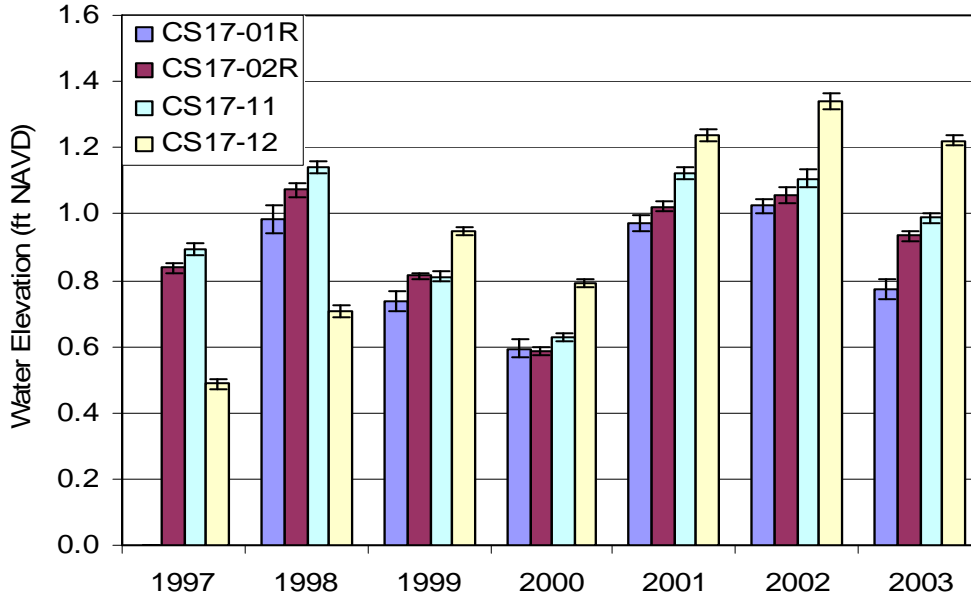
Figure 13. Yearly water levels at each of the stations since 1997. Station CS17-12 has increased relative to the reference stations since 1997.

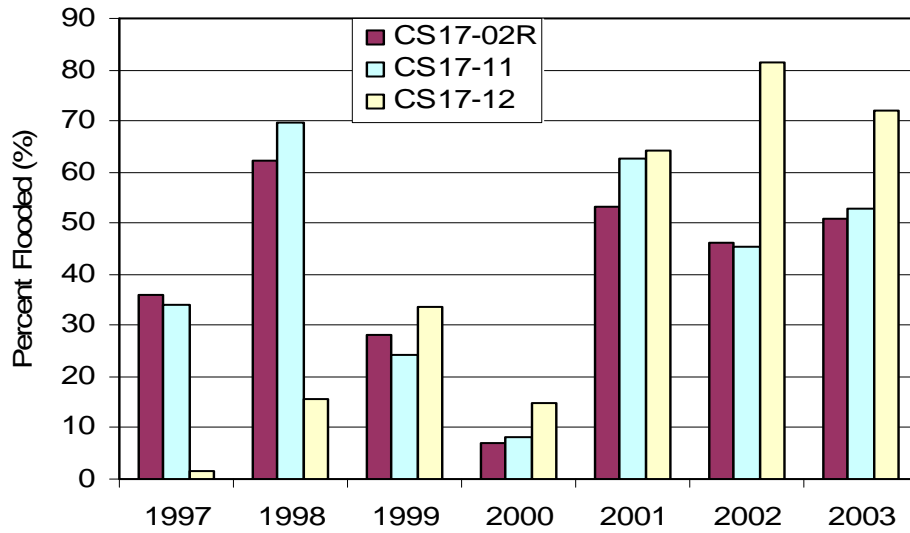
Water levels were lower at station CS17-01R than the other 3 stations in 2003 (figure 12). Water levels were highest at CS17-12 ($p < 0.0001$). Stations CS17-02R and CS17-11 had approximately the same mean water level for the year. Water level and the percent of time the marsh was flooded at station CS17-12 in the southern project area has increased relative to the reference station CS17-02R since 1999 (figures 13 and 14). One goal of the CS-17 project was to decrease the duration of flooding in the southern project area. These data show that water levels have increased in the southern project area.

Figure 14. Percent of time the marsh was flooded at recorder stations in the CS-17 project area. Station CS17-12 has increased since 1999 relative to the reference recorder.

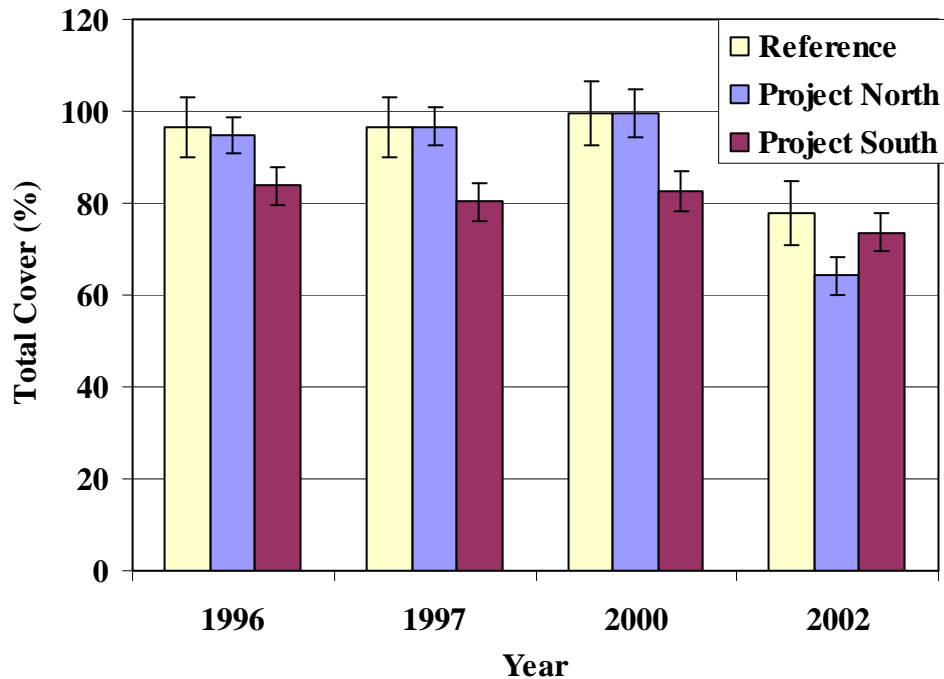
Figure 15. Total percent cover in the two project and reference areas for each sampling year for the CS-17 Cameron Creole Plugs project (LS Mean \pm SE). Cover in 2002 was significantly lower than the other sampling years ($p < 0.0001$). There was also a significant interaction between project/reference areas and years ($p = 0.0211$). Post-ANOVA contrasts showed that the Southern Project area was significantly lower than the Reference area in both 1997 and 2000. The low cover values in 2002 could be due to increased frequency of inundation in 2001 and 2002 (figure 14).

Percent cover of emergent vegetation was relatively similar in the northern project and reference area until 2002 (figure 15) when cover decreased in both the northern and southern project areas. Cover in the southern project area has been lower than in the reference area throughout the project. The decrease in cover could be due to increased frequency of inundation in 2001 and 2002 (figure 14) but that alone would not explain loss of cover in the northern project area because inundation there was approximately the same as the reference area which did not decrease as much as the northern project area did. SAV decreased in 2000 and returned in 2002 (table 3). Changes in SAV are most likely due to changes in salinity from year to year (figure 11).

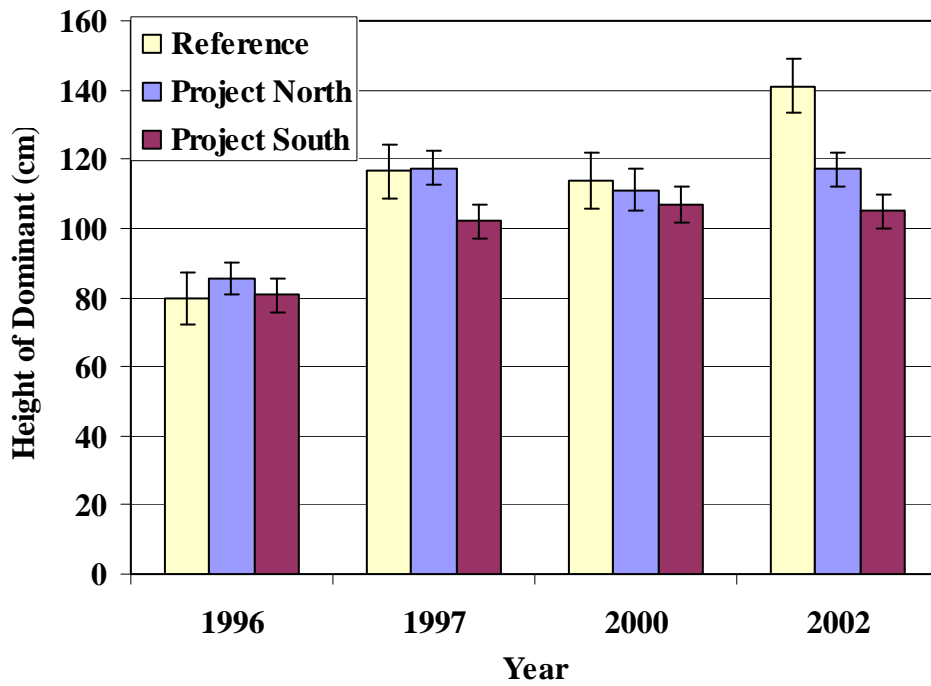
Figure 16. Height of the dominant species (*Spartina patens*) in the project and reference areas for each sampling year for the CS-17 Cameron Creole Plugs project (LS Mean \pm SE). The Southern project areas was significantly lower in height in 2002 ($p=0.0143$). This may be due to more flooding (figure 14).
