THIN BONDED OVERLAY AND SURFACE LAMINATES

**Bridge Deck Overlays Constructed by
The Ohio Department of Transportation**

HAN - 75 - 1383

HAN - 235 - 0652

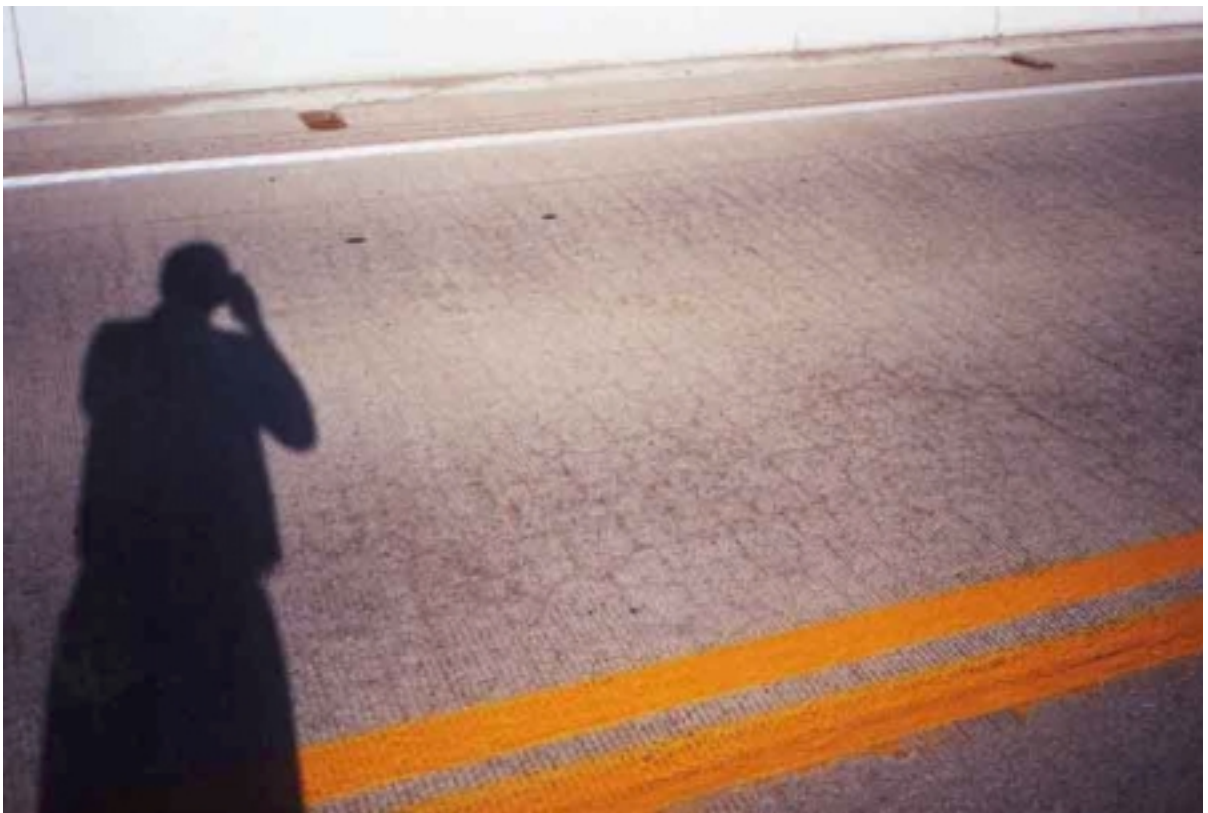
Visually, the overlay was intact with no apparent delaminations. There were many cracks on the surface; some transverse and some map type. It appeared that many of the cracks had been filled with an epoxy or methylmethacrylate. The bottom of the deck had some transverse cracks which exhibited efflorescence; three small (2 sq. ft. or less) areas of exposed bottom mat rebar, two areas of small (less than 2 sq. ft.) full depth patches and a few areas of apparent leakage (very minor).

The Microlite Modified Concrete overlays used on these two bridge decks are holding up very well with no delaminations. The only visual imperfection noted is a significant amount of alligator cracking on bridge no. HAN-235-0652. The cracks, however, are tight and appear to have been sealed with a high molecular weight methacrylate (HMWM) sealer. Apparently these cracks appeared during and immediately after construction (probably due to drying/plastic shrinkage) and are not getting worse.

Map cracking of wearing surface

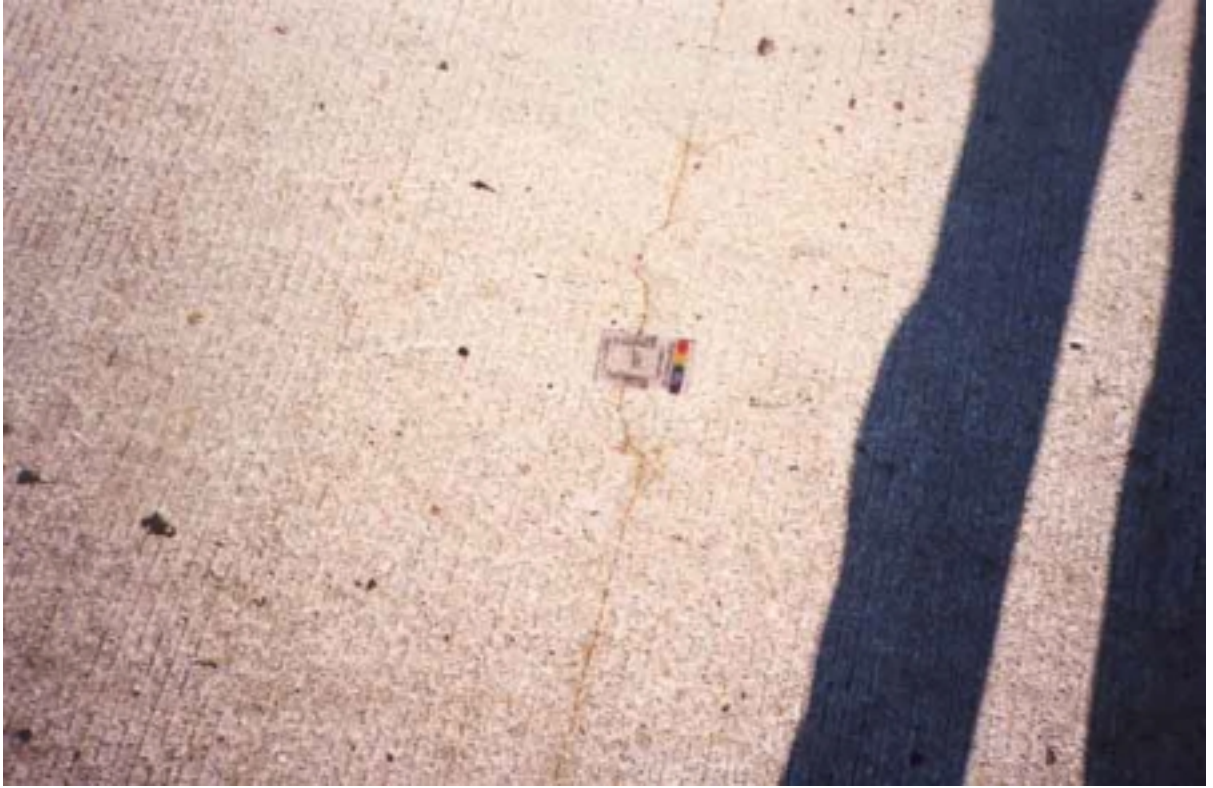
Typical cracking

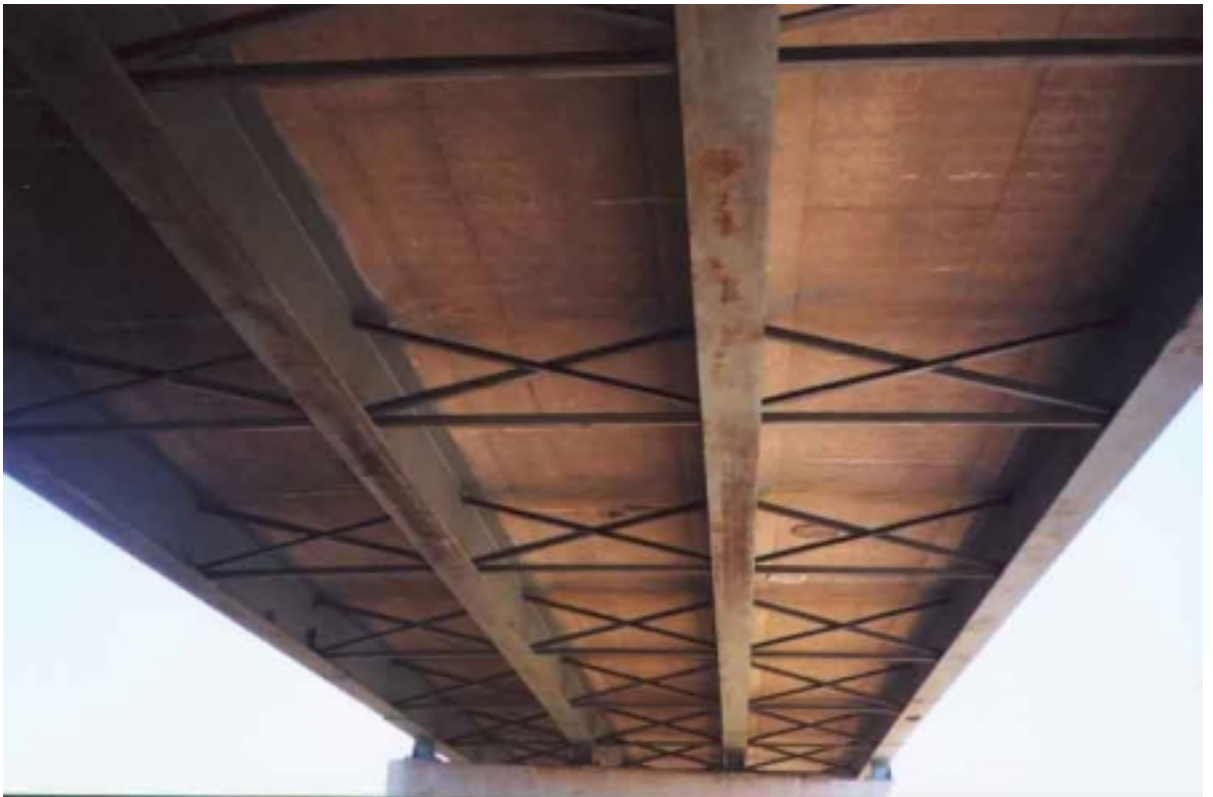
Typical underside

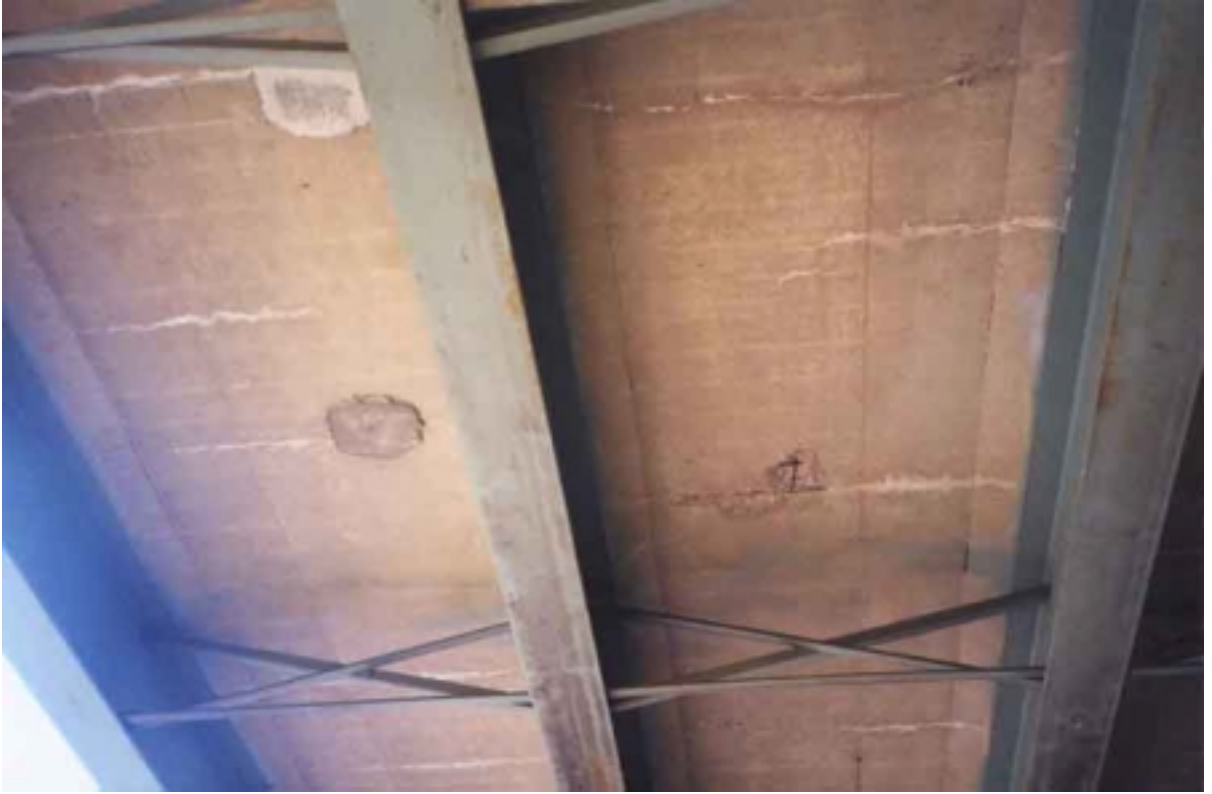
Some previous patched areas; minor spalling; transverse cracks with efflorescence

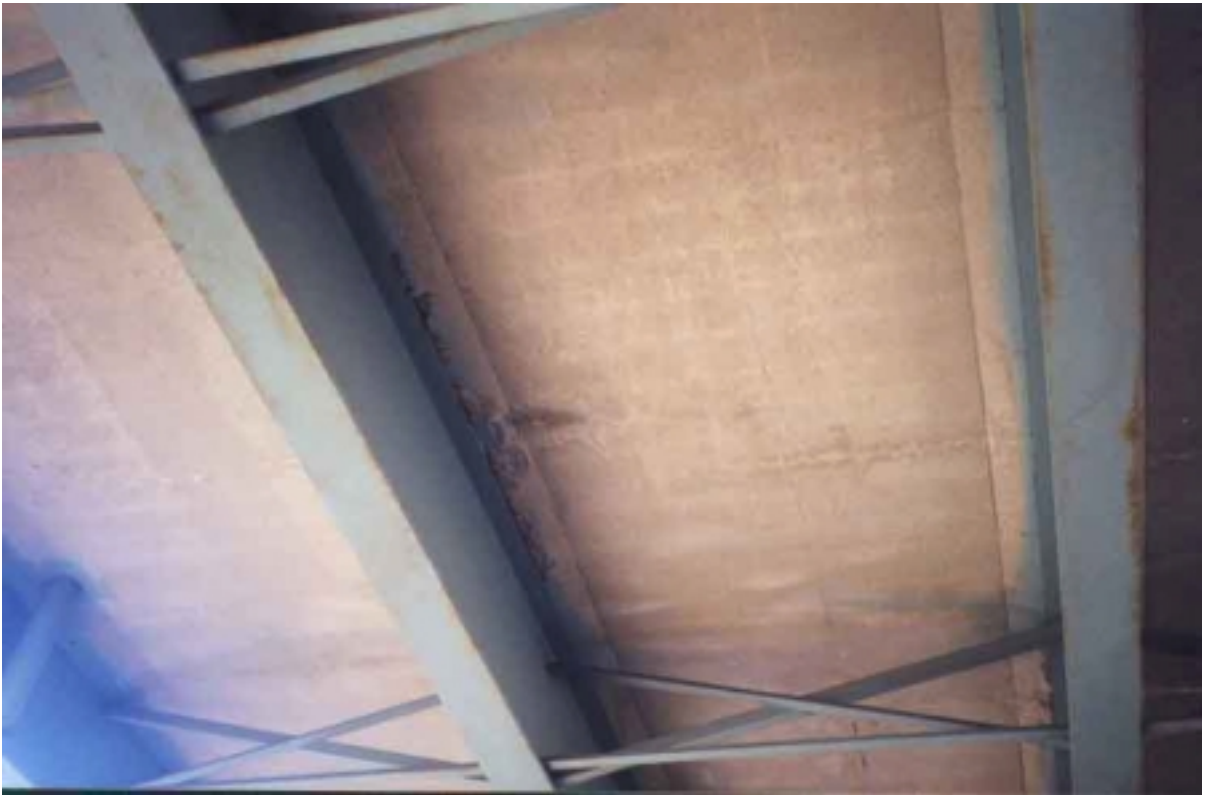
The bottoms of the decks still look very good, except for some minor leakage on HAN-235-0652. It is difficult to determine if the leakage stains were apparent before the overlay was placed or since.

Minor leakage

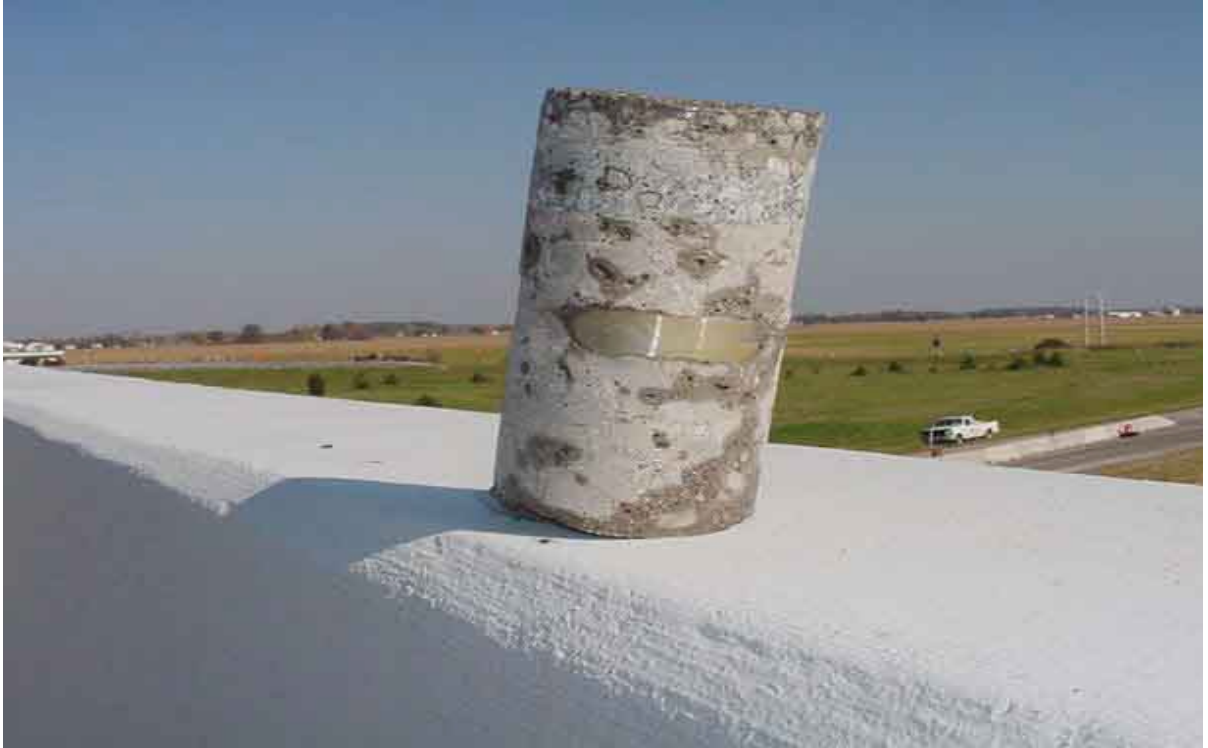
Core taken through the side of a reinforcing bar

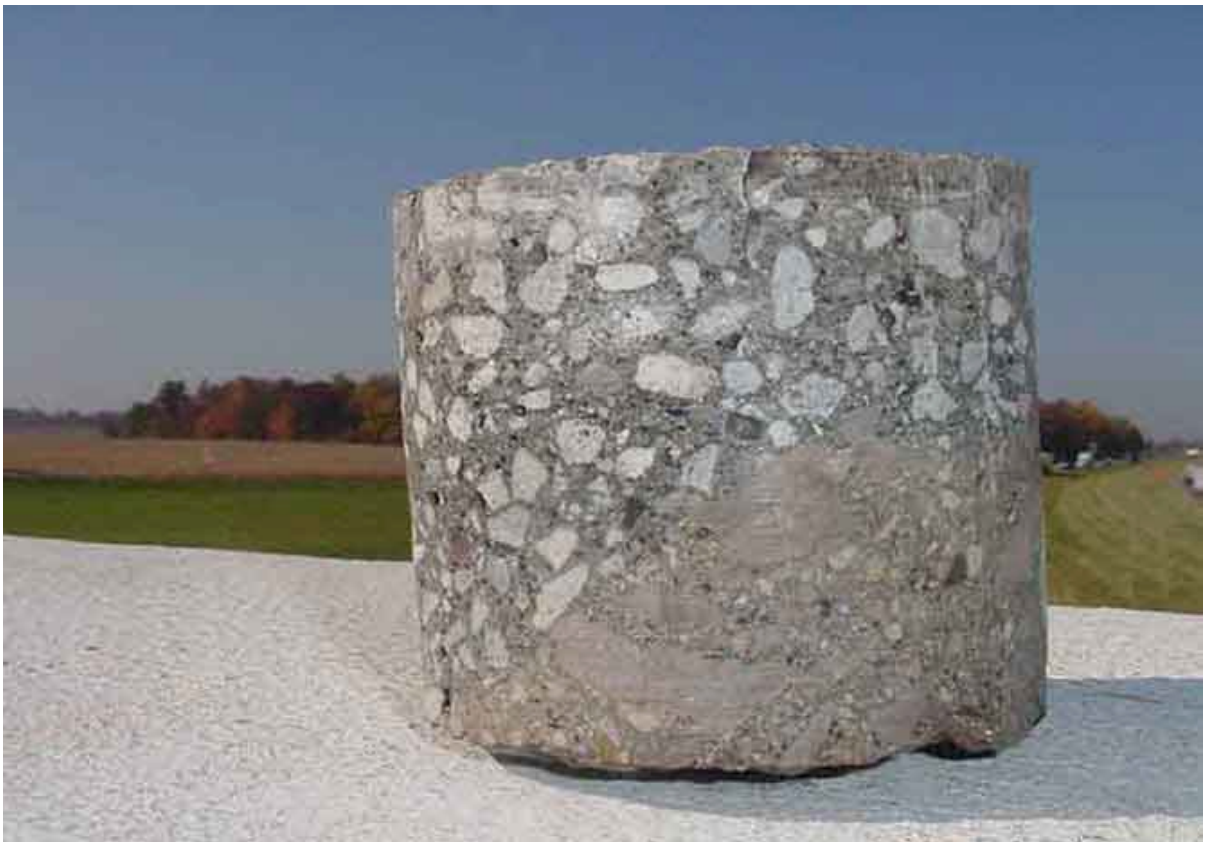
Core showing variable thickness of overlay

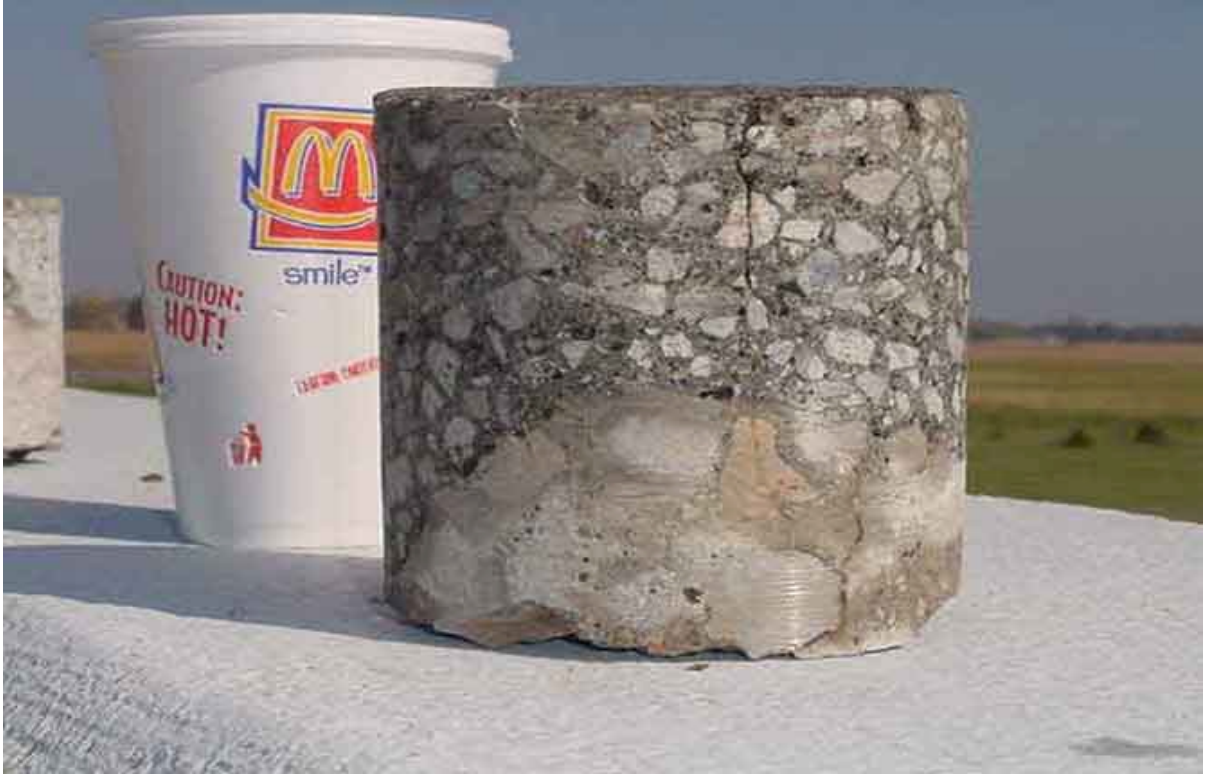
Core taken at crack

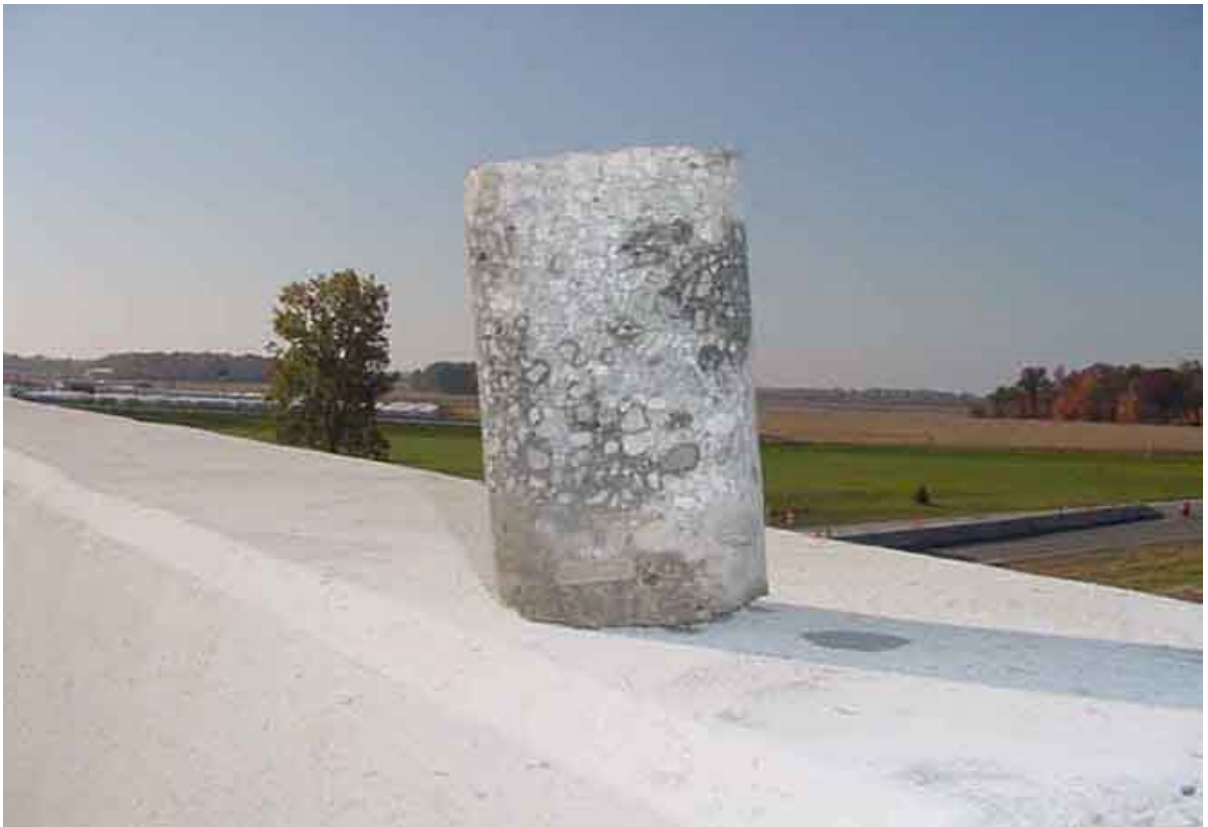
Core taken in variable thickness area

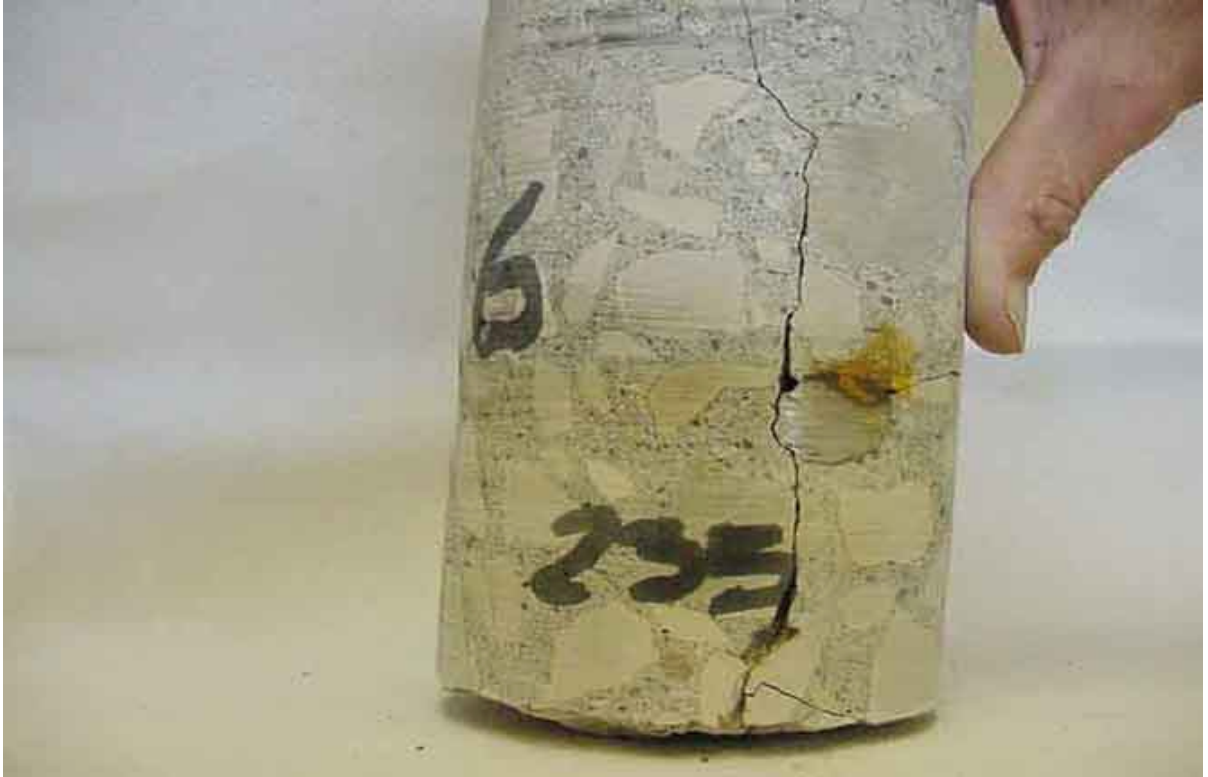
Core showing crack propagating from corroded reinforcing steel in parent concrete

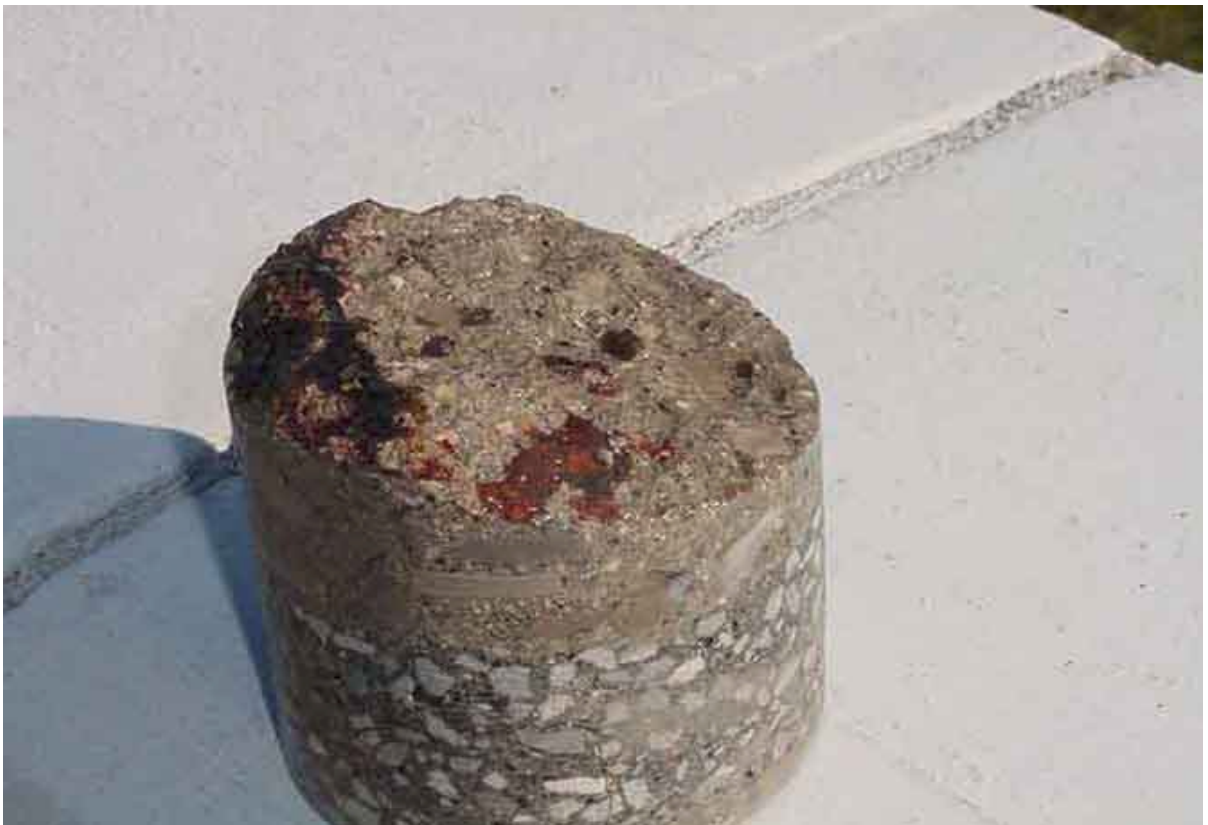
The cores confirmed excellent bond with the original concrete surface. There was some evidence of corrosion taking place on the reinforcing steel, but again, it cannot be determined if this corrosion product was on the bars before the overlay was placed or if it occurred afterwards.

Core showing corrosion at reinforcing steel in parent concrete (upside down core)

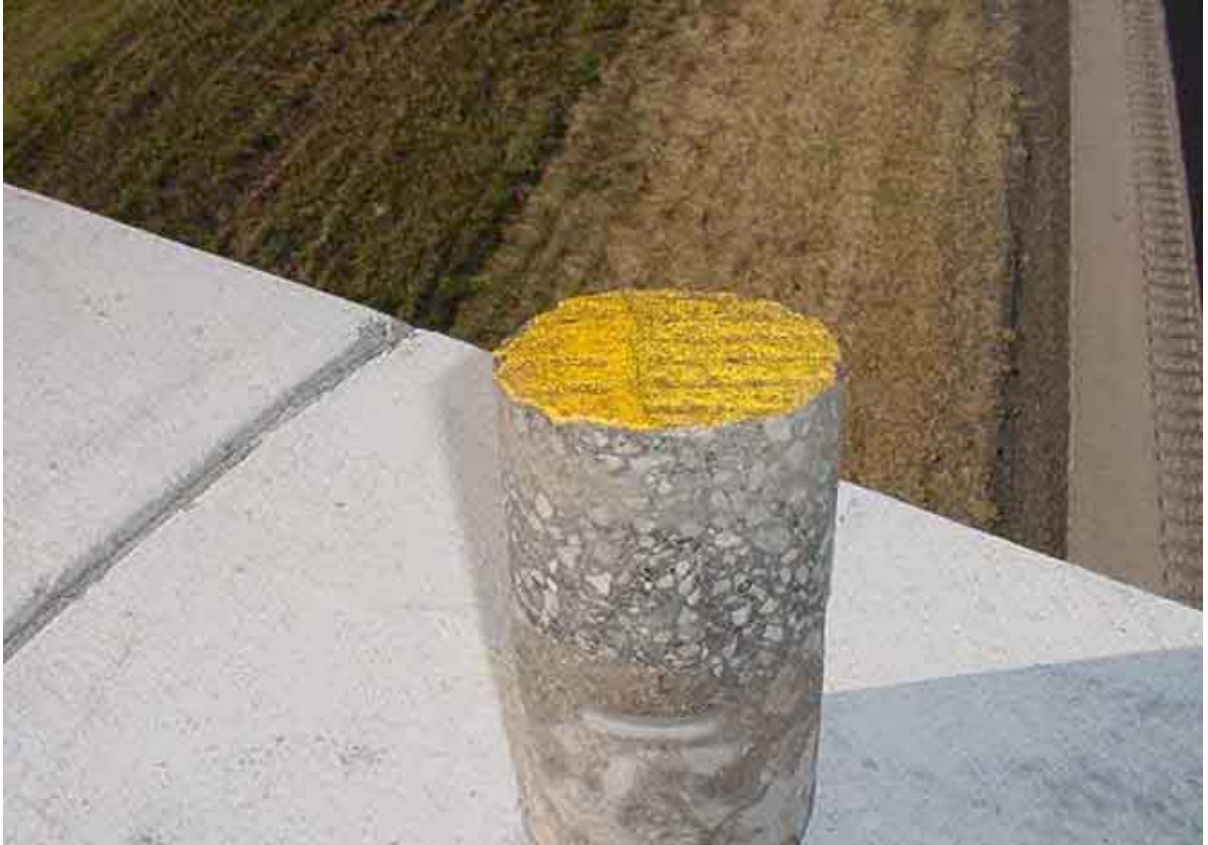
Core broke off at 7 1/2" depth
Taken at centerline (between two pours)
Rebar encountered at 3 1/2" depth
Overlay material was 3" thick
No corrosion noted on rebar
Overlay was well bonded to parent concrete

Core taken at centerline construction joint

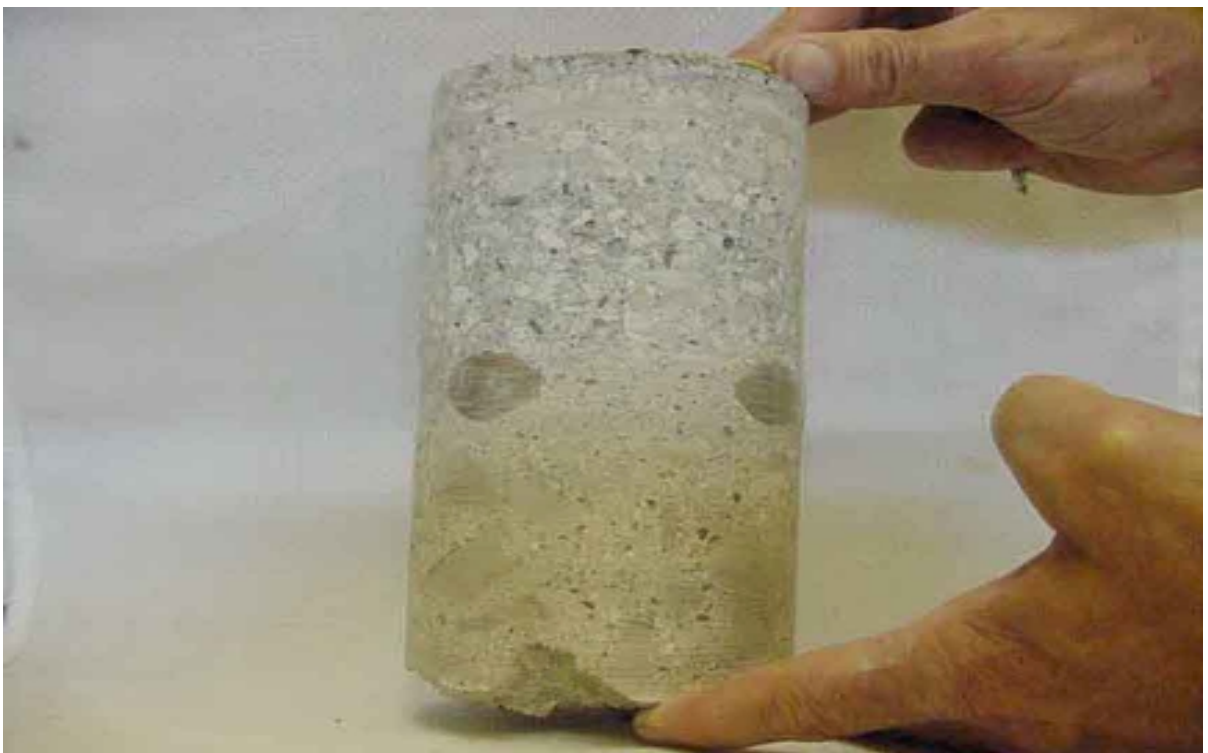
Core showing that not all reinforcing steel indicates corrosion activity

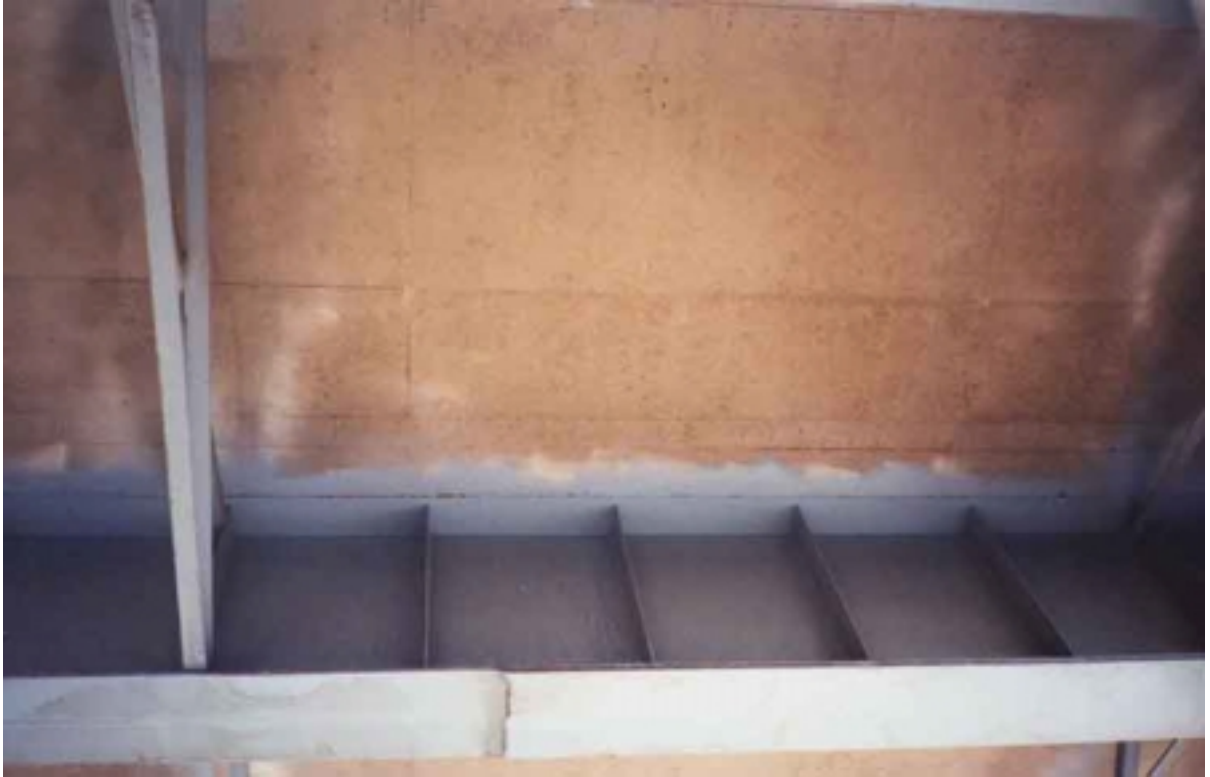
Typical underside condition

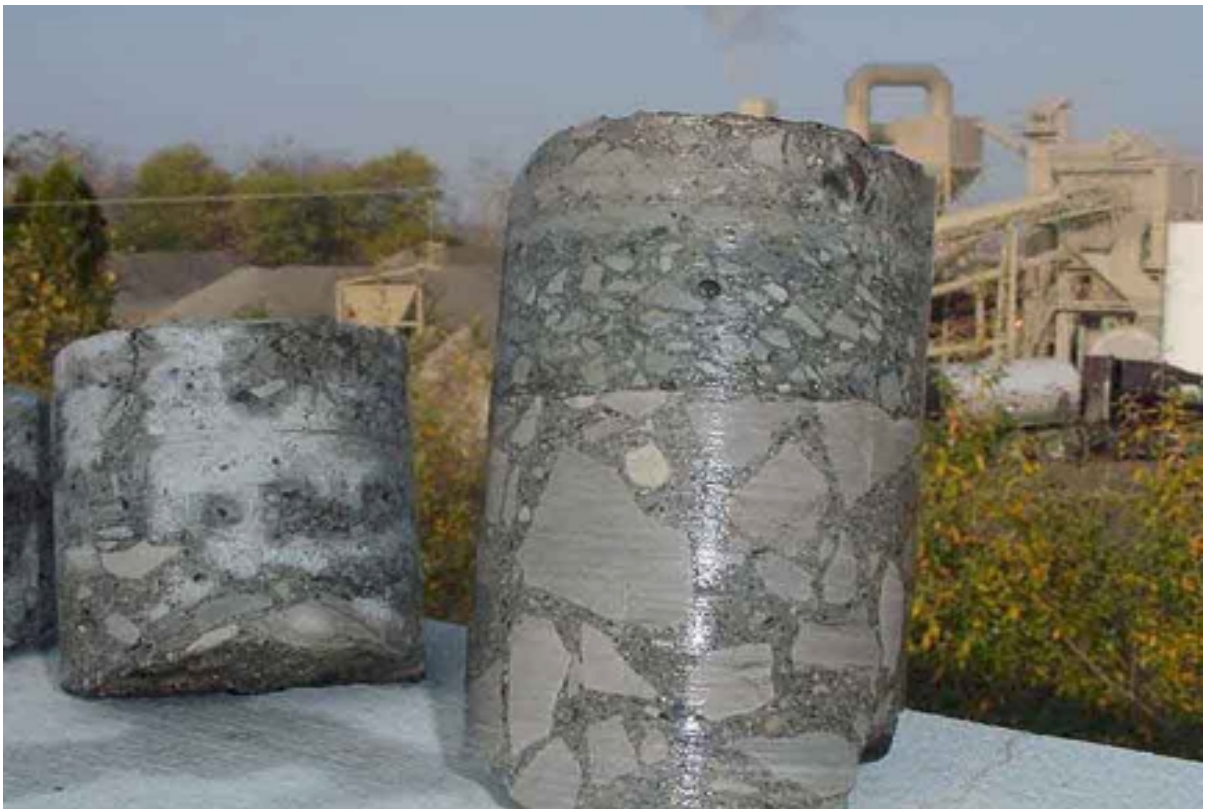
Core showing bond line

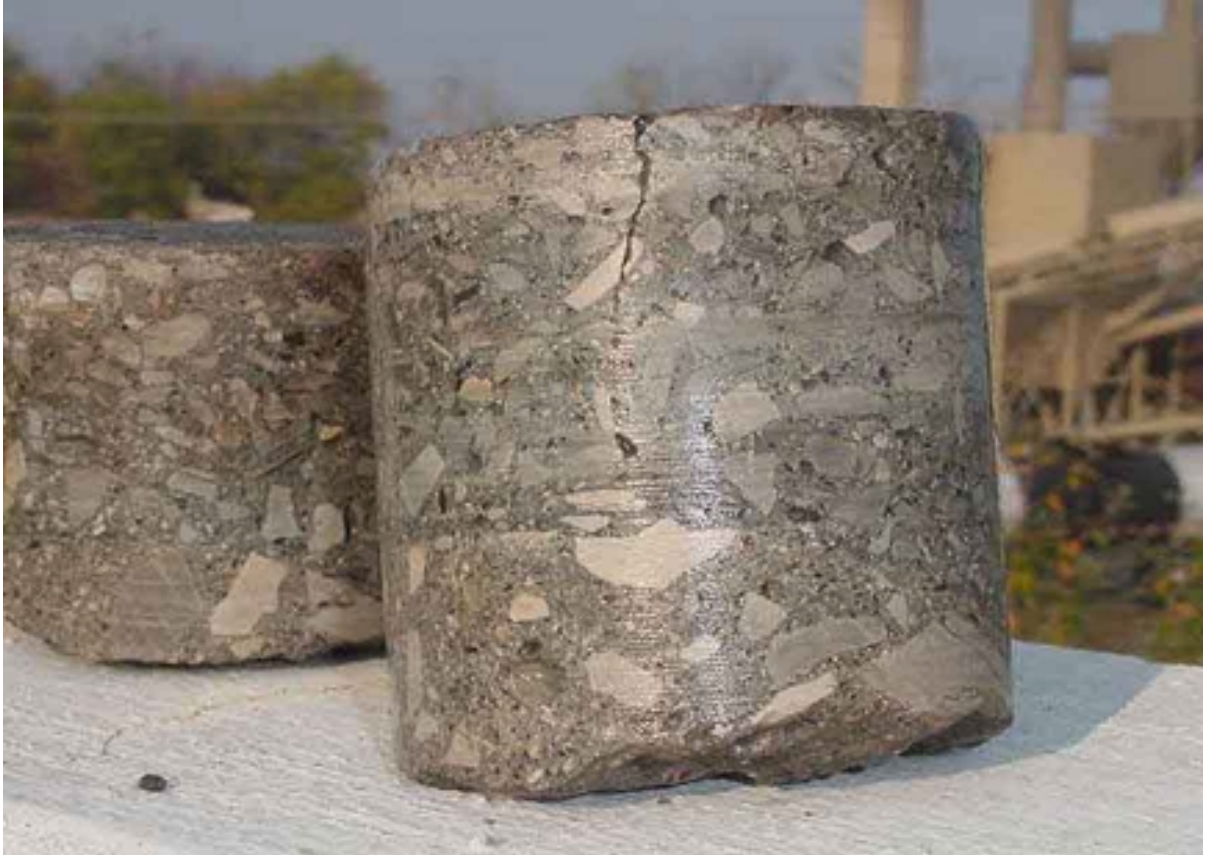
Crack extending part way through overlay

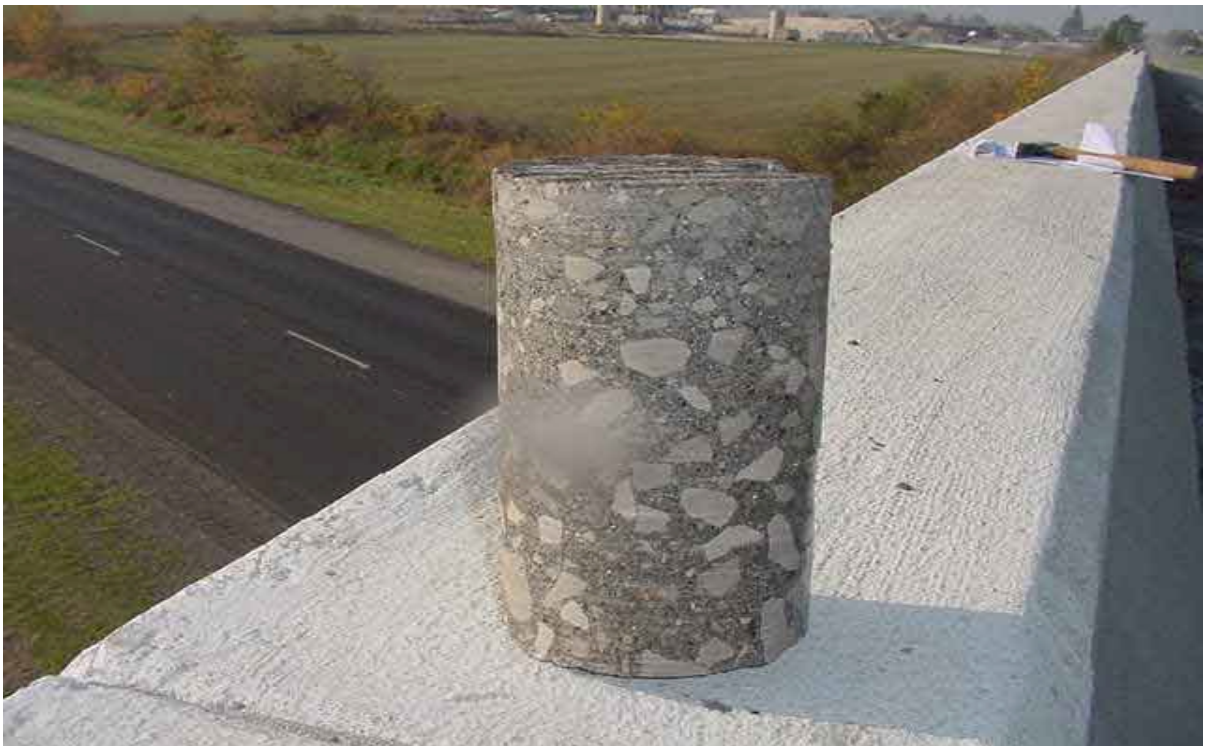
A good core
