*Federal Railroad Administration
Office of Safety
Headquarters Assigned
Accident Investigation Report
HQ-2005-13*

*Amtrak/Canadian National
Roseland, Louisiana
February 13, 2005*

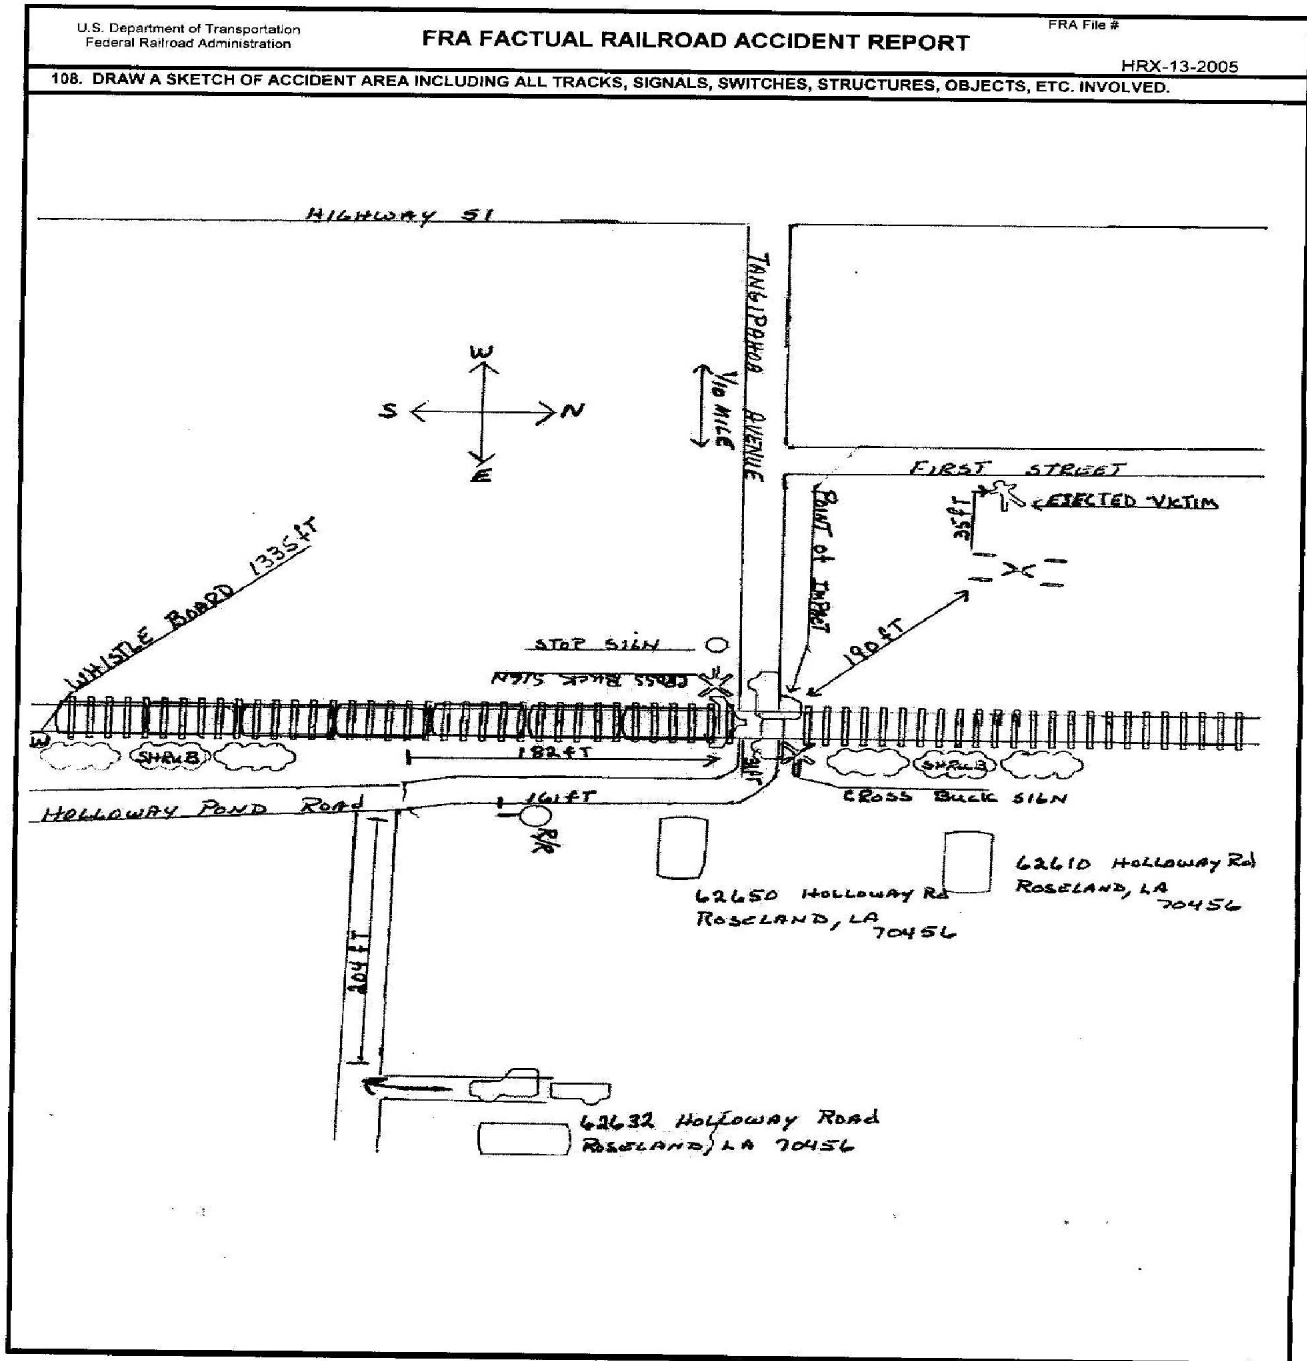
108. DRAW A SKETCH OF ACCIDENT AREA INCLUDING ALL TRACKS, SIGNALS, SWITCHES, STRUCTURES, OBJECTS, ETC., INVOLVED.

The highway-rail grade crossing is 24 feet wide at the crossing boards. This crossing is also the dividing line for the two named streets. On the west side is Tangipahoa Avenue. It starts at the crossing and goes west across Highway 51 or Commercial Street. It is a tangent road with an asphalt surface. On the east side is Holloway Road. The road starts at the crossing making a 90 degree right turn and goes south one and a half mile to Duncan Street. This road is an asphalt surface road then turns into a gravel road about 182 feet from the crossing. Holloway Road is also used as the main entrance to a cypress mill.

The driver of the vehicle approached the crossing in the following succession, traveled 204 feet west from a side street to Holloway Road, made a right turn, traveled 182 feet north, approached an advance railroad warning sign at 161 feet from the crossing. After encountering a left hand curve with an ascending grade near the crossing, the driver had to stop to yield, at which point he was roughly 27 feet from nearest rail. After stopping to yield, the driver had a site distance of about 1788 feet for a train approaching the crossing from the south. The posted speed limit for Holloway Road is 20 mph.

The collision occurred because the driver of the pickup truck failed to stop at the highway-rail crossing at grade, as required by Louisiana Statute 32:175. The driver having to encounter a 90 degree curve with an ascending grade just 35 feet from the highway-rail grade crossing may have been a contributing factor.
