**LEVEL 1 ACCIDENT INVESTIGATION REPORT**  
**OF AUGUST 17, 2004**  
**FATAL AIRCRAFT ACCIDENT**  
**ON THE**  
**GRAND COULEE-BELL NO. 6**  
**500 kV LINE**

**FINAL REPORT**  
**OCTOBER 1, 2004**

**BPA**  
**Level 1 Aircraft Accident, August 17, 2004 in Mead, WA**  
**FINAL REPORT**

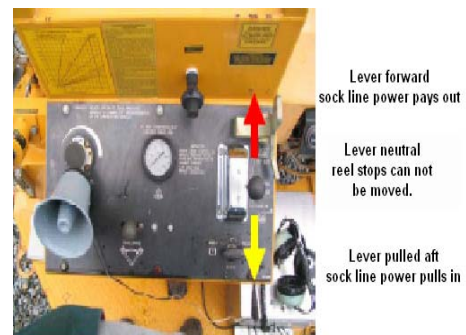
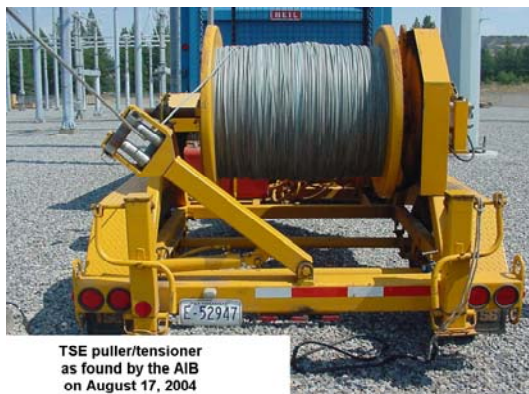
TSE puller/tensioner as found by the AIB on August 17, 2004

The aircraft had traveled approximately 700 feet from the puller/tensioner when a snag on the reel occurred. The snag caused the sock line to double back onto the reel. Instead of paying out toward the helicopter, even though the reel rotation was in the proper direction, the line was being pulled in. The reel operator sensed the machine lugging down and then noted the snag. He immediately attempted to shift the power lever to neutral, but he overshot the neutral detent (lever stop position) and went into reverse. At the same time he radioed, "Hold the pull."

Evidence indicates that for approximately six seconds, the reel machine had pulled about 36 feet of sock line back onto the reel. Then, when the TSE reel operator shifted the lever through neutral to reverse, the rope once again snagged and doubled back on itself, pulling in an additional 9 ft. 7 in. of sock line, before the TSE was shut down. (The Accident Investigation Board (AIB) believes the last 9 ft. 7 in. of rope was reeled in after the helicopter's longline was cut by the Kaiser 13.8-kV overhead static line.) This was the condition in which the AIB found the equipment, see photo at left.

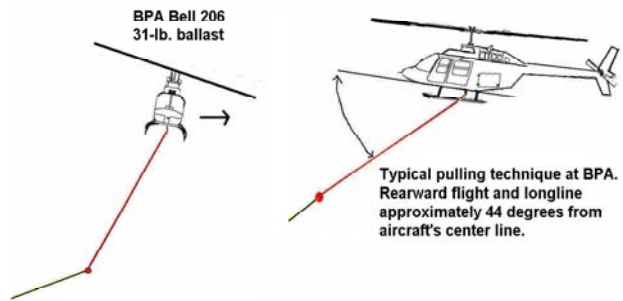
“Load rigging methods can have a broad impact on the Center of Gravity and flight dynamics of the load.<sup>3</sup>” BPA typically uses 25 to 150 feet of longline, a 31-lb. ballast weight, and a 14-lb. remote cargo hook. Total weight of the ballast, remote hook and shackles together was 45 pounds. BPA’s use of this equipment limited the operation of the Bell 206 aircraft during sock line pulls to rearward flight. The reason for flying rearward is that the ballast weight is not heavy enough to maintain a 90 + or – 15 degree angle between the helicopter’s horizontal centerline and the longline (see picture below).

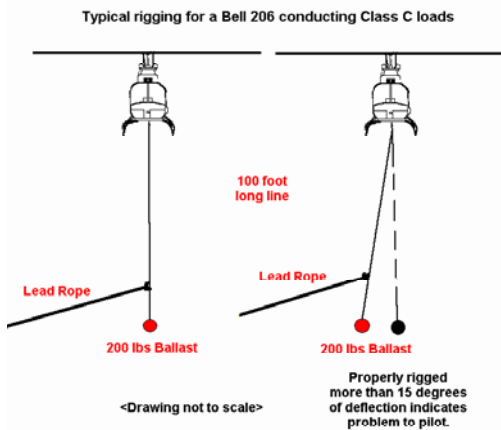
Ballast not heavy enough, forcing helicopter to add more lateral thrust to pull sock line.  
 Extended flight using this method causes damage to engine-to-transmission drive shaft.

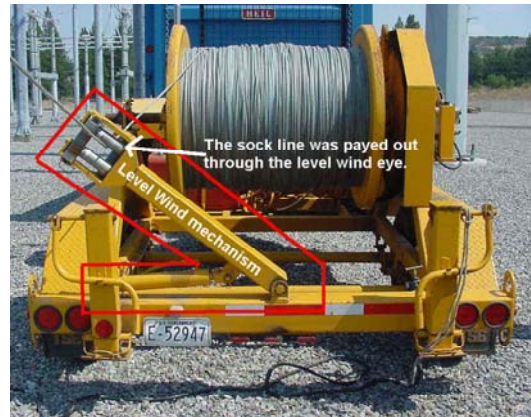
Use of the level wind in payout mode (power or free wheel) restricts the operator's view of the sock line where it comes off the reel. This also gives the operator another control to manage because the level wind is manually operated, distracting his attention from the sock line and reel. The level wind in the pay out mode adds another point of suspension and friction to the sock line increasing the possibility of a snag reversing the direction of the sock line.

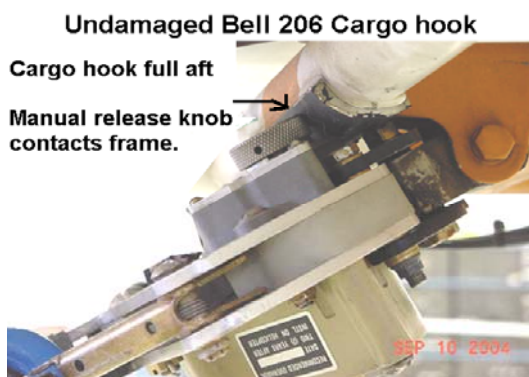
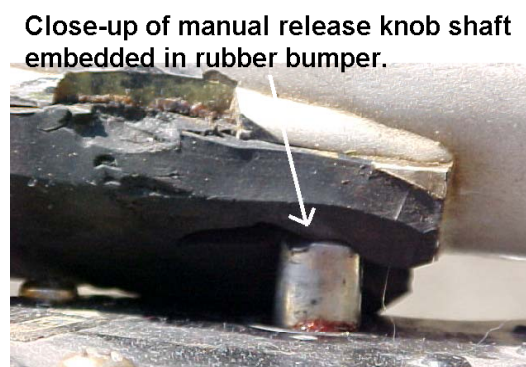
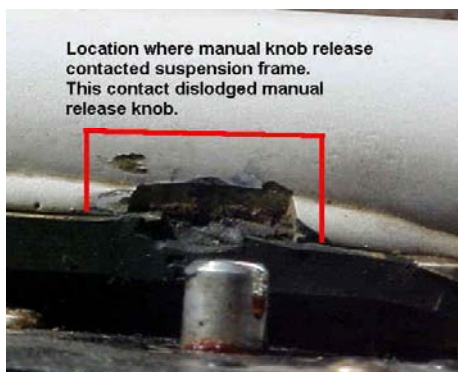
The postaccident investigation and analysis revealed that when the belly cargo hook is pulled full forward, the plastic housing encasing the electrical release connection and solenoid contacts the cargo suspension frame. This contact can--and in the case of the accident helicopter, did--cause damage to the housing where the cannon plug is located. When the belly hook is pulled full aft, the manual release knob contacts the frame. On the accident helicopter, the force was great enough to force the knob off in flight.

This allowed the exposed shaft where the knob is mounted to become embedded in a rubber bumper mounted on the suspension frame. Tests were done with the accident helicopter's cargo hook in the full aft position with the shaft embedded in the rubber bumper. The test proved that the electric solenoid could not open the hook. The same tests were conducted on a flyable Bell 206BIII's cargo suspension system, except with the manual release knob installed, and the results were identical. However, the manual release connected to the T-handle would work under the same conditions.

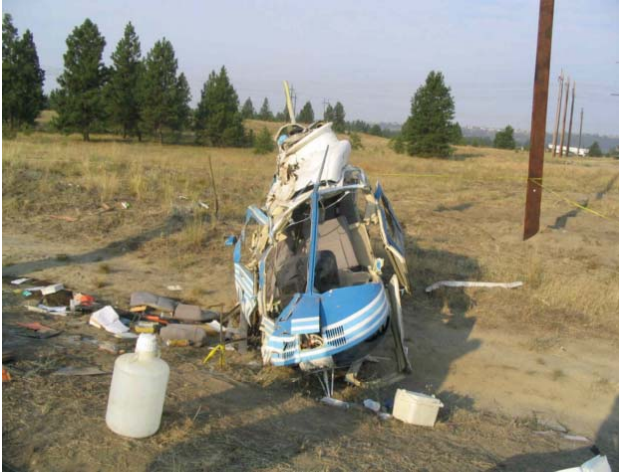
Front View. Looking westerly.

Aircraft was moved to extract pilot. The aircraft was pulled upright and tail end moved onto roadbed. This placed the nose heading ENE, original heading at impact 003 degrees.

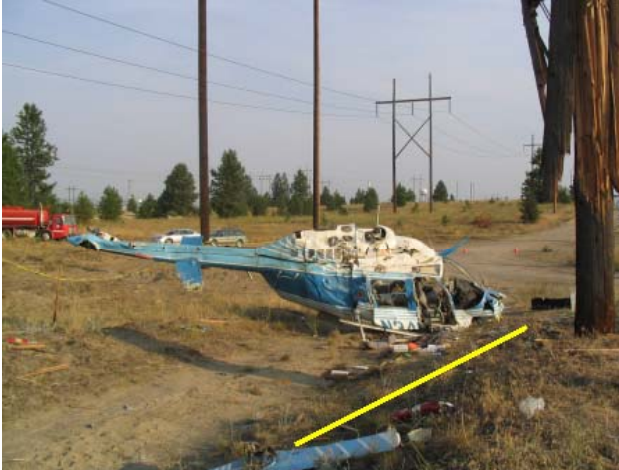
Right Side View. Looking north.

Yellow line indicates actual impact. The impact was hard enough to create a small depression, which is visible underneath yellow line.

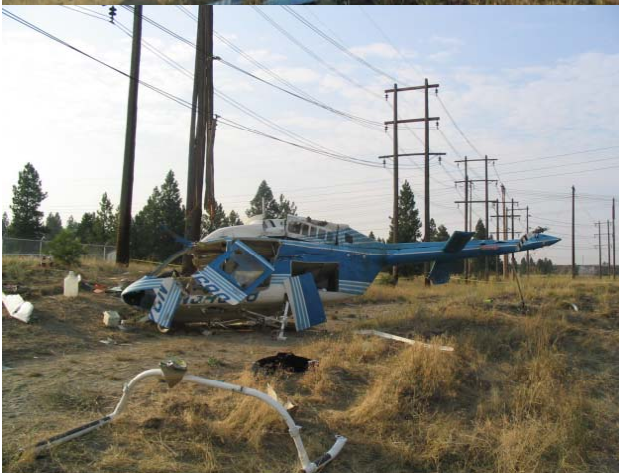
Left Side View. Looking south.

Red M/R blade struck upper cabin at left door post. Rescue workers pulled door off during extraction of pilot.

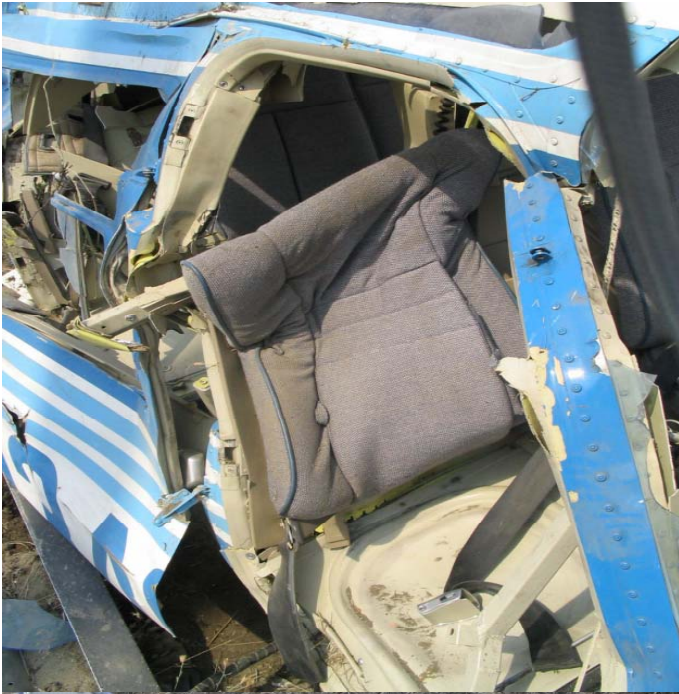
Right side close up shows extent of upper cabin crushing exposing pilot seat to ground impact.

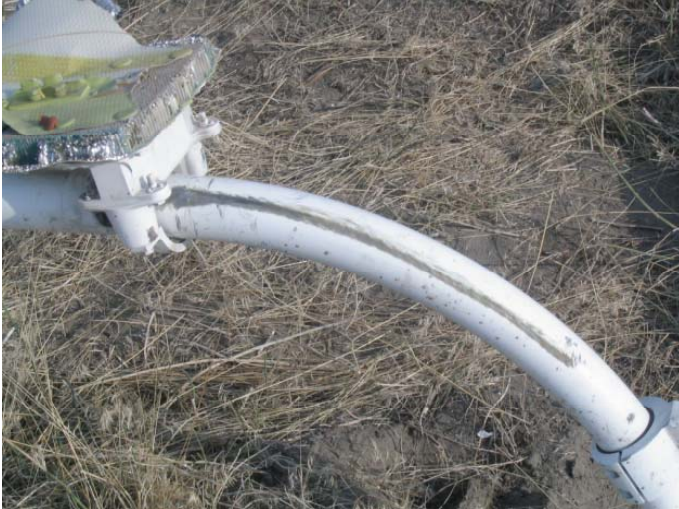
Left front cross tube scuffing is where landing gear caught on second conductor of 13.8 Kv Kaiser Feeder power line.

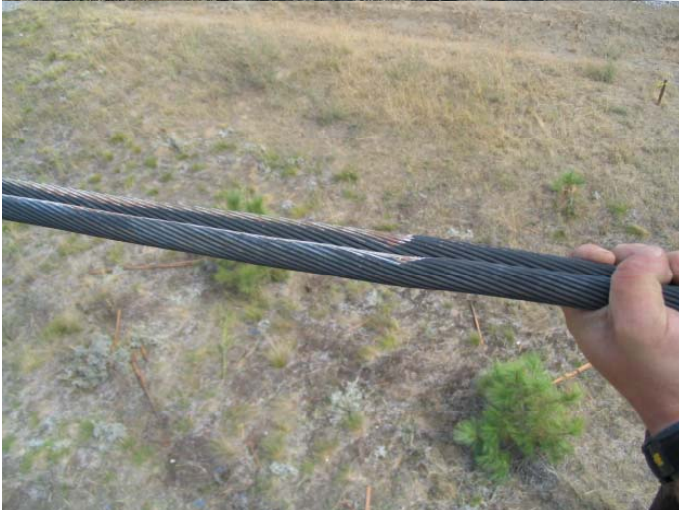
Picture of 13.8 Kv Kaiser power line (second conductor) shows paint transfer from left cross tube and indications of direction as cross tube moved across before tearing loose from aircraft.

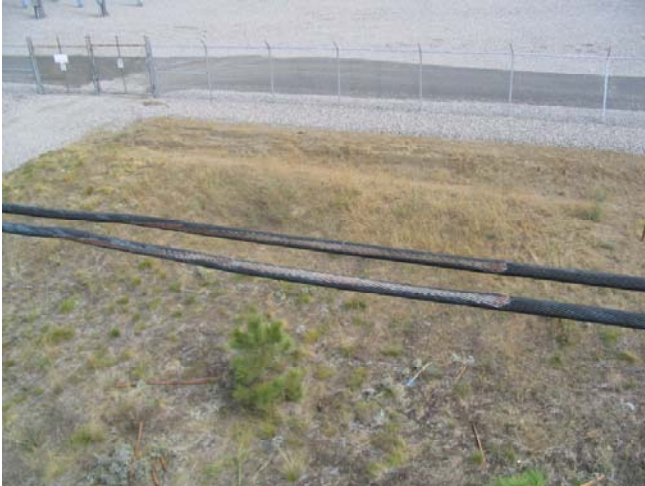
Close up picture of 13.8 Kv Kaiser power line (second conductor) showing paint transfer from left cross tube and indications of direction as cross tube moved across before tearing loose from aircraft.

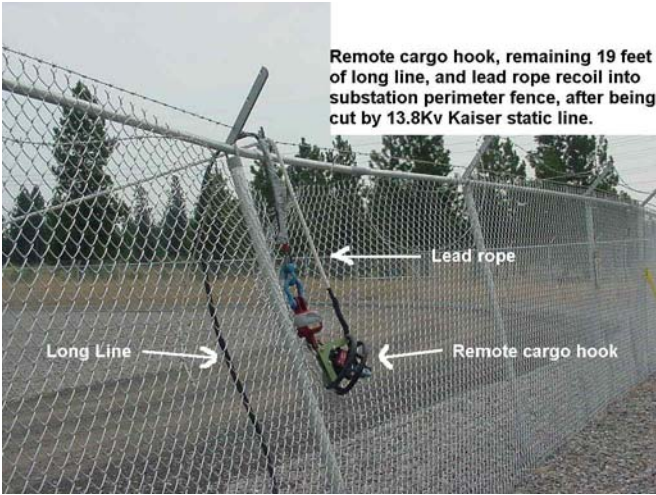
Remote cargo hook, remaining 19 feet of long line, and lead rope recoil into substation perimeter fence, after being cut by 13.8Kv Kaiser static line.

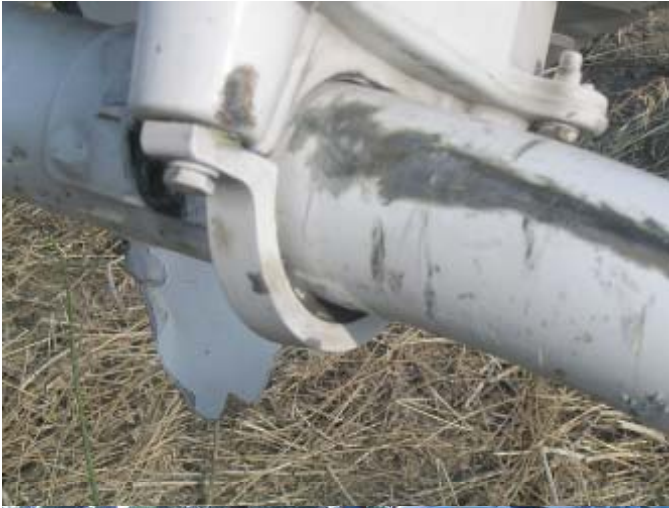
Close up of left front cross tube showing scuffing and where landing gear caught and was torn out of aircraft's underside.

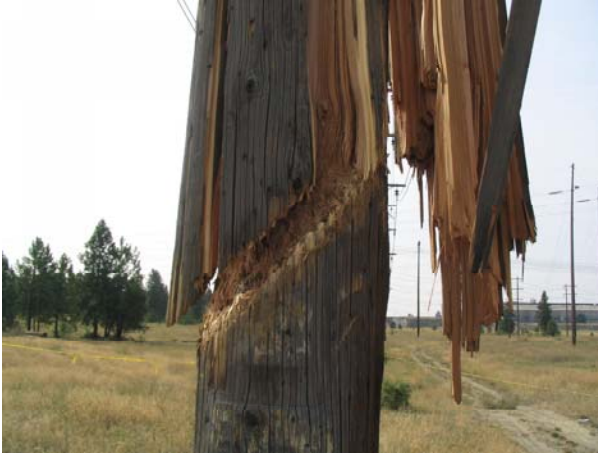
13.8 Kv Kaiser Feeder power line west pole showing red M/R blade strike when aircraft was inverted.

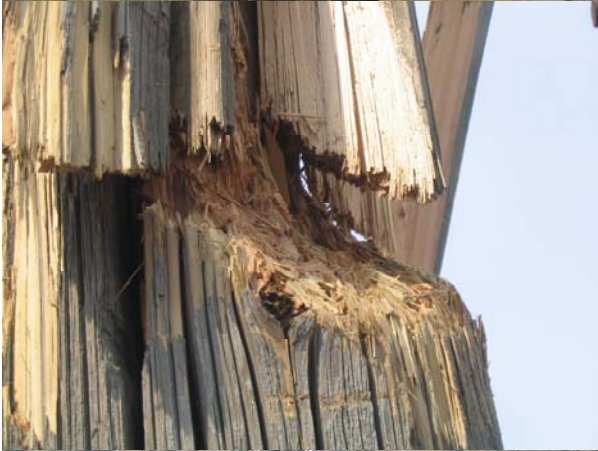
Close up of red M/R blade strike looking due west. M/R was under full power when it struck pole.

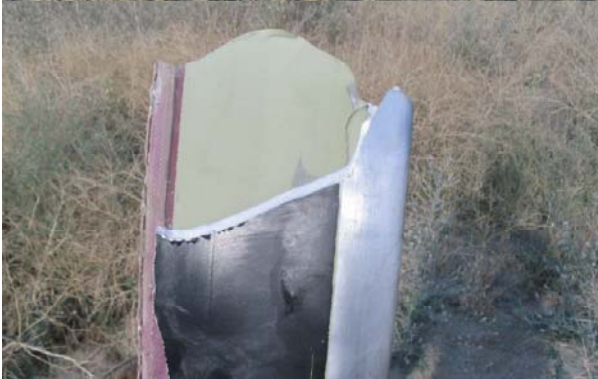
Photo of red M/R blade showing where blade wrapped around pole prior to braking.

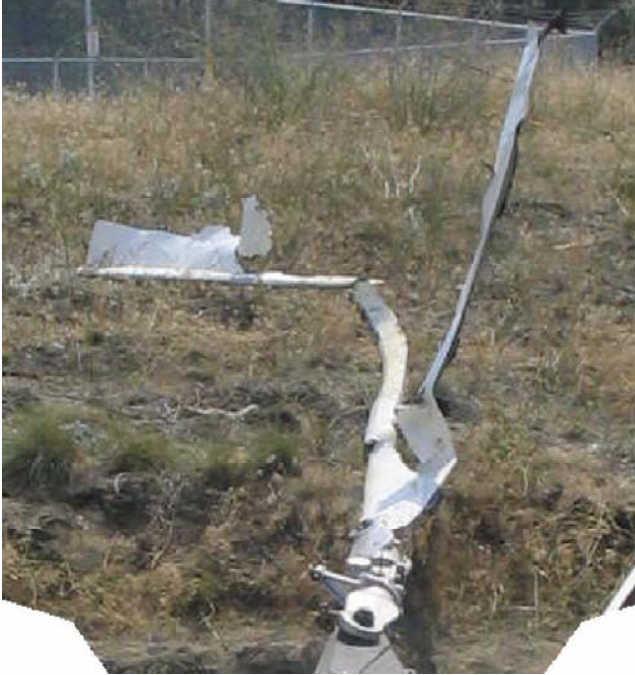
Below all parts of the main rotor system are placed next to each other. White blade is on left. White M/R blade tip was embedded in the dirt just forward of the cabin. (See wreckage map Appendix 4)

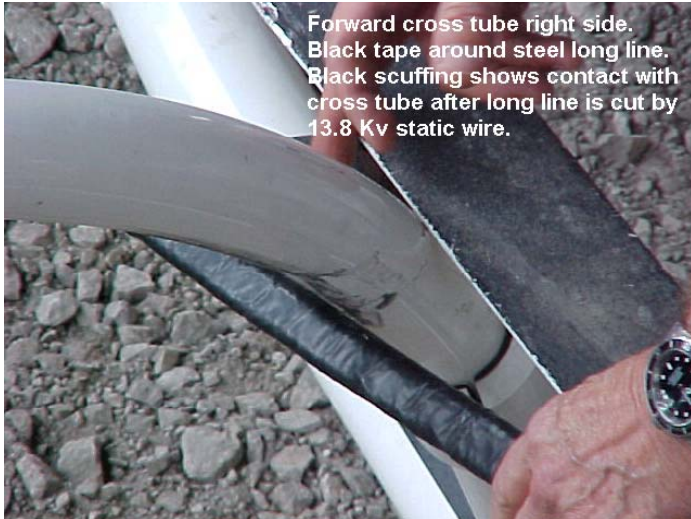
Forward cross tube, right side.

Forward cross tube right side.  
Black tape around steel long line.  
Black scuffing shows contact with  
cross tube after long line is cut by  
13.8 Kv static wire.

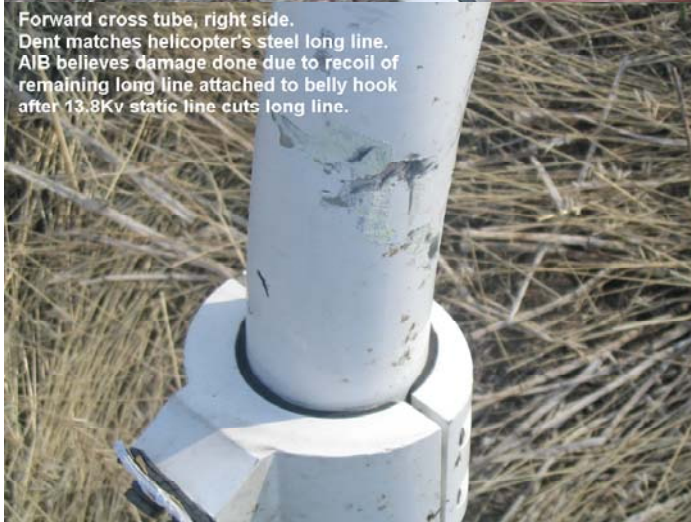
Forward cross tube, right side.  
Dent matches helicopter's steel long line.  
AIB believes damage done due to recoil of  
remaining long line attached to belly hook  
after 13.8Kv static line cuts long line.

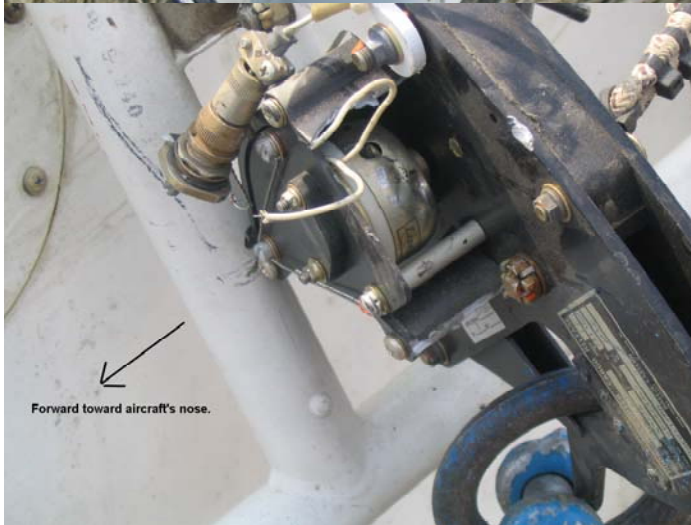
Forward toward aircraft's nose.

Aircraft's belly cargo  
hook. Pilot's electric  
release disabled due to  
contact with cargo  
suspension frame.  
Solenoid dents due to blue  
clevis bolt contact.

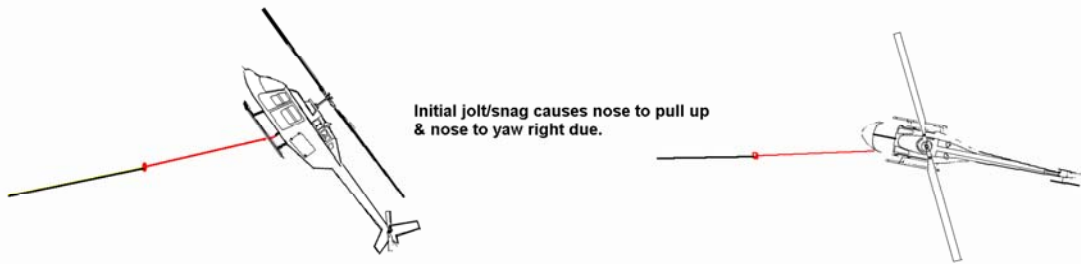
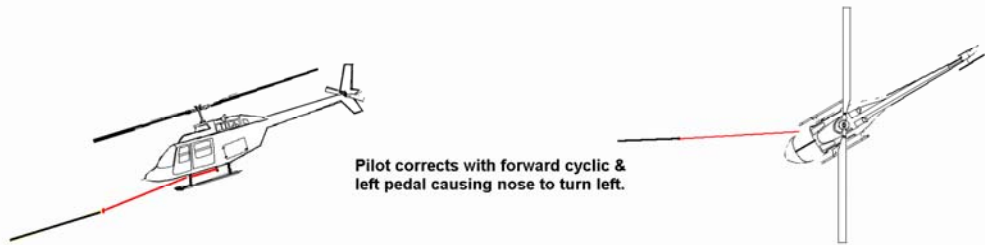
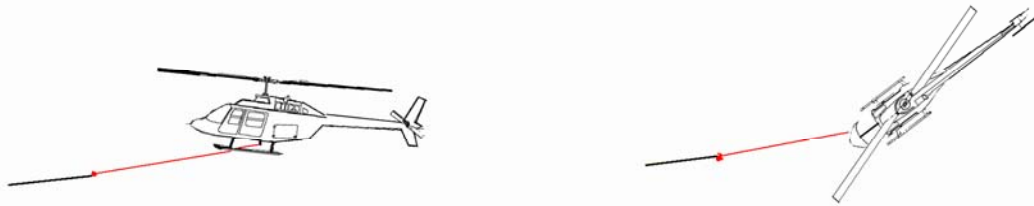
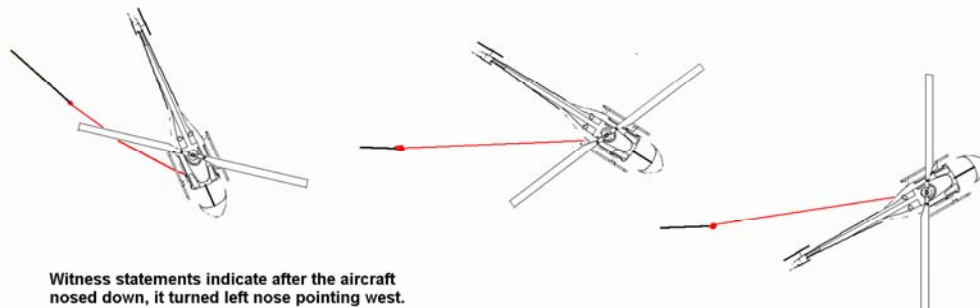
Based on post accident analysis this is the position of the aircraft when it struck the upper cross arm of the Kaiser 13.8Kv power line.
